National Transportation Safety Board

Railroad Accident Brief

CSX Transportation Coal Train Derailment Killed Two Individuals

Accident No.:	DCA12MR009
Location:	Ellicott City, Maryland
Date:	August 20, 2012
Time:	11:54 p.m. eastern daylight time
Train:	CSX Transportation coal train U81318
Railroad:	CSX Transportation
Property Damage:	\$1.9 million
Injuries:	0
Fatalities:	2
Type of Accident:	Derailment

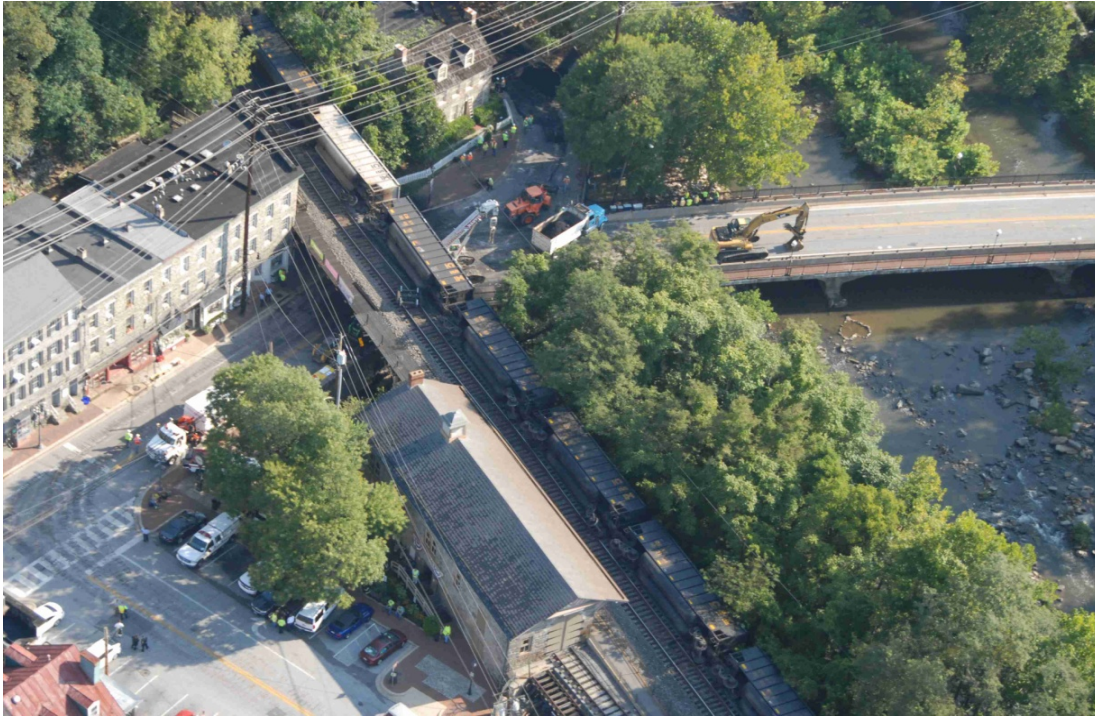
On August 20, 2012, about 11:54 p.m. eastern daylight time, an eastbound CSX Transportation (CSXT) coal train, U81318, derailed the first 21 cars at milepost (MP) 12.9 while crossing the railroad bridge over Main Street on the Old Main Line (OML) Subdivision in Ellicott City, Maryland.^{1,2} The train consisted of two locomotives and 80 loaded coal cars; the train length was 4,227 feet and the weight was 9,873 trailing tons. Seven of the derailed cars fell into a public parking area that was below and north of the tracks. The remainder of the derailed cars overturned and spilled coal along the north side of the tracks. (See figure 1.)

Figure 1. Derailed train on the railroad bridge. (Photo by the Howard County Police Department)

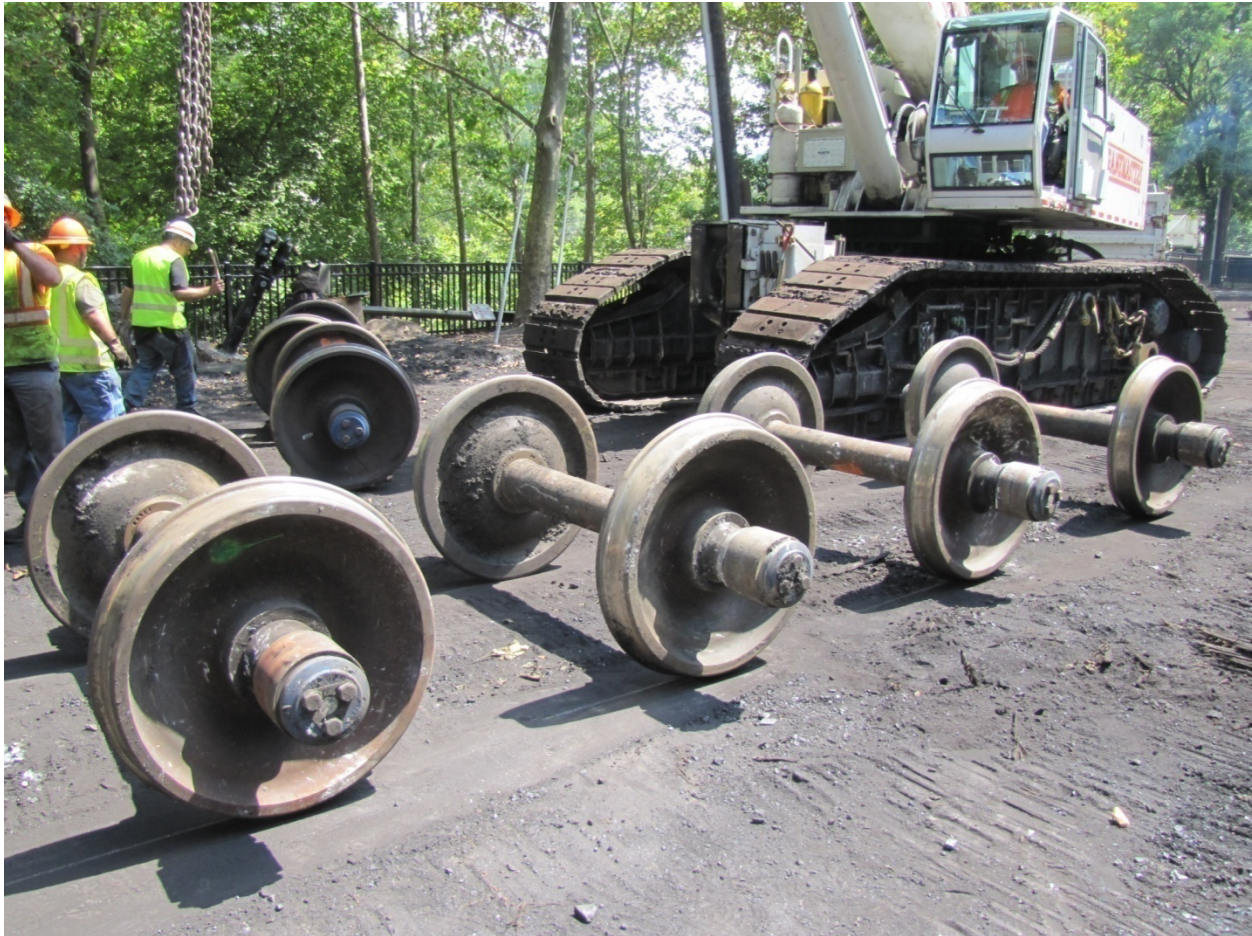
Investigators noted that many of the examined wheels had witness marks that were similar to those found on cars 1 through 10. Investigators positioned the wheels from the 12th car (CSXT 302724) as the wheels would have been while traveling through the derailment area. (See figure 2.)

Figure 2. Wheel sets from car CSXT 302724.

On close examination, investigators observed several perpendicular strike marks in the wheel tread of the third set of wheels that indicates a track-related defect. These marks were the first to have a pattern of successive impacts that were about 3 inches apart. (Marks were not found on the wheels of first and second set of axles.) In addition, a corresponding mark, or a mark on the adjacent wheel in the same horizontal plane of reference, was observed on the L3 wheel (the second wheel on the right side of the car in the direction of travel), located on the outside rim of the wheel.

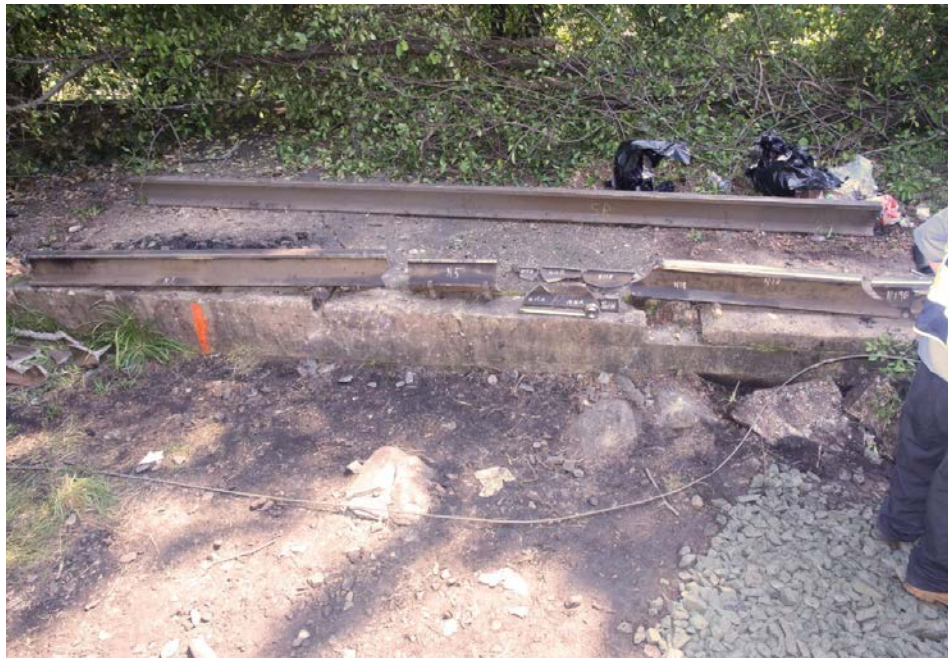
Investigators pieced together and examined the recovered rail. The entire south rail was reconstructed. While reconstructing the west portion of the north rail, investigators found that about 5 inches of rail were missing (and could not be located in the derailment debris). Based on the inspection data for July and August 2012, investigators estimated that the length of rail from the west end of piece N1 to the location of the repaired defect in N19 was about 17 feet 1 inch (205 inches).

Figure 3. View of rail rebuild.

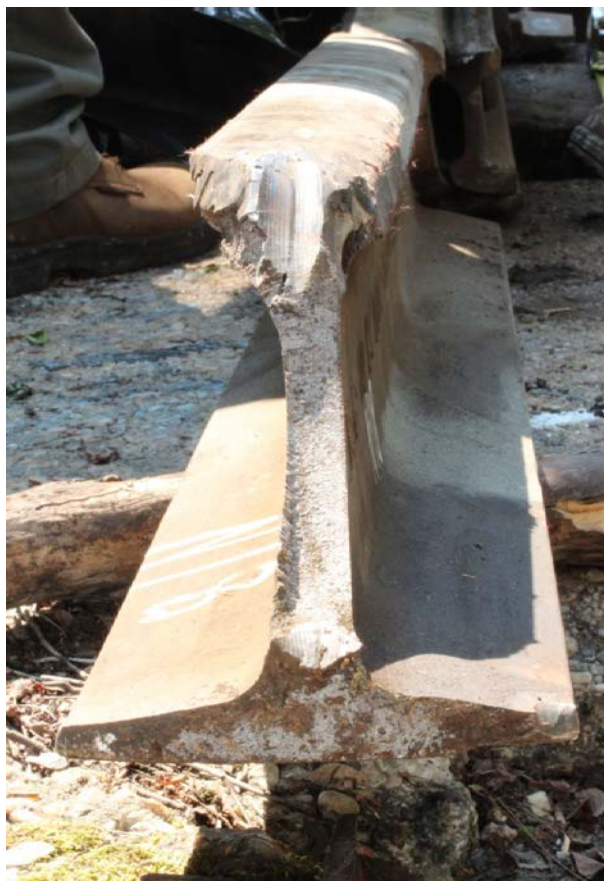
The rail under the derailed cars was destroyed. Some sections of the broken rail had indications of overstress fractures that are characterized by a shiny, granular appearance with sharp edges around the freshly exposed metal. In addition, a section of broken rail that was found under car 21, had the appearance of recent longitudinal loading at the exposed edge of the rail head that is consistent with wheel tread impacts.^{4,5}

Figure 4. Cross-sectional view of a severe wheel flange strike mark on the head of a broken rail.

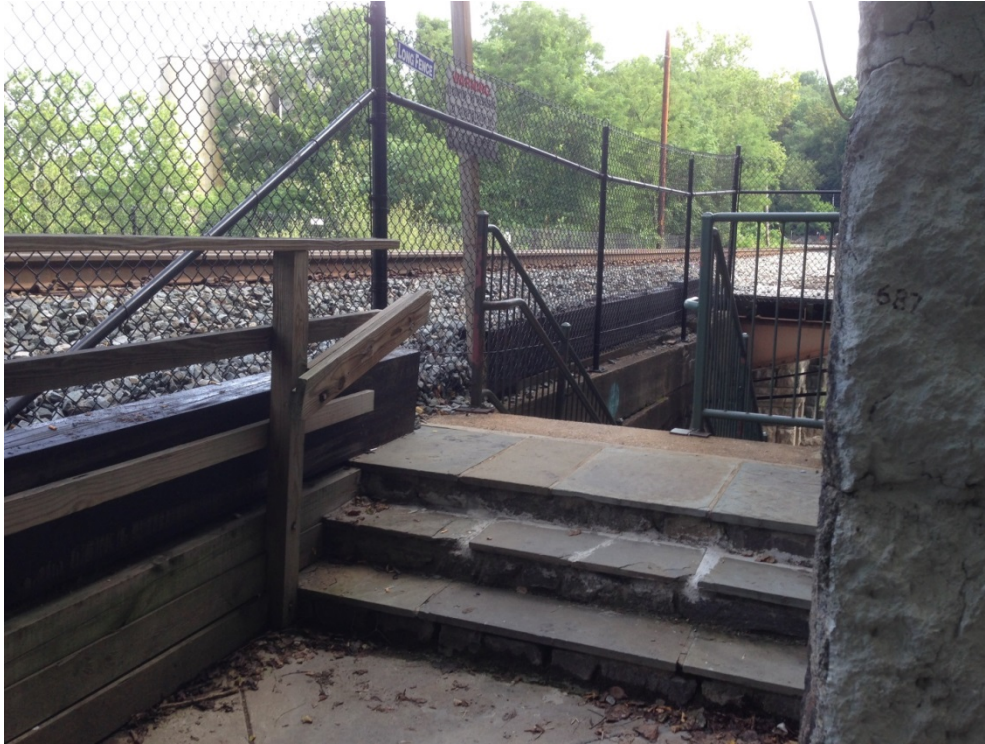
Figure 5. The chain-link fence installed along the railroad right-of-way to deter trespassing.

After the accident, CSXT installed a chain-link fence along the right-of-way in an attempt to deter future trespassing. (See figure 5).
