National Transportation Safety Board

Safety Recommendation

In reply refer to: A-09-55 through -60

On September 19, 2008, about 2353 eastern daylight time, a Bombardier Learjet 60 (Learjet 60), N999LJ, operated by Global Exec Aviation, overran runway 11 while departing Columbia Metropolitan Airport, Columbia, South Carolina.¹ The pilot, copilot, and two of the four passengers were killed; the two other passengers were seriously injured. The aircraft was destroyed by postcrash fire. Visual meteorological conditions prevailed, and an instrument flight rules flight plan was filed for the 14 *Code of Federal Regulations* (CFR) Part 135 nonscheduled domestic passenger flight to Van Nuys, California.

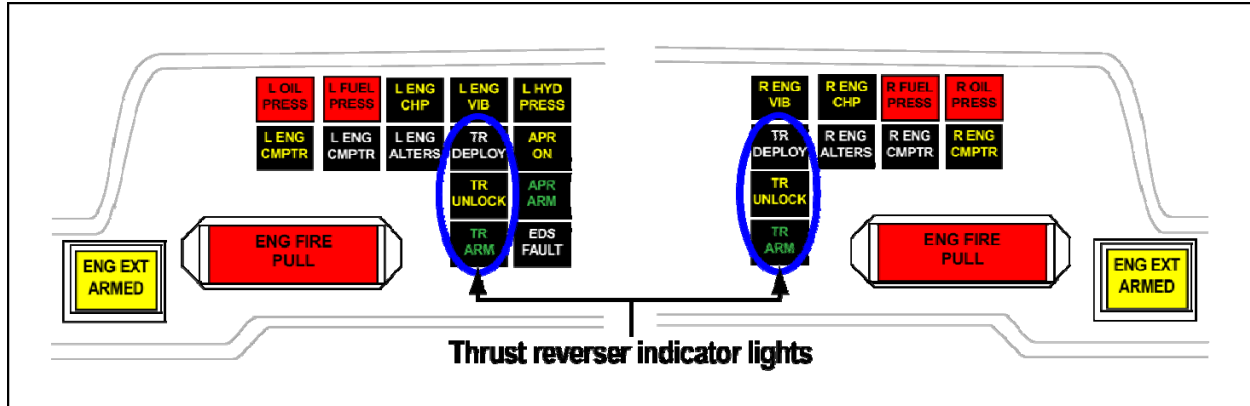
Normally, six lights⁷—three for each engine—will illuminate on the forward instrument panel to indicate the status of the thrust reversers (see figure). Each bottom light (TR ARM) is green and indicates that prerequisites for reverse thrust exist, such as the availability of hydraulic pressure to deploy the engine thrust reversers. Two of the conditions that trigger the TR ARM lights and that would be apparent to the pilots were that (1) the squat switches sense that the aircraft is in ground mode, and (2) the engine power levers are in the idle positions. The TR ARM lights denote that the reverse levers can be moved upward if the pilot elects. Because these lights are normally on when the engines are at the idle position on the ground and go out whenever the engine power levers are moved to and from idle, the pilot can become conditioned to these lights going on and off during normal taxi.

When the reverse levers are raised to the DEPLOY position, hydraulic pressure unlocks the engine thrust reverser doors, and, subsequently, two amber lights (TR UNLOCK) will illuminate to indicate that both thrust reverser doors are unlocked. When the amber TR UNLOCK lights illuminate, the green TR ARM lights extinguish. After the engine thrust reverser doors are fully deployed, two white lights (TR DEPLOY) illuminate, and the amber TR UNLOCK lights extinguish.

Figure. Diagram of a Learjet 60's lights on the main annunciator panel.

- The white TR DEPLOY light(s) would extinguish,
- The amber TR UNLOCK light(s) would illuminate momentarily, and
- The green TR ARM light(s) would blink momentarily.⁸

The only indication available to the pilots that the cockpit reverse levers and engine thrust reversers were not in agreement would be the pilots' comprehension that neither of the TR DEPLOY lights was illuminated while the reverse levers were in the positions normally associated with reverse thrust. The NTSB concludes that, during a rejected takeoff, which requires quick and concentrated pilot actions, it may be difficult for a pilot to recognize the significance of the absence of reverse thrust indicator lights.

Require Learjet to develop and install improved aural or visual cues on future-manufactured Learjet 60 airplanes that would allow pilots to recognize an inadvertent thrust reverser stowage in a timely manner. (A-09-57)

Once improved aural or visual cues are developed per Safety Recommendation A-09-57, require Learjet 60 operators to install those cues on existing Learjet 60 airplanes. (A-09-58)
