NATIONAL TRANSPORTATION SAFETY BOARD

Global Positioning System (GPS) Device

Specialist's Factual Report by Bill Tuccio, Ph.D.

| Location: | Overton, Nevada |
|---|---|
| NTSB Number: | WPR14FA243 |

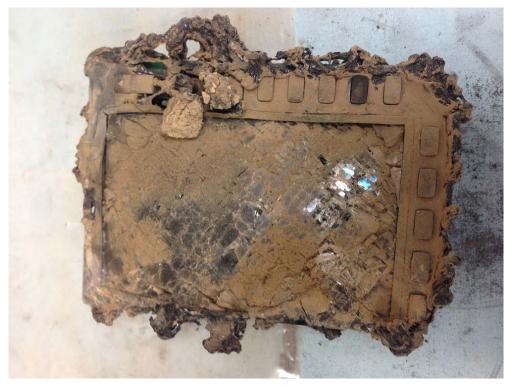
Upon arrival at the Vehicle Recorder Laboratory, an exterior examination revealed the unit had sustained significant impact damage, as shown in figure 1. An internal inspection revealed the main memory chip had separated from the printed circuit board, as shown in figure 2. Figure 3 shows numerous cracks observed in the chip. Due to the cracks, no further recovery attempts were made.

Figure 1. Garmin GPSMAP 696 damage photograph.

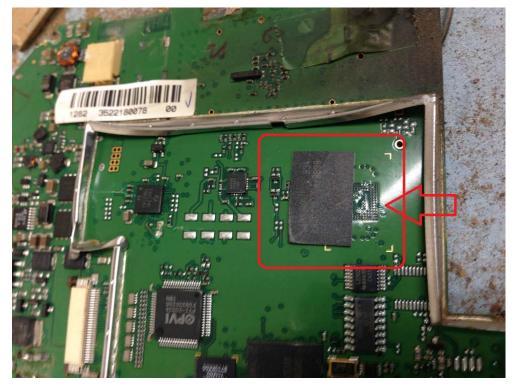
Figure 2. Garmin GPSMAP 696 main memory chip separated from component board.

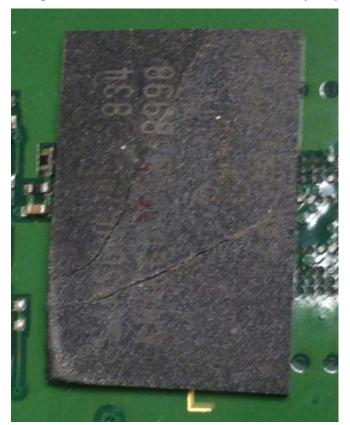
Figure 3. Garmin GPSMAP 696 main memory chip.
