# NATIONAL TRANSPORTATION SAFETY BOARD

## STRUCTURES STUDY 21 imbedded photographs

### ACCIDENT

Location: Wichita, KS  
Date: September 25, 2015  
Time: 1550 central daylight time  
Aircraft: Cessna 310Q, N301JA

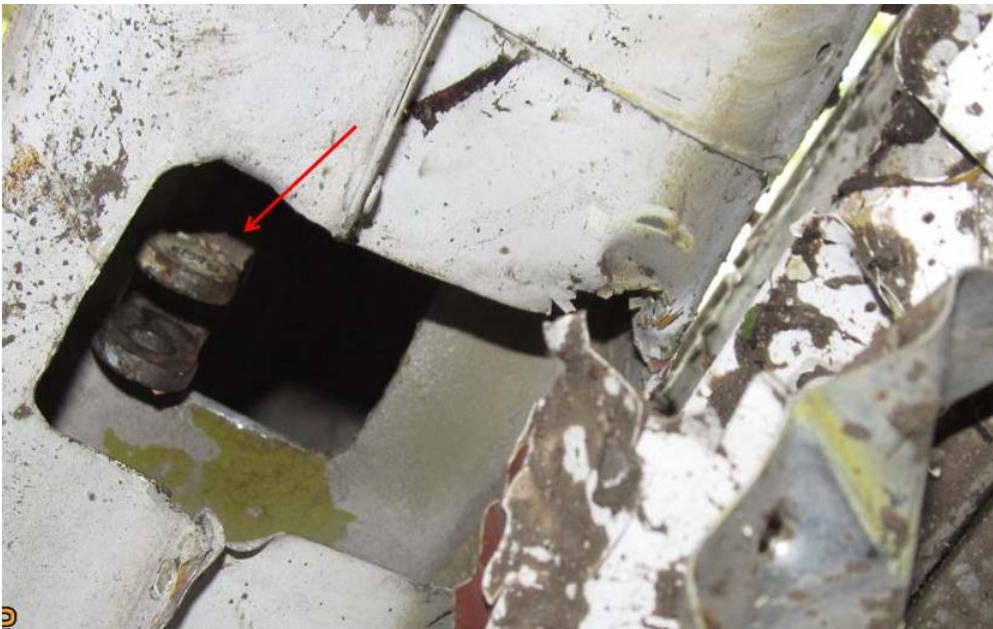
Photo 1 – Forward end of trim tab rod. The bolt was missing and not found. (see arrow)

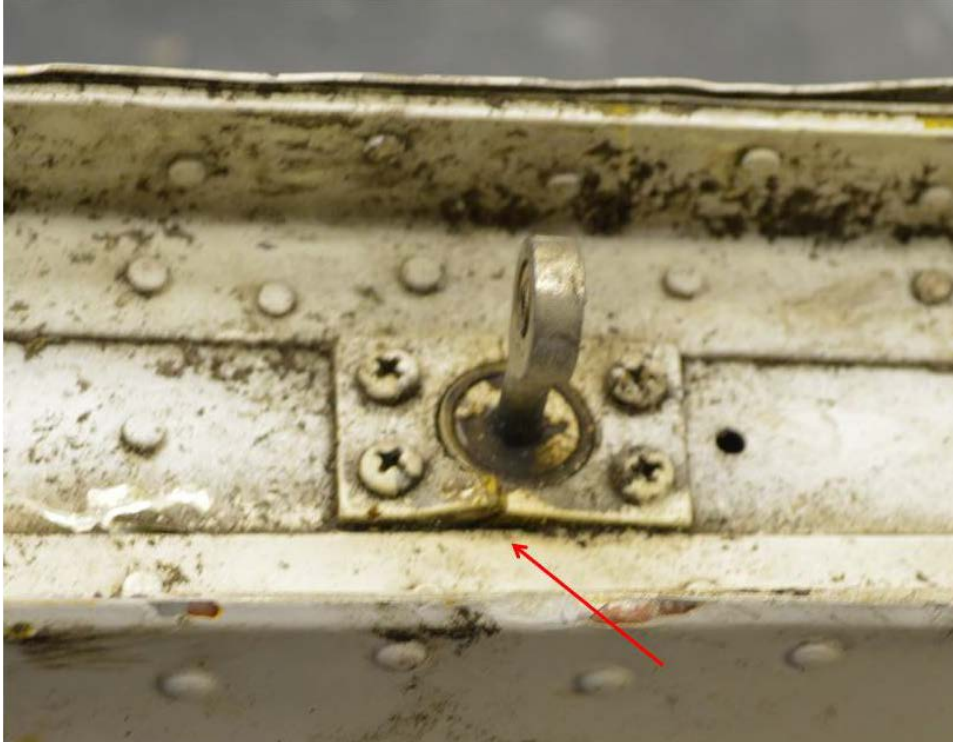
**Photo 2 - The rod end bearing. The bolt was missing and the actuator was fully retracted to the ANU trim position. The only damage noted to the actuator attach hardware was the cracked doubler (see arrow).**

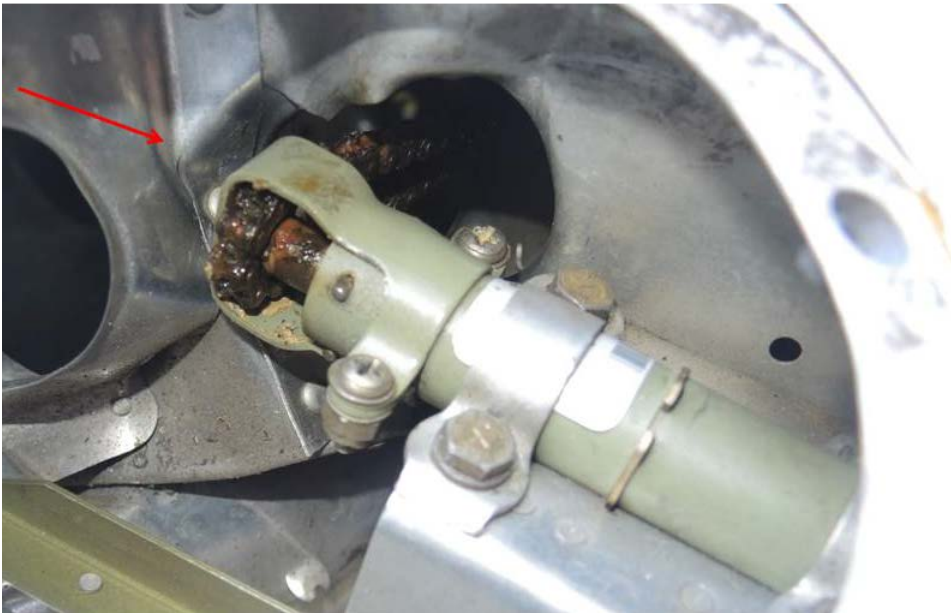
**Photo 3 - Trim tab actuator. The actuator had been impacted from the front (see arrow).**

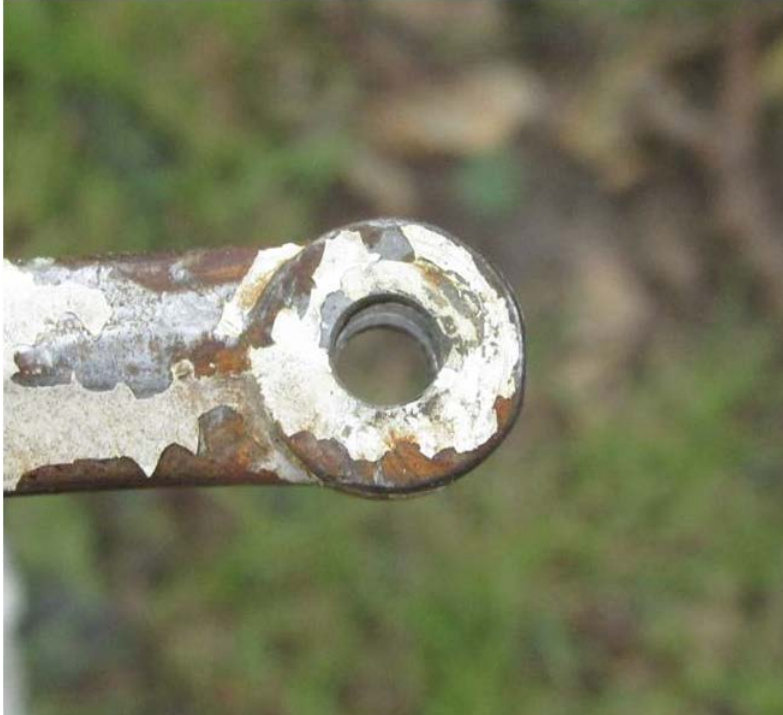
**Photo 4 - Forward end of the pushrod. There was no apparent damage to the bolt hole (side one).**

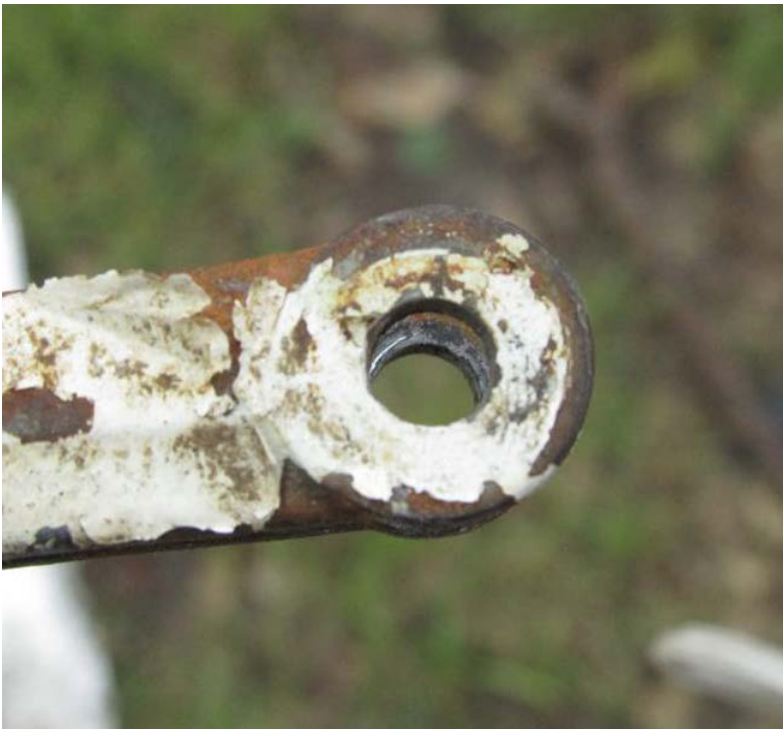
**Photo 5 - Forward end of the pushrod. There was no apparent damage to the bolt hole (side two).**

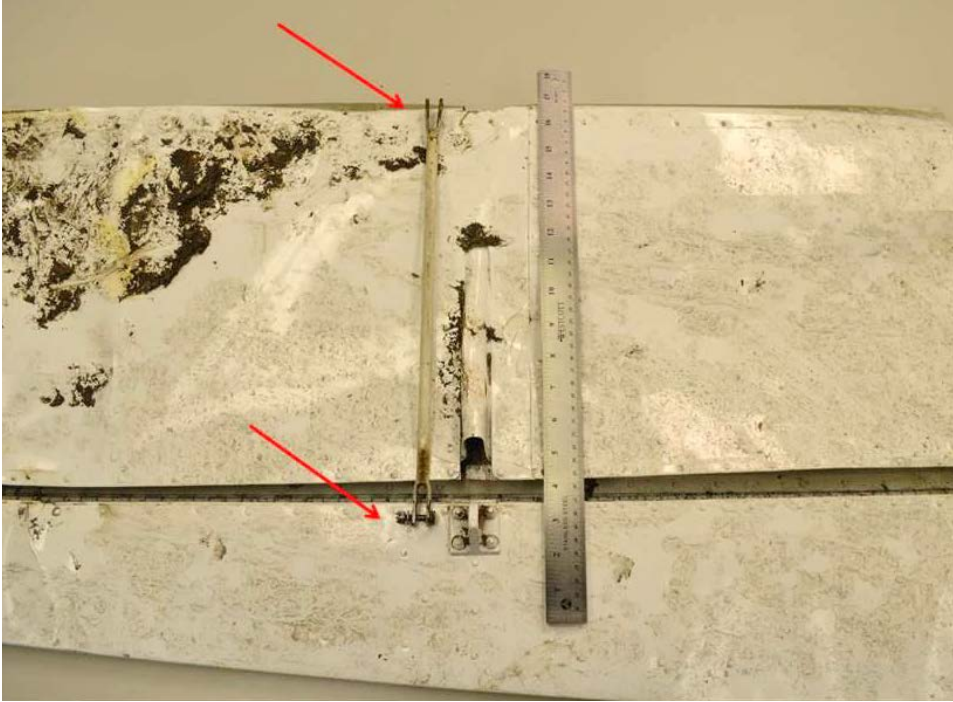
**Photo 6 – General pushrod and tab alignment with the pushrod placed outside of the elevator and tunnel. The tab is at the bottom of the photograph.**

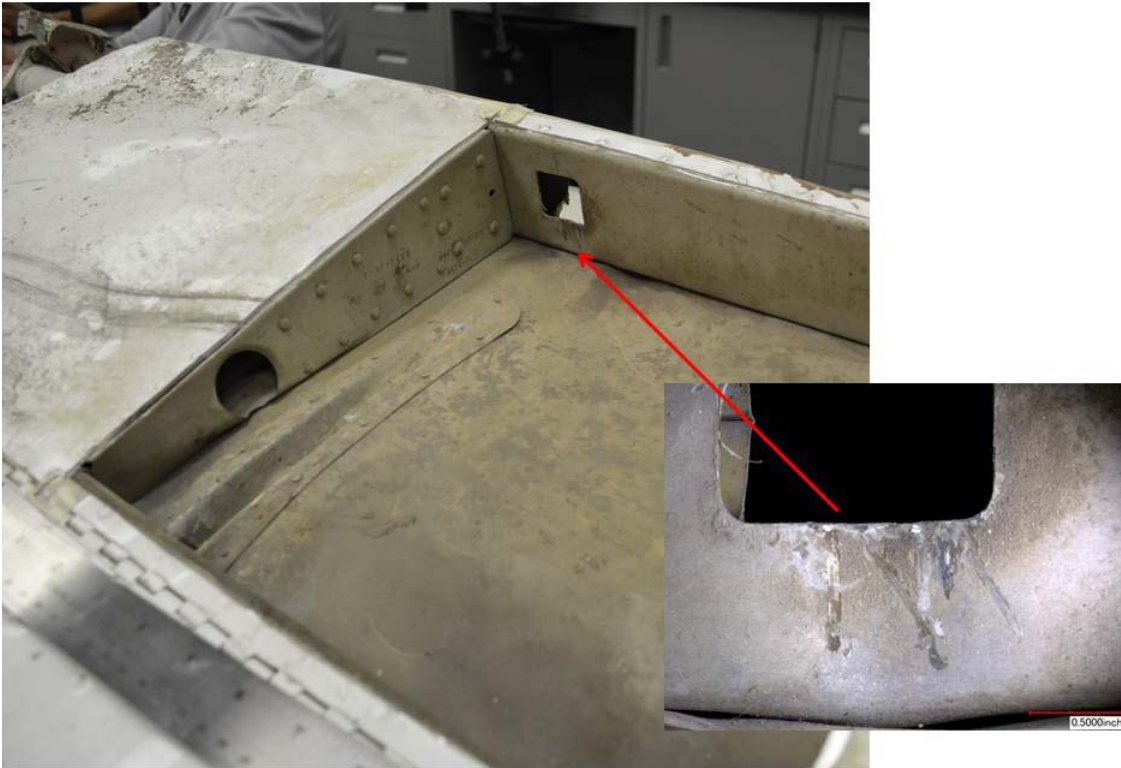
The right-hand elevator, trim tab and trim actuator were removed from the scene and taken to Textron Aviation's laboratory for further examination. A portion of upper skin of the elevator was removed to examine witness marks in the leading edge spar of the elevator. Witness marks matching the forward push-pull tube end were consistent with the clevis hitting against the aft side of the front elevator spar after separation from the actuator. Additionally, the edge of tube guide hole exhibited signs of impact on the interior face, consistent with rubbing from the hardware on connecting bolt. The forward end of the trim tab push-pull tube, in the bottom of the clevis fork, had impact marks consistent with contact with the rod end bearing attached to the trim actuator.

**Photo 7 – Scrape marks on the aft side of the elevator spar that match the forward end fork. The inset photo provides a detailed view of the scrape marks.**

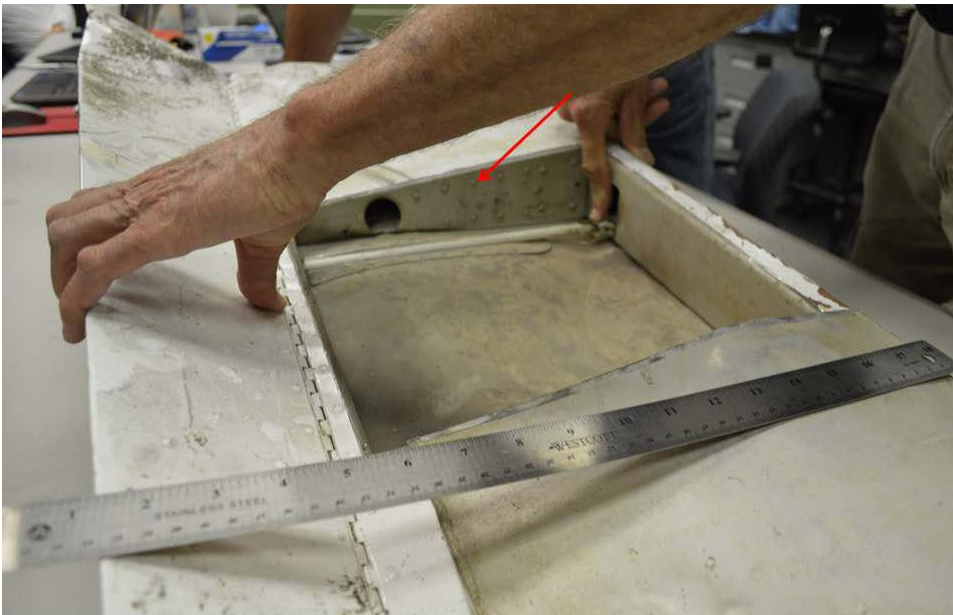
**Photo 8 – The clevis fork is placed behind the elevator spar. The tab is deflected up to pull the fork aft, well past the limits of normal travel.**

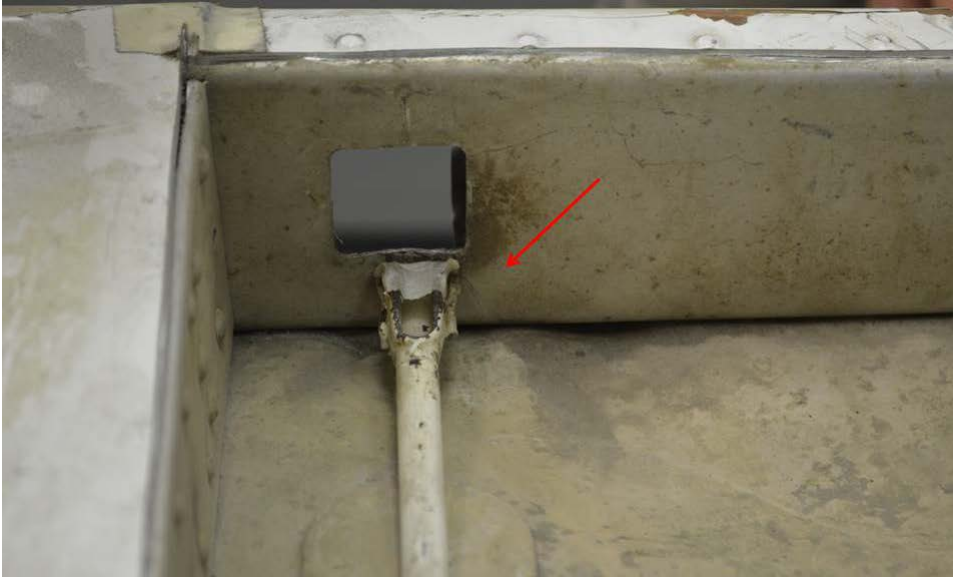
**Photo 9 - Fork touching the aft side of the elevator spar.**

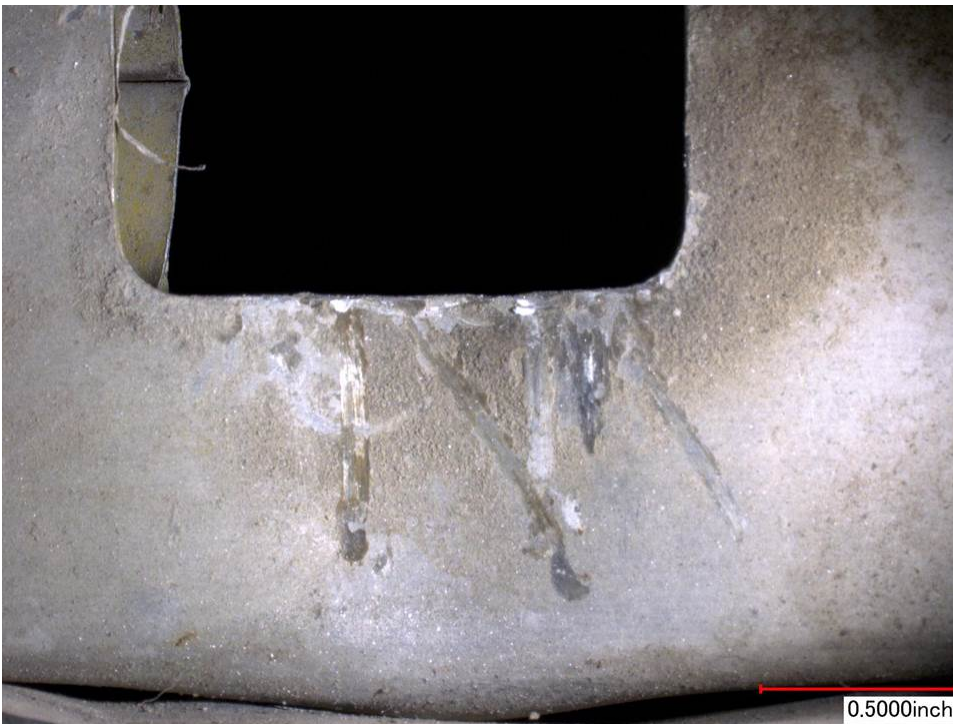
**Photo 10 - Detailed view of scrape marks on aft side of elevator spar. View looking forward.**

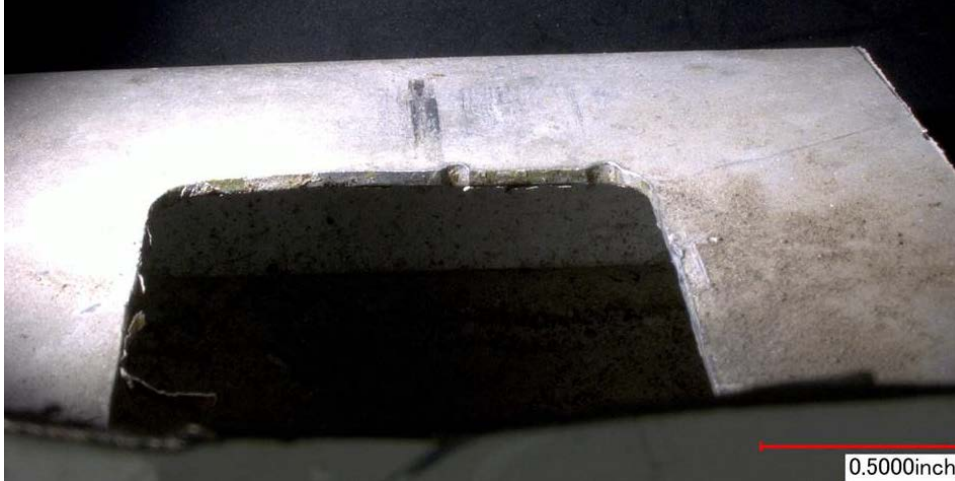
**Photo 11 - Detailed view of damage at the top of the pushrod access hole. View looking forward.**

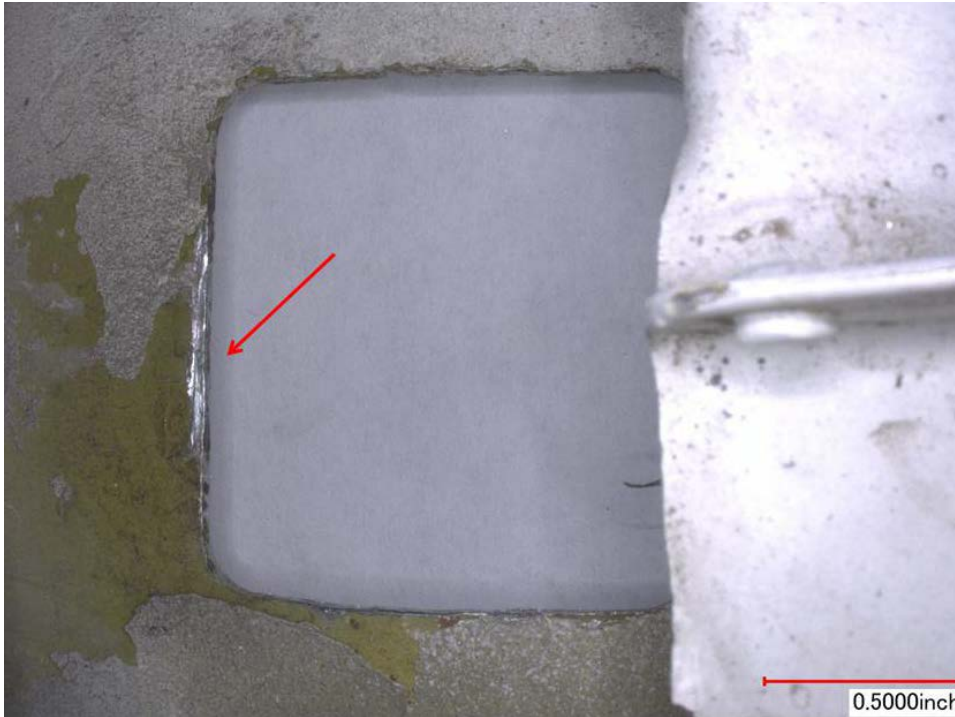
**Photo 12 - Damage at the edge of the pushrod access hole. The damage is on the forward side of the elevator spar, outboard edge.**

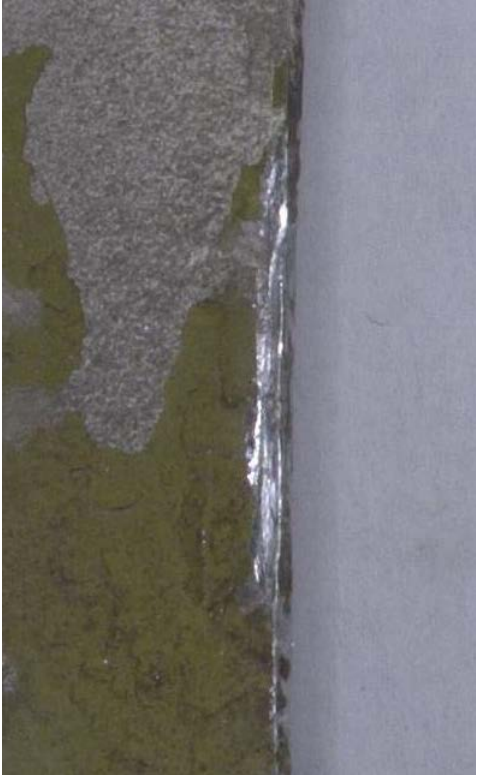
**Photo 13 - Detailed view of damage show in Photo 12.**

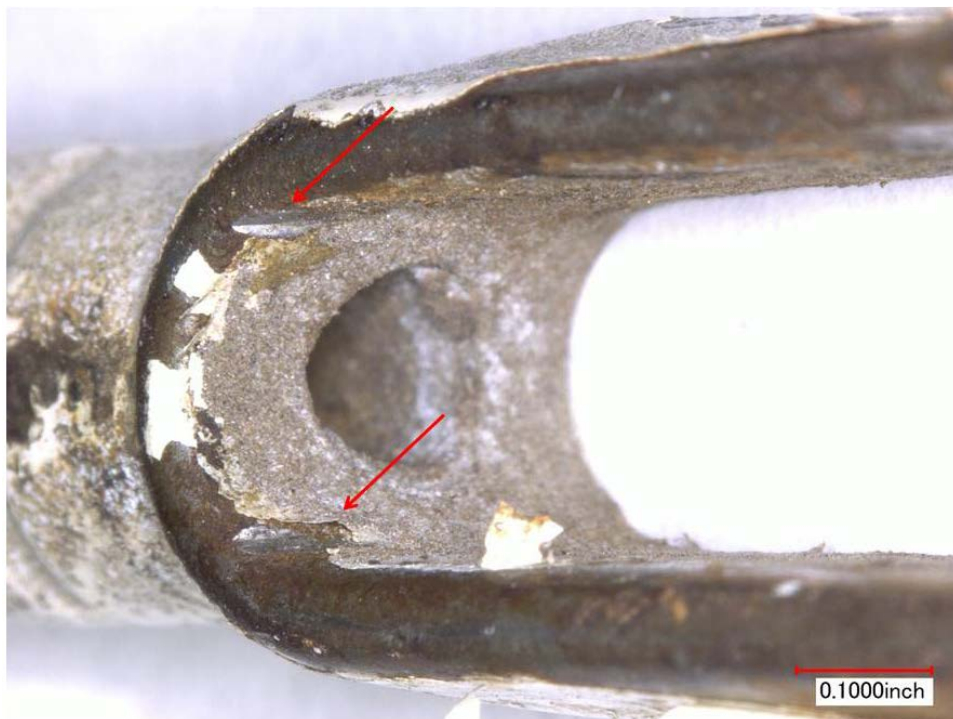
Damage to the separated clevis and bearing was consistent with the bolt not being present.

**Photo 14 - Damage marks to the inside portion of the clevis. The width of the marks is consistent with the width of the rod-end bearing.**

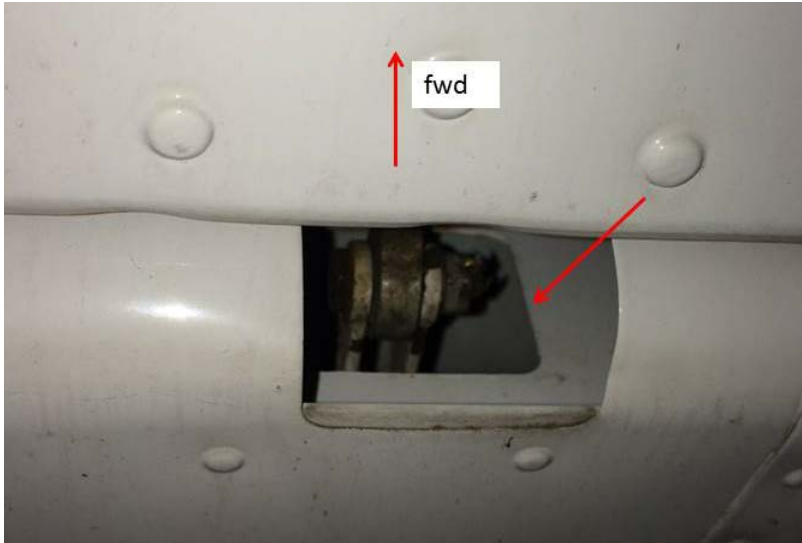
**Photo 15 - Another C310. View looking up and aft. The trim actuator was fully extended (AND trim). The bolt through the rod-end bearing and fork is near the elevator spar.**

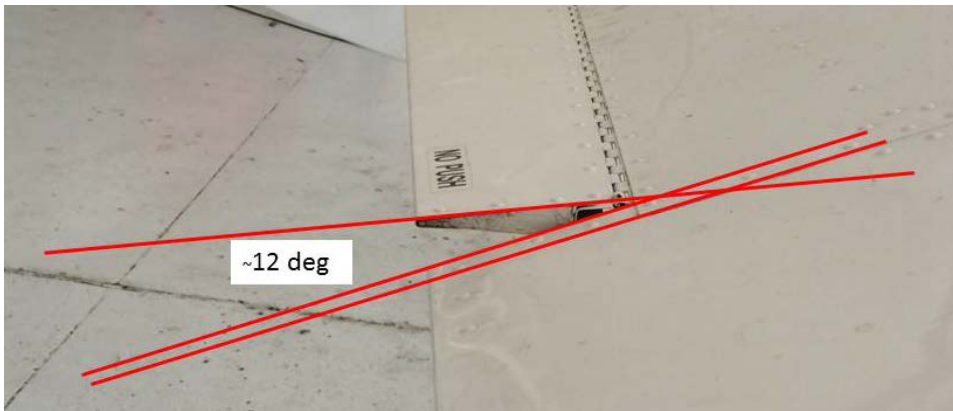
**Photo 16 - Another C310. The tab TEU or actuator AND trim position, about 12 degrees.**

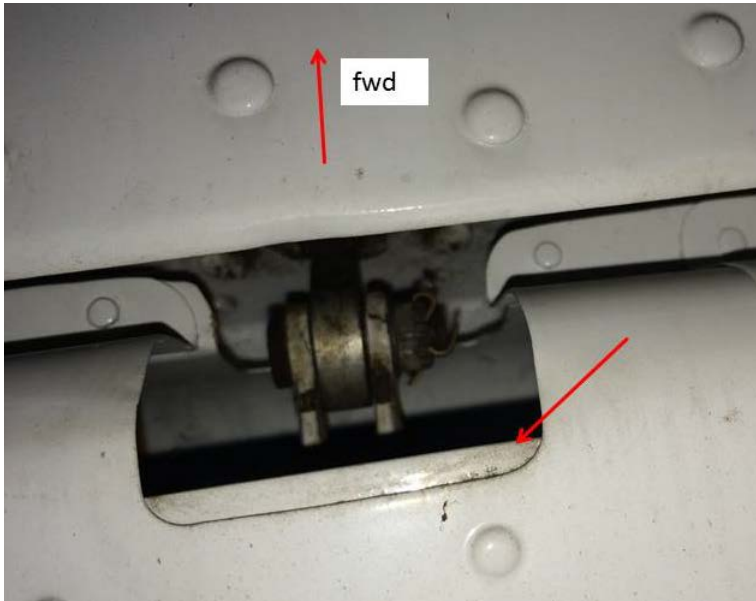
**Photo 17 - - Another C310. View looking down. The trim actuator was fully retracted (ANU trim). The bolt through the rod-end bearing and fork is near the leading edge of the elevator D-tube.**

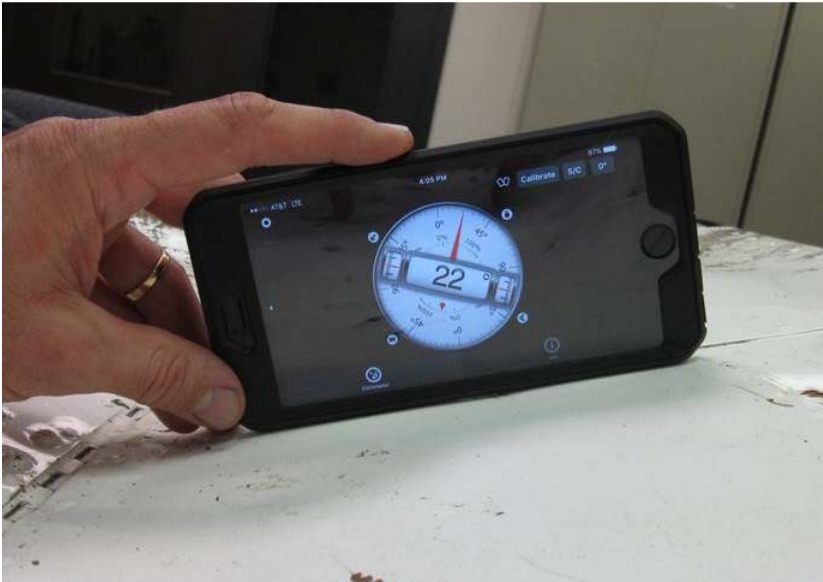
**Photo 18 – Slope of elevator**

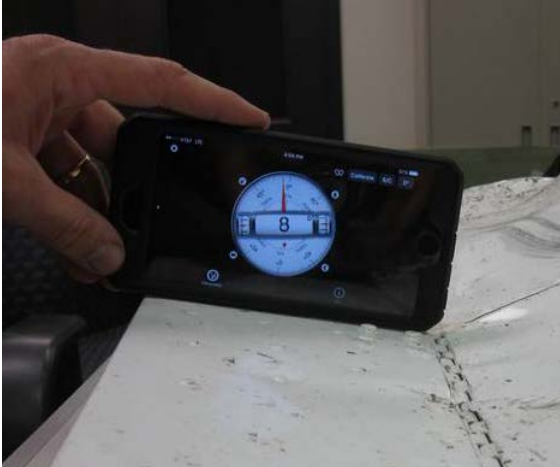
**Photo 19 - Slope of tab. The tab deflection is about 30 degrees TEU. The pushrod was touching the bent portion of the elevator spar.**

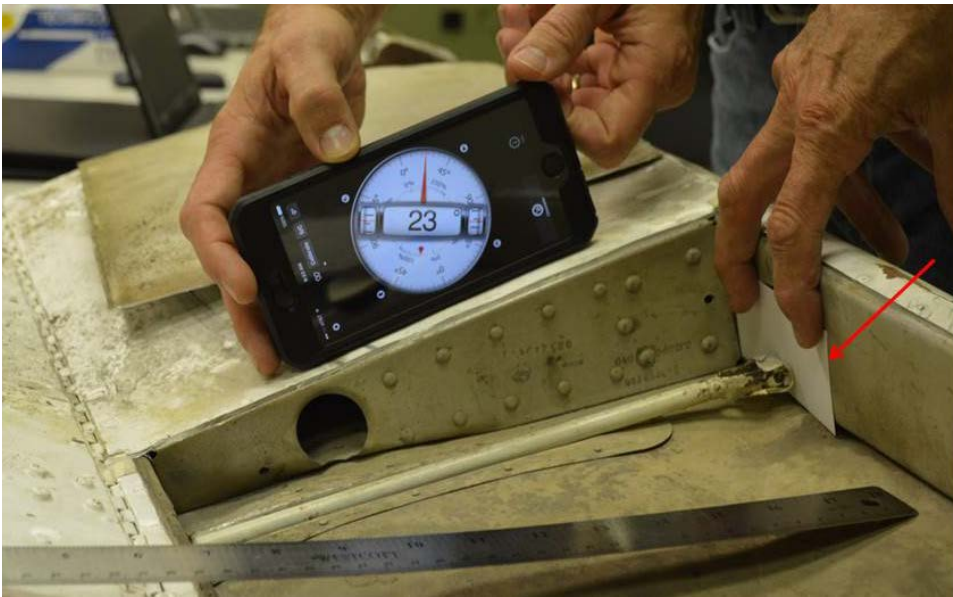
**Photo 20- Slope of elevator. The pushrod was positioned as if the elevator spar had not been bent. The white paper replicates an unbent spar.**

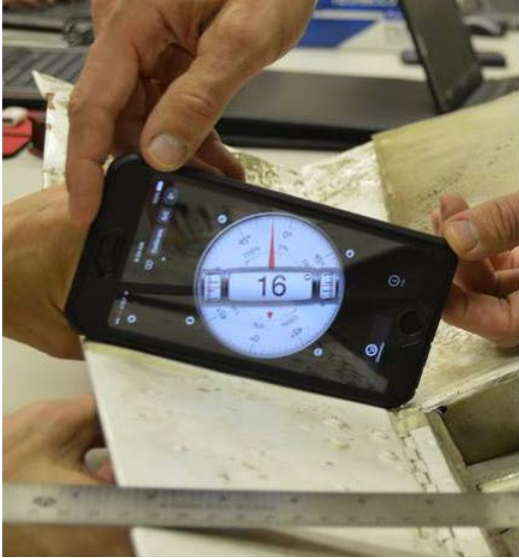
**Photo 21 – Slope of tab. The tab deflection is about 39 degrees.**
