NATIONAL TRANSPORTATION SAFETY BOARD

TRACK & ENGINEERING FACTUAL REPORT

RRD18MR003

**CSX Railroad, Amtrak Passenger Train/Freight Train Collision with Derailment
and Crew Fatalities**

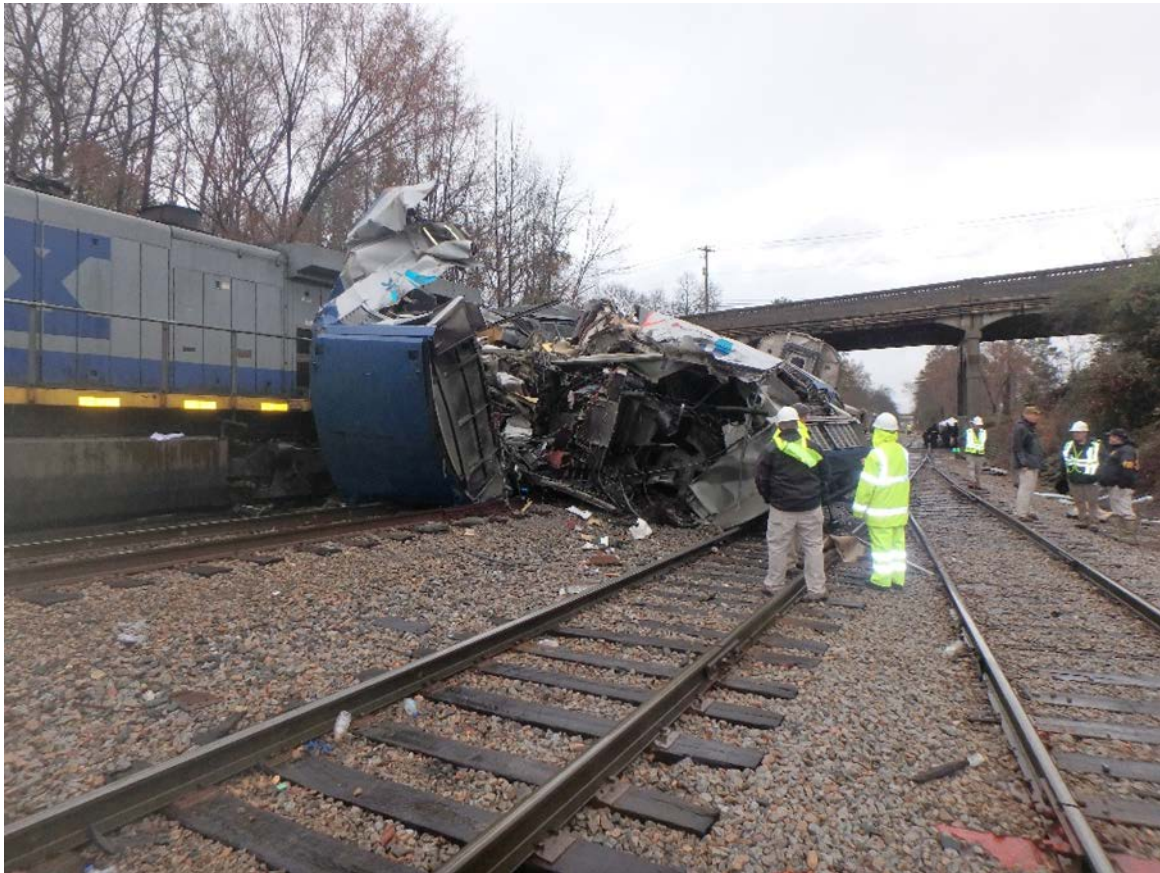
Figure 2. Photo facing north showing the damaged lead locomotives of each train (Photo: NTSB)

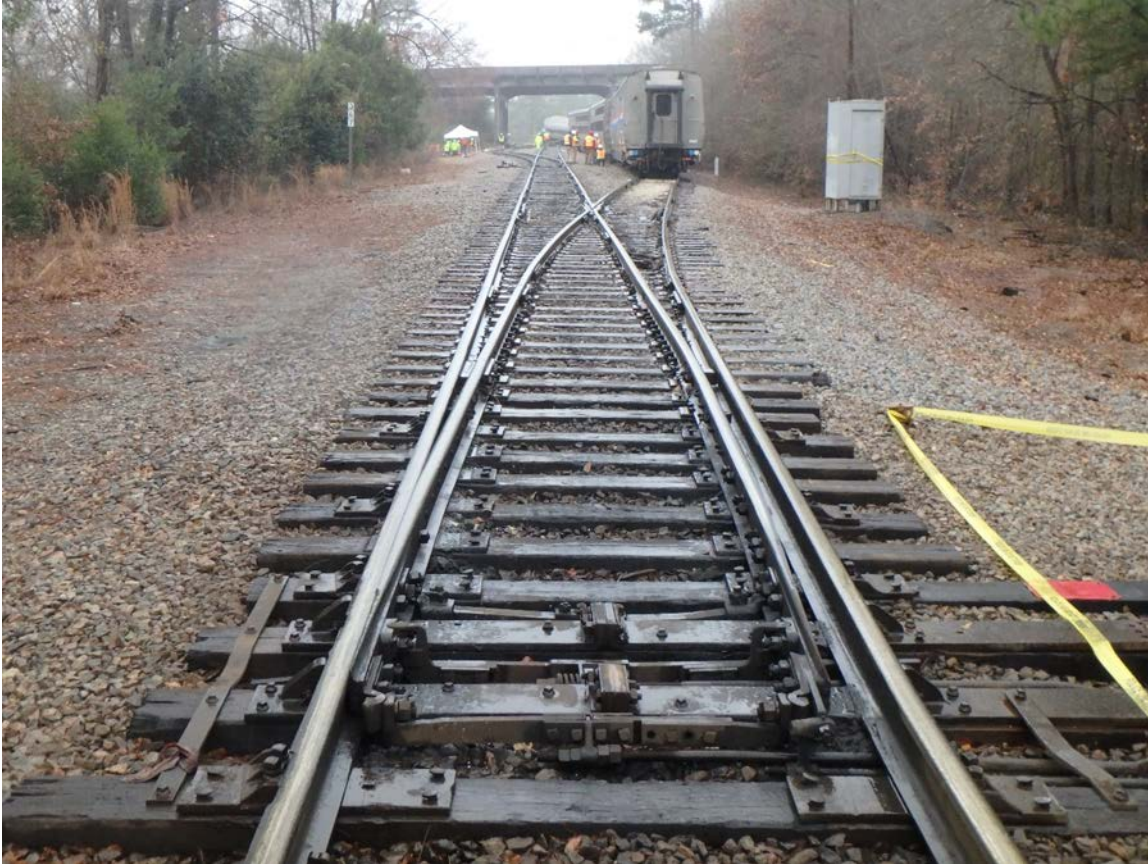
To provide entry into the north end of the Silica Storage Track, there was a No. 10, right-hand turnout. The switch points of the turnout were controlled by a hand-operated switch machine with an electric lock. The design standard of the turnout denoted an average degree of curve through the curved closure rail of less than 7.5-degrees. Measurements taken by the investigative team revealed a less than 1-inch deviation from uniform alinement in the turnout. Investigators inspected the switch and turnout components and noted two conditions that did not meet Federal Railroad Administration (FRA) minimum track safety standards. The defective conditions noted were: guard check less than allowable (54-5/16") for class 3 track, and the tread portion of frog worn in excess of allowable (1/2"). Both standards are relevant to rail wheels and flanges traversing through the frog portion of the turnout. Investigators also noted that the inside rail spikes of the curved-closure rail had been raised from the switch-ties between the left-hand, rigid heelblock and the frog. These spikes were between one-quarter and three-eighths of an inch raised.

Figure 3. Photo facing south, showing the North End Silica Storage Track switch. The switch is lined as found by investigators. (Photo: NTSB)

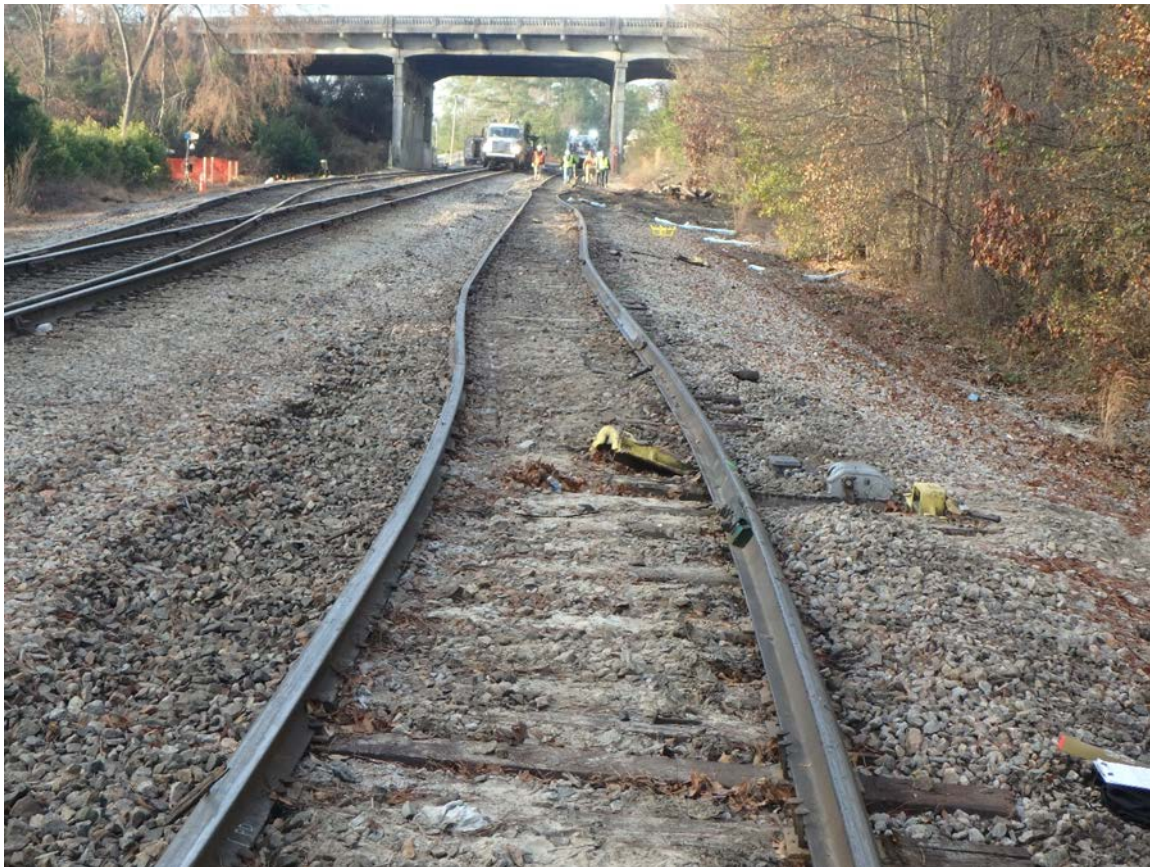
curve could not be verified).³ As the Amtrak train entered this curve, the track structure was displaced to the right or in a west direction about 20-inches.⁴ The rail was displaced as it canted outward. Investigators took track geometry measurements at this location; the track gage was measured by documenting the location of the rail plates. Investigators found no evidence of noncompliance with FRA and CSX standards that existed prior to the accident.

Figure 4. Photo showing the track misalignment/displacement, and unseated rail near the derail at the north end of Silica Storage Track.

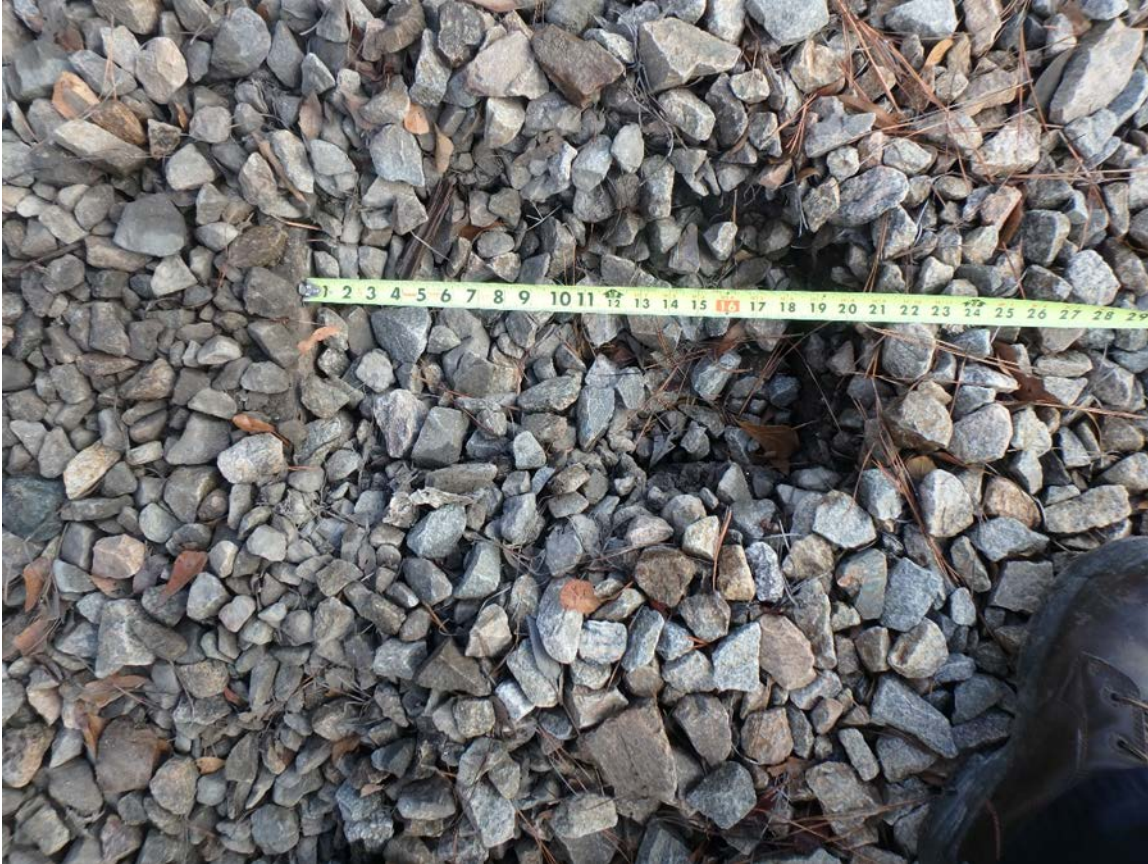
Figure 5. Photo showing distance the track structure in the Silica Storage Track return curve had been displaced because of the accident. The track structure shifted west about 20 inches; the void in the ballast from the edge of the crosstie was measured.

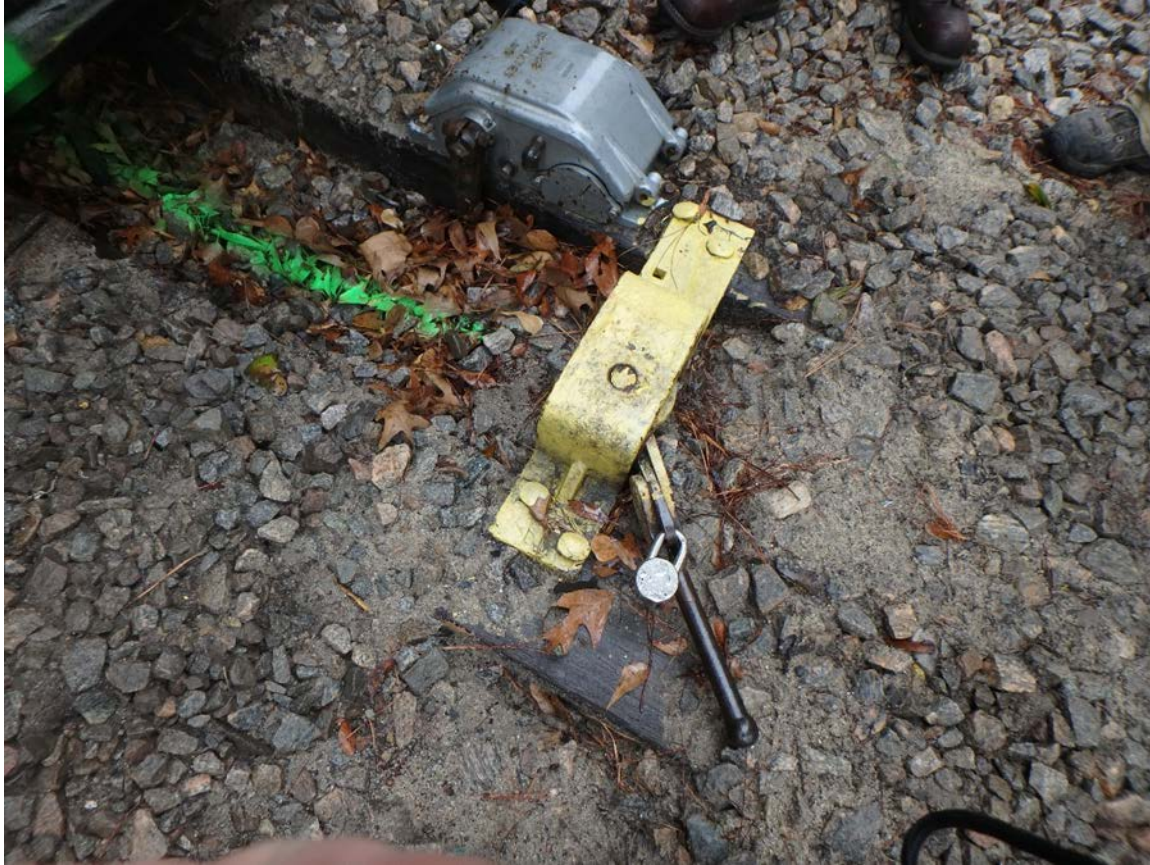
Figure 6. Photo of derail operating handle applied and locked in the derailing position-as found.

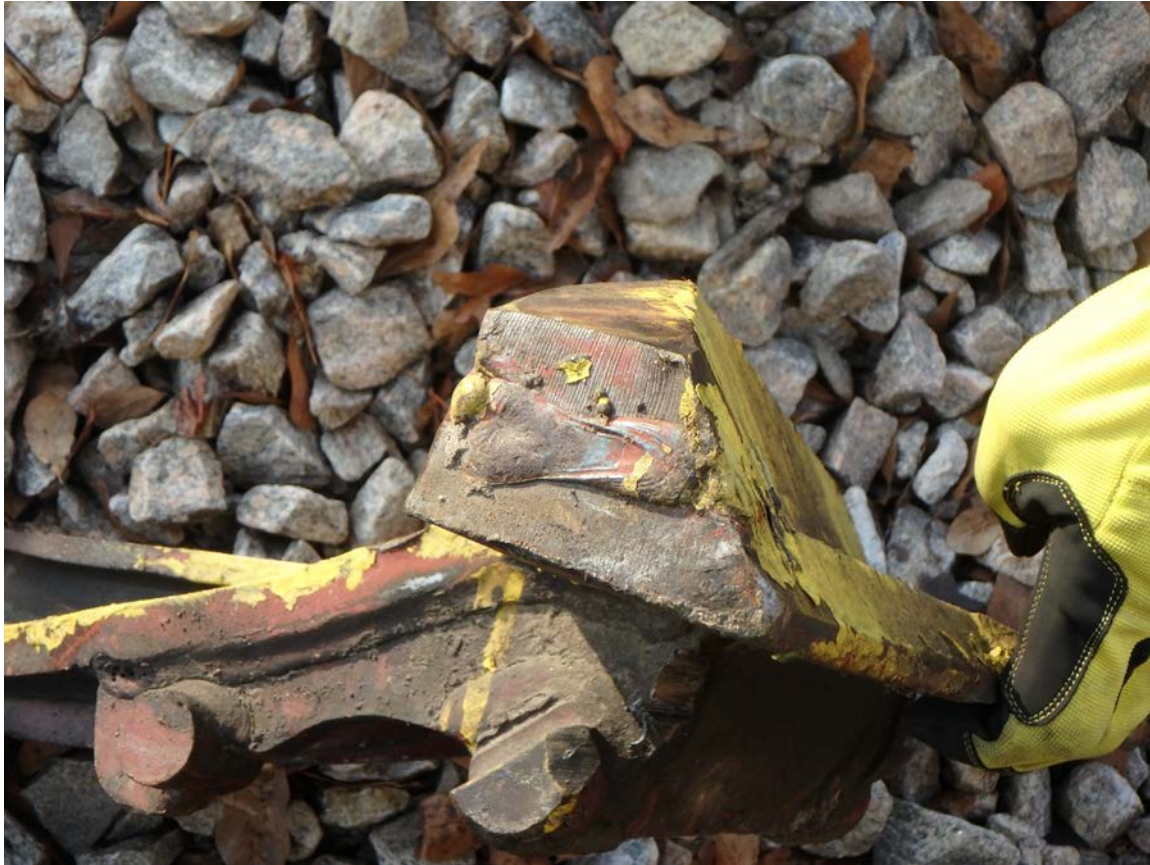
To prevent unintended movement of equipment from the Silica Storage Track onto the main track, slide on type derails were installed at both ends of the storage track. These derails were designed to derail equipment in only one direction; to prevent train and equipment movements from the storage track to the main track. At the north end of the storage track, the position of the derail handle indicated that the derail was in the derailing position, the handle was locked in the derailing position. Investigator examined the derailing portion of the derail at the north end of the storage track and found no marks from rail wheel strikes on the north facing end (non-derailing

end) of the derail shoe. Investigators noted wheel departure marks across the rail head of the east rail near the derail.

Figure 7. Photo showing the non-derailing end of the derail shoe with no indication of contact from railroad equipment.
