VEHICLE FACTORS GROUP CHAIRMAN'S FACTUAL REPORT

NTSB Vehicle Photos

Biloxi, Mississippi

HWY17MH010

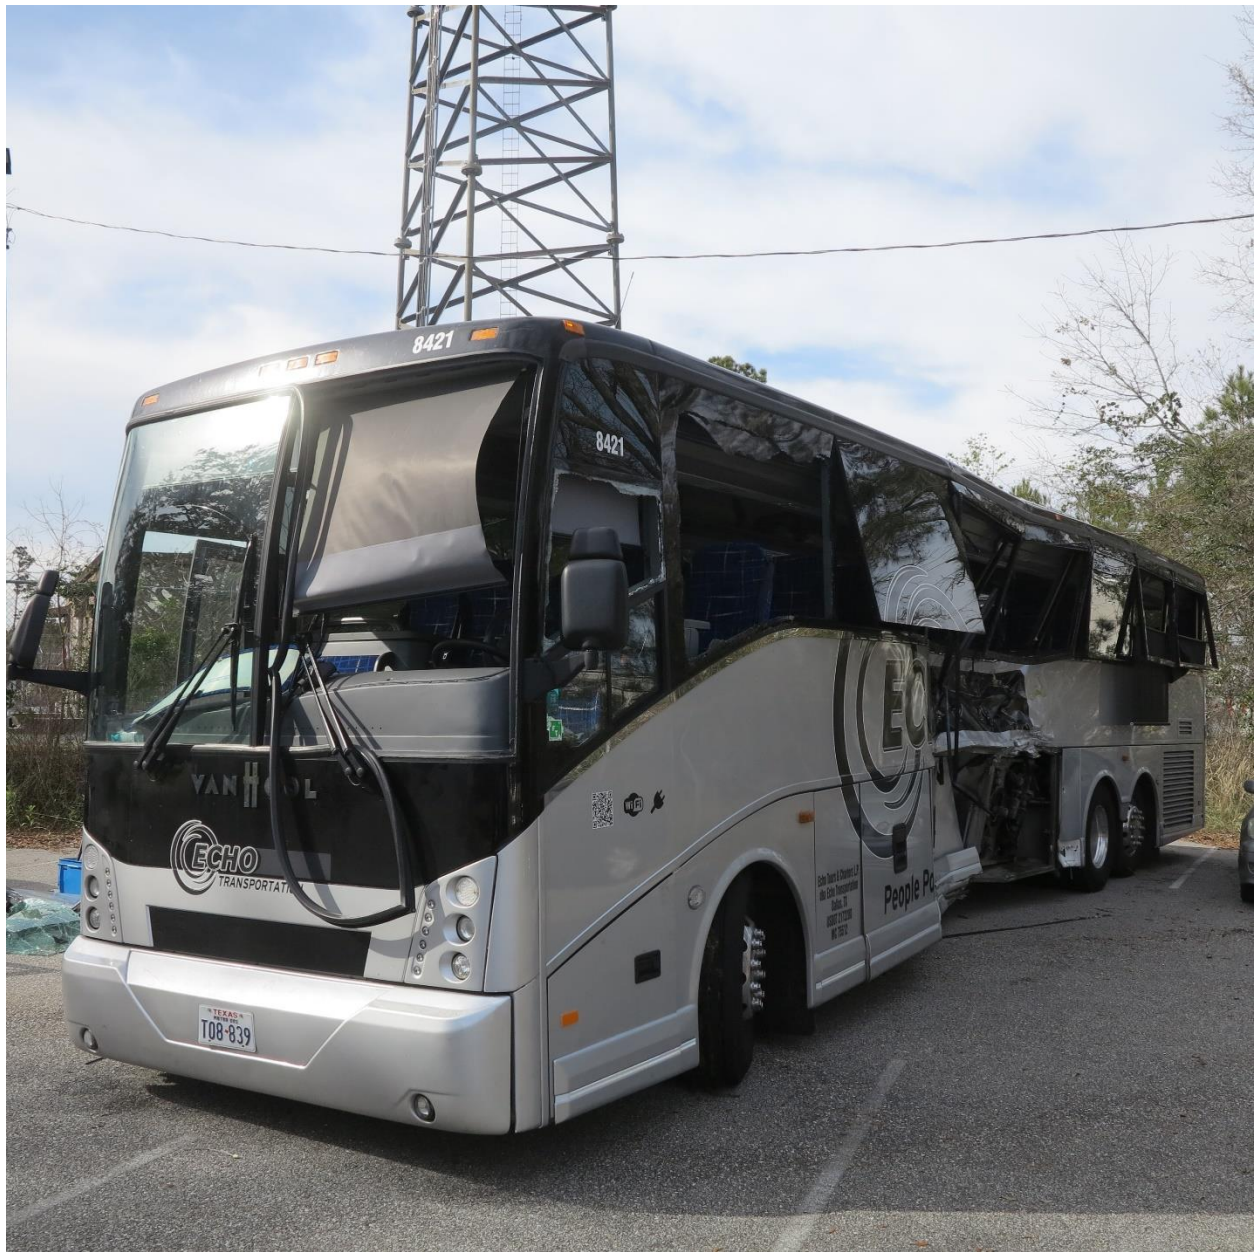
Vehicle Photo #1 – Overall view of the damage to the left side of the Van Hool Motorcoach during inspection at the Biloxi, Mississippi Police Department Impound Yard.

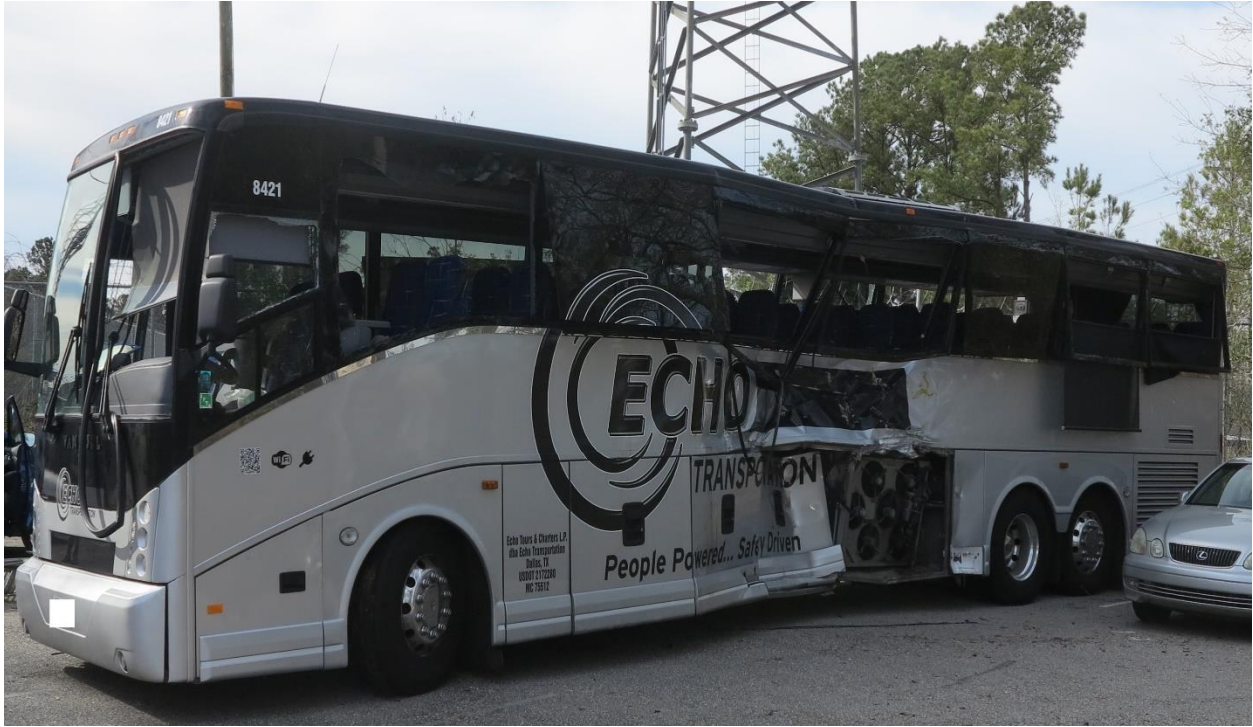
Vehicle Photo #2 – View of the damage to the left side of the Van Hool Motorcoach.

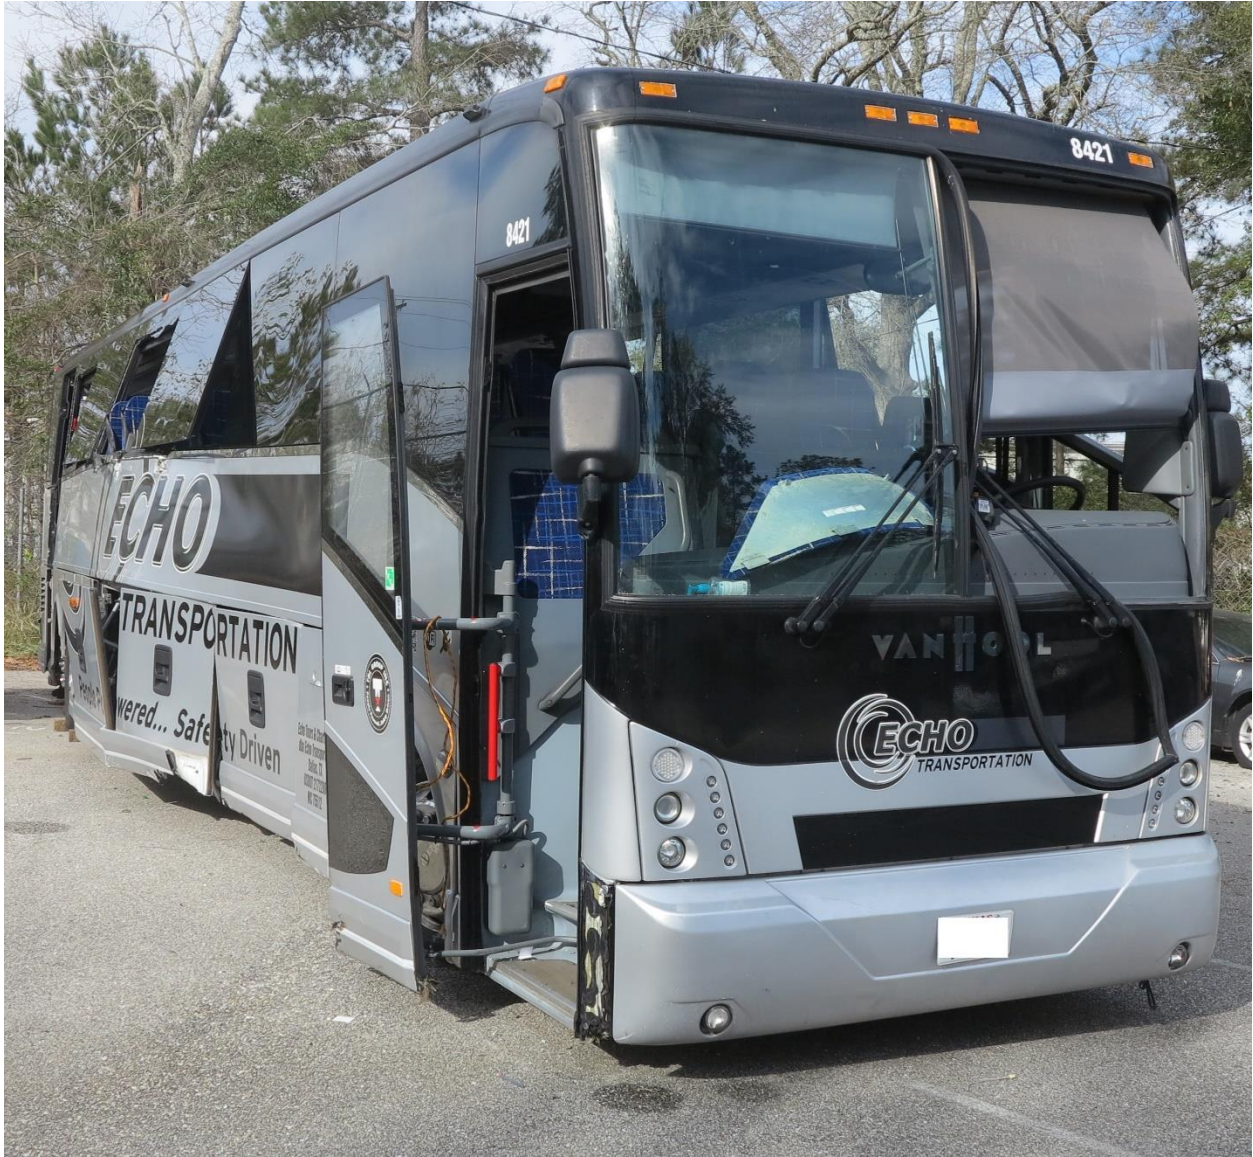
Vehicle Photo #3 – View of the damage to the right side of the Van Hool Motorcoach from the right front corner.

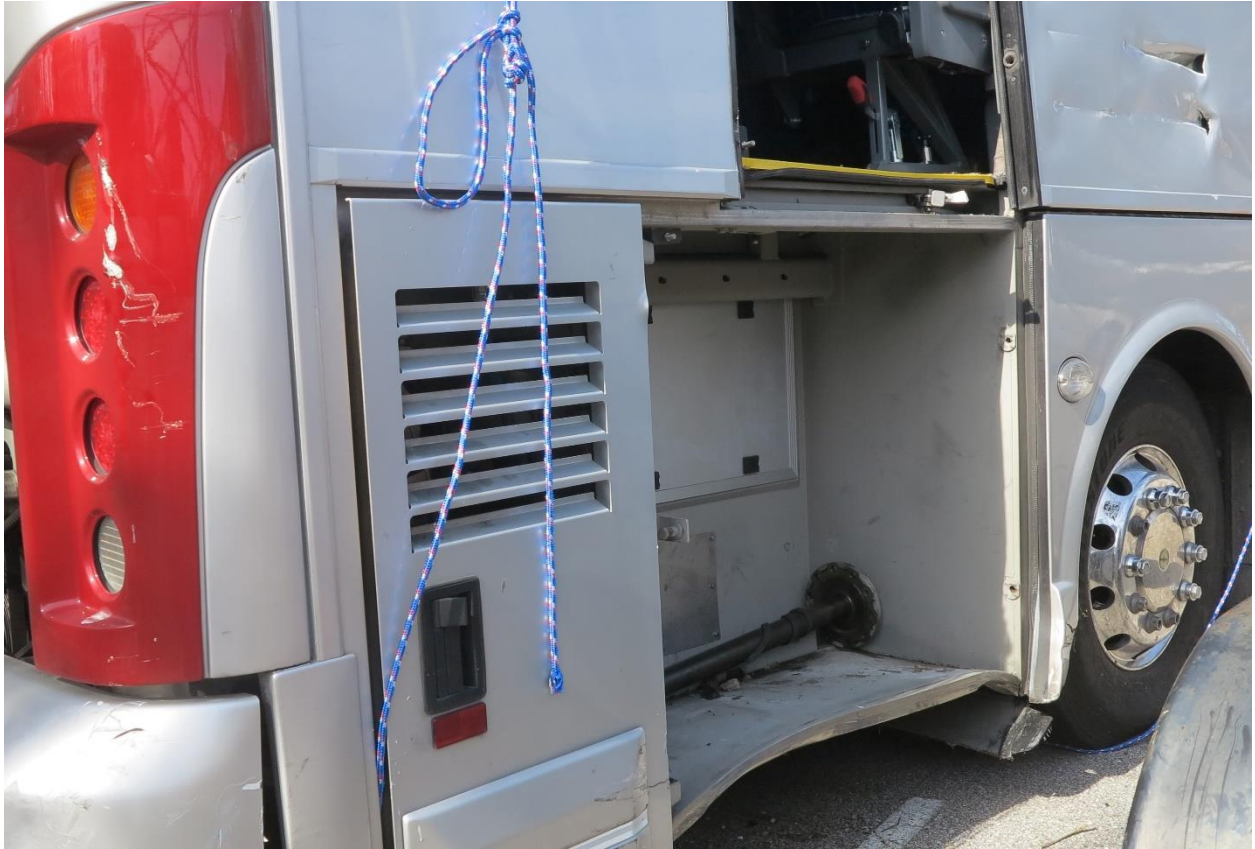
Vehicle Photo 4 – View of the contact damage to the right rear of the Van Hool Motorcoach. Photo shows damage to the right rear taillight and to the side of the motorcoach above the rear axle.

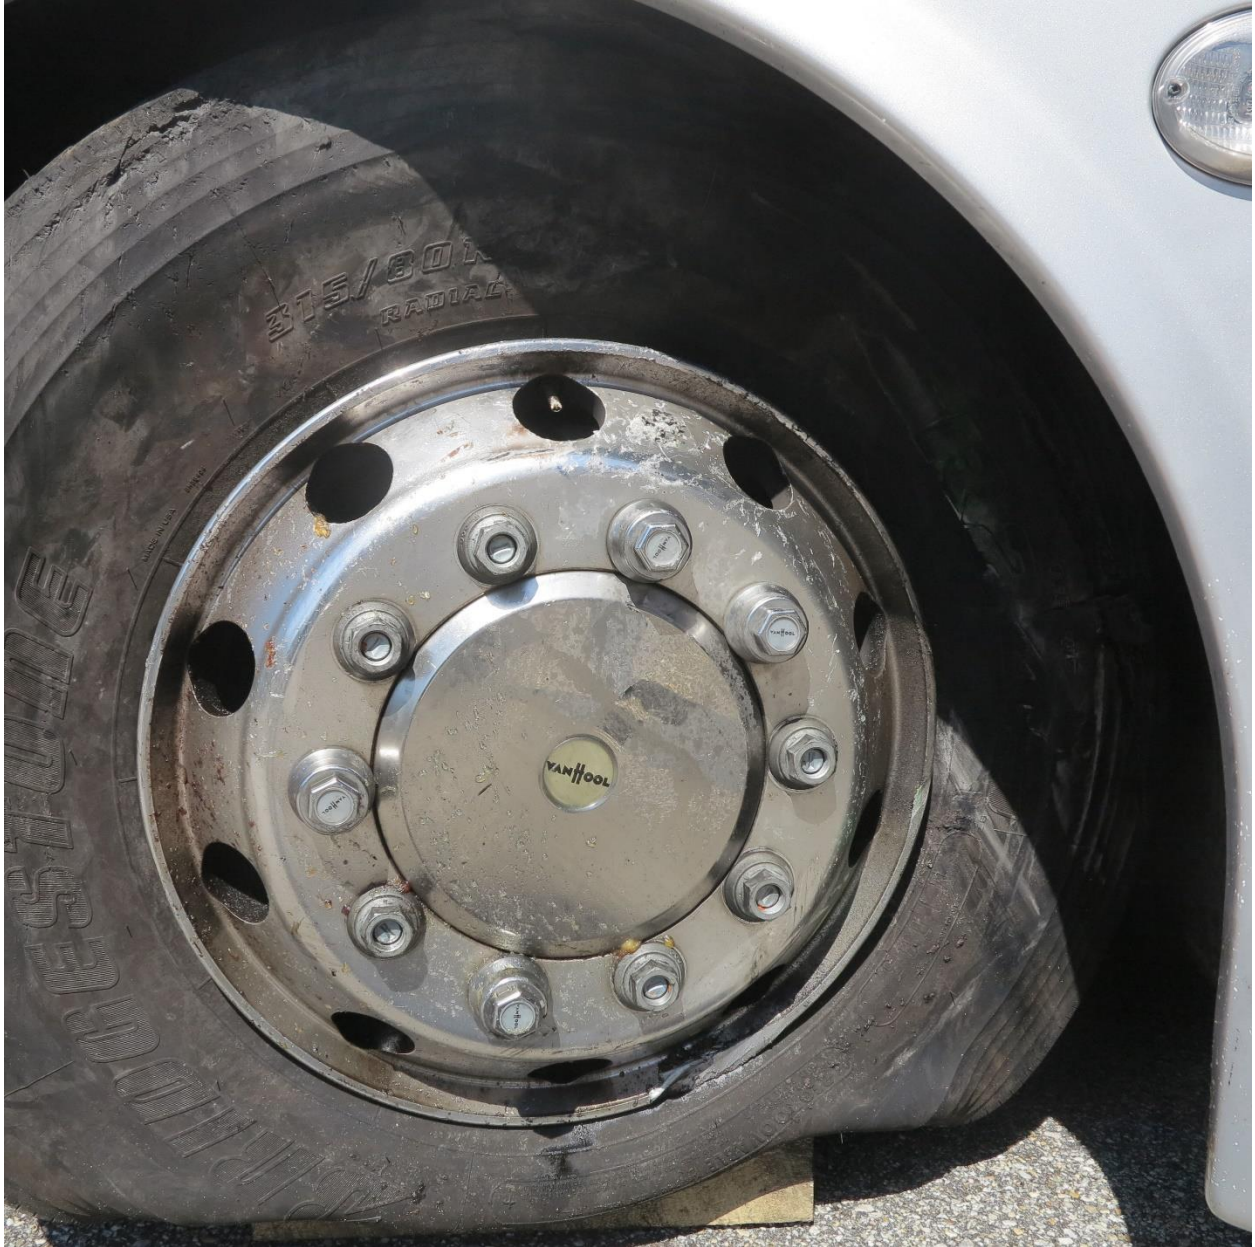
Vehicle Photo #5 – View of the damaged and flat right steer axle tire of the Van Hool Motorcoach.

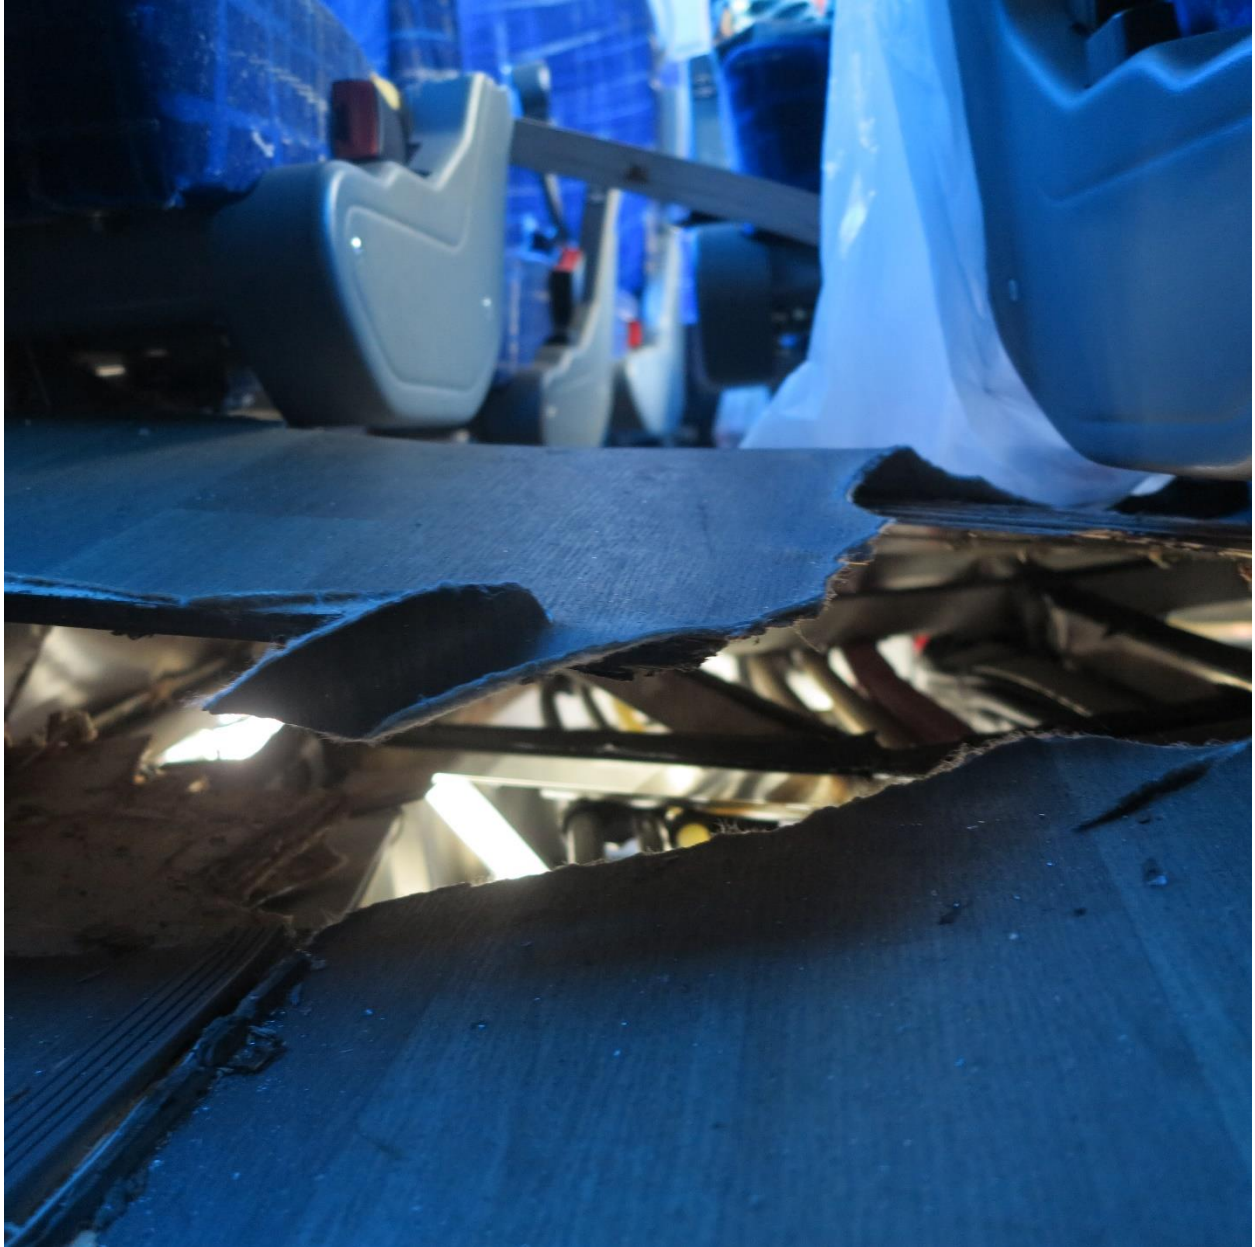
Vehicle Photo #6 – View of the damaged interior floorboard of the Van Hool Motorcoach. The luggage compartment below can be seen through the large crack in the floorboard.
