NTSB Vehicle and Scene Photos

Chattanooga, TN

HWY15FH009

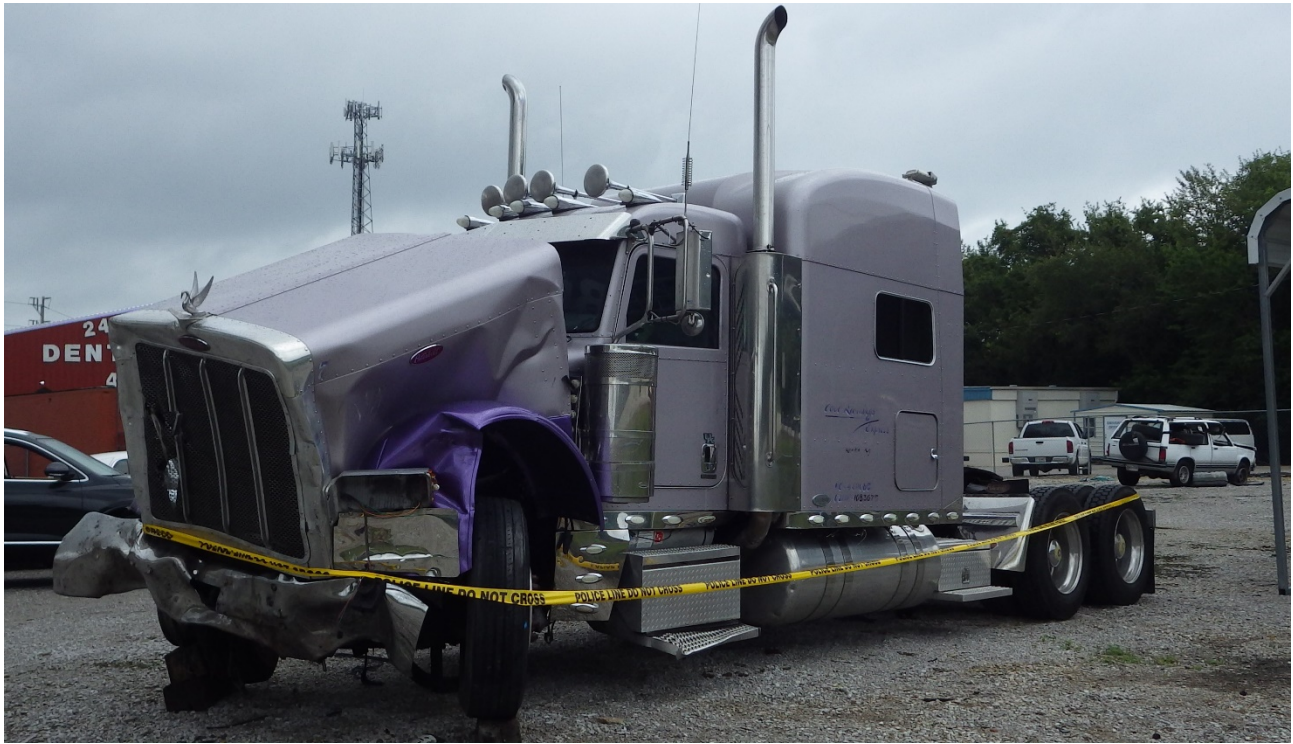
Photograph 1 - Looking at the left-front corner of the 2007 Peterbilt truck-tractor, the left tire and wheel are turned to the left. The left fender and side of the hood are crushed inward, towards the engine area. The hood is held ajar from the displacement and collision damage. The left side of the bumper is displaced rearward.

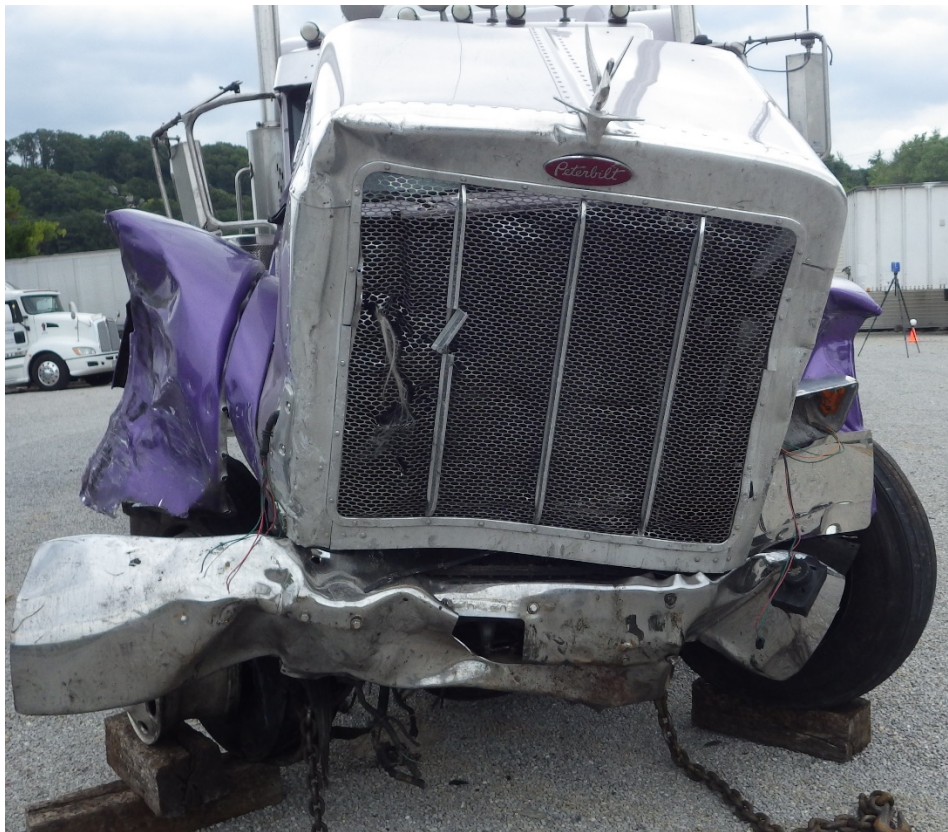
Photograph 2 – Looking at the front of the 2007 Peterbilt, the bumper is displaced rearward. The radiator cowling is crushed rearward and both headlamp and turn signal assemblies are missing.

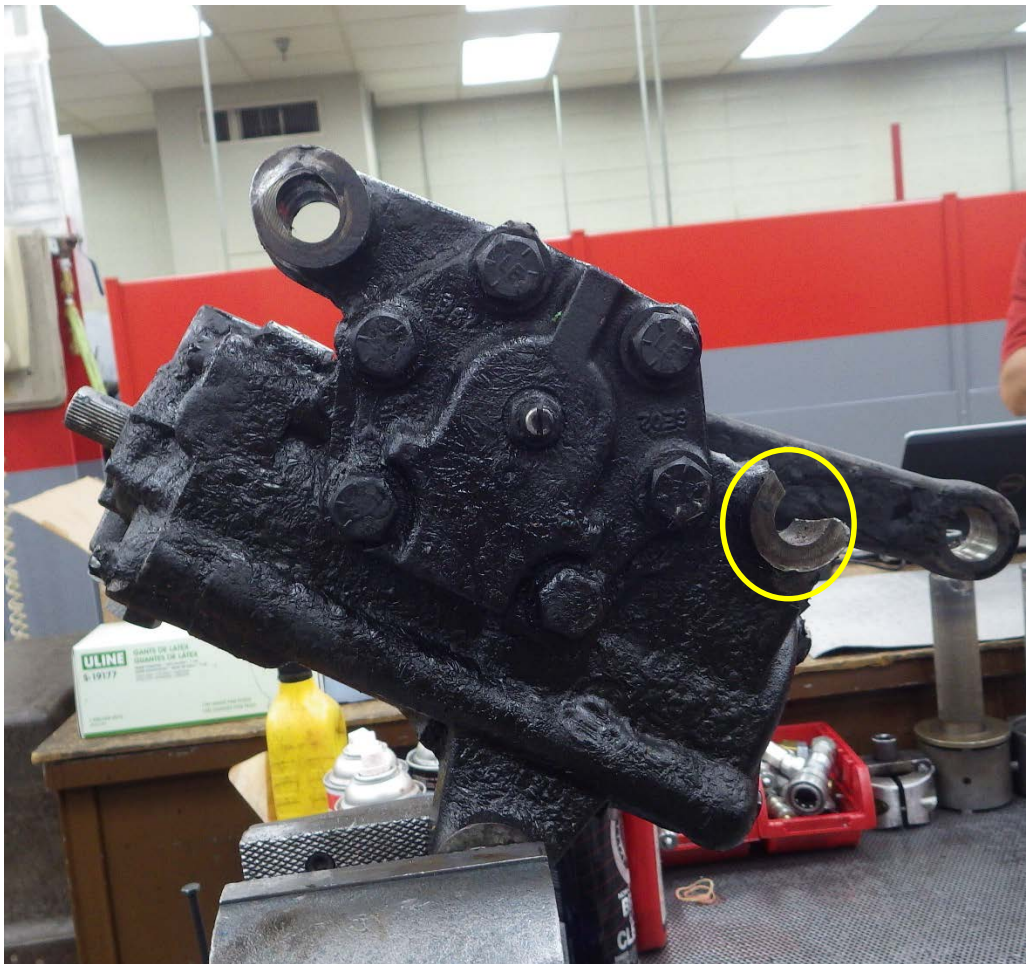
Photograph 3 – Looking at the steering gear box, you can see that the front mounting boss is broken, and the rear mounting boss is elongated.

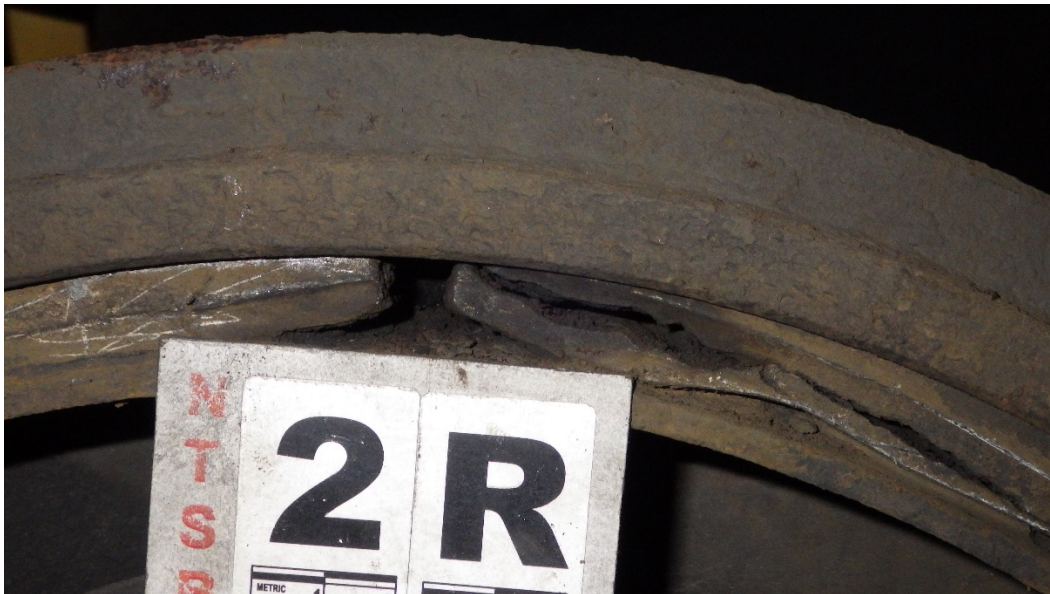
Photograph 4 – This picture is of the cracked axle 2 right upper brake linings. The crack in the side of the rear brake lining is in excess of 1.5 inches in length and has a void in excess of 1/16 inch.

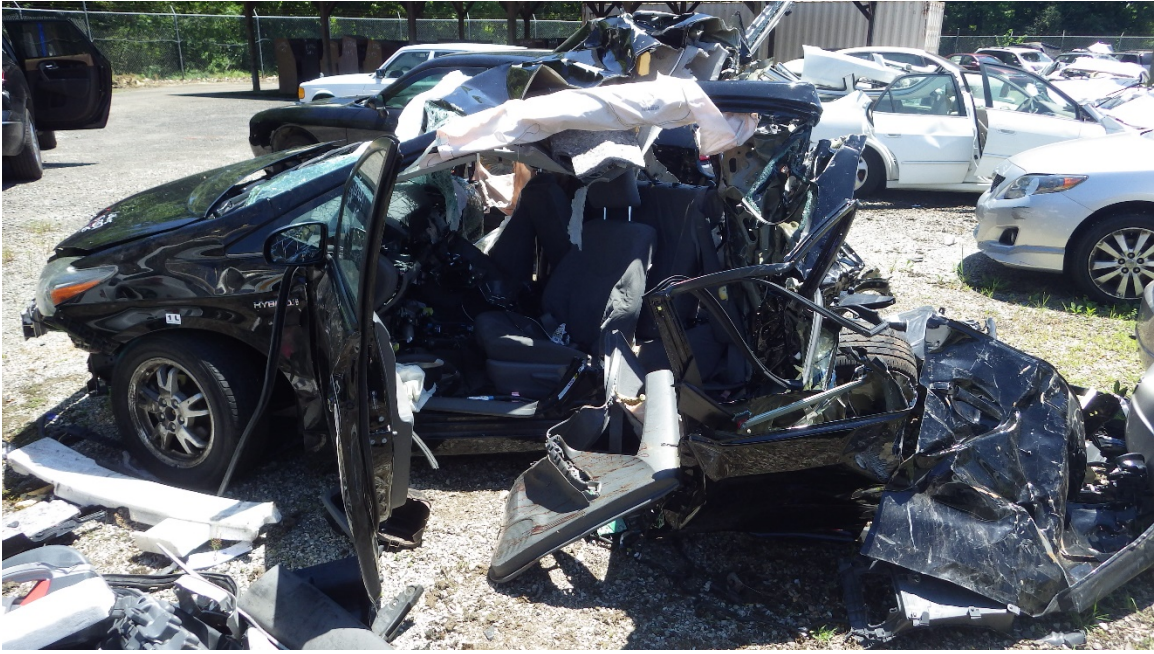
Photograph 5 – Shows the left side of the 2010 Prius. The rear passenger compartment is crush forward to the backs of the front passenger seats. The rear passenger door is torn away from the vehicle.

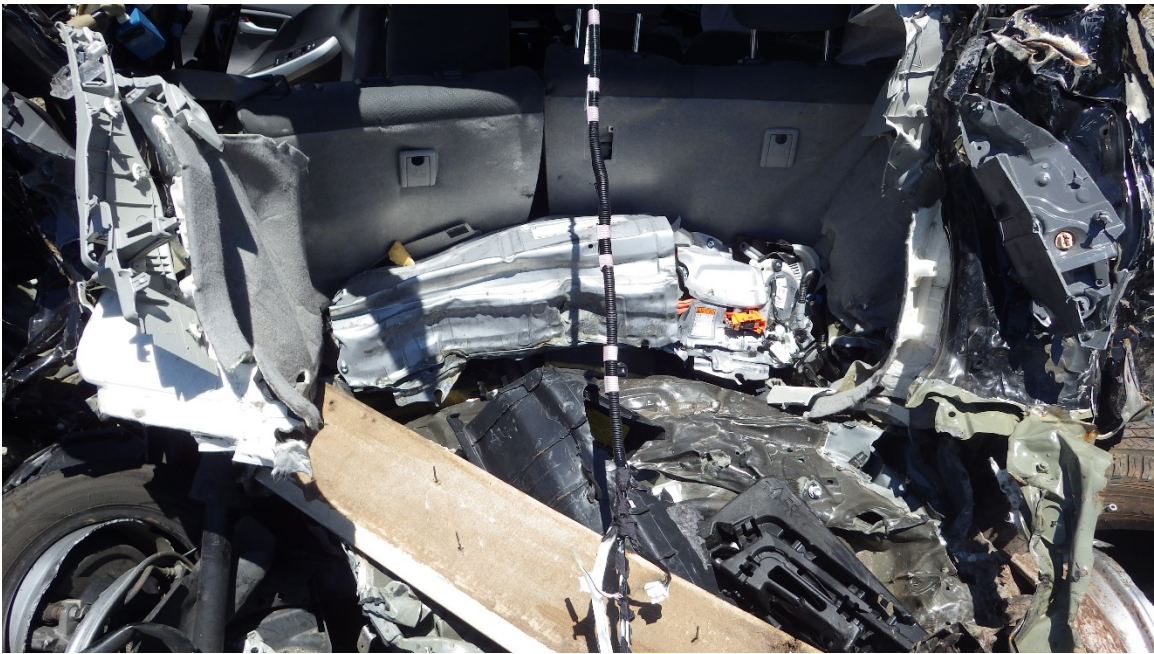
Photograph 6 – Shows the rear cargo area and the damaged battery pack. The left wheel is split.

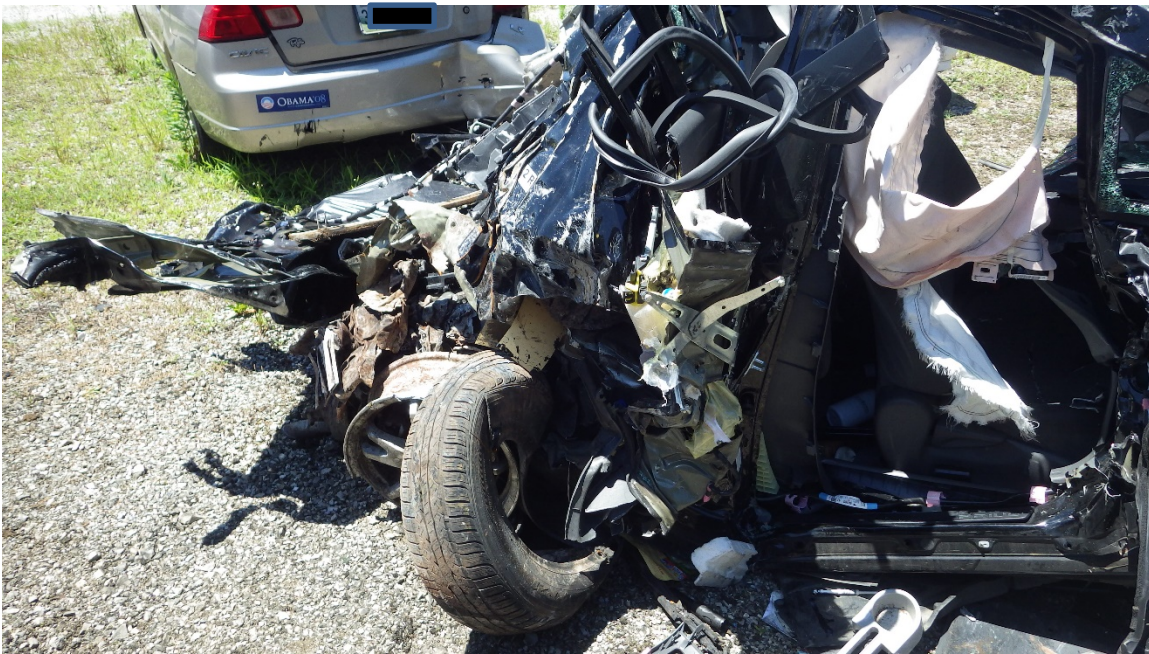
Photograph 7 – Shows the right rear of the vehicle. The tire is separated from the wheel. The rear passenger compartment is crushed forward almost to the “B” pillar. The passenger doors are missing.

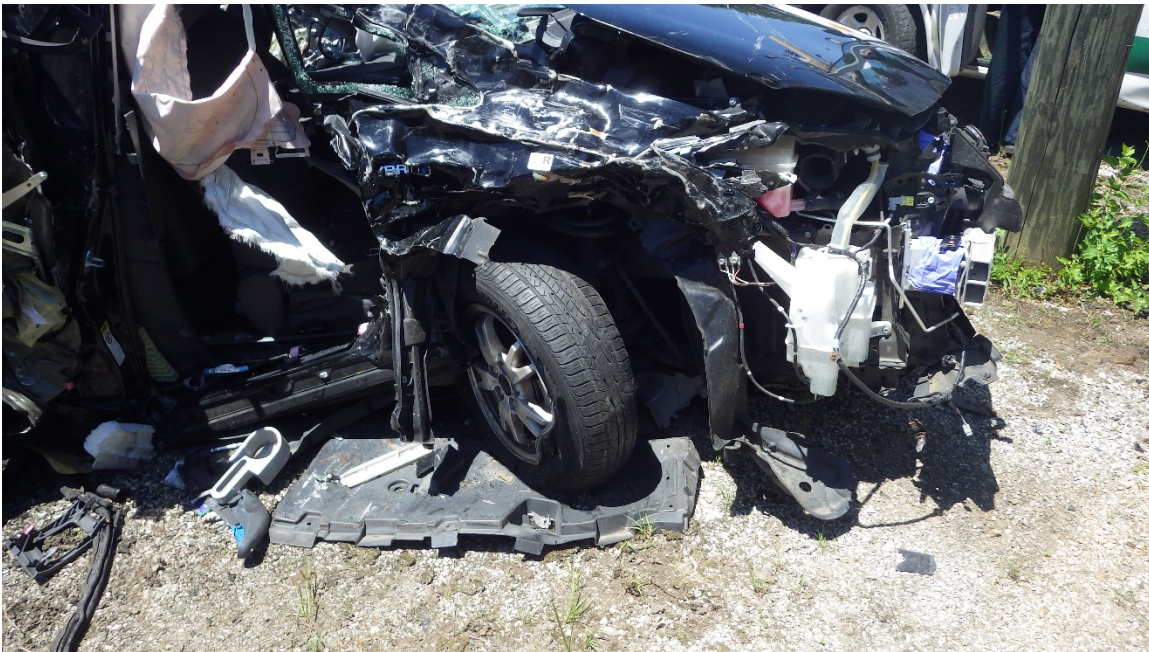
Photograph 8 – Shows the right front corner of the vehicle. The quarter panel is crushed. The edge of the bumper beam is exposed. The windshield is shattered.

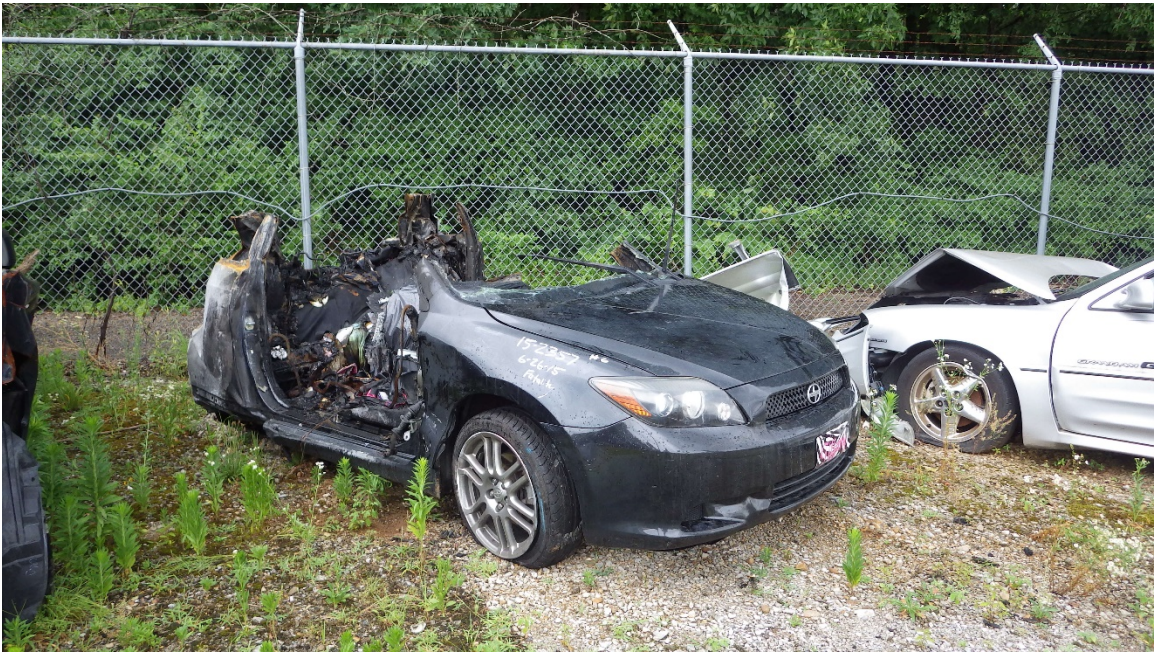
Photograph 9 – This is the right front corner of the 2010 Scion looking rearward. The front of the vehicle sustained little to no damage, forward of the “A” pillars.

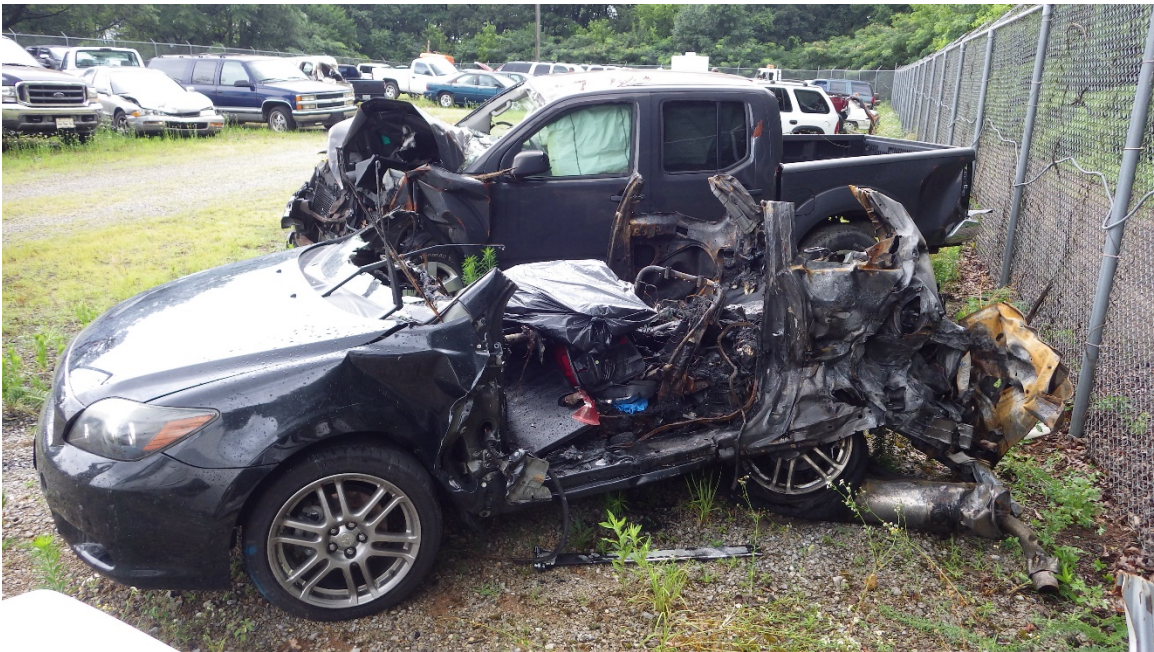
Photograph 10 – The left side of the Scion sustained major collision and fire damage from the rear of the front quarter panel rearward. The roof is detached from the vehicle. The rear tire and wheel are trapped inside the body of the vehicle.

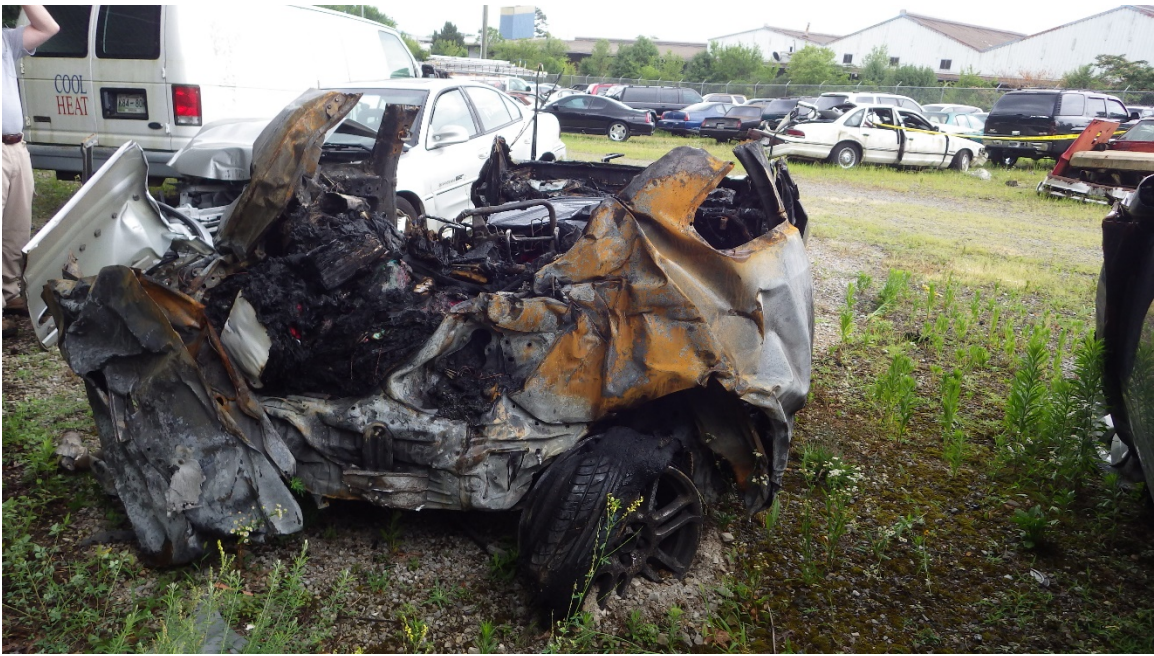
Photograph 11 – The rear of the Scion shows sign of extreme heat and collision damage. The cargo area is crushed forward and the body of the vehicle has no color left and is rusted. The right rear tire is separated from the wheel has burn marks on the tread area.

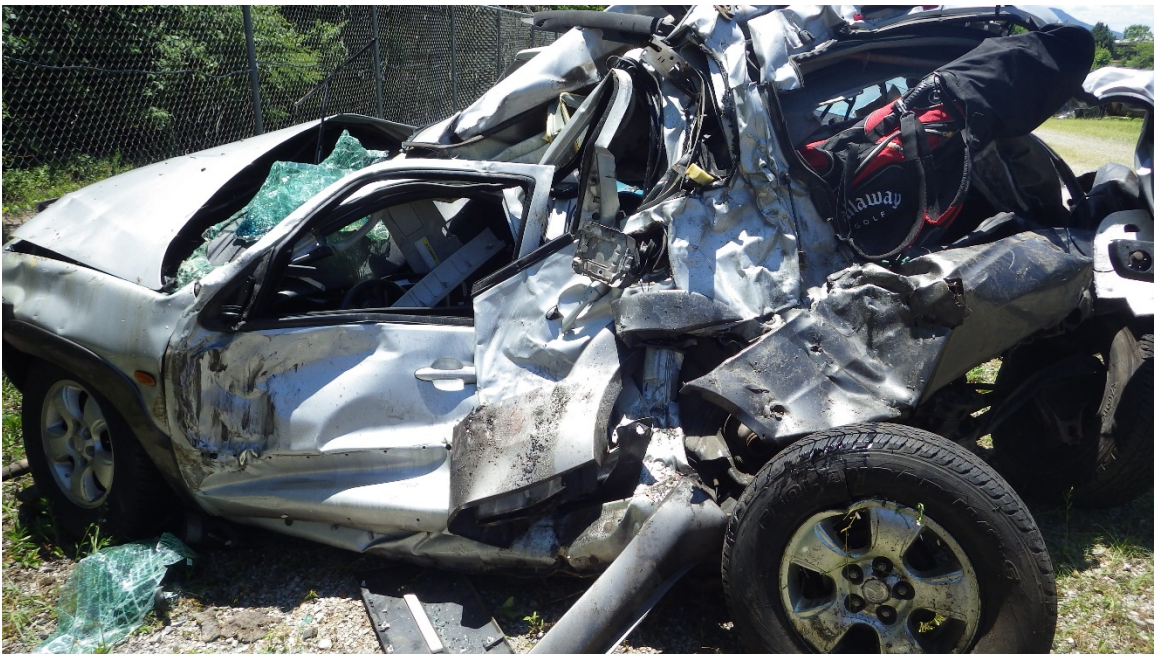
Photograph 12 – The left side of the Mazda Tribute is crushed inward, upward, and is inside the rear tire and wheel. The distance between the "B" pillars is approximately 24 inches.

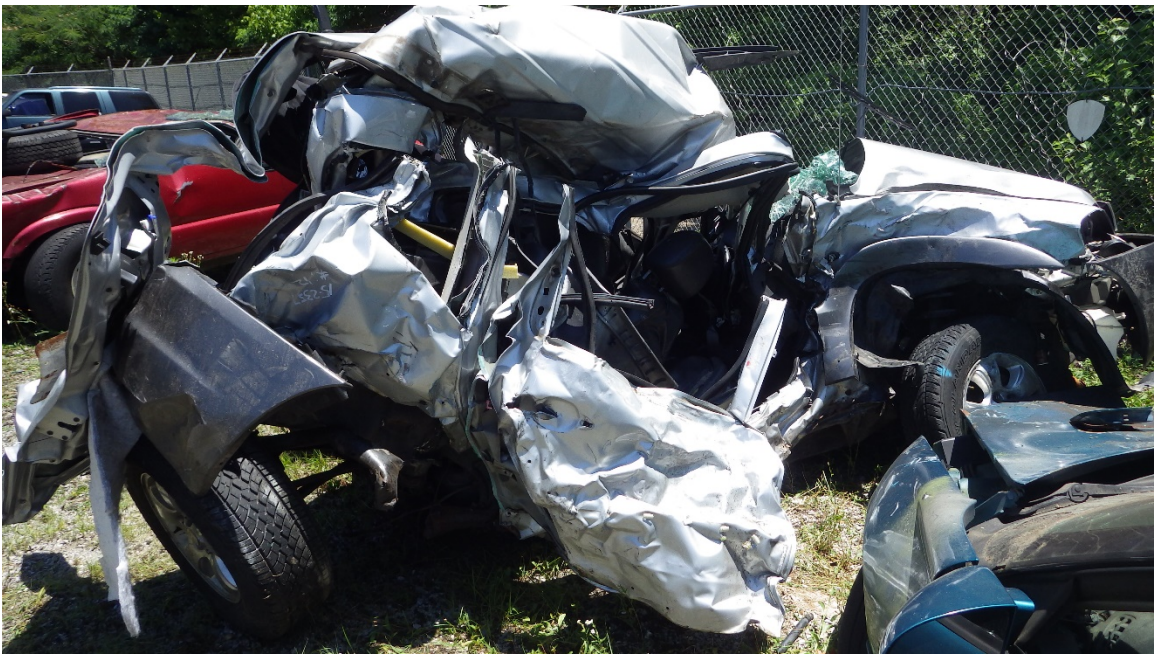
Photograph 13 – Shows the overall substantial damage to the right side of the Mazda Tribute. The body of the vehicle is extremely crushed and torn away from the vehicle, exposing the interior. The rear axle is broken and displaced rearward at almost a 45 degree angle from its original position.

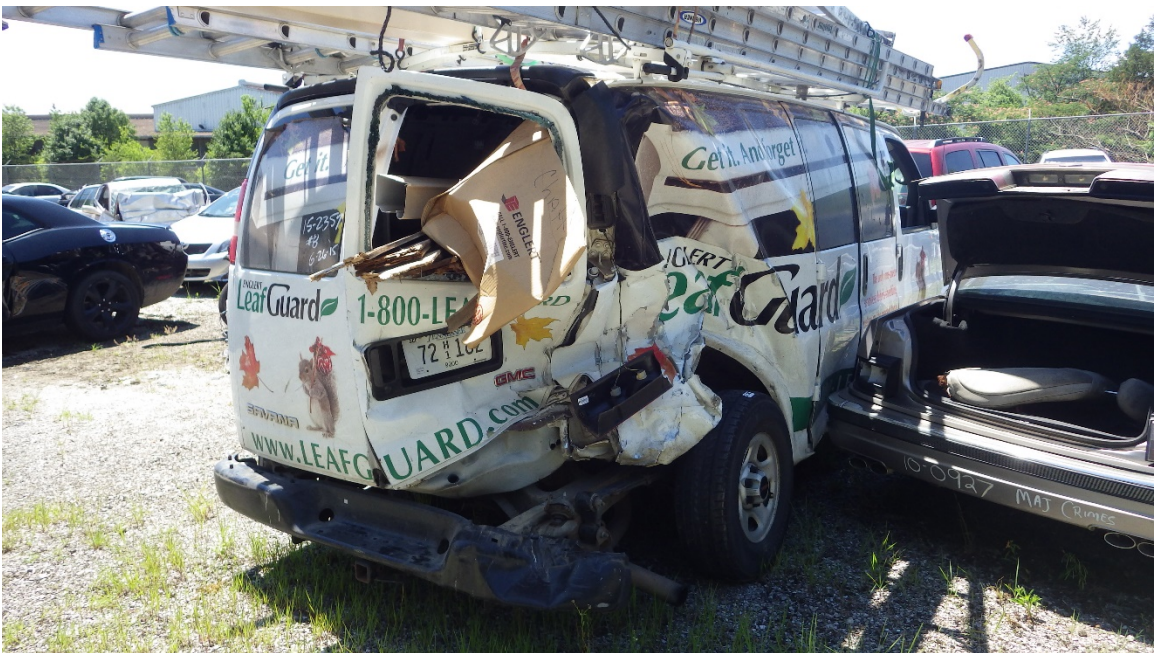
Photograph 14 – Shows the right rear of the GMC Savana. The rear panel and rear cargo door are crushed forward and to the left. The tail lamp assembly is displaced from its mount and is hanging by its electrical wires. The rear bumper is bent forward.

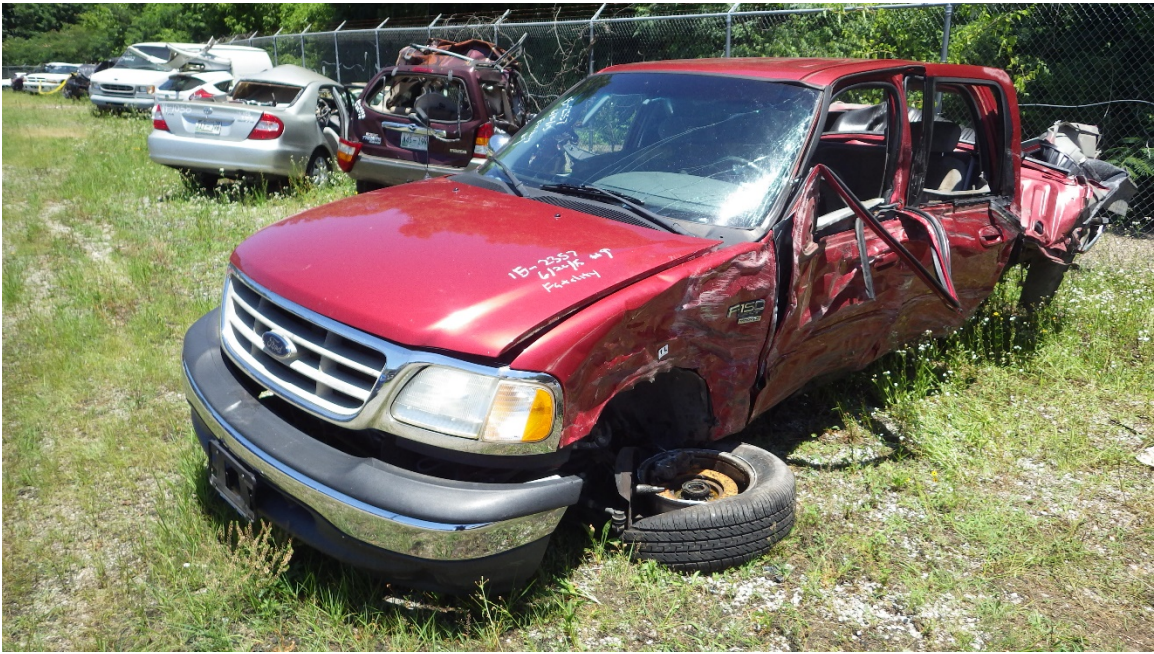
Photograph 15 – looking from the left-front corner towards the right-rear corner of the F150, the left-front fender is crushed inward and covered with abrasions. The left-front wheel, tire, and disc brake assembly are separated from the spindle. The tire is deflated. The left side of the windshield contains multiple cracks towards the center. The leading edge of the driver's door is crushed rearward, the top of the window frame is bent downward, and the body of the door is crushed inward and covered with abrasions.

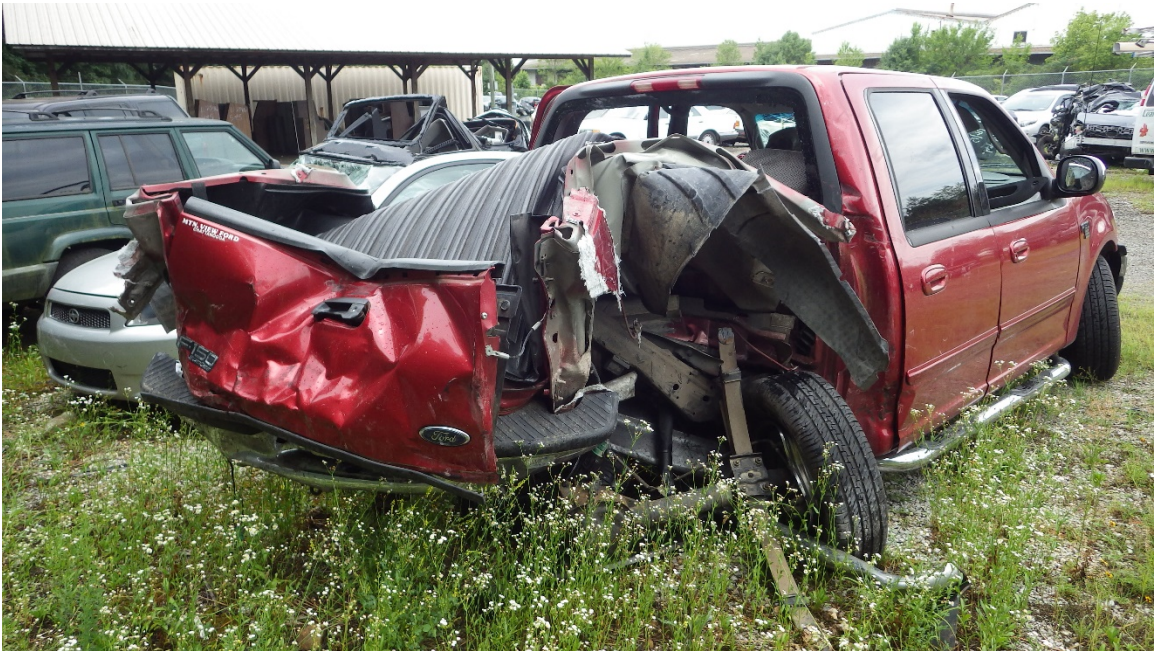
Photograph 16 – Looking from the right-rear corner towards the left-front corner of the F150, the cargo bed, frame rail, and bumper are crushed forward and to the left. The rear axle housing along with the right leaf-spring package, and right tire and wheel assembly, are separated from the F150. The left axle tube is broken and separated from the differential. The rear window to the passenger area is broken.

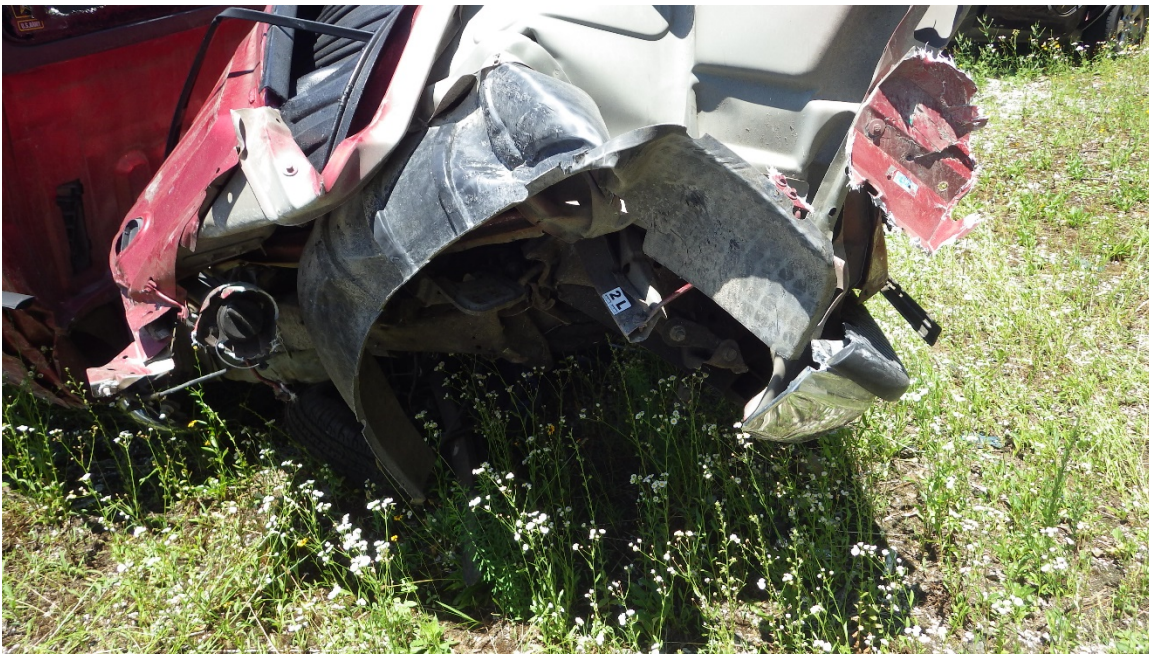
Photograph 17 - Looking at the left-rear fender well area, the cargo bed is displaced inward and forward, the left axle assembly is displaced rearward under the F150, and the leaf spring package is displaced rearward. The fuel filler neck and fuel cap are present and the plastic wheel well liner is crushed.

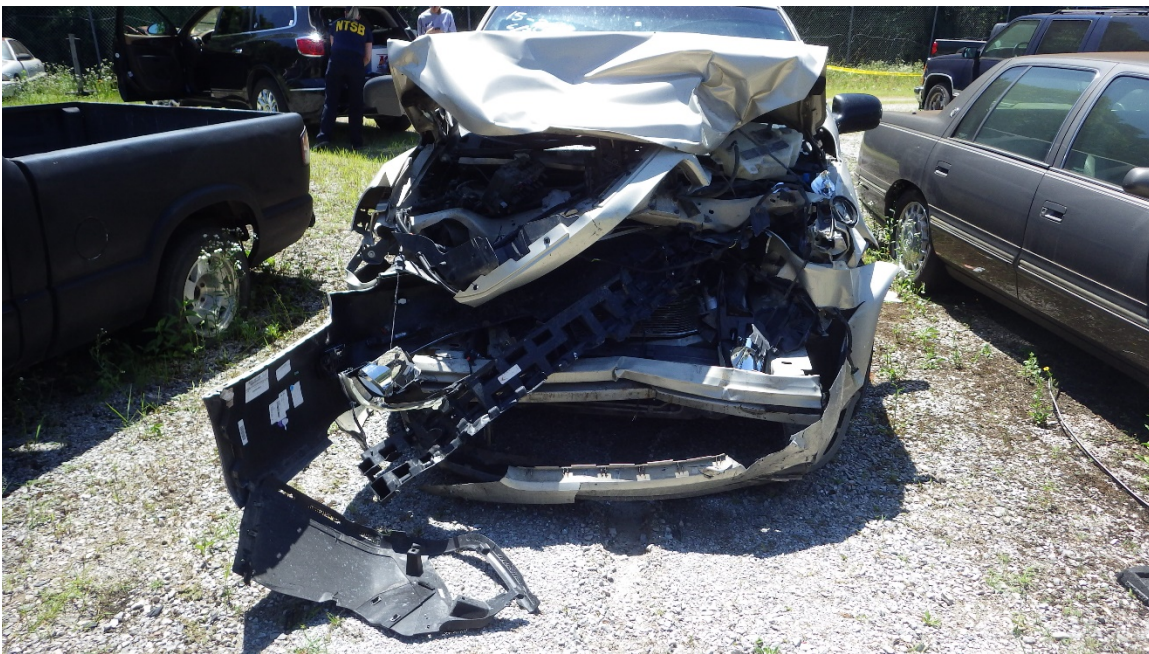
Photograph 18 – The front of the Chevrolet Uplander was displaced rearward across the entire front area. The hood is crushed rearward and is bowed upward. The plastic cover to the rear of the Cadillac is embedded into the engine compartment. The bumper beam is bent rearward and the plastic cover is lying on the ground.

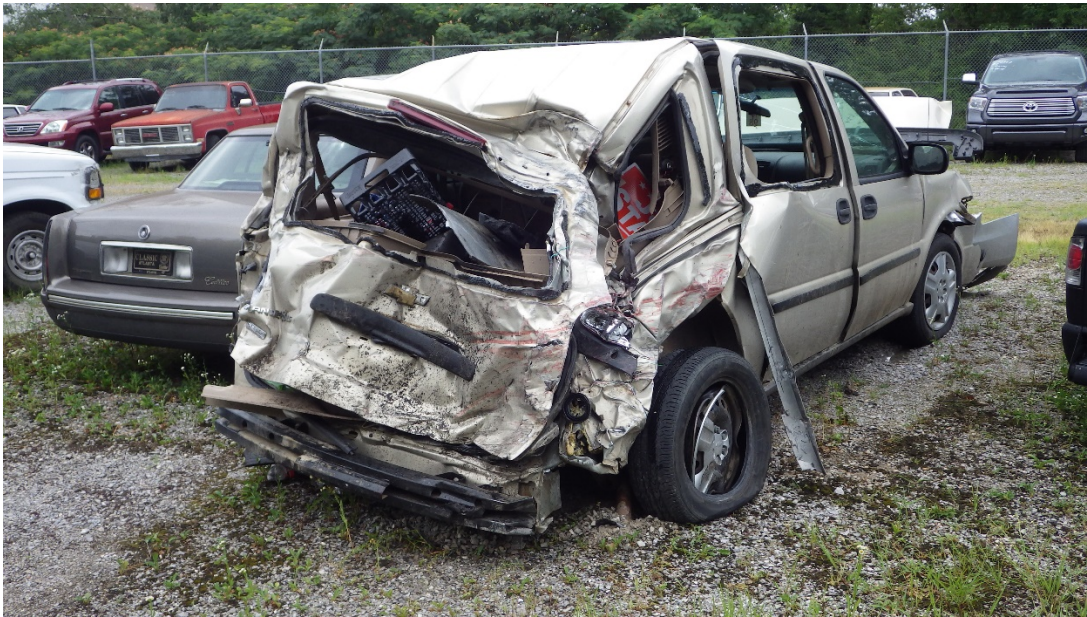
Photograph 19 – Looking at the right-rear corner towards the left-front corner of the Chevrolet Uplander, the right-rear quarter panel and wheel well are crushed forward and downward. The rear lift gate and cargo area is crushed forward and downward, the rear window and right-side window are missing. There is red transfer across the right-side of the lift gate and along the right quarter panel. The tire is deflated.

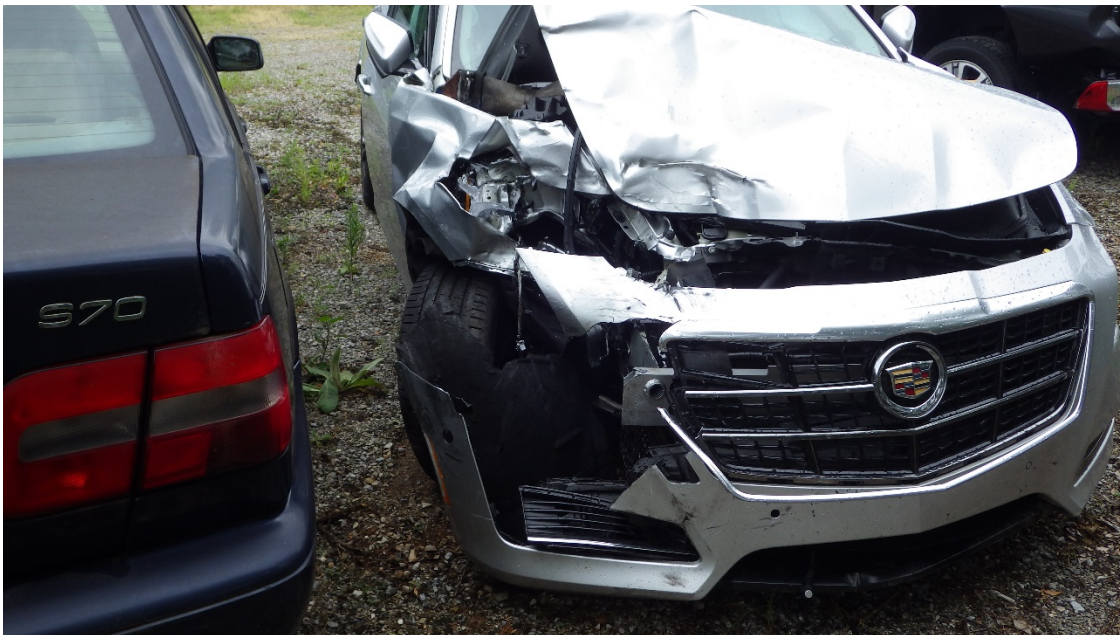
Photograph 20 - Shows the damage to the front of the 2014 Cadillac. The right side of the plastic bumper cover and radiator cowl is damaged and missing a large portion. The left side of the hood is displaced rearward and bowed upward. The right quarter panel is crushed rearward to the approximate center of the tire.

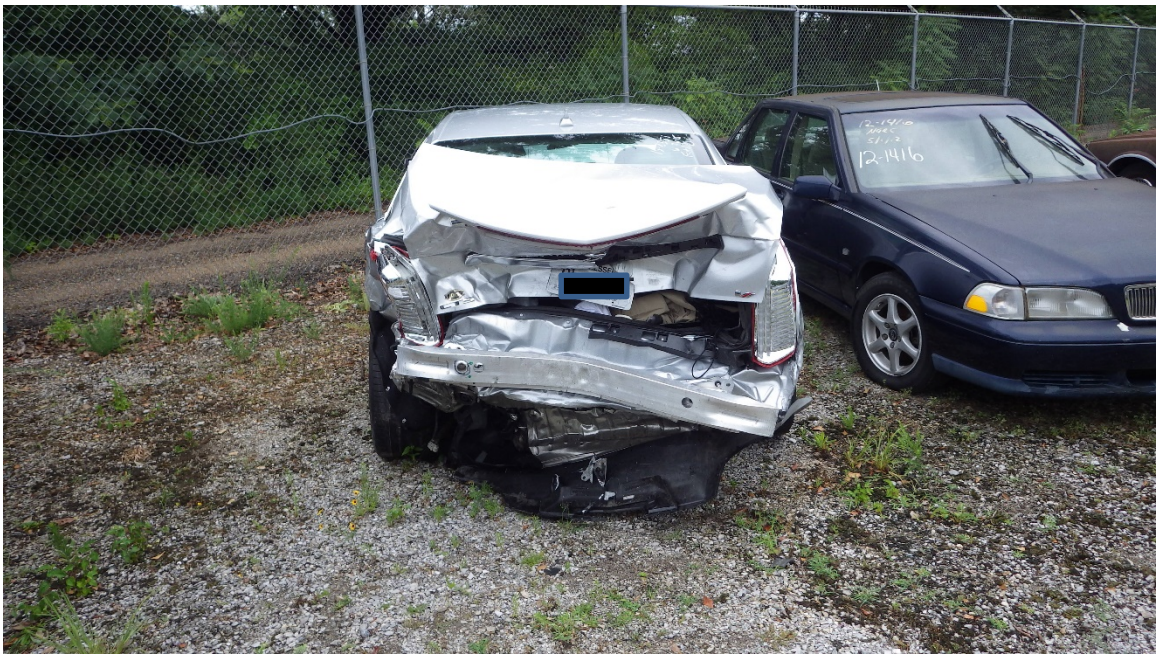
Vehicle Photograph 21 - Shows the damage to the rear of the 2014 Cadillac. The trunk lid is crushed forward. The plastic bumper cover is missing and the rear bumper beam is bent and displaced forward. Both of the tail lamps are missing their red lens covers. The bottom of the trunk is visible beneath the bumper beam.

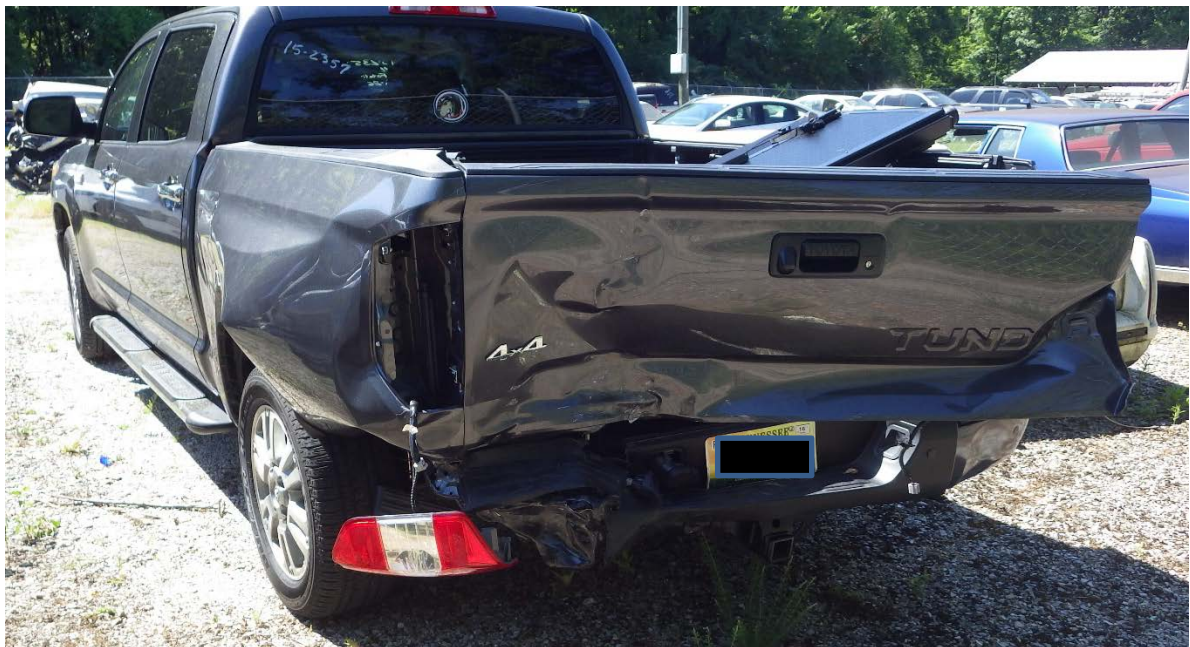
Photograph 22 - Shows the damage to the left rear of the Toyota Tundra. The left tail lamp assembly is displaced from its mounting location and is hanging by its electrical wires. The tailgate is damaged. The left side of the bumper is crushed forward.
