NATIONAL TRANSPORTATION SAFETY BOARD

AIRFRAME AND ENGINE EXAMINATION

WPR14FA382

Examination Report: N4618J Piper PA28R-180

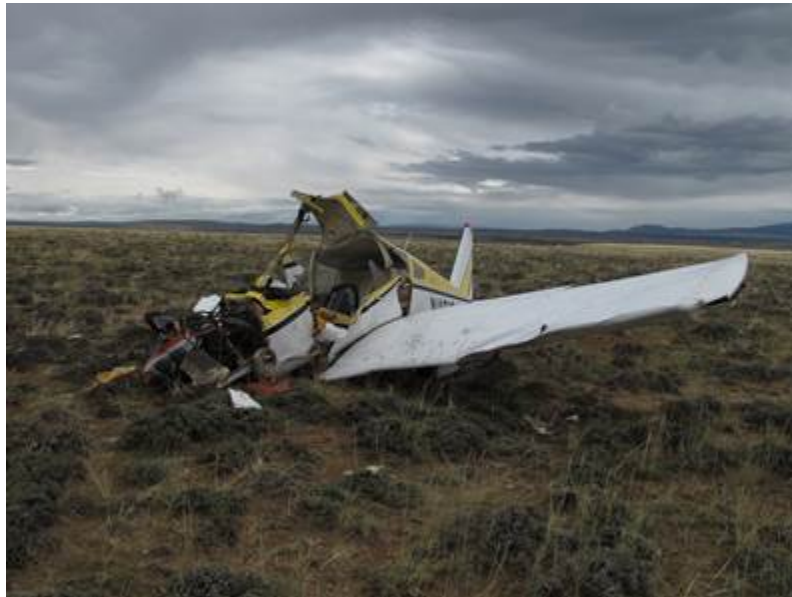
Figure 1: Main Wreckage

The initial point of impact was a shallow 7 foot long ground scar that contained green/blue lens fragments. The ground scar was oriented in direct line of the main wreckage on a magnetic bearing of 240°. The main wreckage was located 130 feet from the initial point of impact on the same bearing. The airplane was upright oriented on a bearing of 212° magnetic. The cockpit had split open behind the engine firewall, the left wing was attached, and the right wing had separated at the wing root. The fuselage behind the cabin and tail appeared undamaged. The propeller had separated from the engine at the crankshaft flange. The engine remained on the engine mount, but displaced down and to the right.

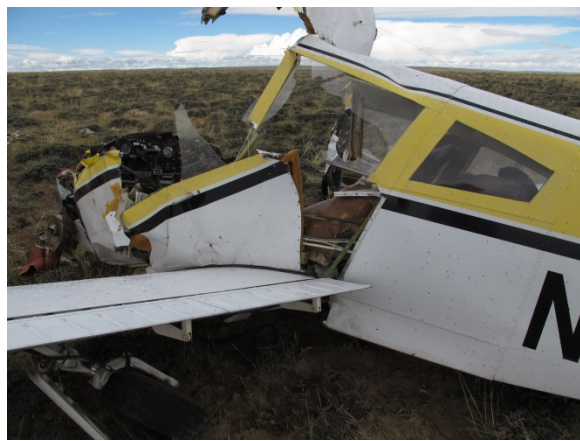
Figure 2: View of the left side of the fuselage.

The fuselage was examined while it was on its belly, laying on a bearing of 212° magnetic, tail to nose. The left wing was attached and the right wing was separated at the wing root. The vertical stabilizer, rudder, and horizontal stabilator were present on the aft fuselage and exhibited minimal damage. The stabilator trim drum exhibited 4 threads (neutral). The engine was attached to the engine mount which was partially attached to the firewall. The instrument panel was impact damaged. The pilot's control yoke was seized, the copilot's control yoke had separated from the control shaft. Control continuity was established from all control surfaces forward to the cabin area with some restriction due to impact damage to the airframe which restricted cable movement. There was no separation of control cables, and all control cables were attached to their respective bell cranks.

The left wing exhibited leading edge crushing, and 45° buckling of the upper wing skin from midspan to the trailing edge. The fuel cap was in place. A bluish fluid could be seen in the tank through the filler port when the fuel cap was removed. The flap was in the up position, and the landing gear was extended with over center lock in the lock position. The aileron was attached to its hinge, and the balance weight was present.

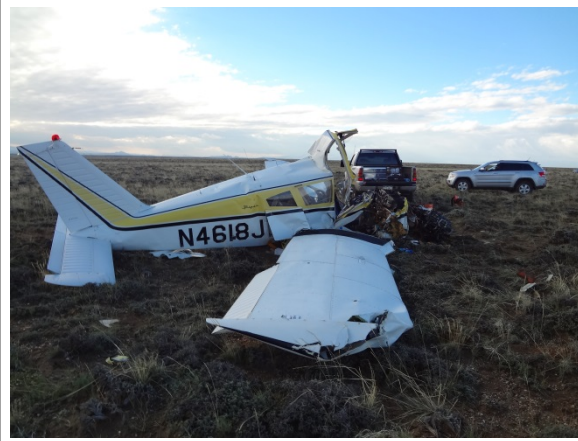
Figure 3: Right side of the entire airplane.

The right wing was separated from the fuselage at the wing root, but the aft spar remained connected to the airframe. The wing tip leading edge indicated aft and upward crushing. The flap was folded under the wing. The aileron and balance weight were present. The fuel cap was in place, and fuel was observed at the tab level when viewed through the filler port. The landing gear was extended and the over center lock was locked.

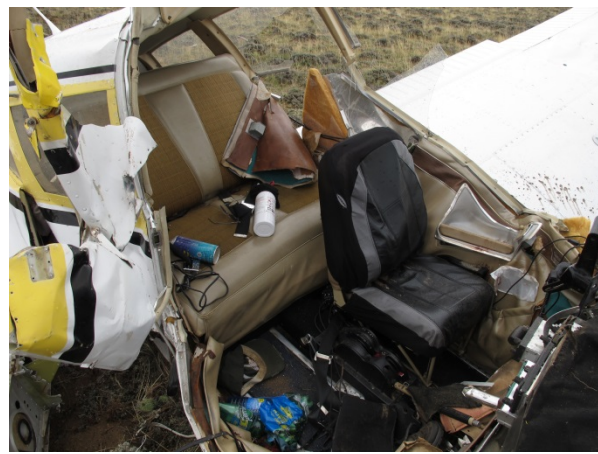
Figure 4: View of the airplane's cabin.

The cockpit was split open behind the firewall. The wind screen was not present and revealed the entire cockpit and cabin area. The right cockpit floor section by the rudder pedals was deformed inward. The right yoke had separated from the control shaft, the left yoke remained in place. The right seat had separated from the rails, the left seat remained on the rails. Two iPads that were in the cockpit had been ejected out and forward of the fuselage.

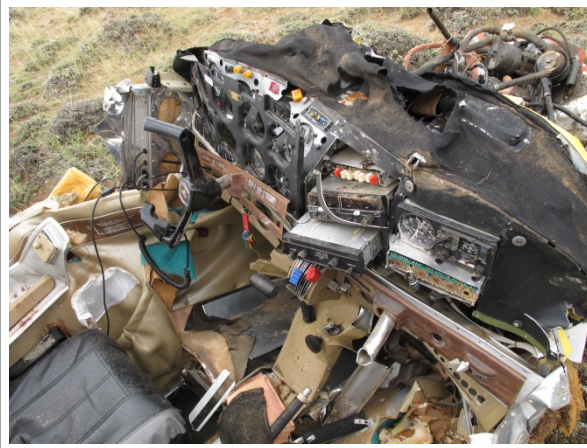
Figure 5: Cockpit and instrument panel.

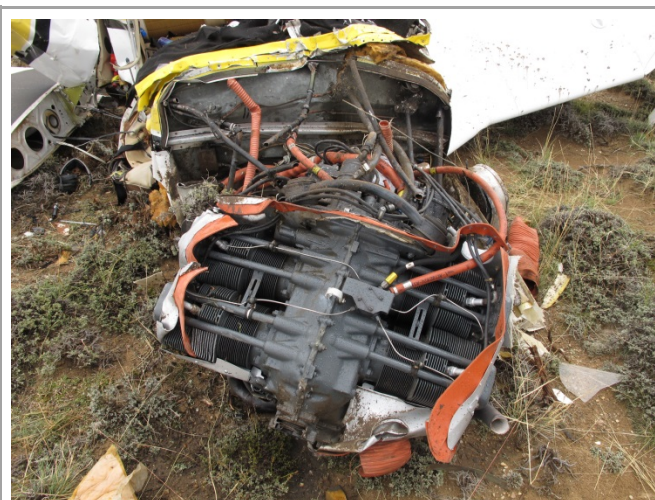
Figure 6: Top view of the engine.

The engine was attached to the engine mount which was partially attached to the fire wall. The propeller had separated from the engine at the crank shaft flange. The throttle cable was connected to the throttle body, the propeller condition cable was attached to the propeller governor control arm, the mixture cable was broken from the fork and exhibited overload signatures. The vacuum pump was removed, could be rotated by hand, rubber shear drive coupling was intact. The vacuum pump was disassembled; the rotor was intact and all vanes showed even wear with no signs of binding. The top spark plugs were removed, Champion REM40E's, and exhibited normal worn wear according to the Champion Check-A-Plug chart. The engine crank shaft was rotated using the

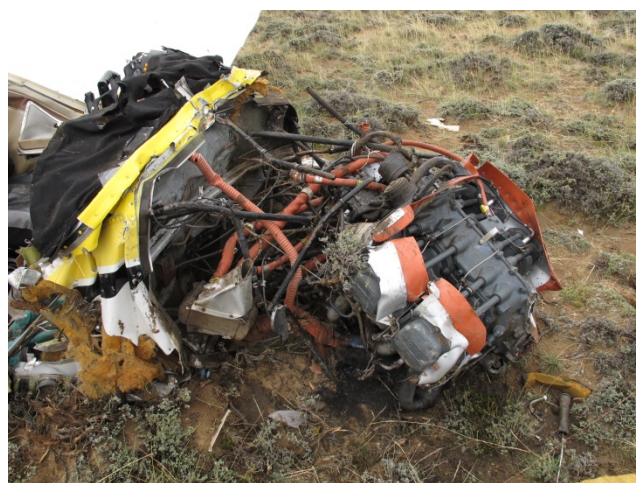
Figure 7: Right side, engine mount and accessories.

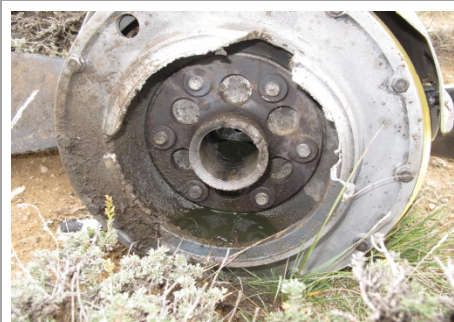
Figure 8: Propeller flange.

The propeller had separated from the engine at the crankshaft flange. The propeller was located approximately halfway between the initial point of impact and the main wreckage. The propeller exhibited leading edge polishing on both blades, and longitudinal twisting. Two distinct propeller slashes were identified in the ground 24 inches apart, 45 feet from the initial point of impact.

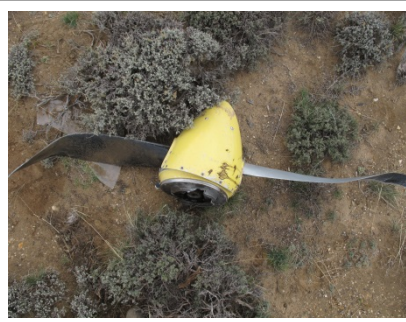
Figure 9: Propeller as found in the wreckage.

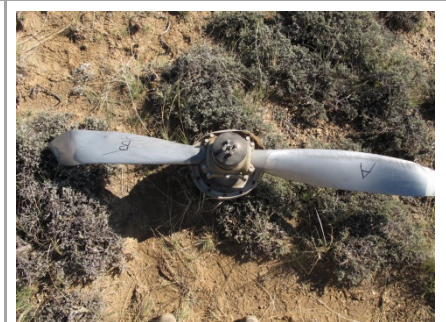
Figure 10: Propeller blade faces and hub.
