NATIONAL TRANSPORTATION SAFETY BOARD

ACCIDENT SITE EXAMINATION SUMMARY

WPR16FA040

Location: Superior, Arizona
Date: December 15, 2015
Aircraft: N74317; Airbus Helicopter AS350B3
NTSB Investigator-in-Charge: Andrew Swick

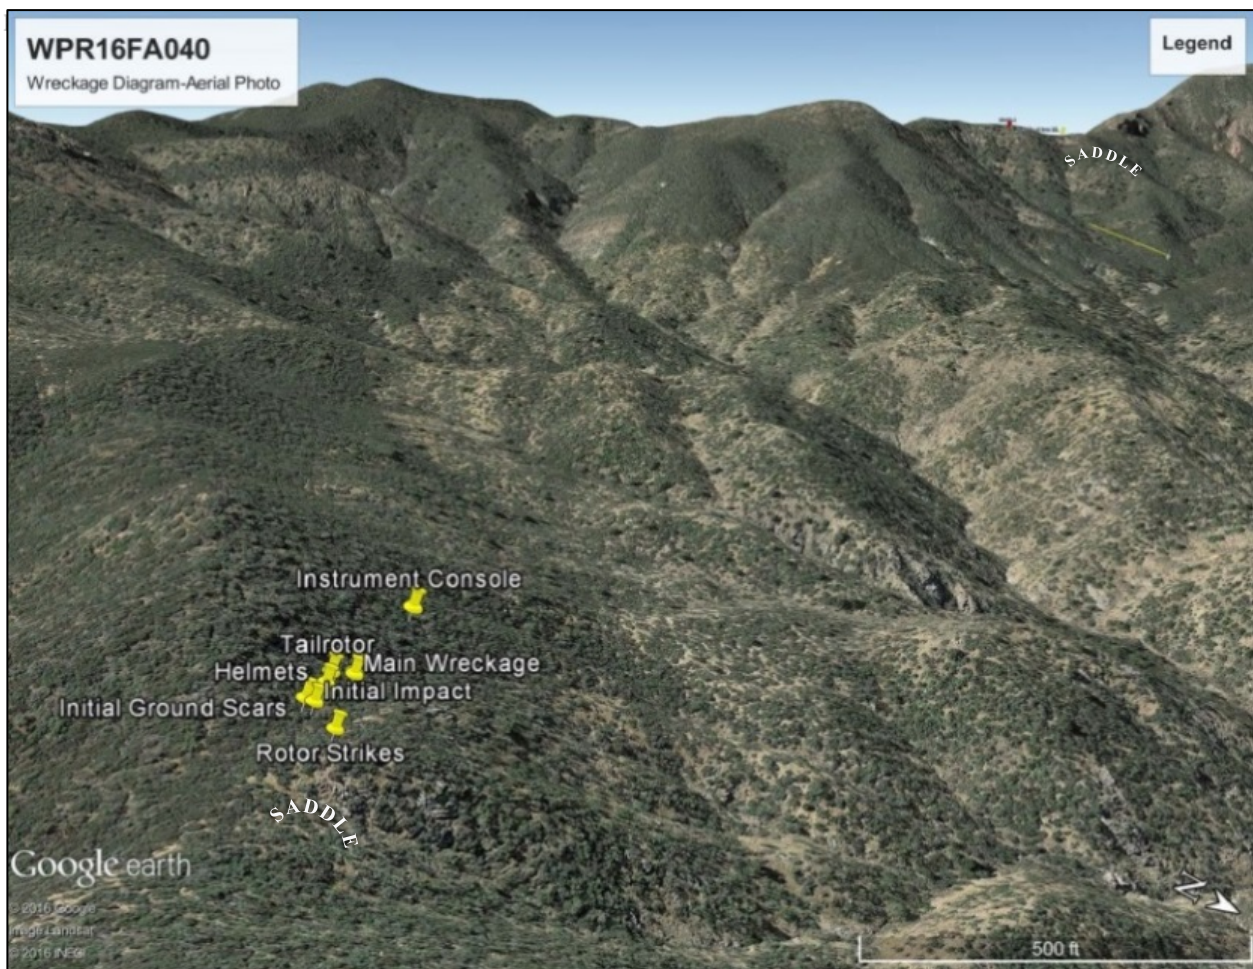
The accident site was located on a northwest facing slope of a ridgeline, near a saddle, and surrounded by mountainous terrain at an elevation of 5,035 feet mean sea level (msl). The surrounding peaks, about 1 to 1.5 miles from the accident site, ranged from about 5,700 to 6,000 feet msl. The debris field was about 330 feet in length on a magnetic heading of about 230 degrees. The last known flight path was identified to pass through the saddle area in the top right of the Figure 1 below.

Figure 1-Accident Site and Surrounding Terrain

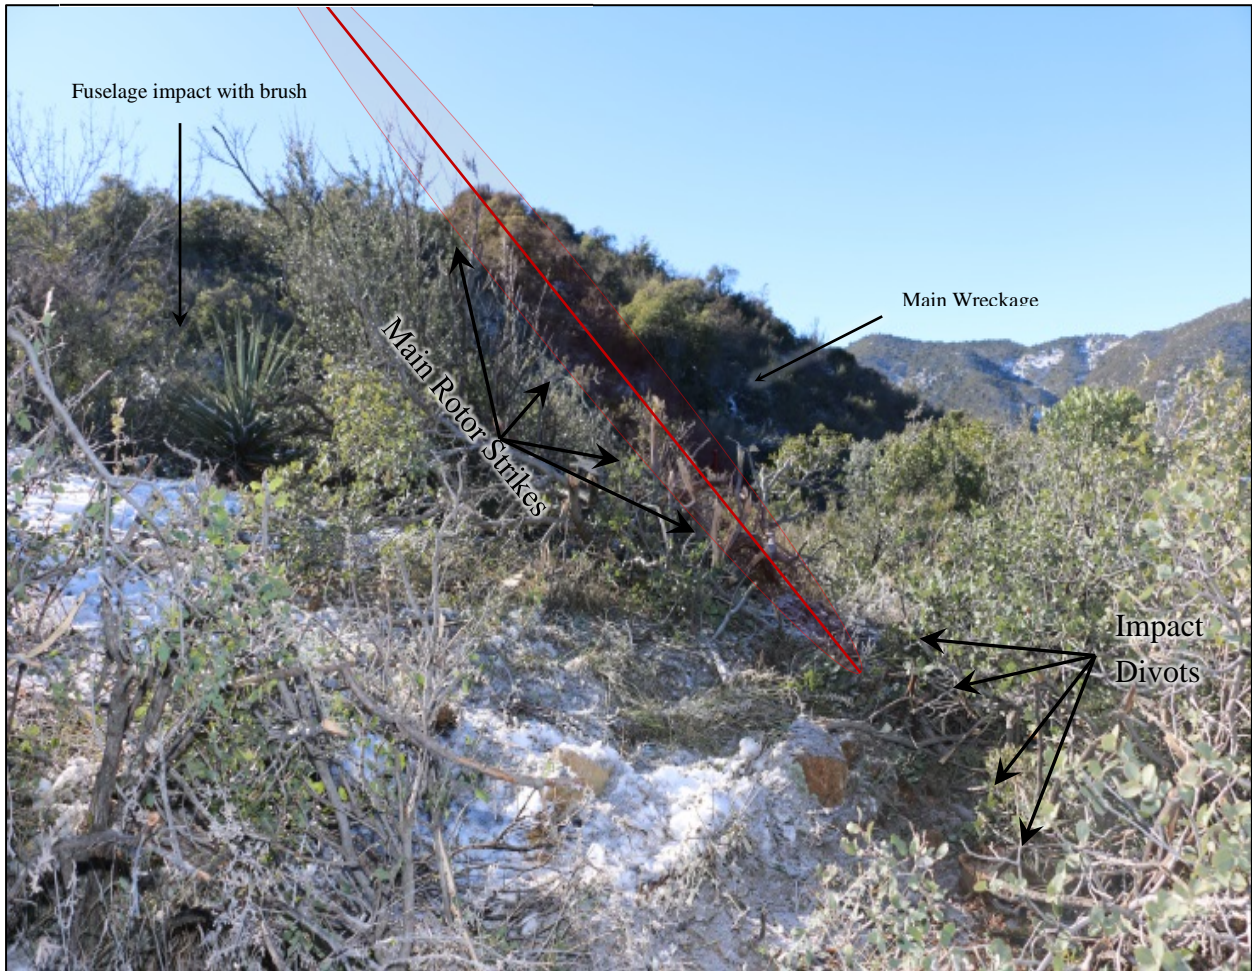
The first identified point of contact (FIPC) were multiple cuts through two bushes that were about two feet apart, and located uphill from one another. The bushes were evenly cut at an angle of about 45 degrees to the horizon. Downhill of the two bushes; were four divots cut from the soil, about 18 inches in length to about 12 inches wide and about 3 inches deep and all span a length of about 20 feet. The multiple cuts in the bushes and divots were consistent with main rotor strikes. Paralleling the span of divots, about 12 feet uphill, were two bushes with broken branches and a red lens cover. The red lens was later identified as the red lens from the lower side of the fuselage. Surrounding this area were fragments of rotor blade material.

Figure 2-First Identified Point of Contact (FIPC)

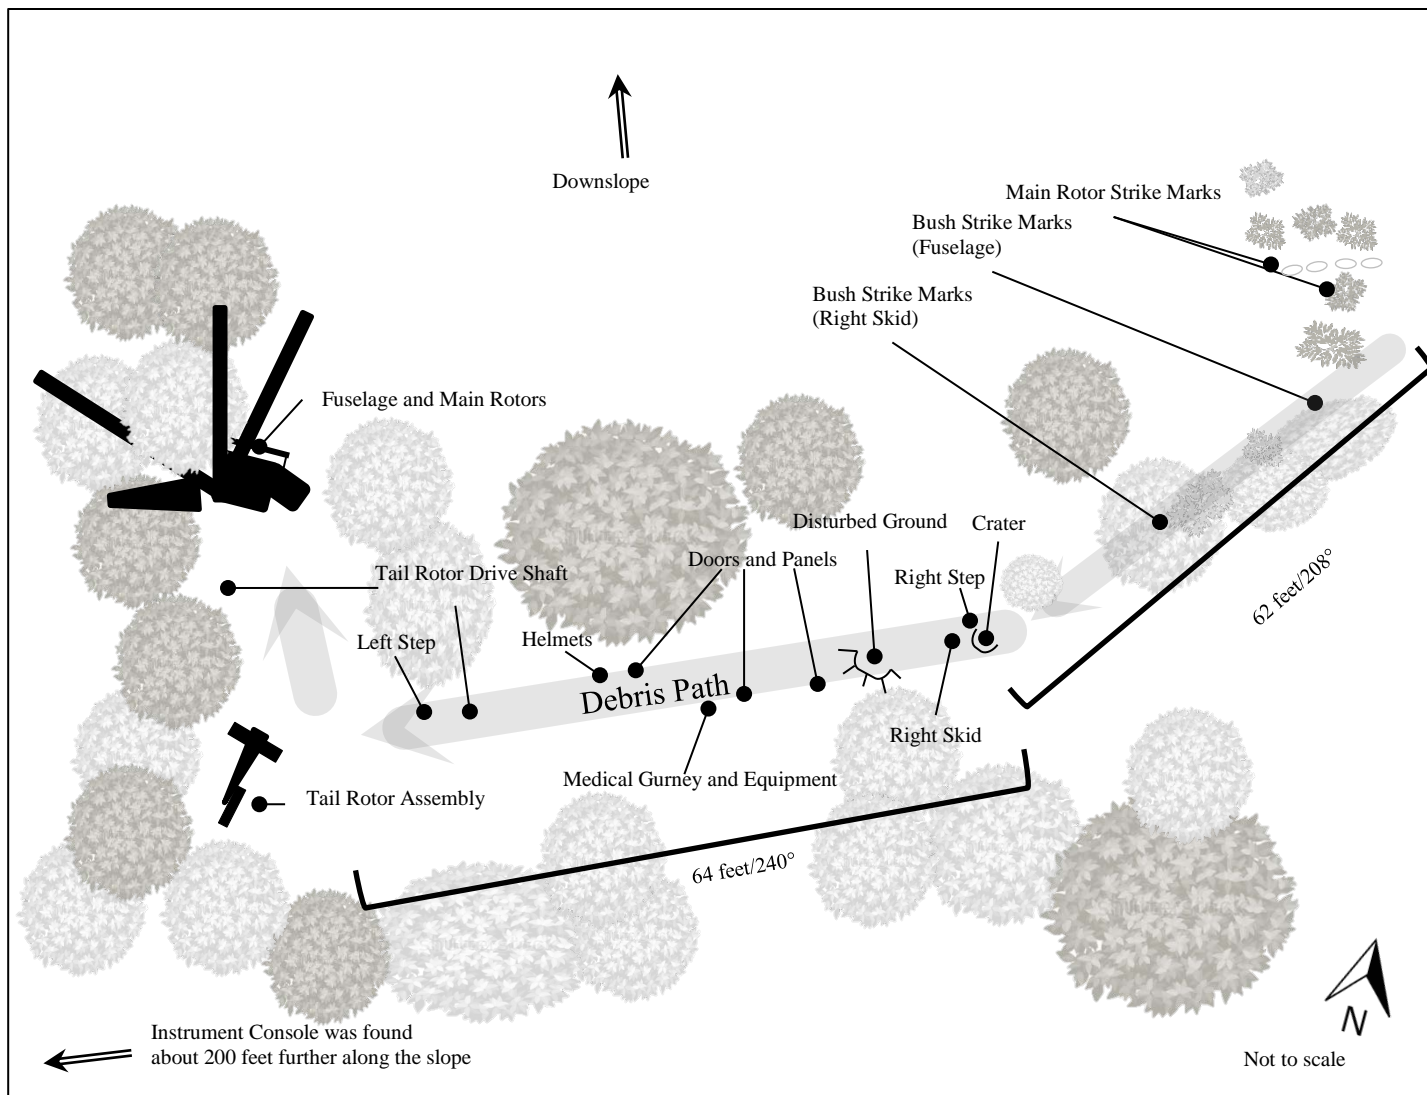
Figure 3-Wreckage Diagram

About 62 feet from the main rotor strikes, along the debris field, was a small clearing and a shallow elongated crater that measured about 1 foot in width and 3 feet in length. In this clearing were large broken branches and the helicopter’s right step and forward right toe skid. Another few feet from this area, was an area of disturbed ground consisting of large rocks and vegetation. The clearing continued level along the slope for 64 feet until reaching the tailboom assembly. About midway along the clearing, the helicopter doors, right side engine cowling, broken interior paneling, gurney, and medic bag were found. About 5 feet further were two helmets identified as belonging to the flight nurse and flight paramedic. About 10 feet from the helmets was the helicopter’s left step and forward left toe skid. The tail rotor assembly and a section of the tail boom separated just forward of the horizontal stabilizers and was uphill from the clearing. The right horizontal outboard end was crushed. The vertical stabilizer lower surface was crushed upward and to the right. The drive shaft was exposed and had separated about 5 feet from the gear box. The drive shaft fairing separated from the tailboom. The tail rotor blades were undamaged and had light rotational scuff marks near the tips.

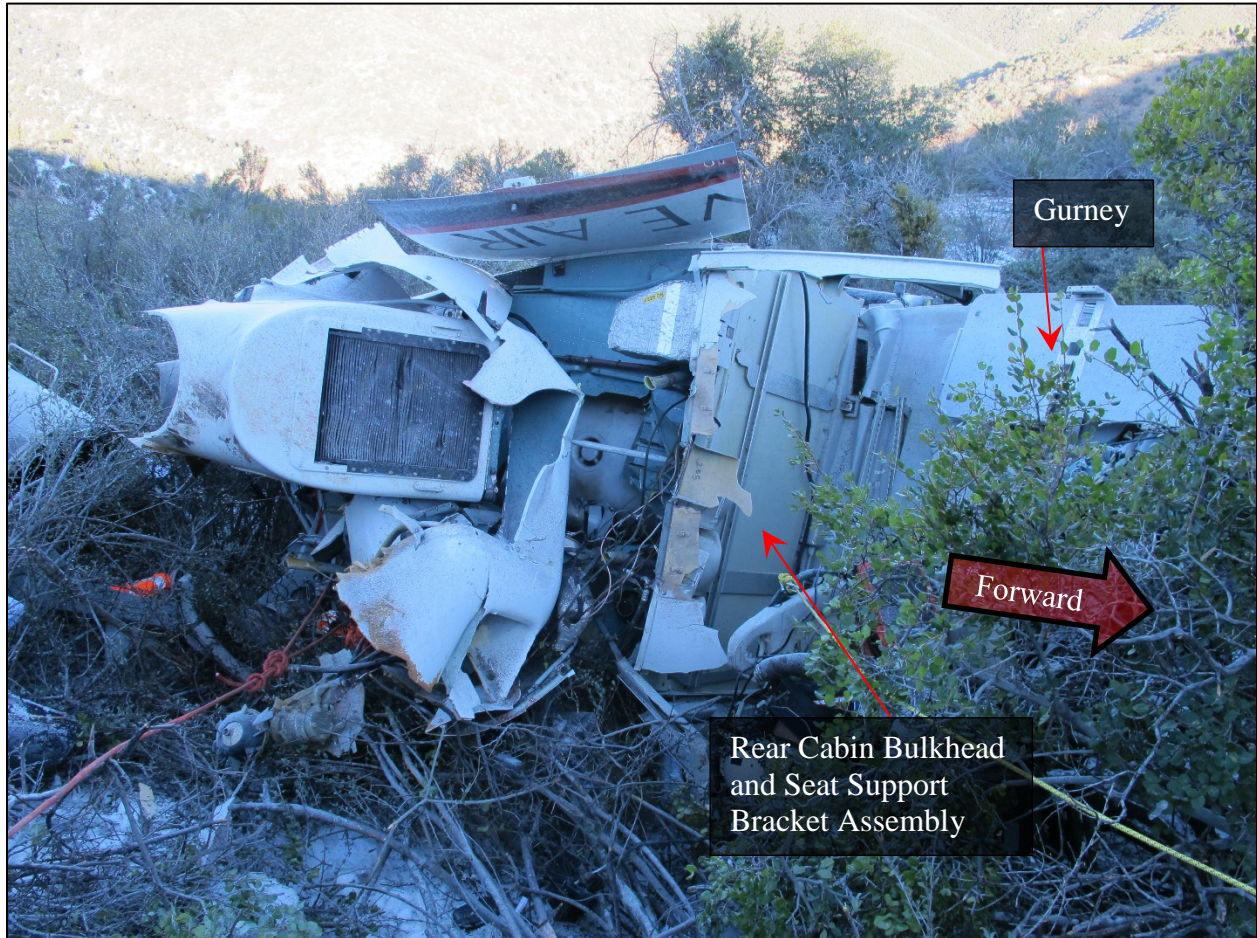
The main fuselage and remaining tail boom was located northwest, about 40 feet downslope from the tail rotor assembly. The fuselage came to rest on its right side exposing the cabin area. The cabin roof was found in sections near the fuselage. The forward cabin floor had separated and the remaining fuselage forward of the forward skid mounting legs, was bent upward about 30 degrees. The pilot remained in the pilot's seat which remained attached to the fuselage. The floor structure and the pilot's seat rails were buckled and distorted.

Figure 4-Main Wreckage (Looking Downslope, Northwest)

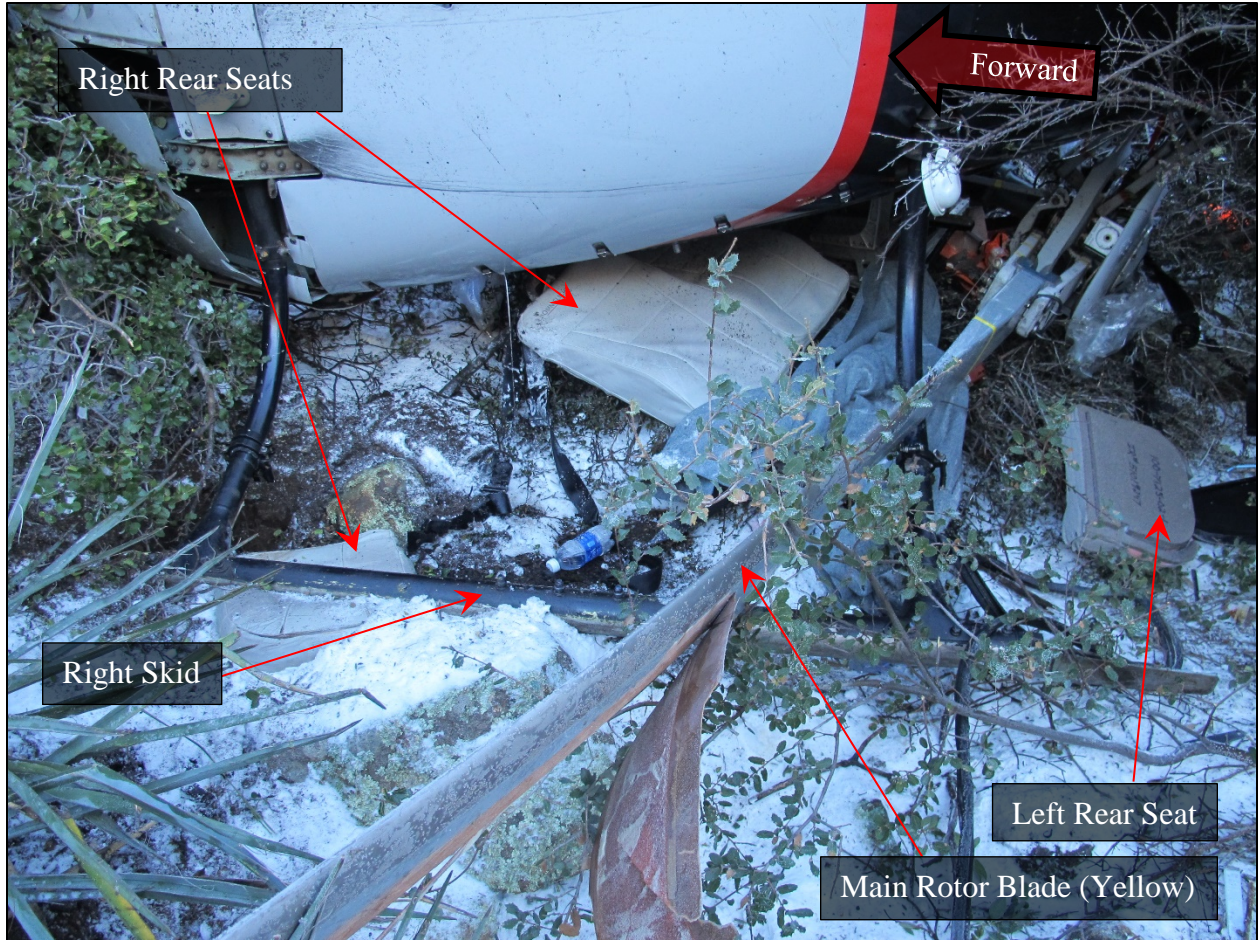
The rear cabin modular seating system consisted of a single seat on the left, and two seats on the right, separated by a medical equipment console. The modular seating system separated from the rear cabin wall and was located below the fuselage. The two right seats remained attached to the lower horizontal support bracket. The two right seats were found near the right skid, upslope from the flight nurse's onsite location. The seat bottoms separated from the seat backs near the hinge locations. Both seat buckles were unlatched. The single left seat separated from the rear support brackets. The single left seat bottom, cushion and leather cover was found near the main rotor hub and its seatbelts, which were unbuckled, and taugth around a portion the main rotor head. The flight paramedic's onsite location was downhill about 4 feet from the single left seat bottom location. The single left seat back was found near the main rotor head and remained attached to the seat belts.

Figure 5-Main Wreckage, Looking Upslope, Southeast

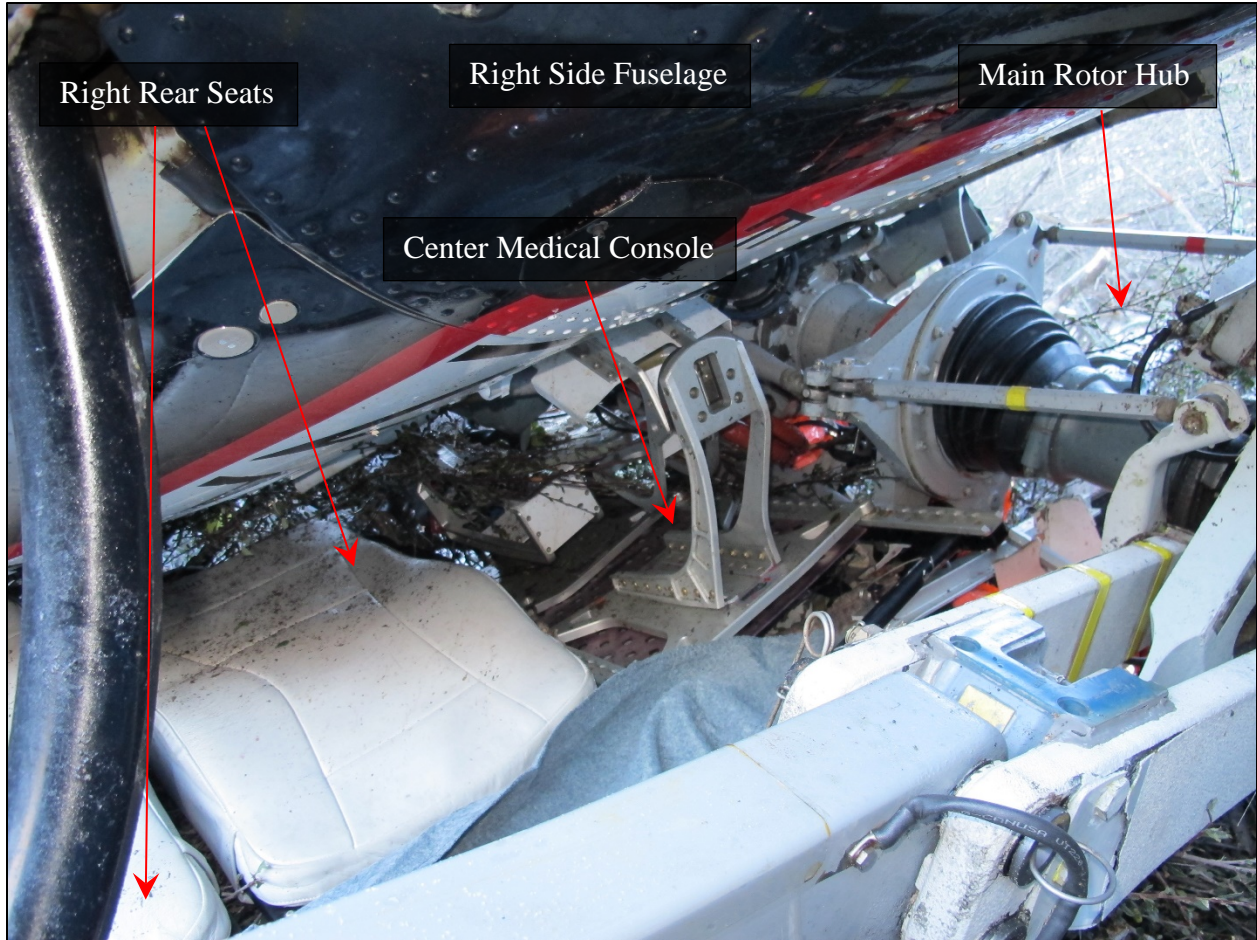
Figure 6-Main Wreckage (Looking Upslope, East)

The engine was exposed and was separated from the main and tail rotor drive shafts. The main rotor hub and blades remained attached and were located below the fuselage. The blades had deformation and delamination from the mid-sections to the tips. The yellow main rotor blade was frayed at the tip. The tail boom, forward of the horizontal stabilizer was partially attached to the fuselage. The fuel tank's right side was visible and intact. Fuel leaked from the right rear access panel during the onsite examination. The ground downslope of the main wreckage was saturated in fuel. The engine remained attached to the fuselage and was crushed and distorted at the exhaust. The instrument console separated from the cabin area and was found during the wreckage recovery about 200 feet further down the debris field in the top of a tree.
