NATIONAL TRANSPORTATION SAFETY BOARD

WRECKAGE EXAMINATION SUMMARY

WPR16FA040

Location: Superior, Arizona
Date: December 15, 2015
Aircraft: N74317; Airbus Helicopter AS350B3
NTSB Investigator-in-Charge: Andrew Swick

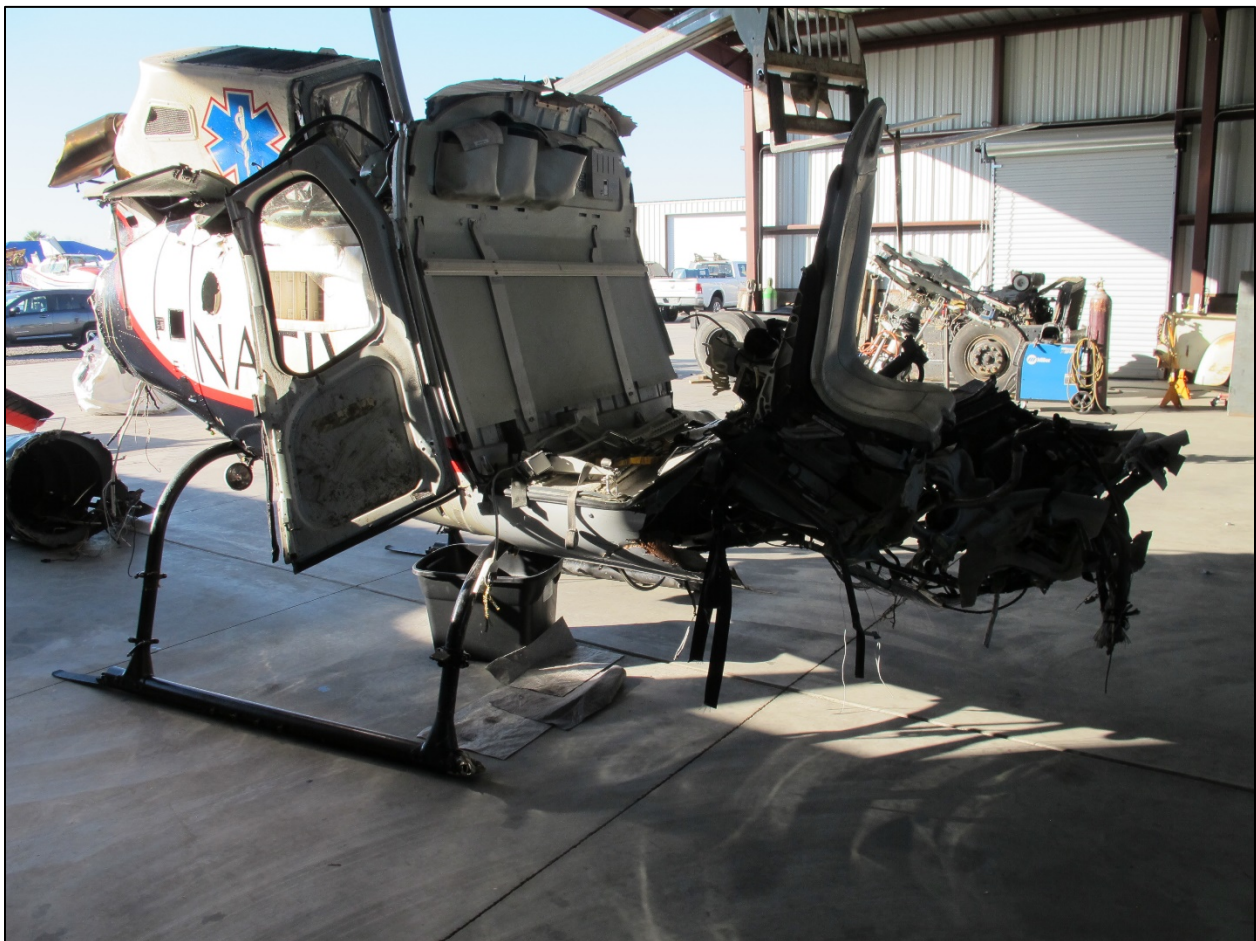
Figure 1-Main Wreckage, Forward Right Side View

The fuselage remained intact with impact damage to the nose section. The forward section of the floor board was crushed up and aft, limiting the movement of the anti-torque pedals. The cabin roof, windshield and the nose dome structure separated and were found with the main wreckage.

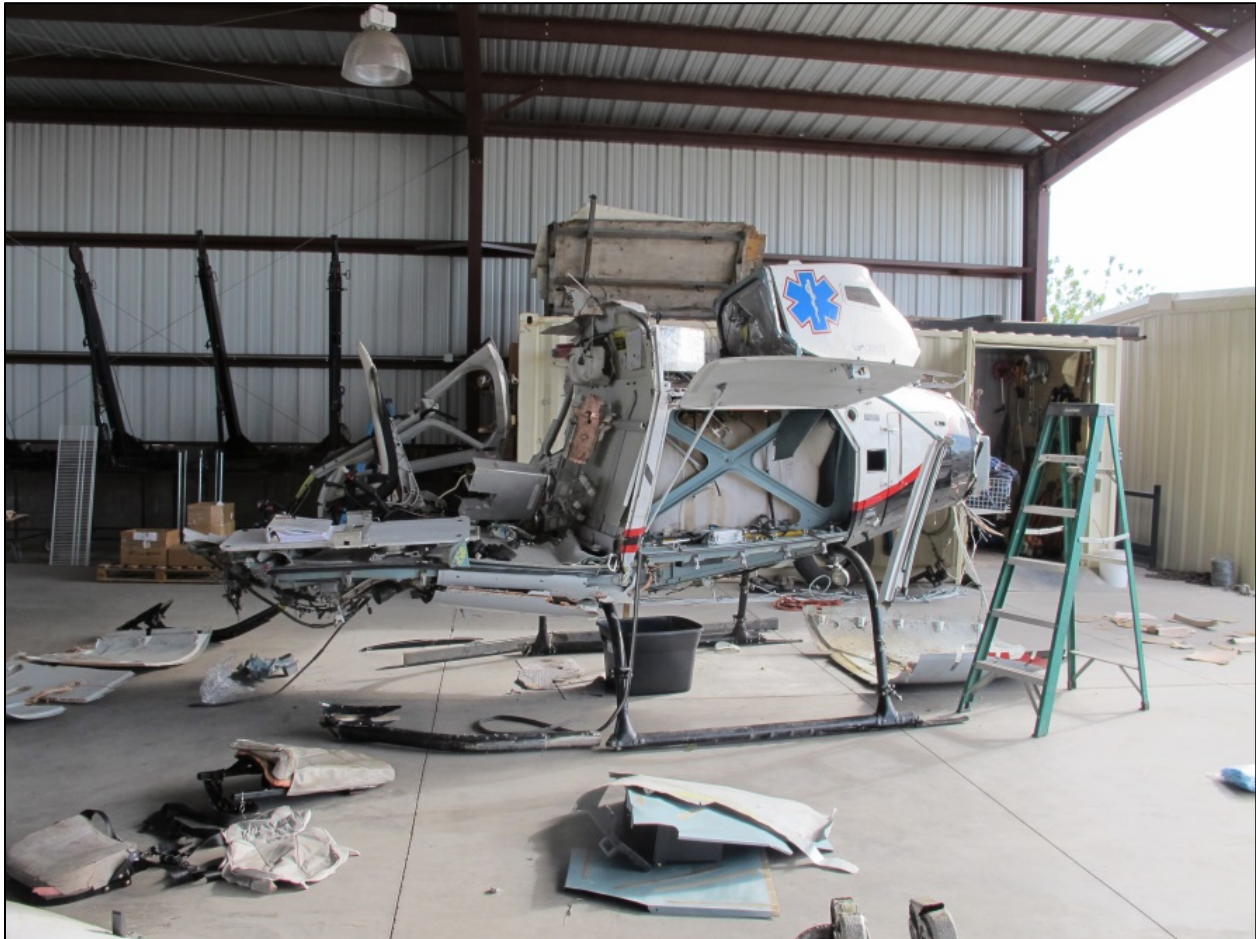
Figure 2-Main Wreckage, Left Side View

The rear equipment access doors and right rear cabin door remained attached to the fuselage; all other doors separated from the fuselage and were found in the debris field. The pilot seat remained attached to the buckled cabin floor and seat rail. The rear seats separated from the cabin and only the upper cross rail and three vertical rails remained attached to the aft bulkhead structure. The left vertical rail separated from the fuselage and was found with the wreckage. The medical center console separated from its floor mount and remained attached to cables. The gurney platform remained attached to the cabin floor.

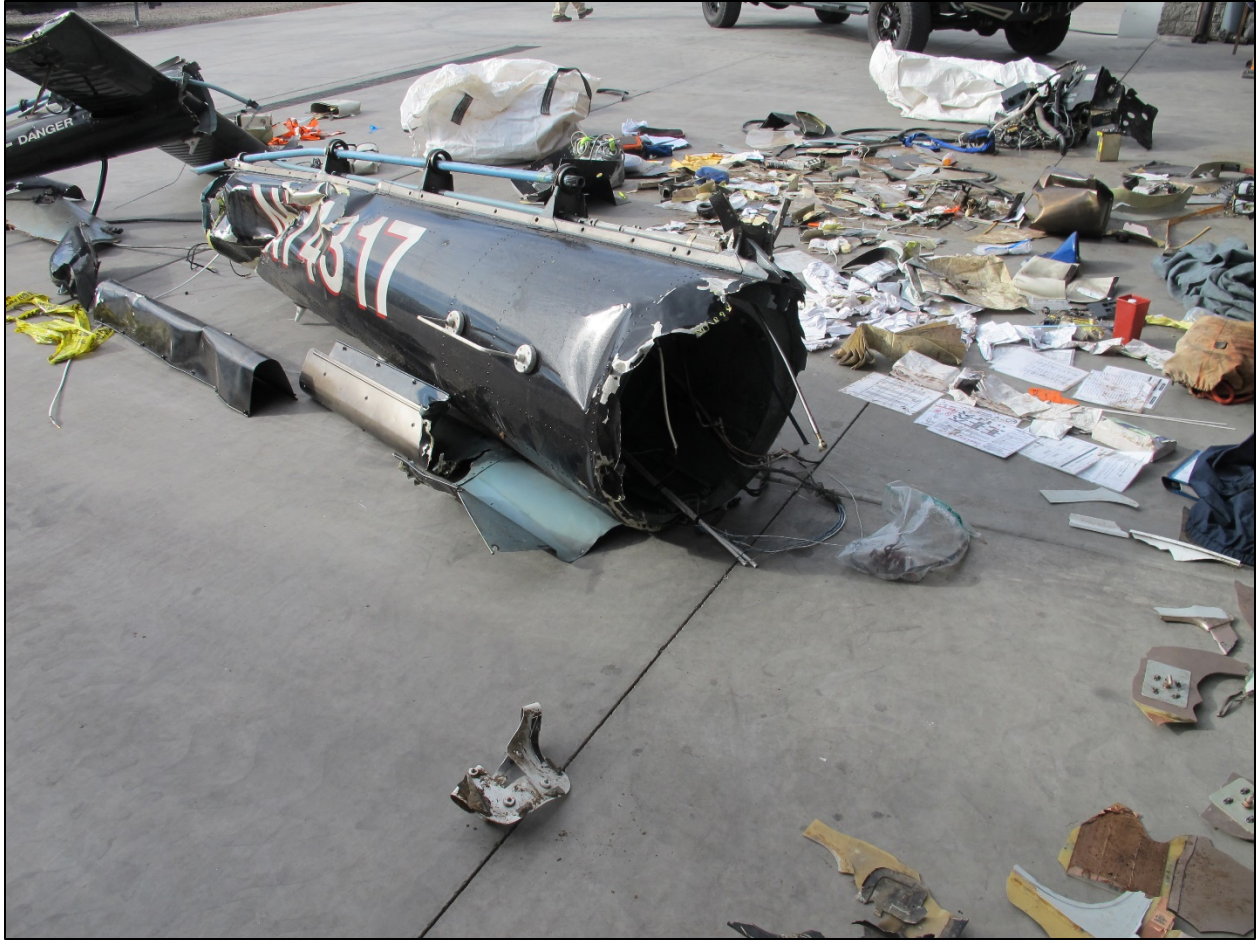
Figure 3-Tailboom

The tailboom separated from the fuselage at the aft bulkhead and separated from the aft tail section forward of the horizontal stabilizers. This section of the tailboom had diagonal impact damage to the right side consistent with a main rotor blade strike. The aft tail section had minimal damage to the top vertical fin, and the lower vertical fin was bent to the right. The spring stinger was slightly bent upwards. The right horizontal stabilizer tip was crushed and a tree limb had pierced through the surface from the bottom up. The left horizontal stabilizer was undamaged.

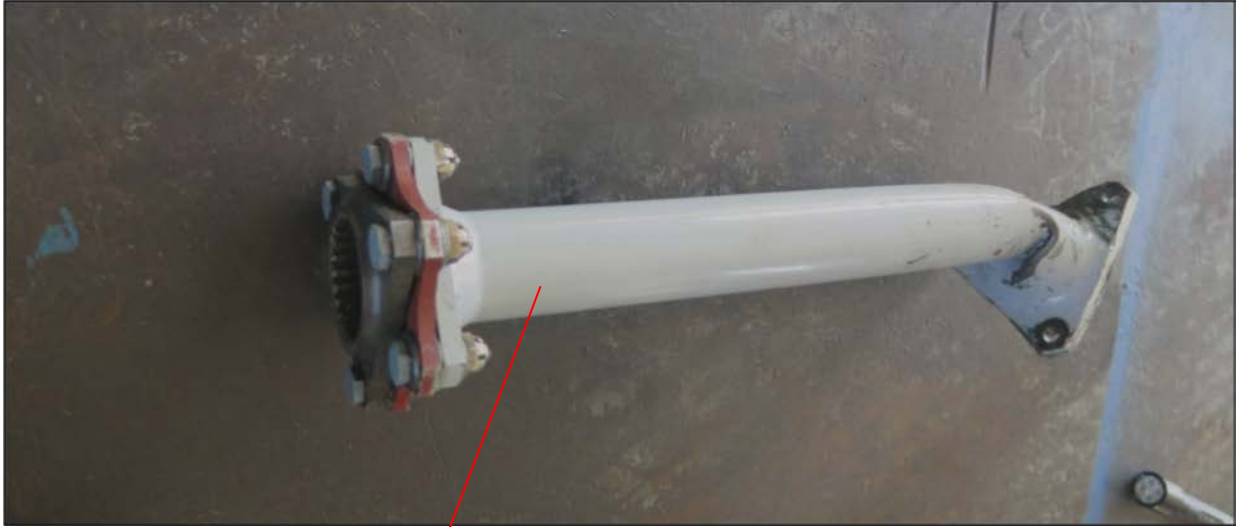
Figure 5-Tailrotor Drive Shaft

The aluminum tail rotor drive shaft was separated between the No. 1 and 2 hangar bearings. The forward spline was separated from the forward steel drive shaft. The flex coupling on the forward and aft sections of the forward steel drive shaft were damaged. The steel shaft had a twist near the aft flex coupling attachment flange.

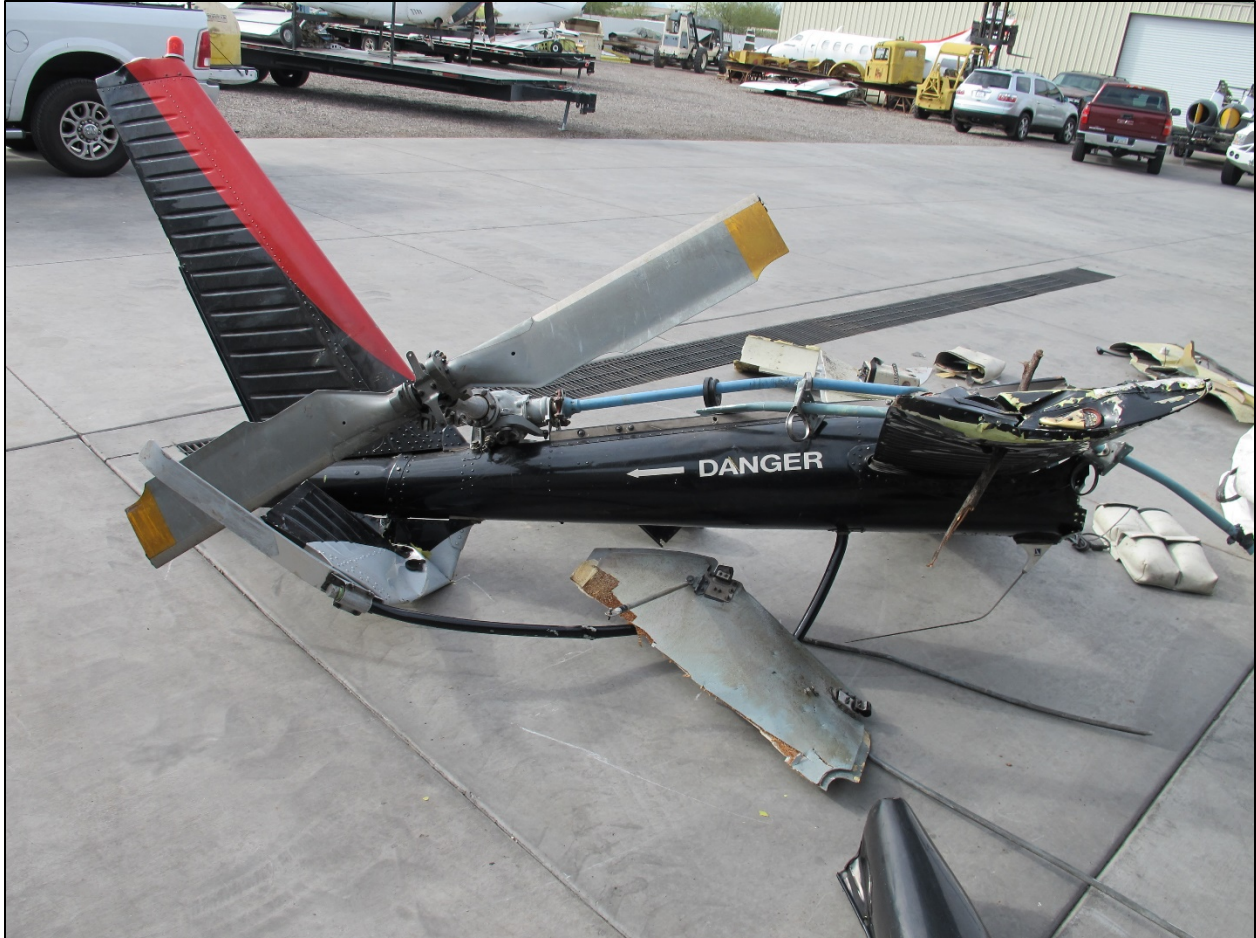
Figure 7-Empennage

The tail rotor blades had minor damage. The tail rotor system rotated freely when turned through by hand at the tail rotor drive shaft. The tail rotor drive shaft was still attached to the tail rotor gear box input shaft flex coupling. The tail rotor gear box remained intact and the chip detector was removed and examined. The chip detector was clean with no metal particles noted. The empennage flight controls remained attached.

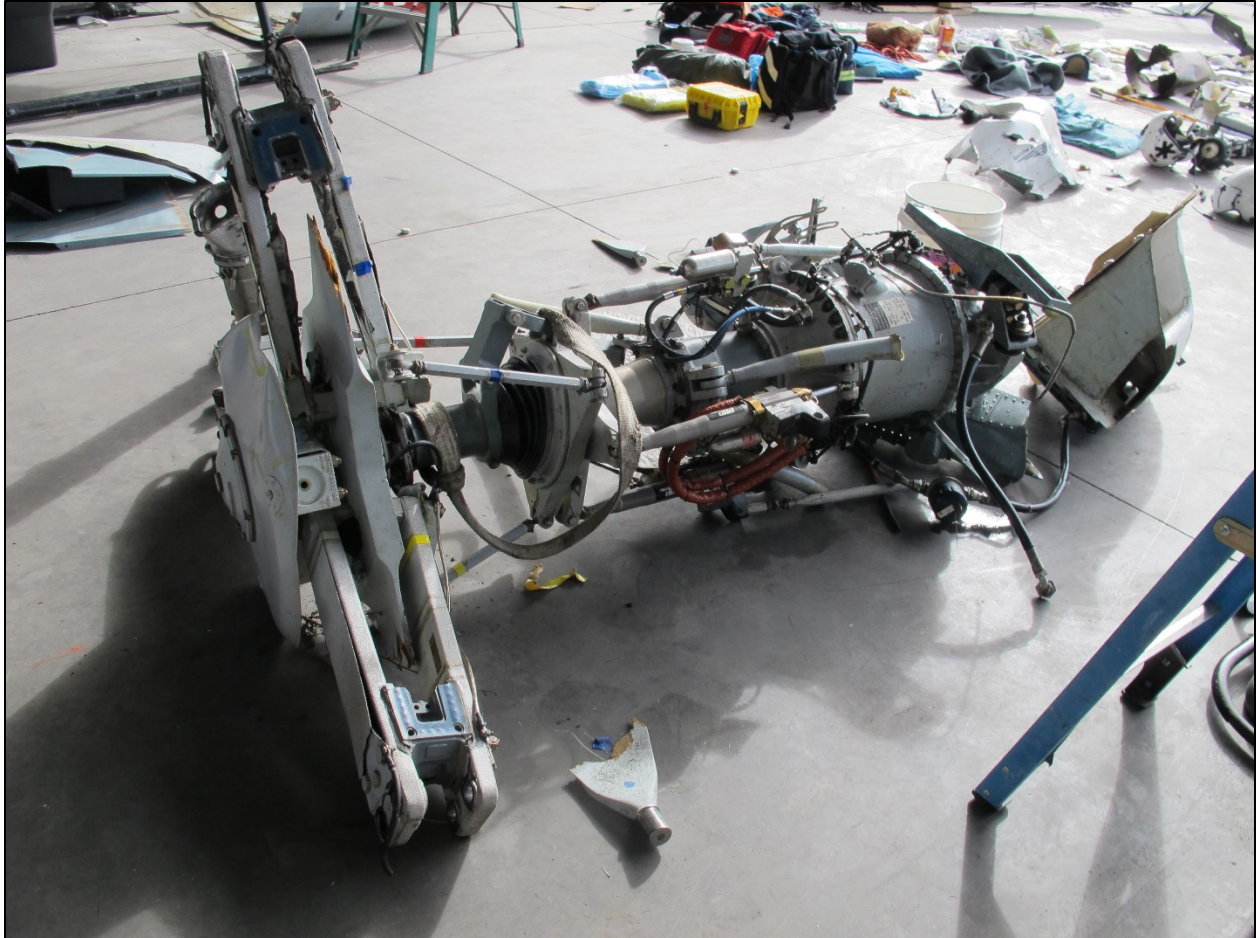
Figure 8-Main Rotor Drive Shaft and Transmission

The main rotor transmission separated from the aircraft during the accident sequence and all main rotor blades remained attached. The main rotor blades were removed from the rotor hub during the recovery of the wreckage.

The hydraulic pump remained attached to the transmission drive with the belt intact, however, was disconnected from the pulley. Continuity through the transmission was observed from the main rotor head to the input drive shaft when the main rotor head was turned through by hand. The transmission chip detector was removed and inspected. The chip detector was clean with no metal particles noted.

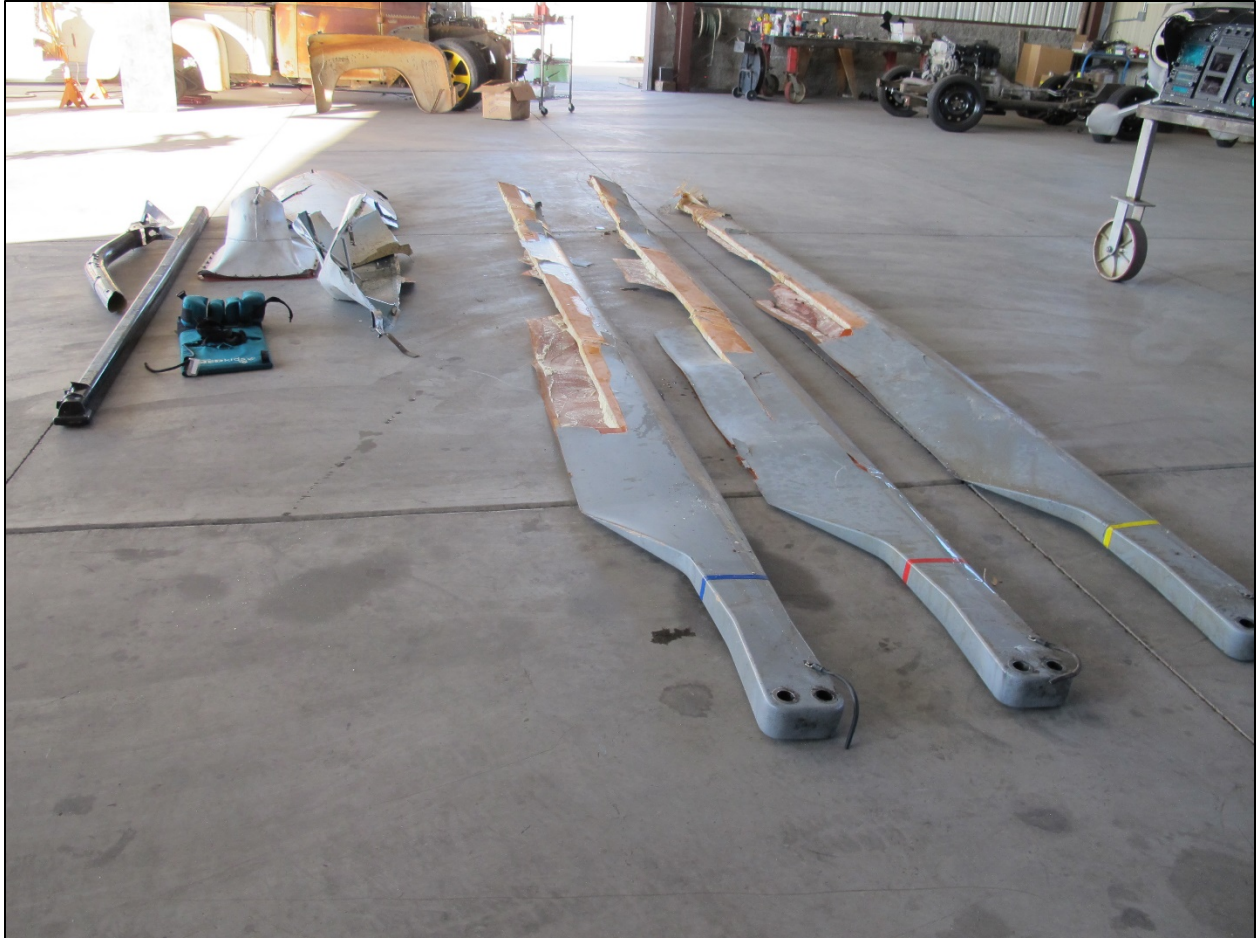
Figure 9-Main Rotor Blades

The main rotor blades were removed from the rotor hub during the recovery of the wreckage. The blade sleeves and star arms were broken. The yellow blade end cap separated and the blade tip was frayed. The trailing edges of all blades had delamination and separation of material from the midsection to the tips.

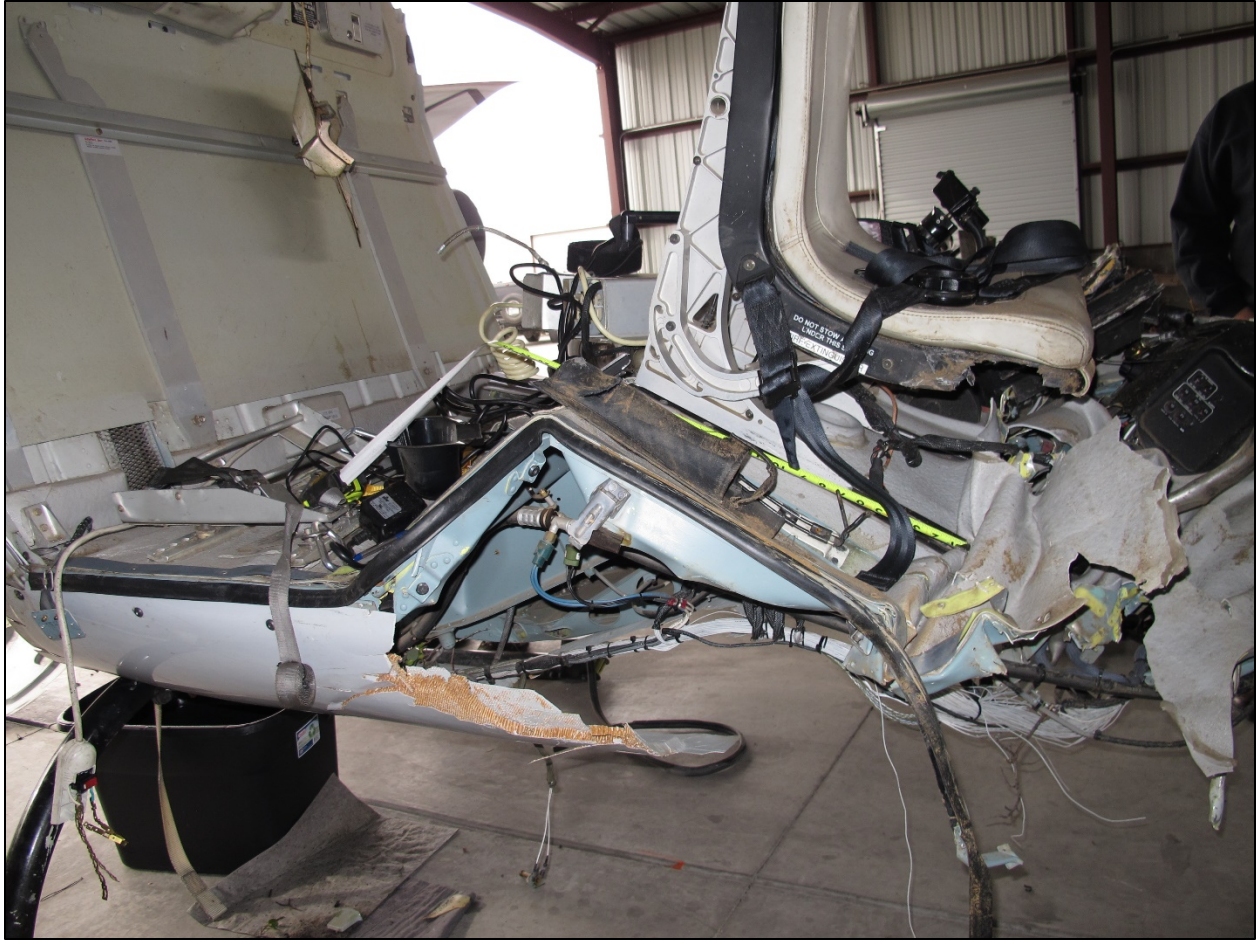
Figure 10-Cabin Area

The forward cabin area had impact damage and was buckled below the pilot seat area. The roof separated from the main wreckage. The helicopter was modified with an STC's medical interior configuration with the pilot and flight controls located on the forward right side. The pilot seat remained attached to the seat rails that remained attached to the buckled cabin floor. The pilot's seat belt (4-point restraint system) was still buckled; and cut by first responder to recover the pilot.

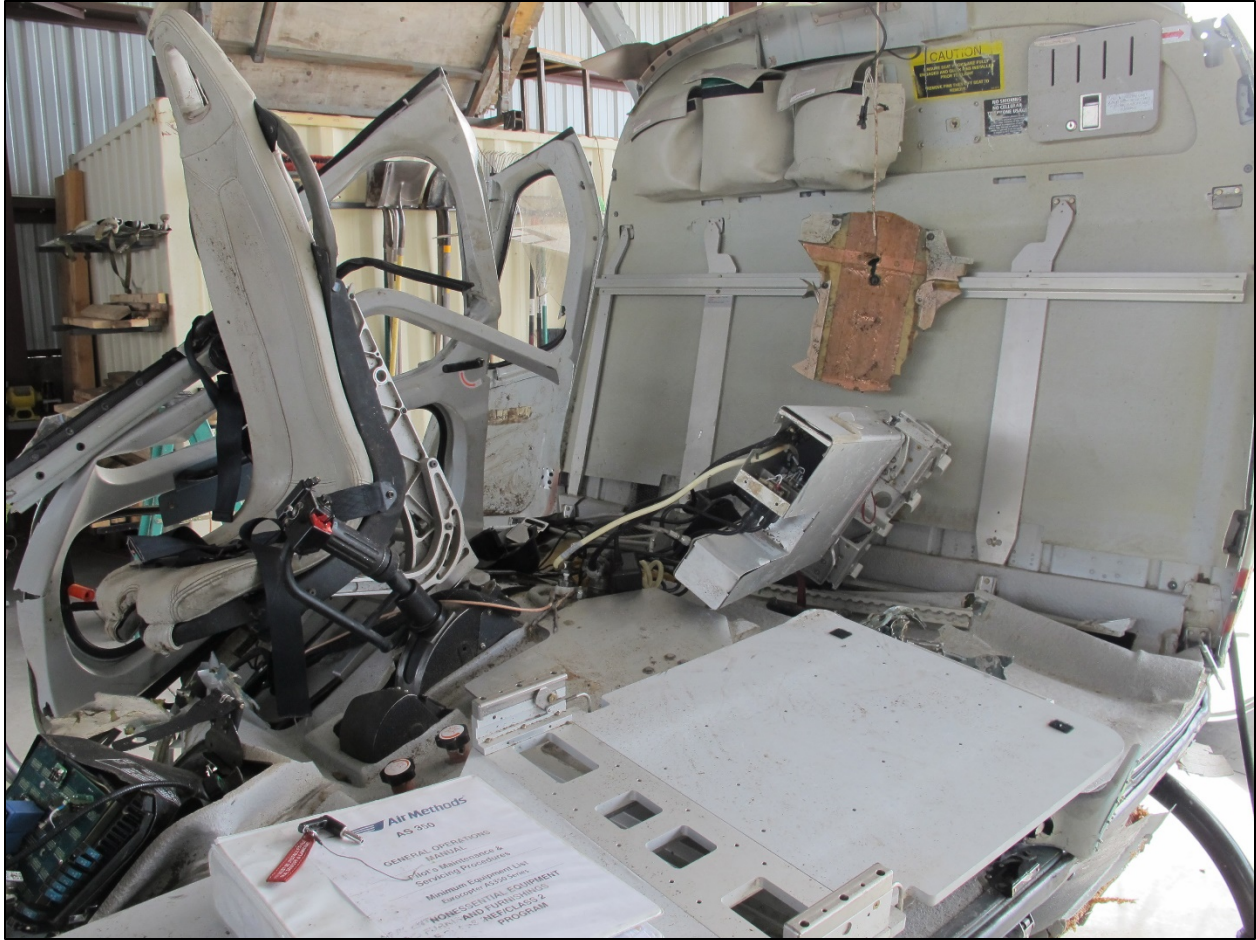
Figure 11-Cabin Area

The STC seat assembly configuration was: two seats on the right aft bulkhead, a medical console in the middle and a medical seat (with a short seat base) on the left with a litter on the forward left cabin. The rear seat assembly separated from the attachment bracket assembly that remained attached to the cabin bulkhead. The left vertical support for the rear seat attachment bracket assembly separated from the aft bulkhead.

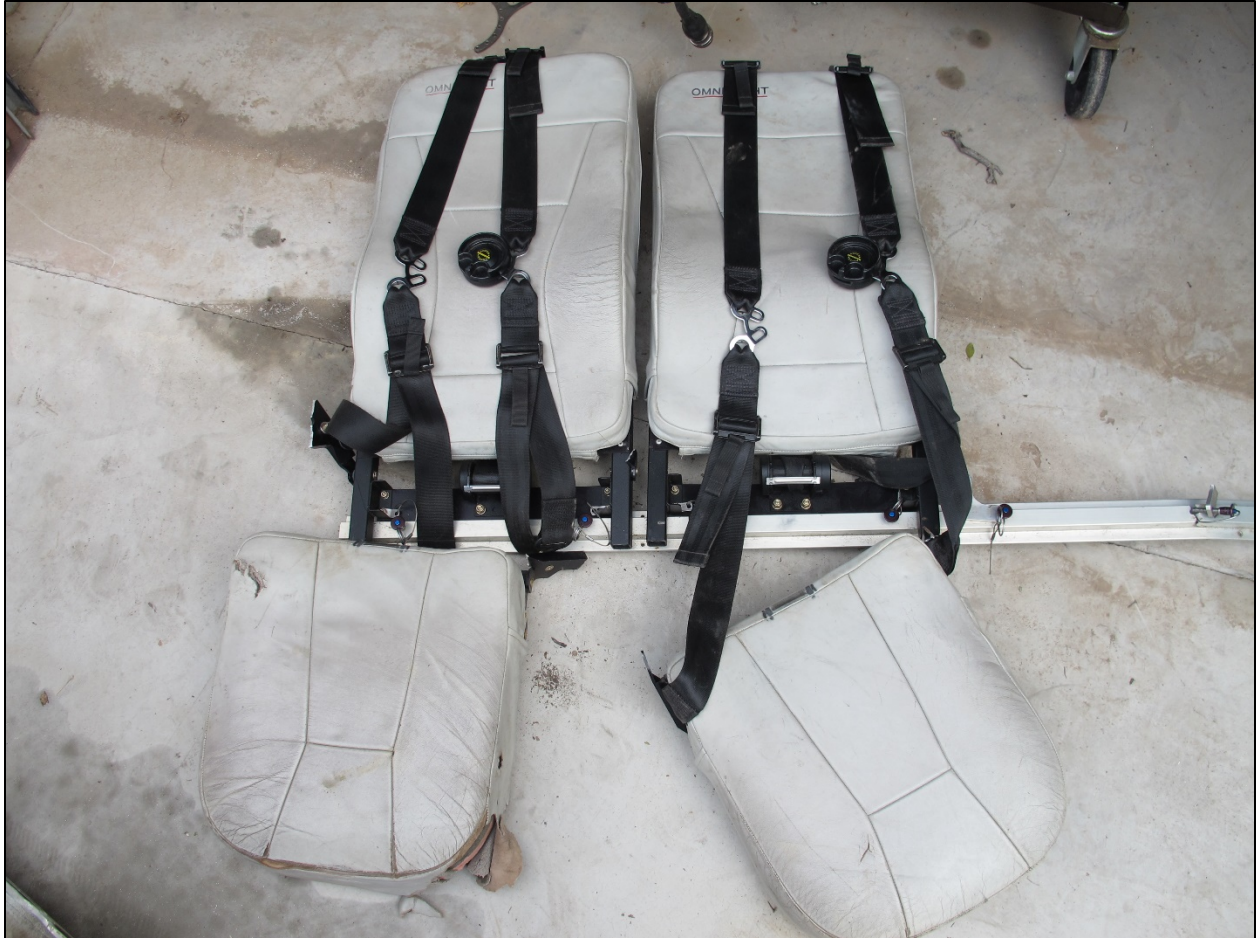
Figure 12-Right and Middle Rear Seats

The flight-nurse, who was seated in the right rear seat, succumbed to his injuries. The flight-paramedic, who was seated in the left rear seat, sustained serious injuries. The middle seat was not occupied. The two occupants were separated from the rear seats, seatbelt use at both locations was not confirmed. The seatbelts for all three seat locations were found unbuckled during the onsite examination of the wreckage. The right and middle seats remained attached to the lower horizontal attachment bracket. Both seat hinges had impact damage.

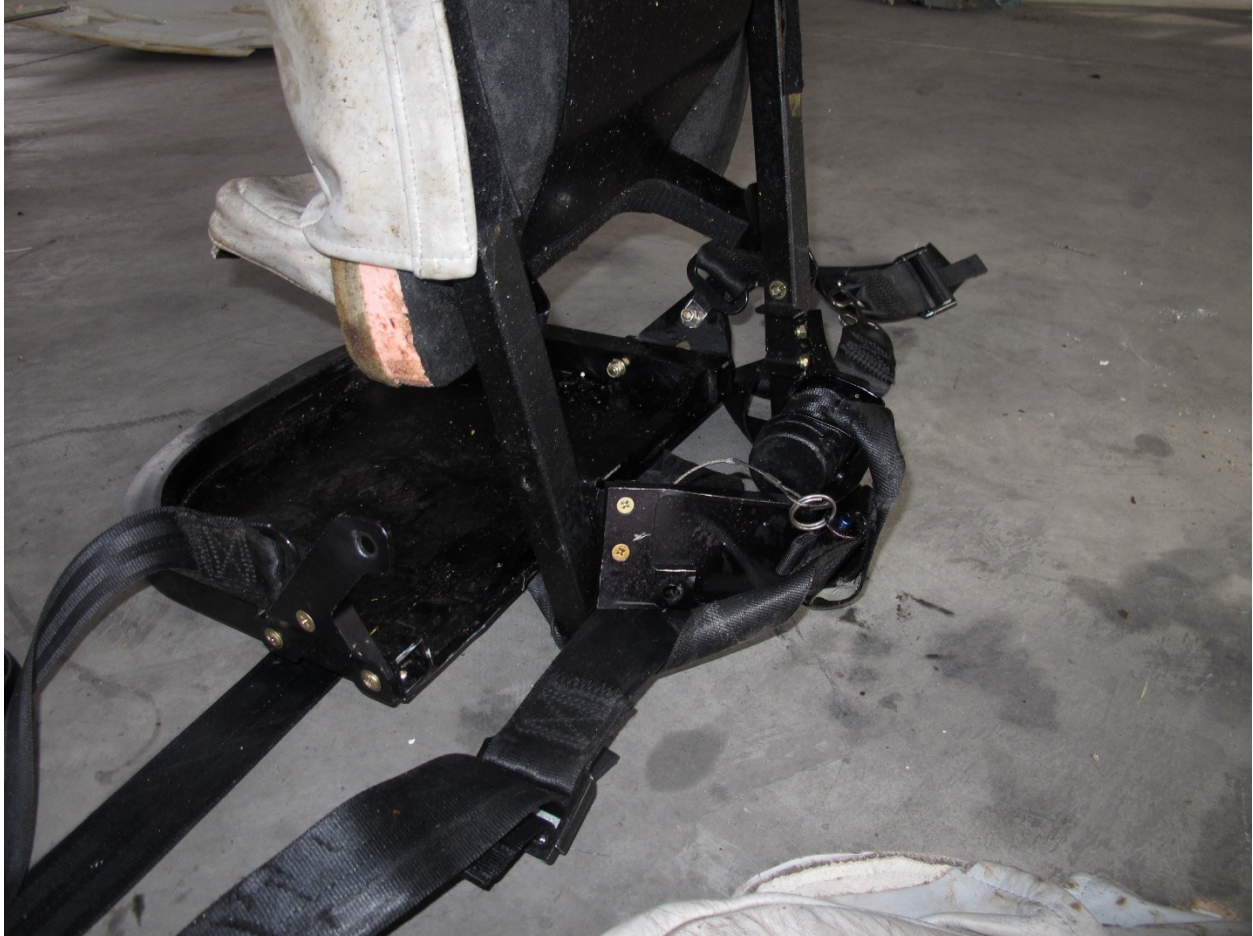
Figure 13-Left Rear Seat

The left rear seat separated from the bulkhead attachment assembly. The seat back lower frame had deformation of its structure and the seat hinges had impact damage.

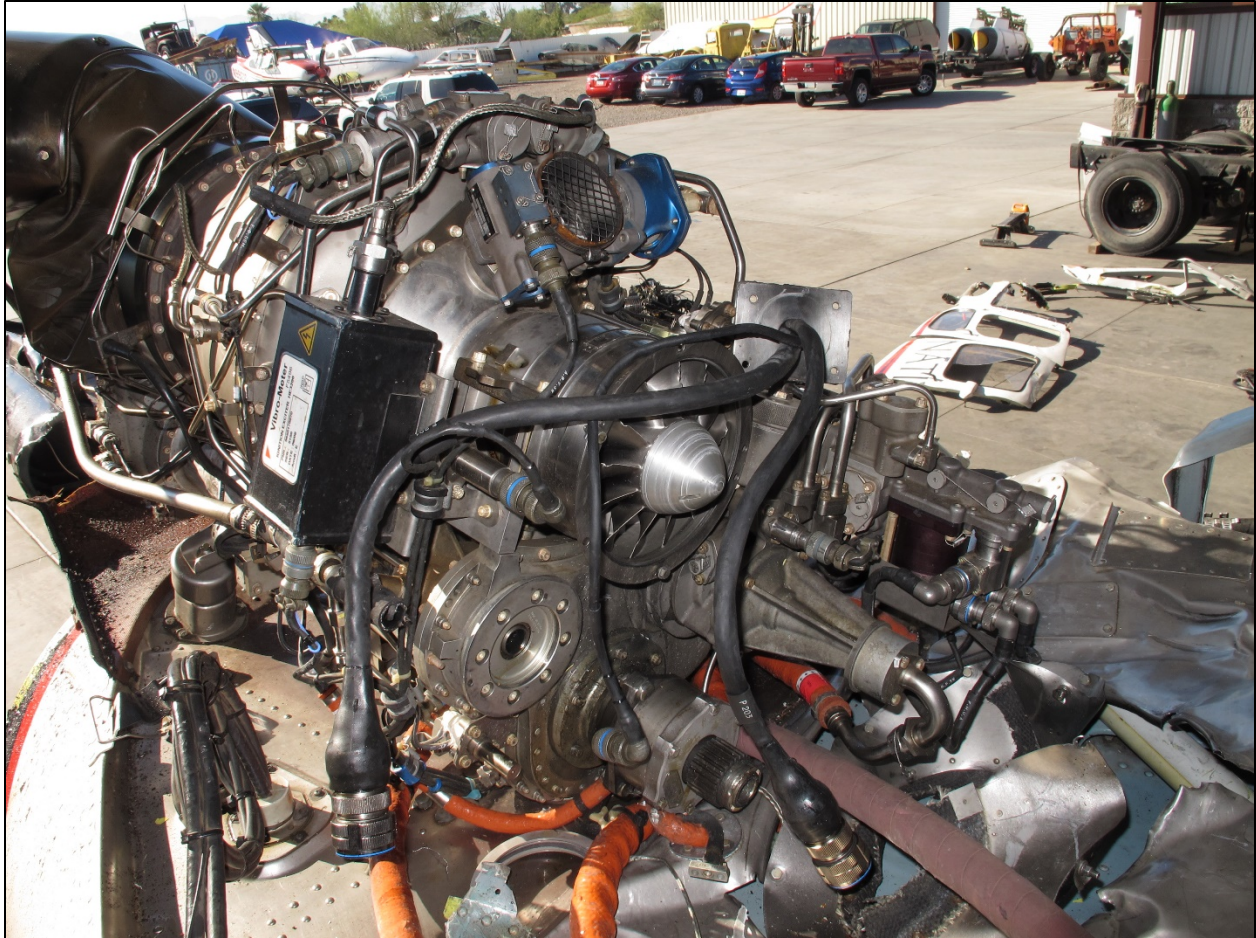
Figure 14-Engine

The engine remained attached to the fuselage by the rear mounts and clamps. First-stage compression blades had leading edge damage. The exhaust duct had impact damage.

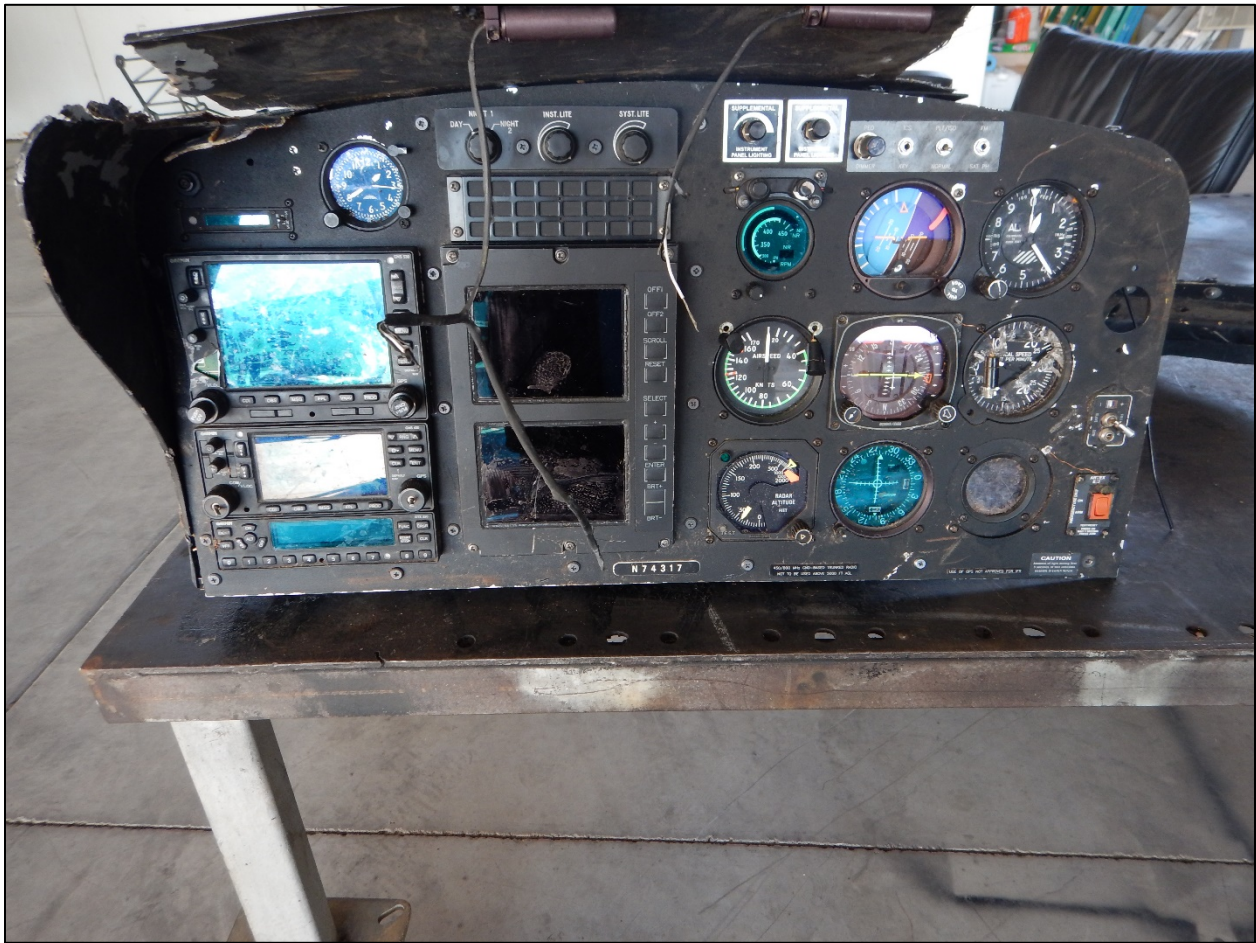
Figure 15-Instrument Panel

The complete instrument panel was separated from the aircraft and found approximately 200 feet further in the debris field at the accident site. All the instruments were in place on the panel. The H.S.I. needle was set at 270 degrees.
