NATIONAL TRANSPORTATION SAFETY BOARD

METALLURGIST'S FACTUAL REPORT

Report No 94-34

Place : Provincetown, Massachusetts
Date : August 2, 1993
Vehicle : Piper PA-28-181, N2093
NTSB No. : NYC 93-F-A140
Investigator : Al Yurman (ASI-NYC)

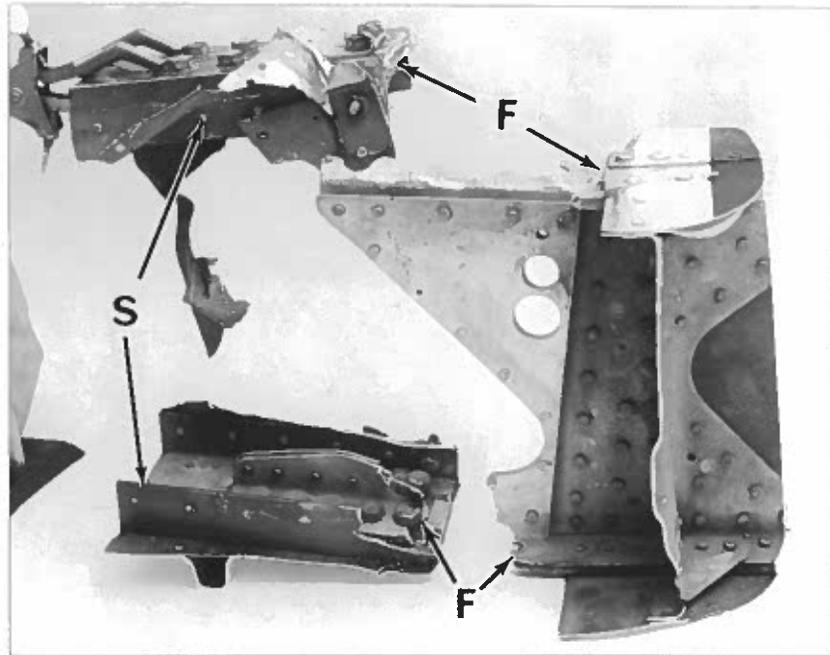
The right wing components included three pieces from the inboard end of the main spar. The main spar was fractured through both the upper and lower spar caps and through portions of the spar web. The spar pieces are shown in figure 1 displayed in their approximate original positions with the mating cap fractures denoted by arrows "F". Both spar caps were transversely fractured at positions near the outboard ends of the fuselage carry-through structure, denoted by arrows "S" in figure 1. A schematic of the wing spar and carry-through structure area is presented as figure 2 with the path of the spar separation depicted by the red section lines. The spar was a riveted assembly composed of extruded aluminum upper and lower spar caps with riveted aluminum sheet webbing and gussets. At the inboard ends, the spar caps are bolted to upper and lower "C" channels which act as the main wing to fuselage attachments and fuselage carry-through structure.

Figure 1: An overall view of the as-received right wing main spar structure with the mating spar cap fractures denoted by arrows "F". View looking forward.

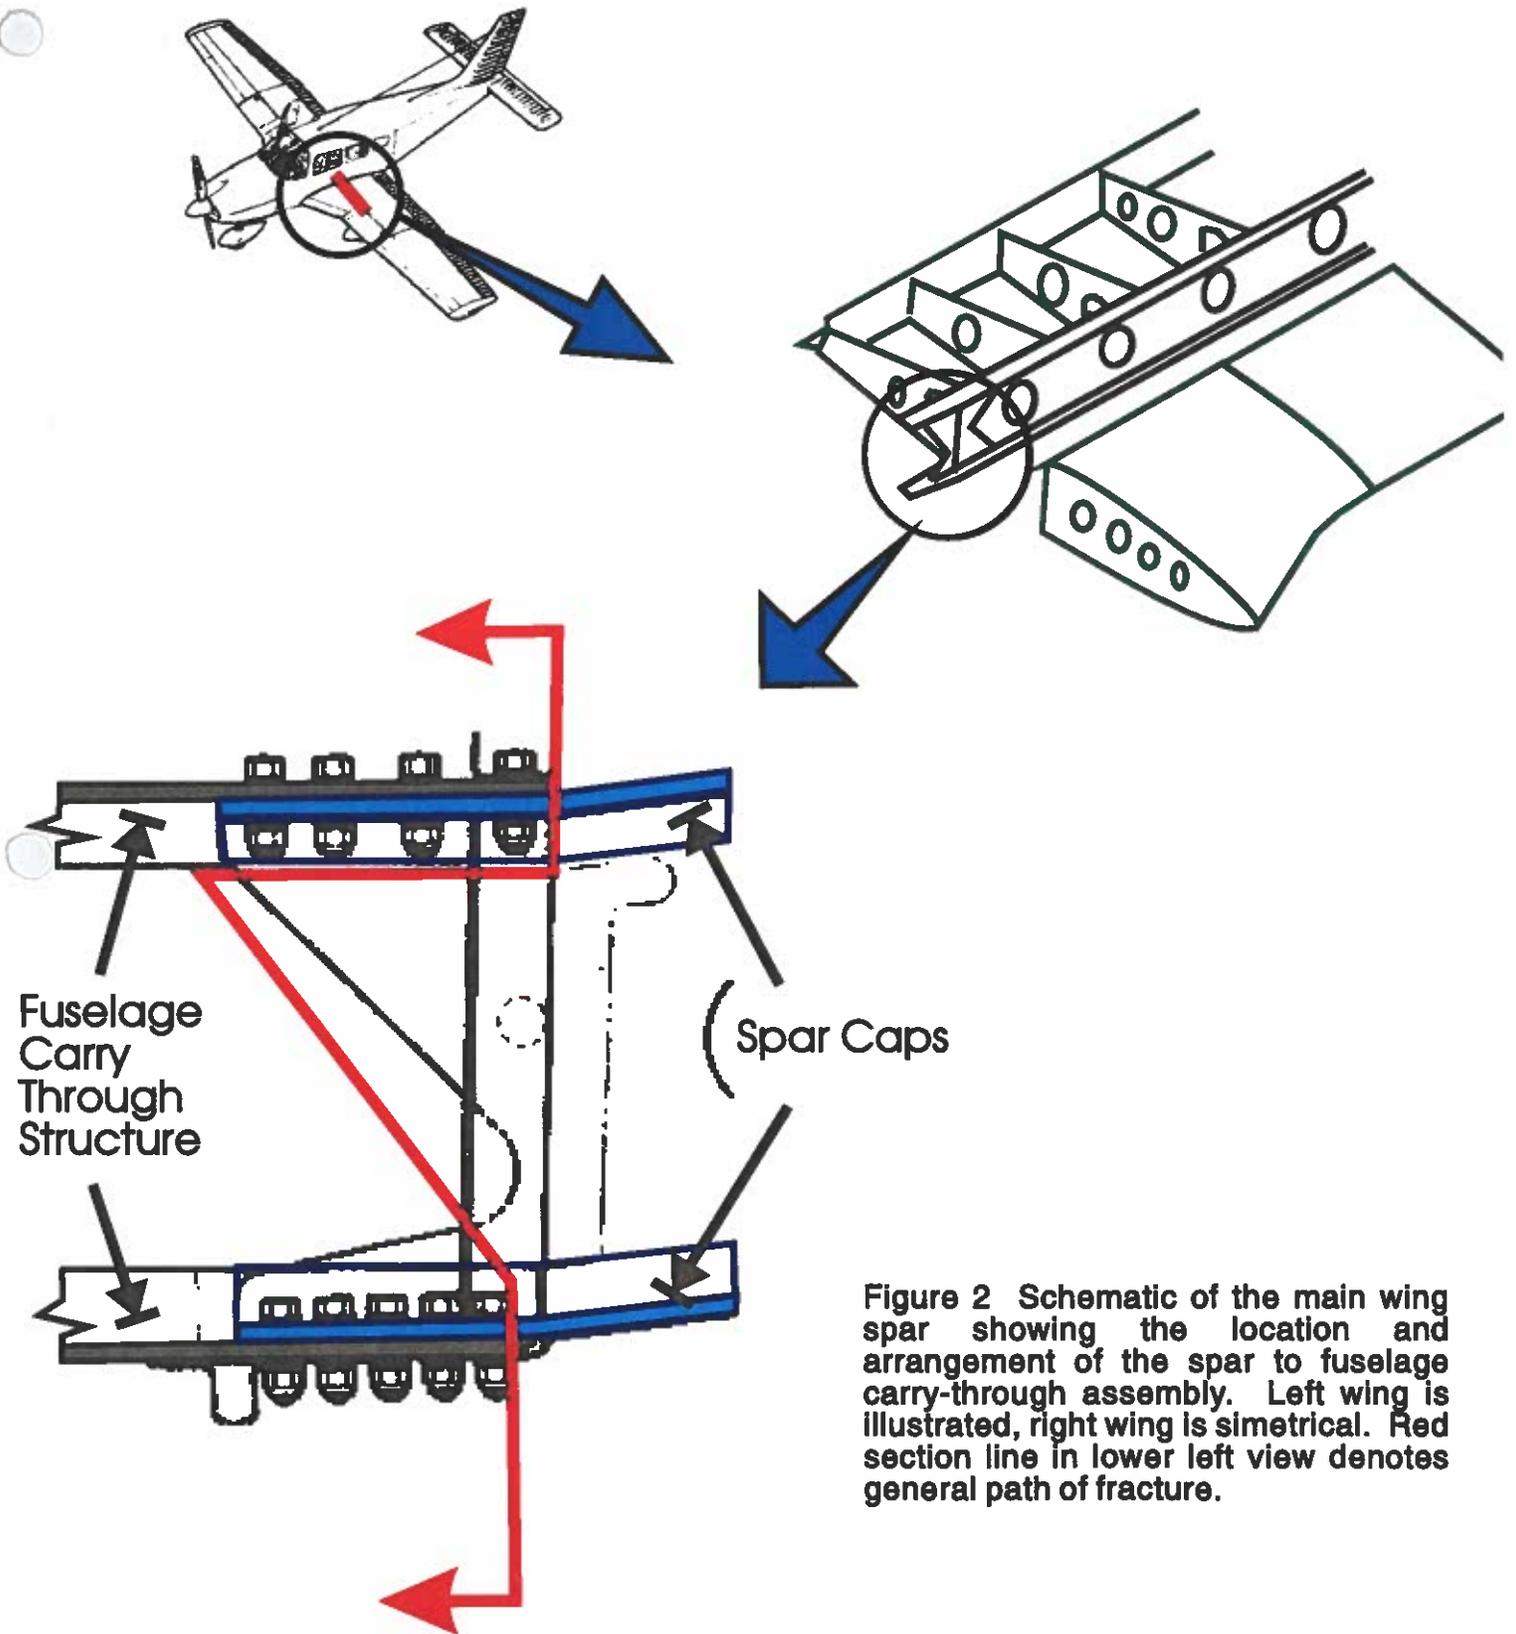
Figure 2 Schematic of the main wing spar showing the location and arrangement of the spar to fuselage carry-through assembly. Left wing is illustrated, right wing is simetrical. Red section line in lower left view denotes general path of fracture.

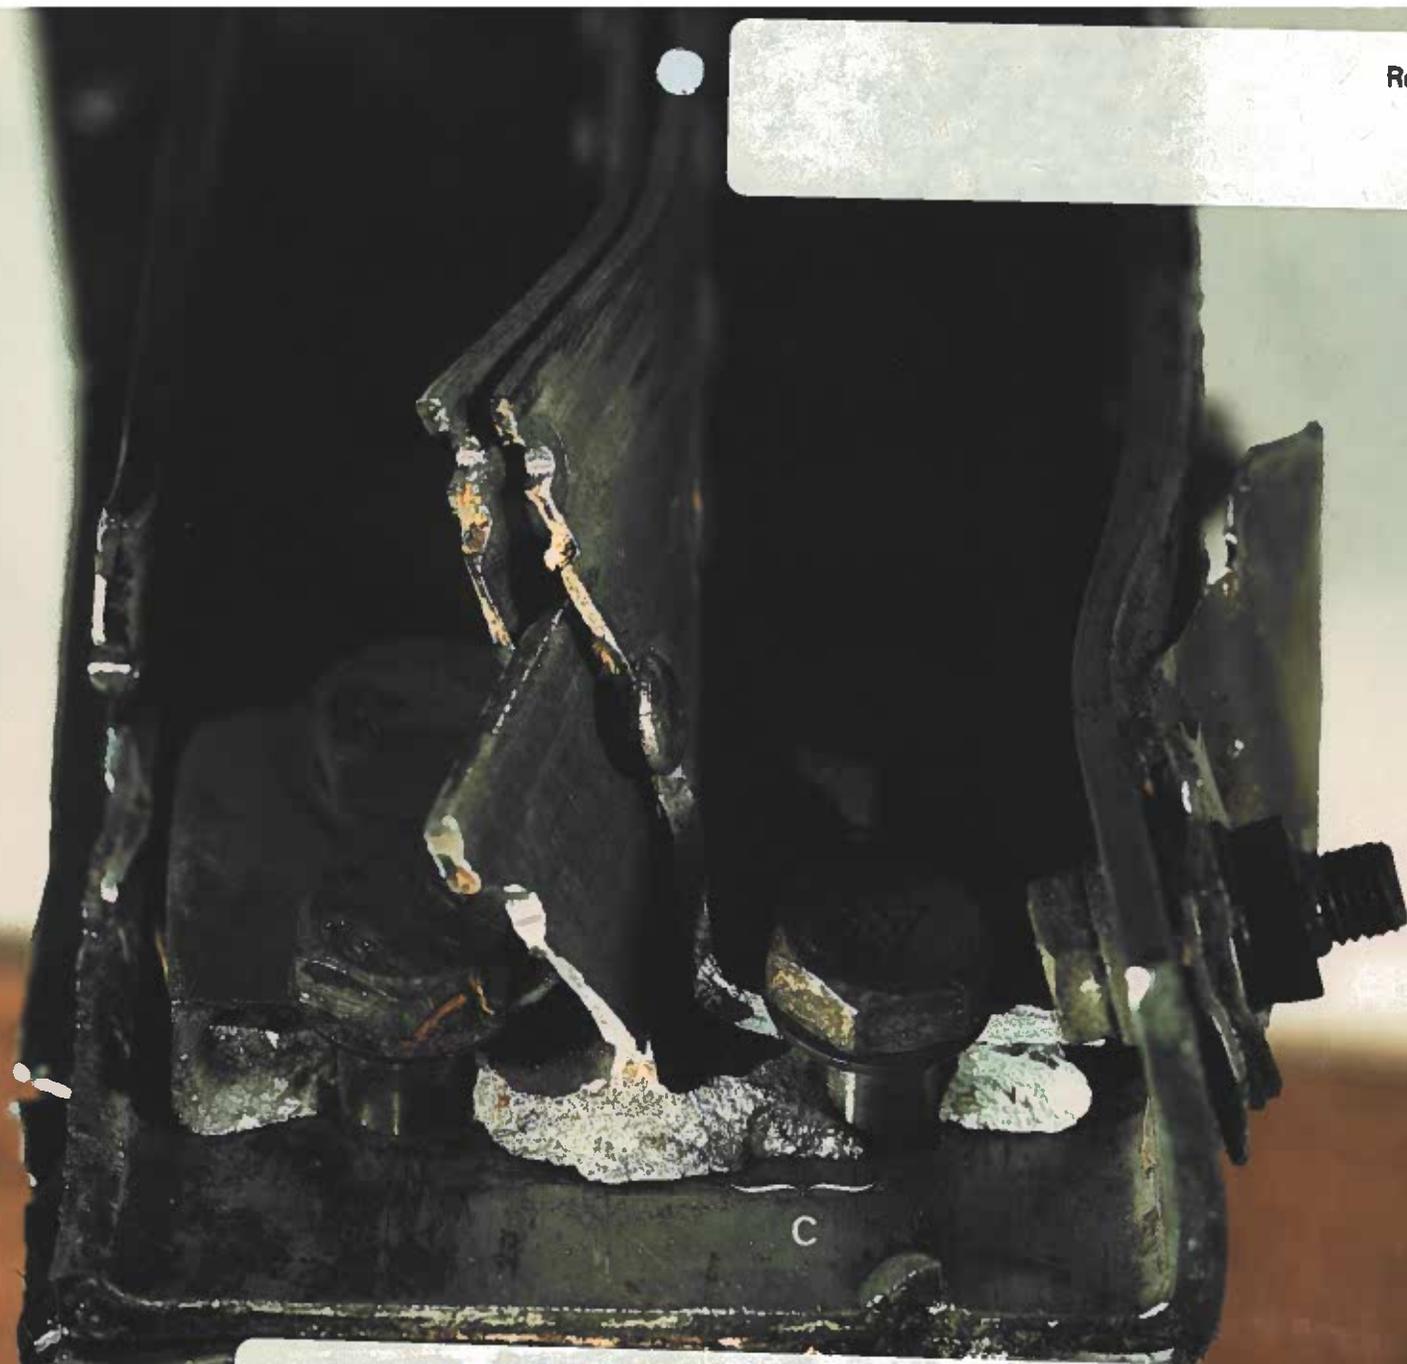
The upper spar cap was fractured just past the outboard end of the upper carry-through, while the lower cap fractured through the most outboard pair of bolts connecting the spar and carry-through, as shown in figure 3. Both spars appeared to exhibit upward bending outboard, however the transition to the upward wing dihedral occurs at this location and masks the amount of actual deformation. Magnified optical examinations of the upper spar cap and sheet metal fractures disclosed evidence typical of overstress separations with the upper cap fracture typical of upward bending of the wing. In contrast, indications of preexisting fatigue cracking was uncovered on the lower spar break.

The lower spar break had a small area of fatigue on the fracture surface near the forward bolt, see bracket "C" in figure 3. The fatigue zone was approximately 0.3 inches wide and had penetrated about 0.2 inches into the spar cap. The fatigue zone was slightly aft and outboard of the forward bolt hole but the fatigue extension had not penetrated the bore surface. The remainder of the lower spar fracture displayed surface features typical of an overstress separation. Closer optical examinations after disassembly of the structure established that the fatigue had initiated on the lower surface of the spar cap at a location approximately 0.073 inches from the edge of the bolt hole. The fatigue had progressed upward and aft away from the bolt hole. Scanning electron microscope (SEM) examination of the outboard fracture face, after it was cut from the remaining spar, uncovered two distinct fatigue origins in close proximity to each other on the surface of the spar in the areas denoted by arrows "O" in figure 4. Further viewing established that the fatigue progressed upward and aft generally avoiding the hole to the fatigue terminus, indicated by arrowheads in figure 4. Beyond the terminus, the fracture morphology was completely ductile dimples typical of an overstress fracture in ductile aluminum alloys.

Figure 3: A 2X view looking generally inboard onto the lower spar cap inboard fracture face. The area of fatigue is indicated by bracket "C". Note its proximity to the bolt.

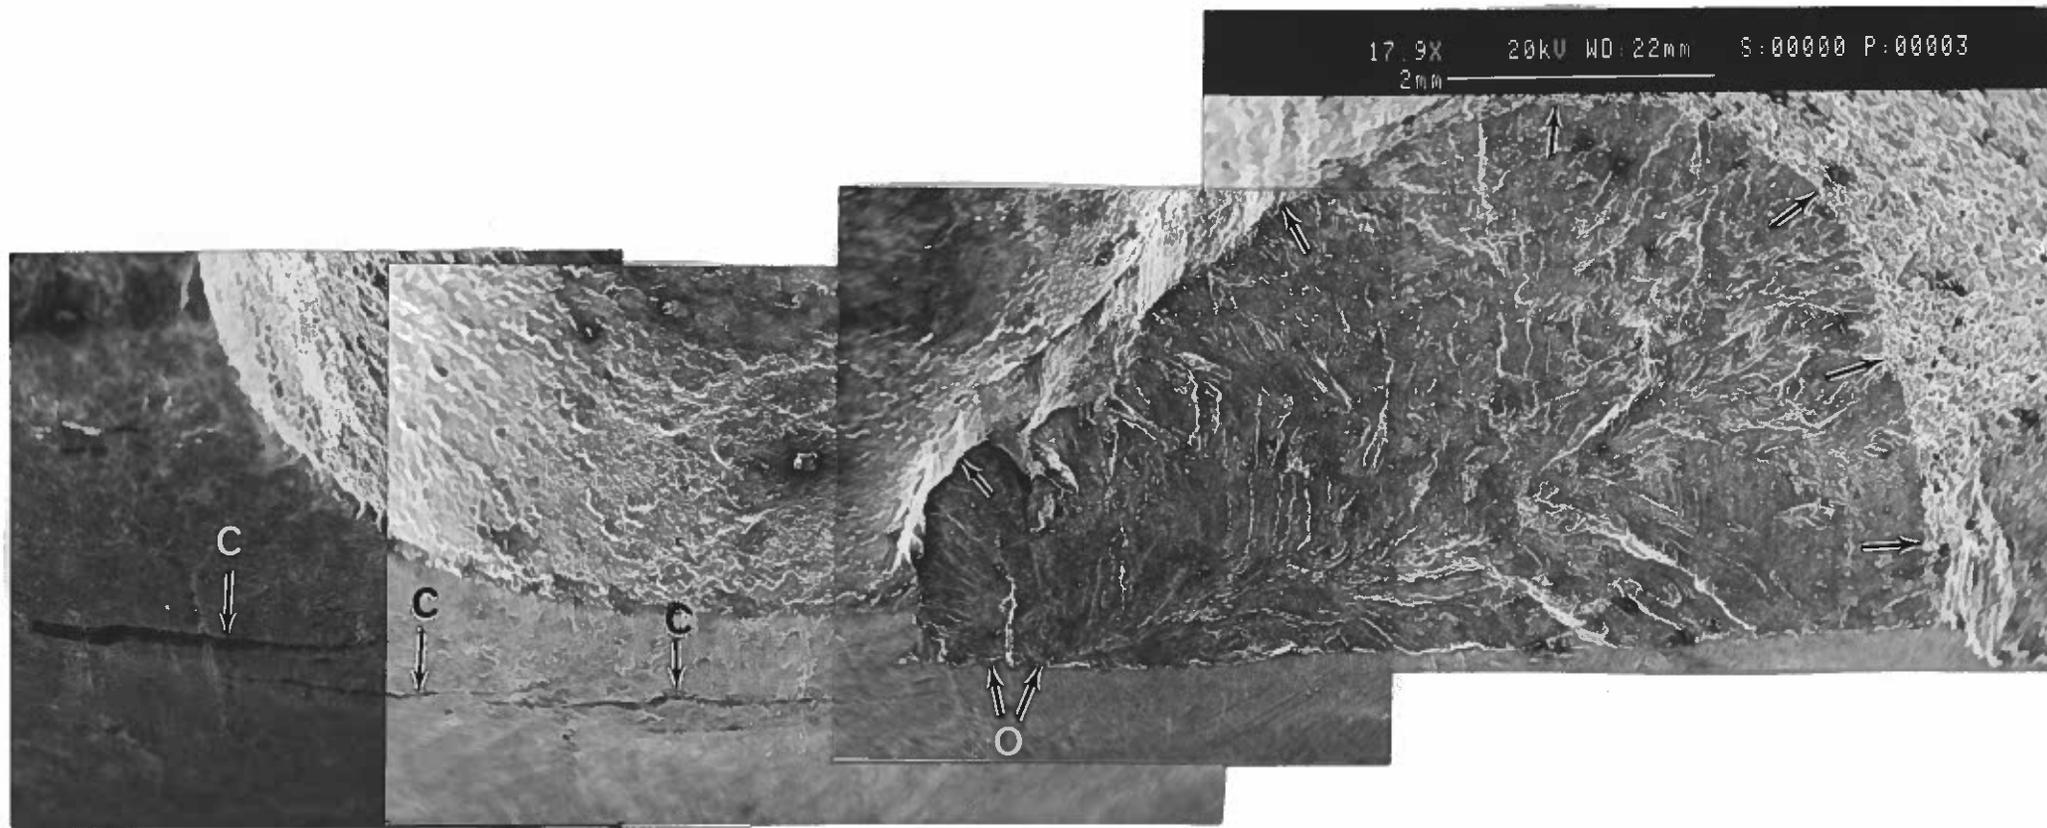
Figure 4: A SEM montage of the fatigue region and lower surface of the spar at 17.9X on the outboard fracture half. Fatigue origins are at arrows "o" with the fatigue terminus at the unlabeled arrows. View looking outboard and slightly up with aircraft forward at left.

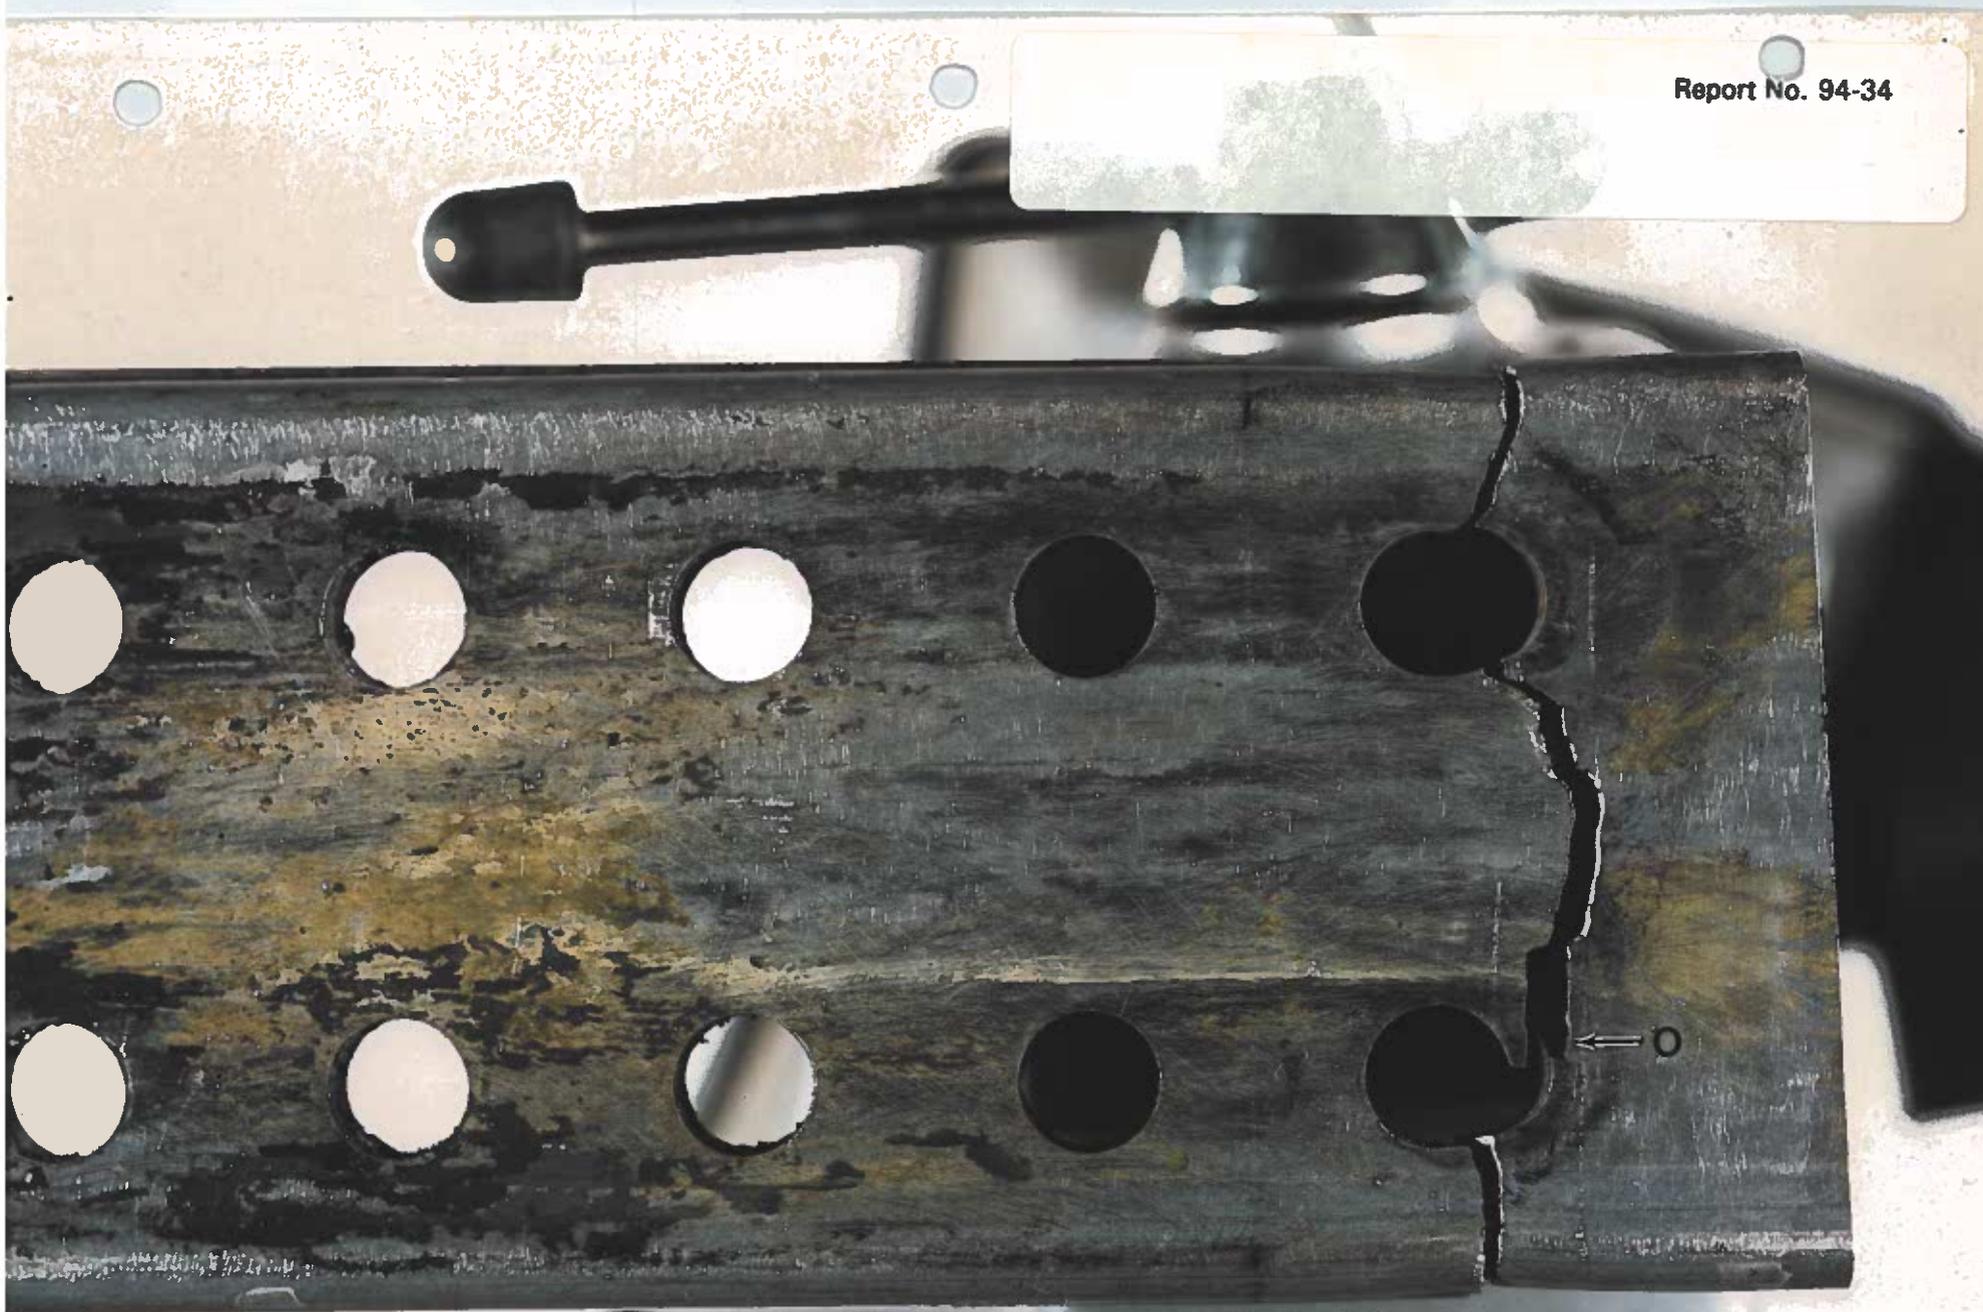
When removed from the carry-through channel, the lower surface of the spar was partially covered by green and yellow primer paint. Removal of loose paint by ultrasonic agitation in acetone uncovered many areas of randomly oriented surface scratches (see figure 5) as if the surface had been lightly sanded prior to assembly. As shown in the left view of figure 6, the fatigue origin, arrows "O", were located at the boundary of a faint polished area around the bolt hole (depicted by the dashed line). Light fretting and wear were also found immediately adjacent to the hole within this polished area. The wear area is indicated in figure 6 by the solid black line.

Figure 1: A 2X photograph showing the lower surface of the spar cap at the fracture and bolt location. Fatigue initiation location denoted by arrow "O".

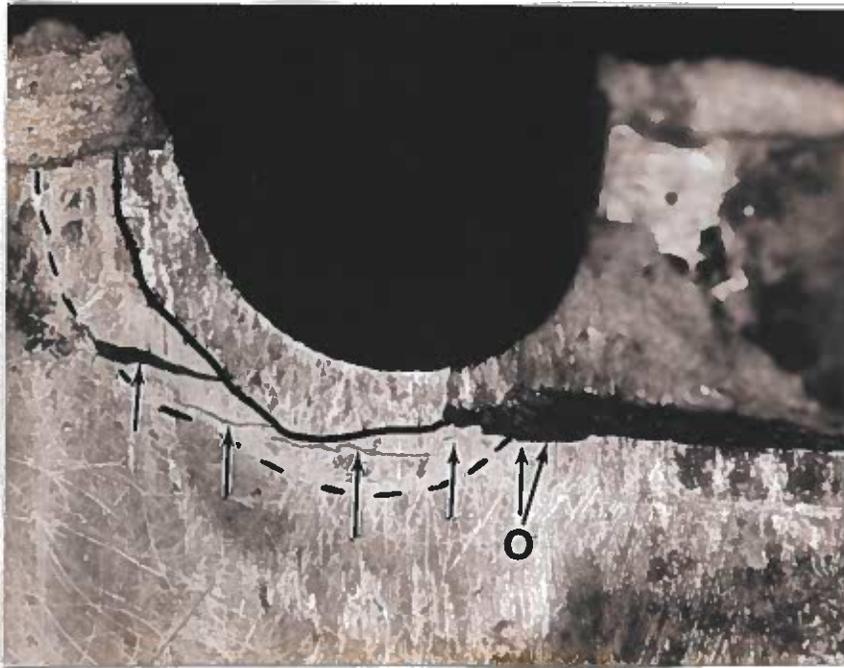
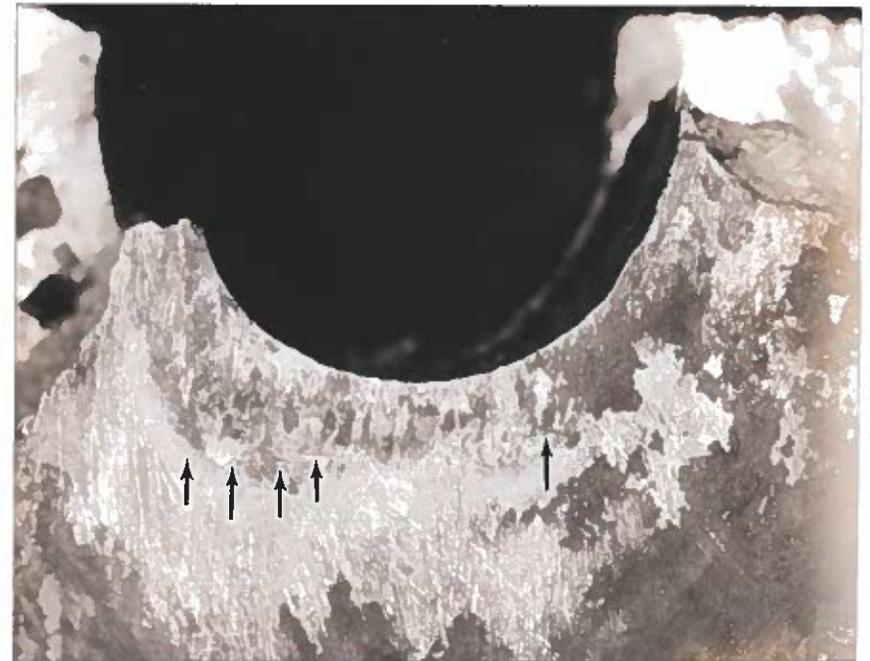
Several cracks, visible as irregular dark lines at the unlabeled arrows in figure 6, were present in the lower spar surface roughly paralleling the fatigue zone. Four cracks were located near the forward outboard hole and five smaller cracks were found near the aft bolt hole. The largest crack, at the forward hole measured 0.13 inches long.

Figure 6: 7.5X views of the lower spar cap surface adjacent to and outboard of the two outboard spar attachment bolts. The left view, of the forward bolt, shows the fatigue origin locations, arrows "o" and areas of polishing (dashed line) and fretting (solid line) surrounding the bolt hole. Unlabeled arrow in both views denote cracks. See also arrows "c" in figure 4.

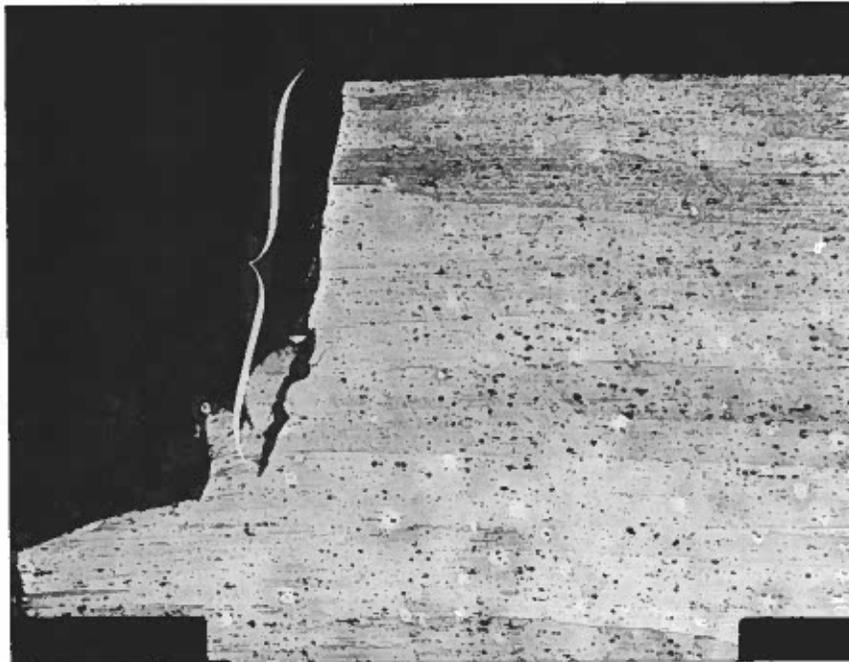
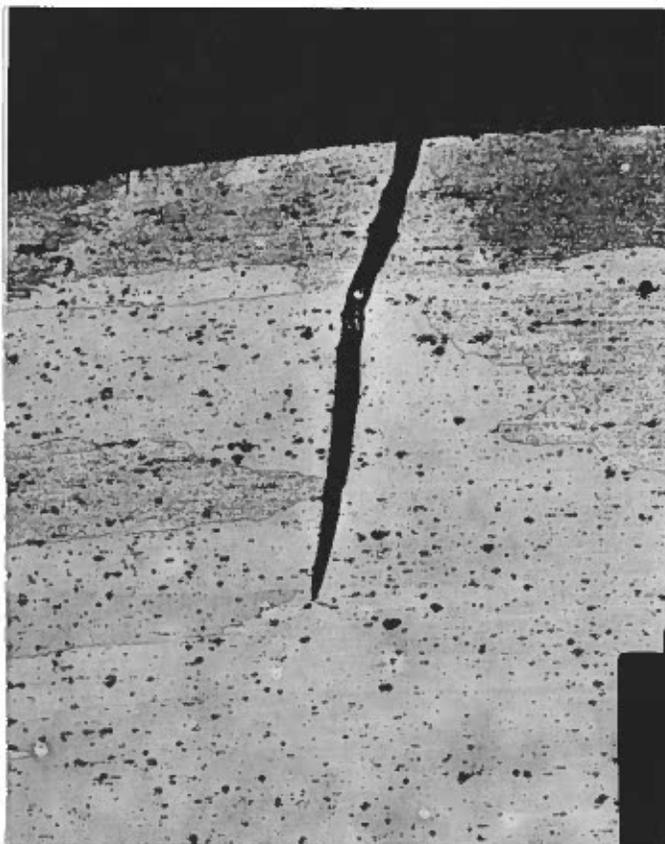
area and the crack both exhibited transgranular paths typical of fatigue progression through aluminum alloys, as shown in figure 7. The crack had only extended about 0.049 inches from the surface in this section.

Figure 7: Metallographic sections through the fatigue origin (top at 32X) and one of the cracks (left at 50X). Fatigue region denoted by bracket in upper view. Keller's Etch

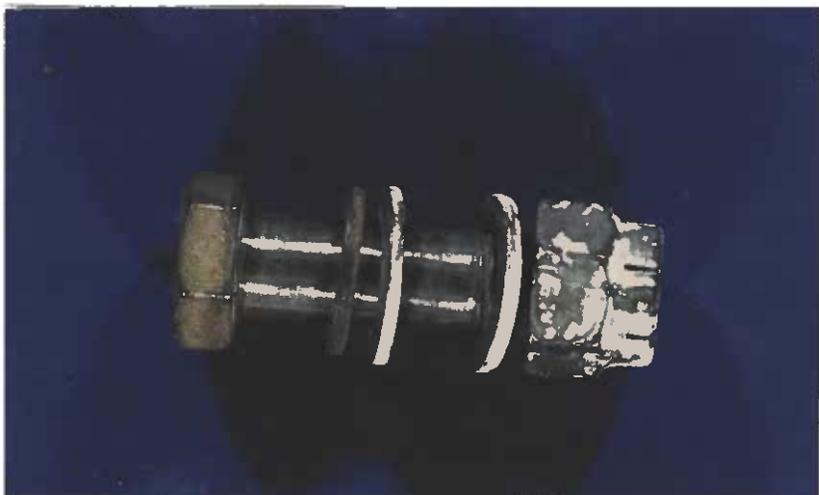
The PA-28-181 maintenance manual lists the fastener hardware to connect the wing spars to the fuselage carry-through structure. For the lower spar cap, AN176-13A⁴ or NAS464-P6-LA13⁵ bolts are to be installed with a combination of AN960-616⁶ and Piper 96352-3 washers and MS21042-6⁷ nuts. The placement order of the washers is also prescribed. Inspections during disassembly indicated that the washers on the received spar sections were in the prescribed order. The loosening torque for the ten lower spar cap to fuselage carry-through assembly bolts exceeded 300 inch-pounds except for the two at the fracture location where the nuts loosened at about 150 inch-pounds each. The maintenance manual lists the installation torque as 360 to 390 inch-pounds and also notes that the tightening torque is to be applied through the nuts on the lower spar cap and through the bolt heads on the upper spar cap. Rotational damaged to the under-nut washers indicated that the nuts were tightened on the received lower spar cap. The bolt heads were marked with an "X" in a triangle and the letters "CS". In accordance with MIL-HDBK-131A⁸, the triangle "X" marking denotes aircraft, close tolerance, alloy steel, machine bolts AN173 through AN186. The AN specification allows the bolt manufacturer to also place an identification mark on the head. Both the maintenance manual and Piper service letter No. 997 specify the use of MS21042 nuts on all of the main spar wing attachment bolts. MS21042 describes a self-locking ring based nut with a reduced hexagon and reduced height. The received nuts (see figure 8) were not marked with a part number or other identification and do not match this description in detail dimensions or style but rather appeared to more closely match one of the allowed configurations for a MS21046 nut.

Figure 8: A 1.5X view (left) of a typical main spar attachment bolts. Compare the nut to the MS illustrations above.

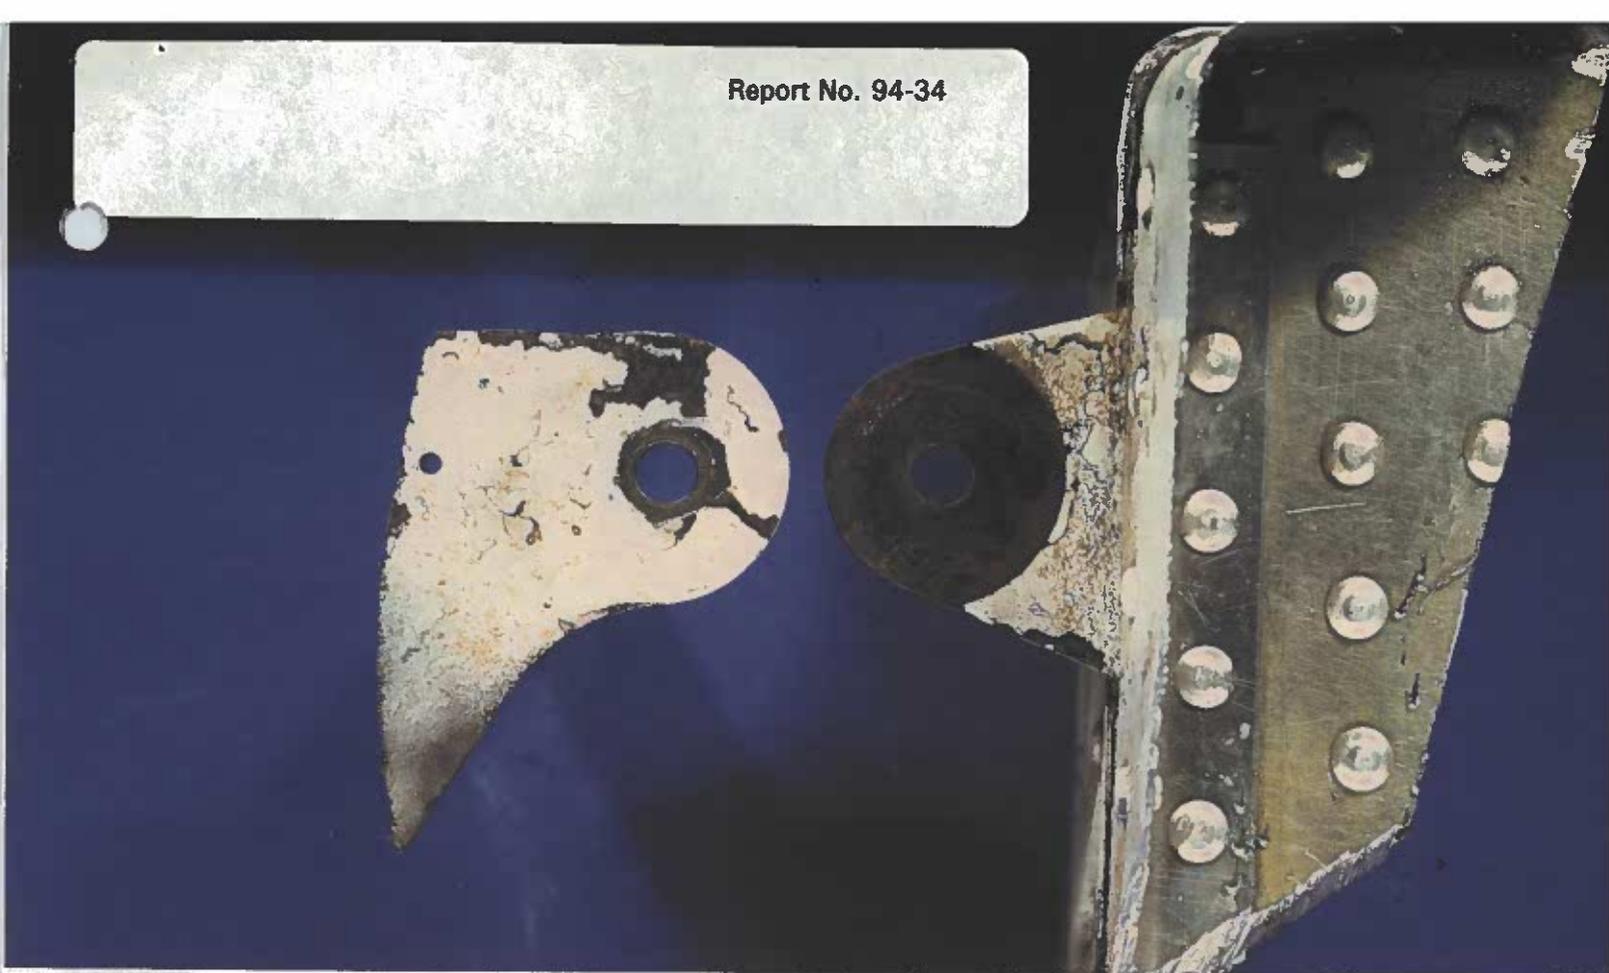
The fuselage and wing lugs of the wing aft attachment fitting were received cut from the aircraft structure. As shown in the upper view of figure 9, the lugs did not appear to be damaged. The Maintenance Manual shows that for this s/n aircraft, the two lugs are connected by an AN5-7A bolt through the holes in each fitting. The investigator was not lugs during assembly. Matching paint and wear patterns on the faying surfaces of each lug, as depicted in the lower view of figure 9, indicated that the lug surfaces had been in direct contact with each other with the bolt holes aligned. Visual inspections also showed that the holes were approximately round showing no appreciable deformation.

Figure 9: Top view looking forward at the wing aft spar attachment lugs. Upper views showing the wear and paint pattern. Lower view with the patterns matched and the holes aligned.
