Factors Affecting In-Service Cracking of Weld Zone in Corrosive Service

This article describes the cause of failure of a monoethandamine (MEA) absorber vessel that ruptured in the state of Illinois in 1984, resulting in 17 fatalities and property damage in excess of \$100 million.

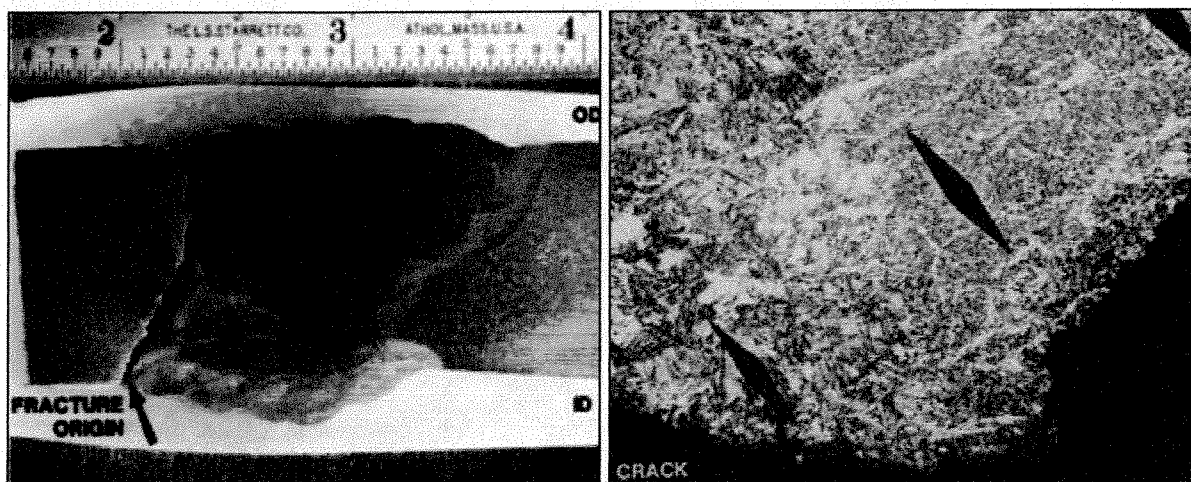
The fracture surfaces exhibited the presence of four major prerupture cracks in the heat affected zone (HAZ) of the lower girth field repair weld. The cracks originated on the inside surface and had progressed nearly through the wall over a period of time. The largest precrack was located in the same area as the prerupture leak reported by the operator. In total, the four cracks encompassed a circumferential length of about 9 feet (33.7% of circumference). The remainder of the fracture exhibited a fast running brittle separation.

Microscopic examination of various cross sections through the failed weld joint area showed the cracking originated in a hard microstructure in the HAZ and progressed in a manner characteristic of hydrogen related damage in hard steels (see figures above). The HAZ exhibited hardness of up to 45 HRC (Hardness Rockwell "C") (450 Brinell), equivalent to a tensile strength of over 200,000 psi in the region of weld cracking. By comparison, the base metal had a hardness value of less than 20 HRC (229 BHN [Brinell Hardness Number], 110,000 psi tensile strength). The following sections discuss technical factors contributing to in-service cracking of weld joints under such conditions.

In potentially critical environments, the weld joint properties must be carefully controlled. Weld HAZ hardness is a function of the cooling rate after welding. Preheating to at least several hundred degrees and maintaining an interpass temperature during welding can warm the joint area sufficiently to prevent rapid cooling after welding. Carbon content and alloy composition will dictate the appropriate temperature. Rapid cooling of even mild steel can result in unacceptably high HAZ hardness for service in aggressive chemical environments.

Postweld heat treating (PWHT) is often necessary in critical weld joints to temper (soften) or stress relieve weld joints in rugged duty or aggressive chemical environments. Higher carbon steels and more alloyed steels are nearly always given PWHT. Even when not specifically called for in ASME Code Section IX, preheating or PWHT may be necessary. In hydrogen environments, avoiding formation of a hard HAZ is crucial. Other corrosive environments present similar concerns.

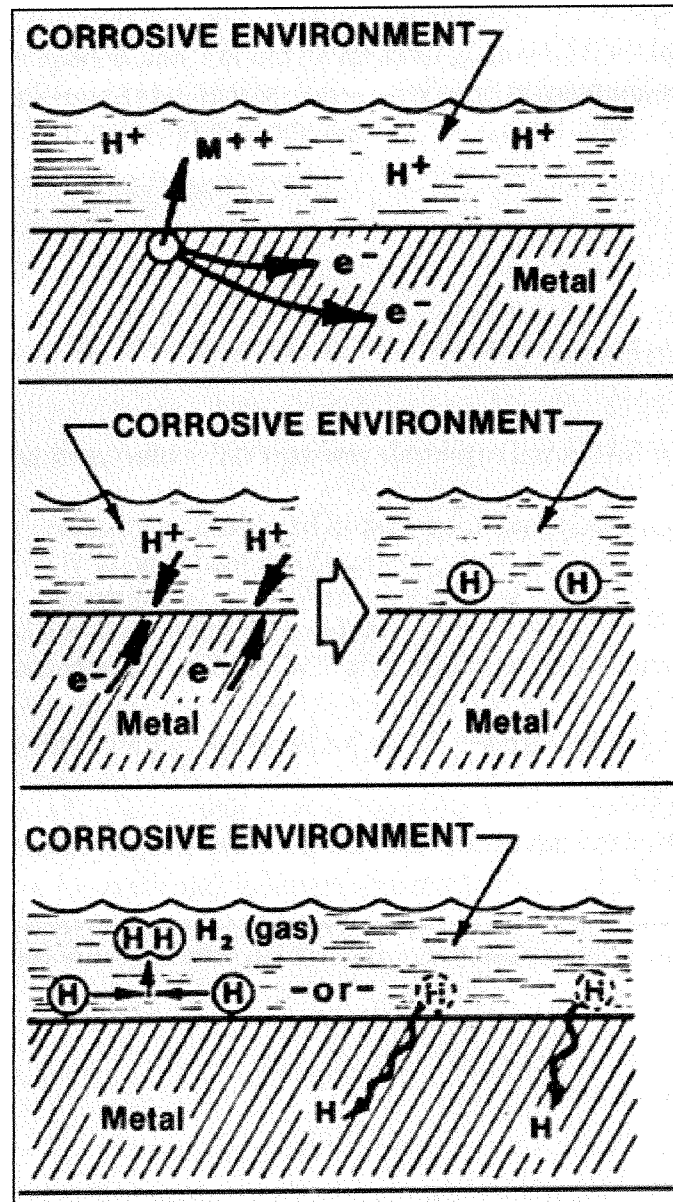
High pressure hydrogen or acidic environments can introduce damaging levels of hydrogen into steel, particularly hard steels or hard HAZs. The mechanism of hydrogen evolution and penetration is illustrated above. The absorbed hydrogen atoms are attracted to high stress regions in the structure, such as crack-like defects. The combination of hard steel and absorbed hydrogen leads to the development of cracks. Once inside the steel, these hydrogen atoms also migrate to inclusions or laminations and create
