NATIONAL TRANSPORTATION SAFETY BOARD

Non-Volatile Memory Devices

Specialist's Factual Report

Location: Mesa, Arizona
Date: July 17, 2017
Aircraft/ID: Lancair Evolution / N571JM
Operator: Private
NTSB Number: WPR17FA155

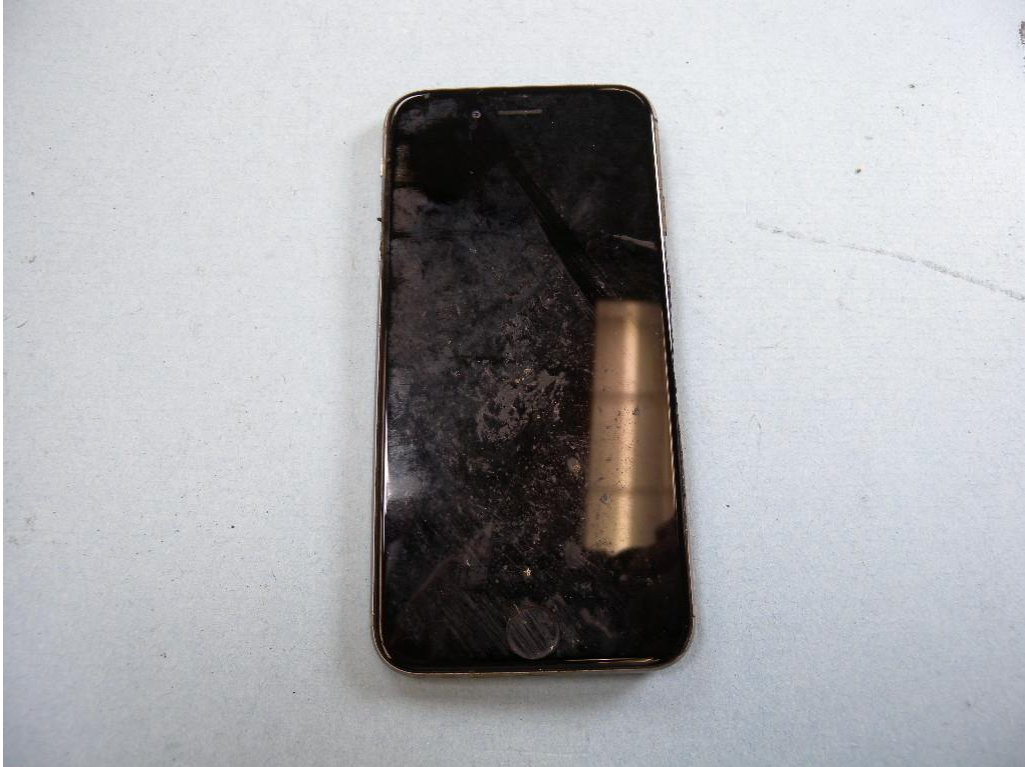
The Apple iPhone 6s arrived in the laboratory exhibiting major damage. Figure 1 shows the device as it arrived. The device's internal components were transferred to a surrogate device and data was extracted normally using laboratory hardware and software.

Figure 1. Photo of the Apple iPhone 6s.

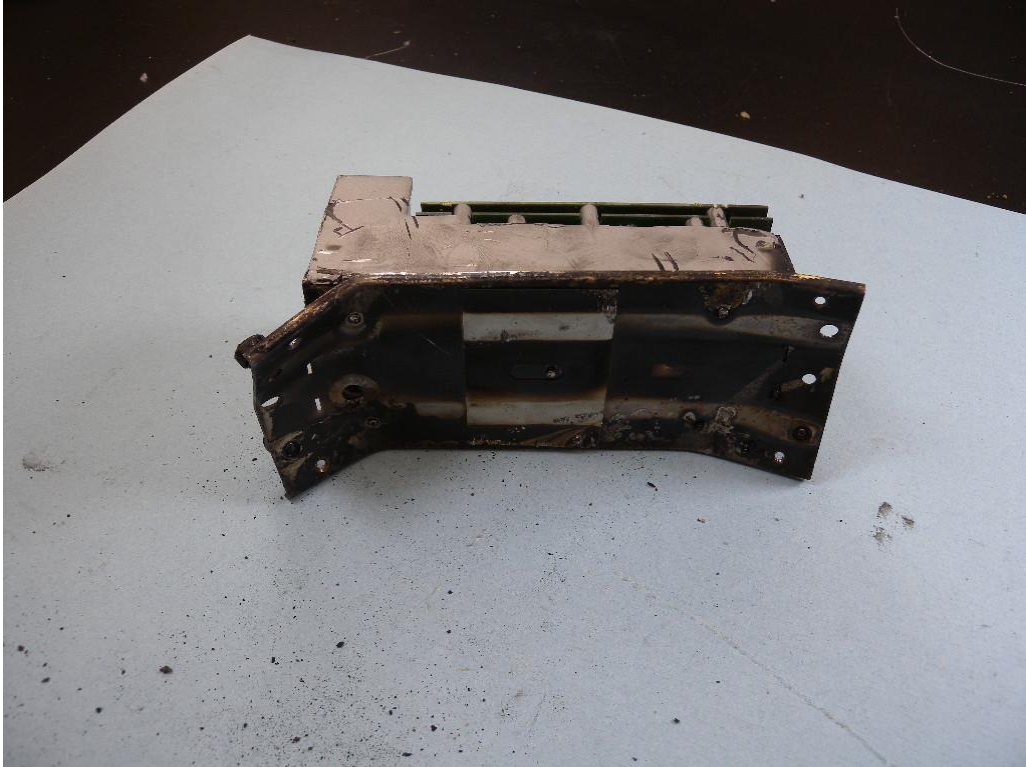
The Garmin 900X arrived in the laboratory exhibiting major damage. Figure 2 shows the device as it arrived. The device typically stores data on an SD memory card. No memory card was located with the device; therefore, no data was recovered.

Figure 2. Photo of the Garmin 900X.

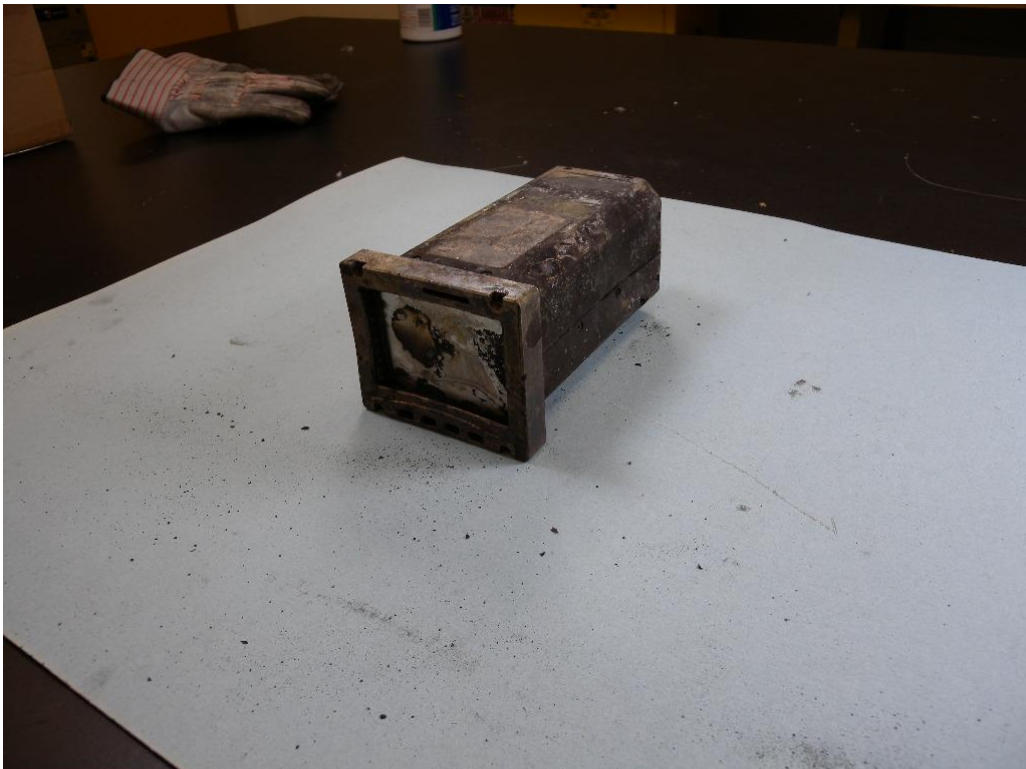
The L3 Trilogy arrived in the laboratory exhibiting major damage. Figure 3 shows the device as it arrived. Due to the damage, no data could be recovered from the device.

Figure 3. Photo of the L3 Trilogy.

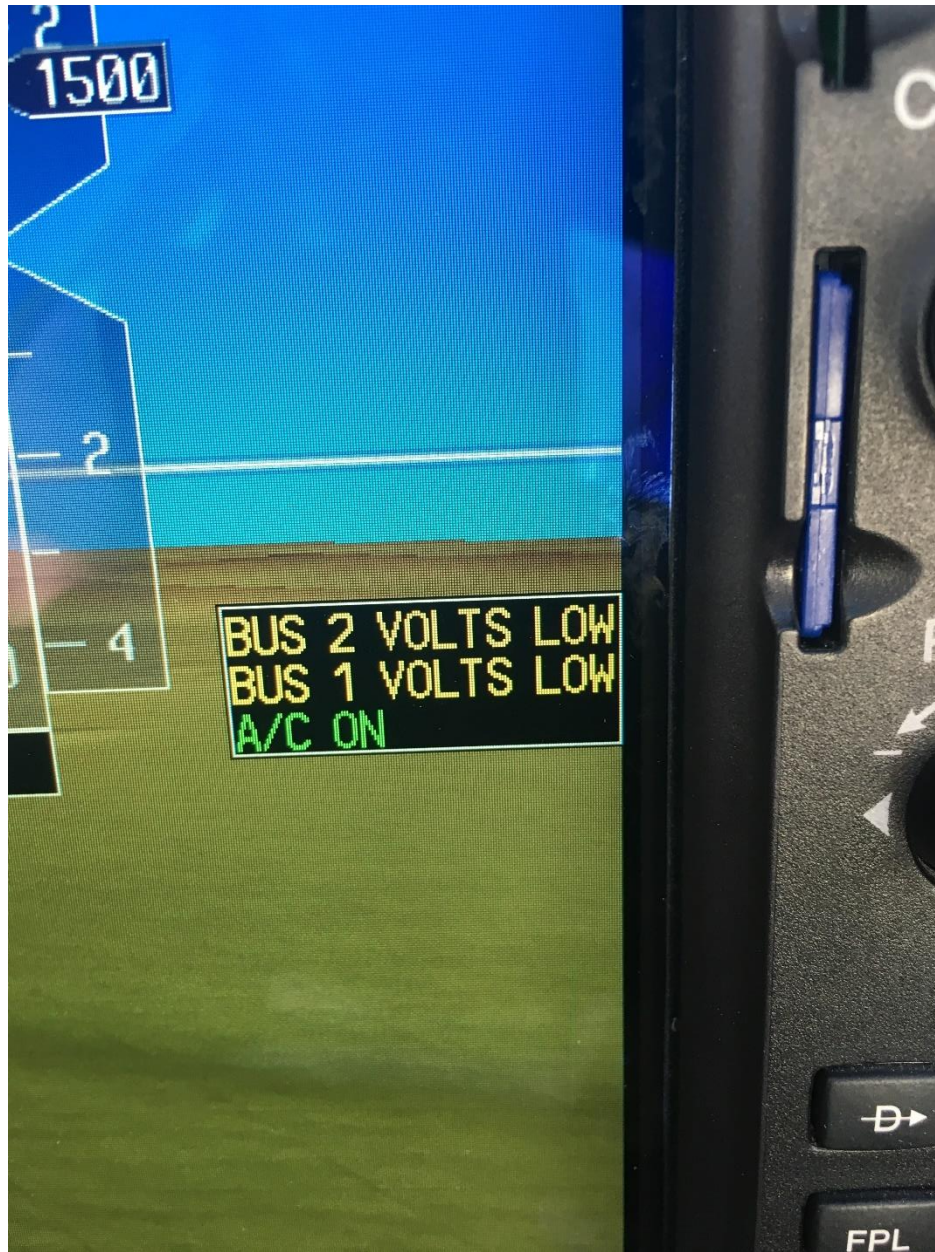
Figure 4. Photo taken at 23:03:21 UTC of a portion of the PFD screen indicating both bus 1 and 2 voltages "LOW" and "A/C ON."

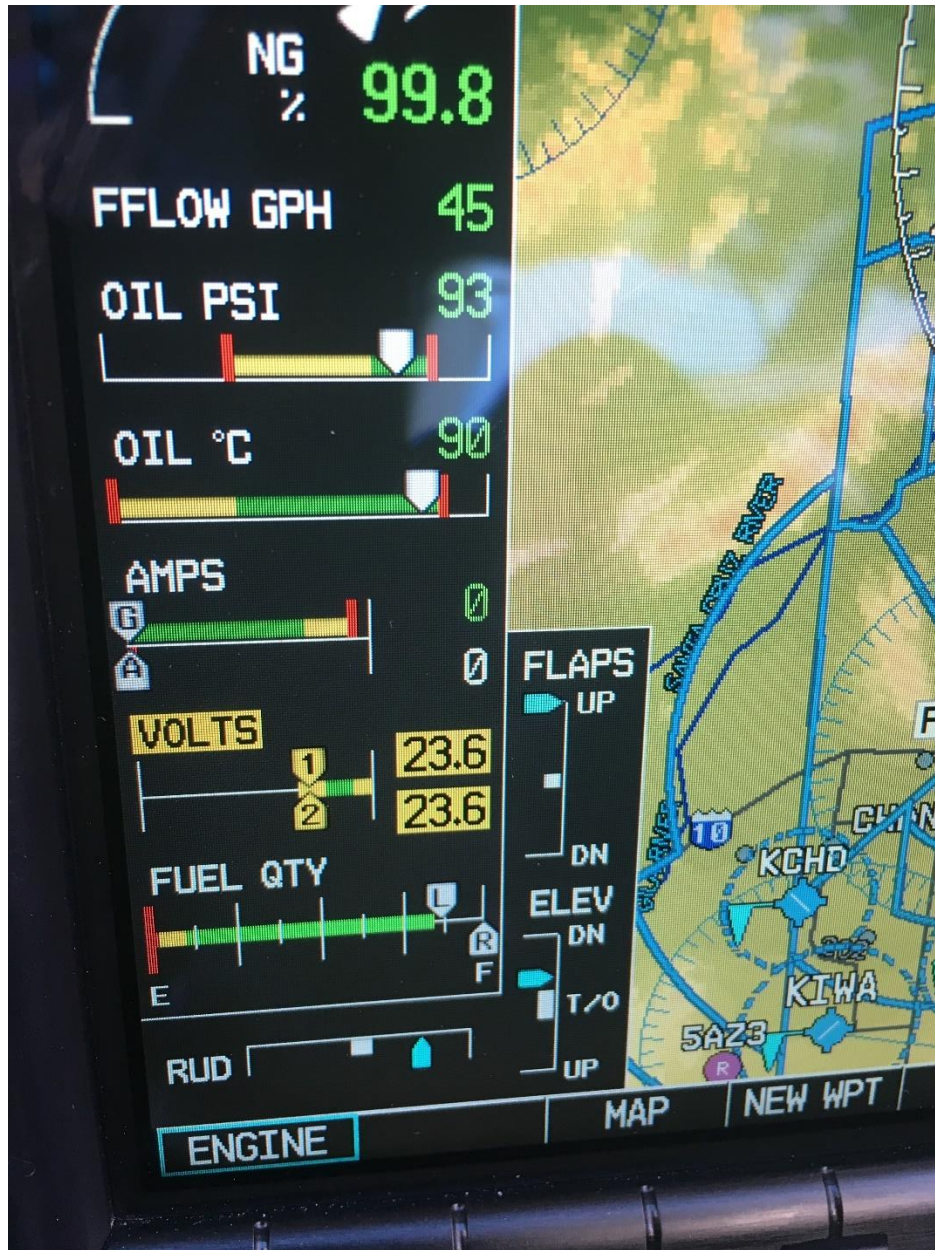
Figure 5. Photo taken at 23:03:26 UTC of a portion of the MFD screen indicating bus 1 and 2 voltages at 23.6V and flaps up.

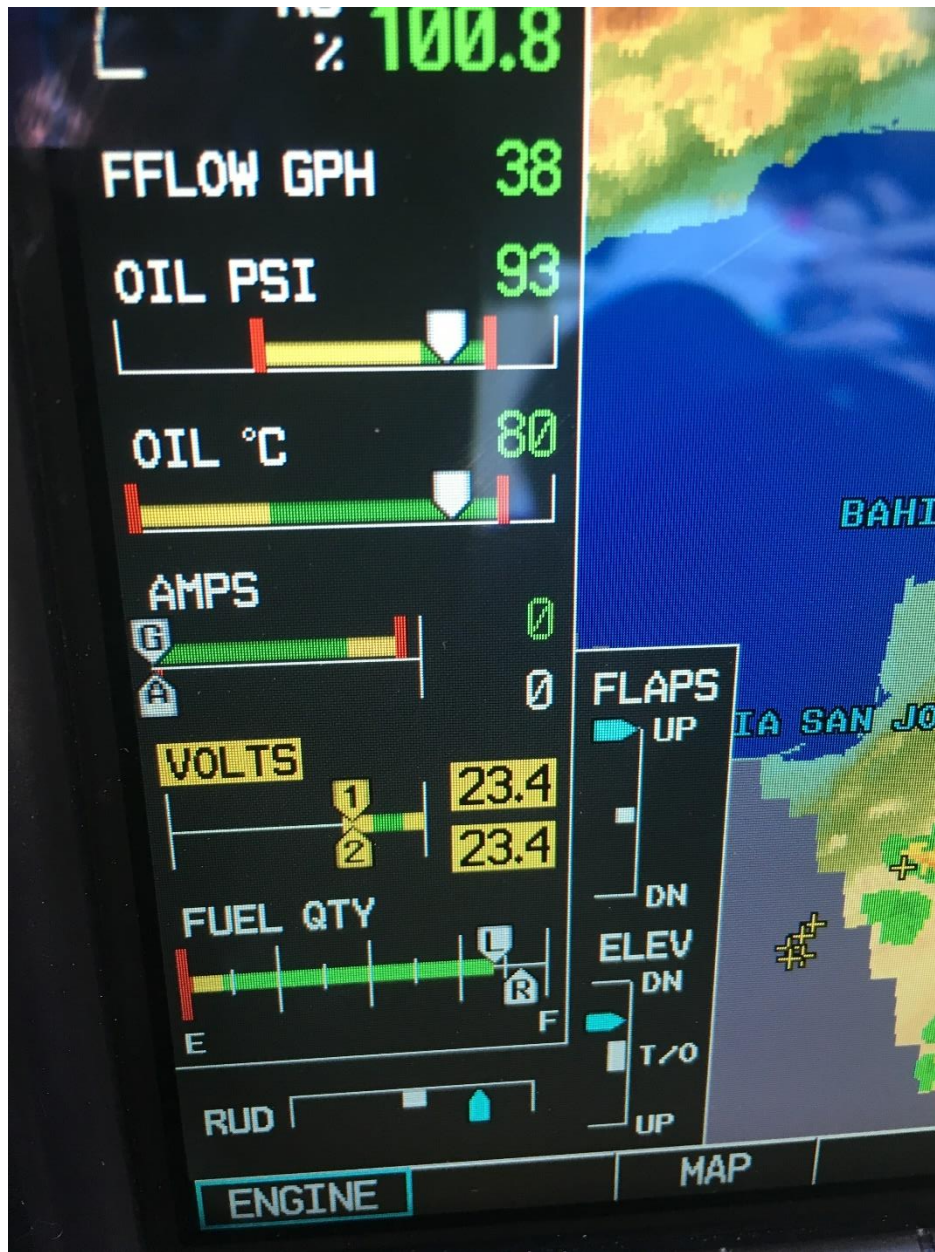
Figure 6. Photo taken at 23:11:46 UTC of a portion of the MFD screen indicating bus 1 and 2 voltages at 23.4V and flaps up.

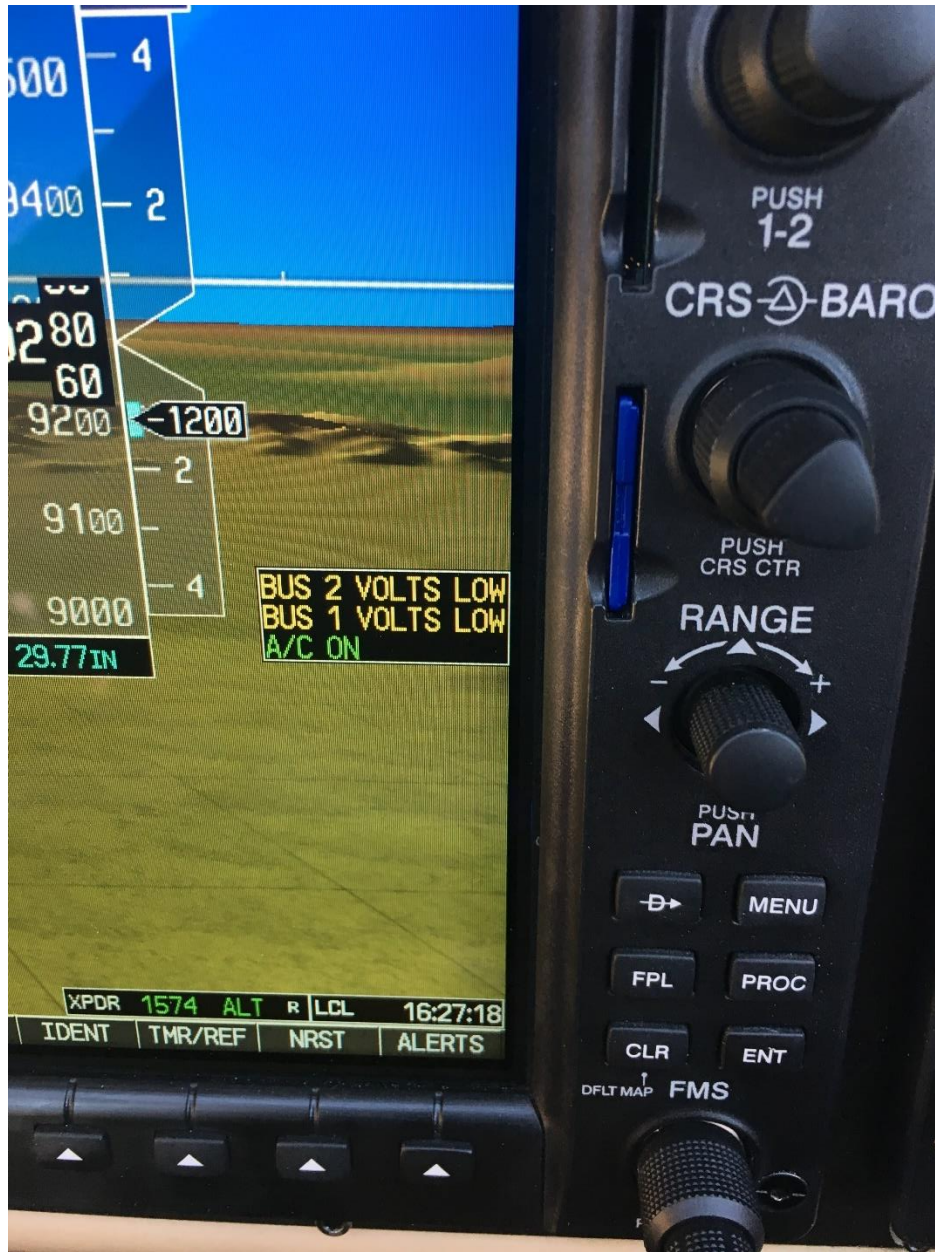
Figure 7. Photo taken at 23:27:18 UTC of a portion of the PFD screen indicating bus 1 and 2 voltages “LOW” and “A/C ON.”

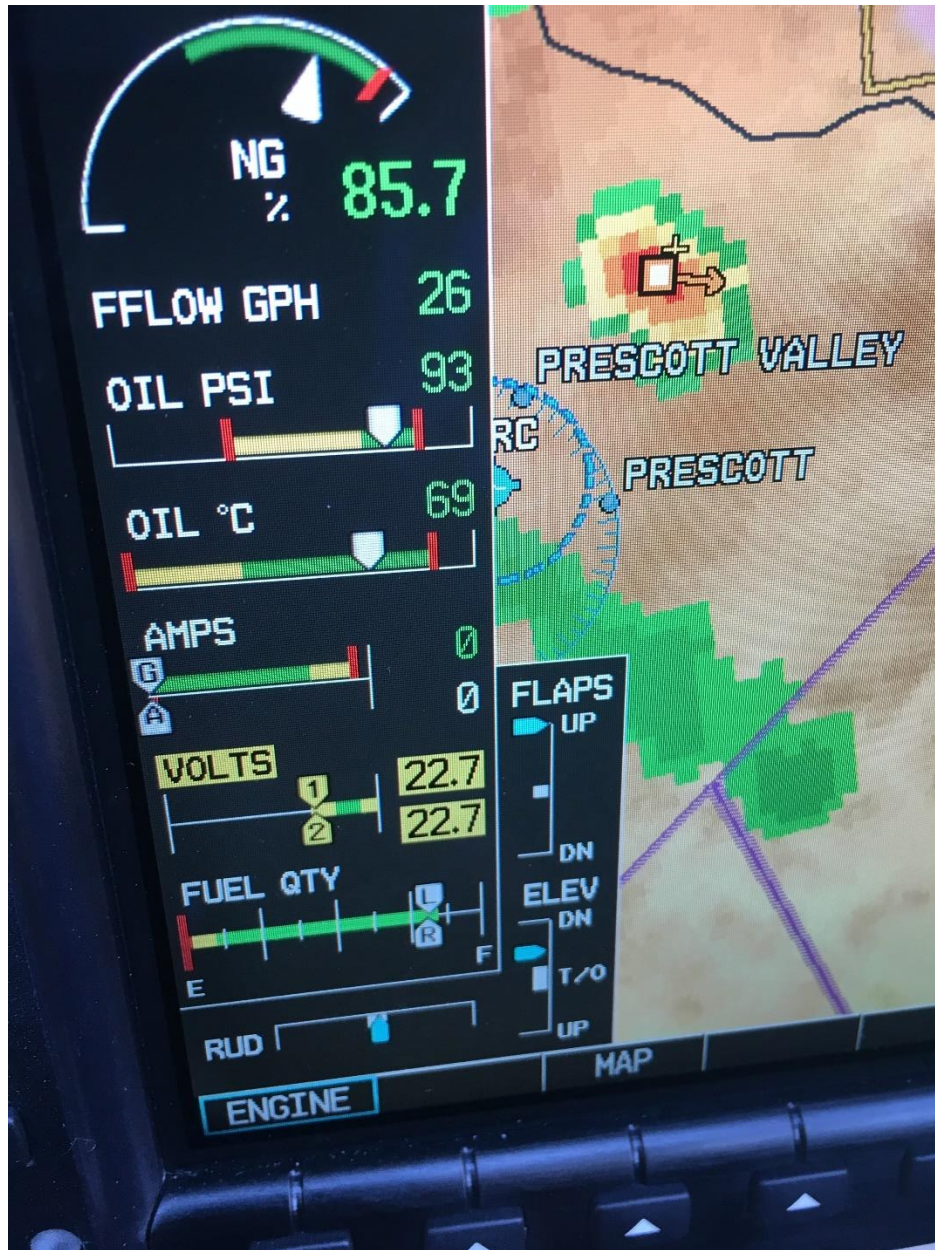
Figure 8. Photo taken at 23:27:21 UTC of a portion of the MFD screen indicating bus 1 and 2 voltages at 22.7V and flaps up.

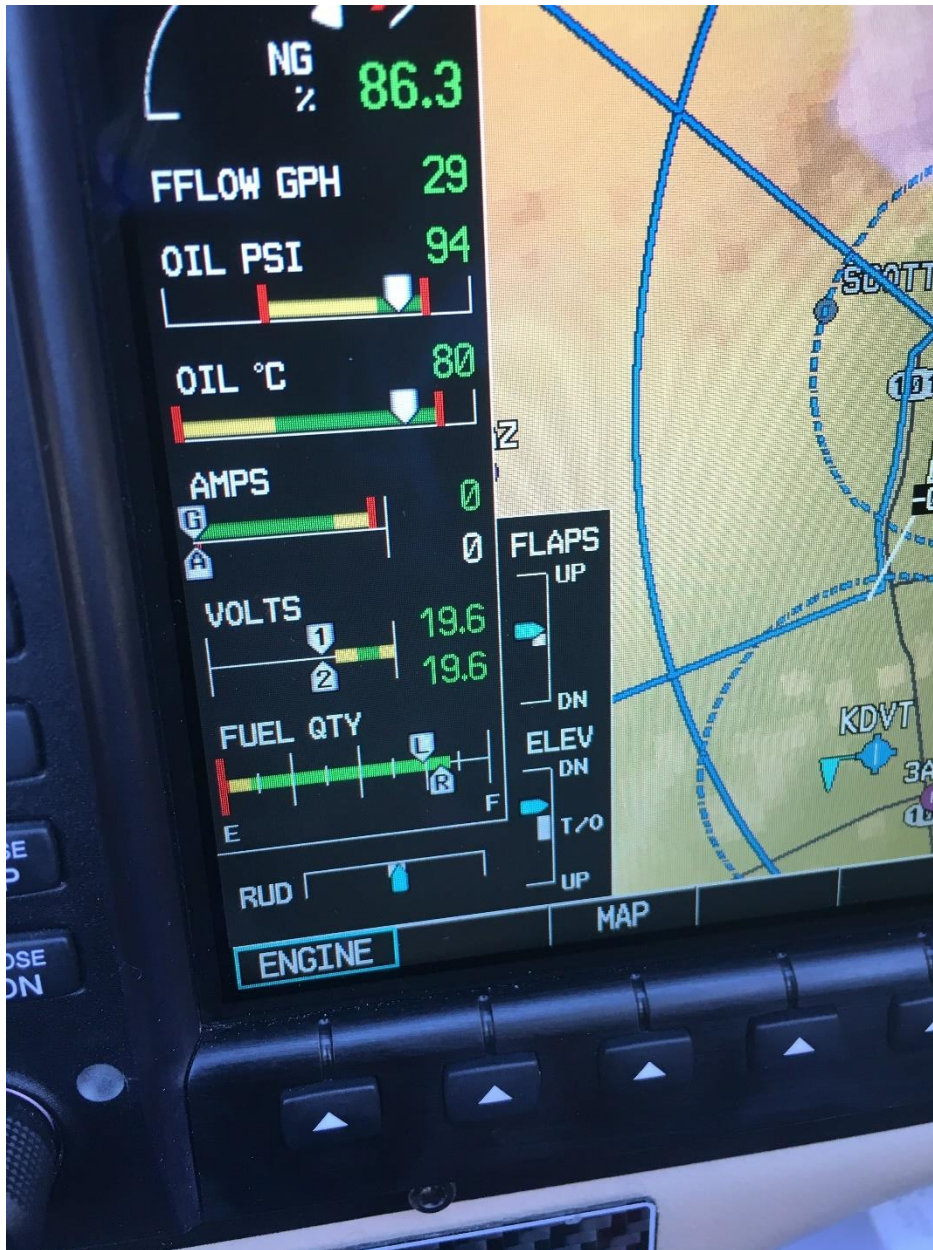
Figure 9. Photo taken at 23:41:12 UTC of a portion of the MFD screen indicating bus 1 and 2 voltages at 19.6V and flaps.
