SUBJECT: ACCIDENT OF N509AM (NTSB WPR10FA371) ON JULY 28, 2010

OPERATIONS GROUP CHAIRMAN'S FACTUAL REPORT, WPR10FA371

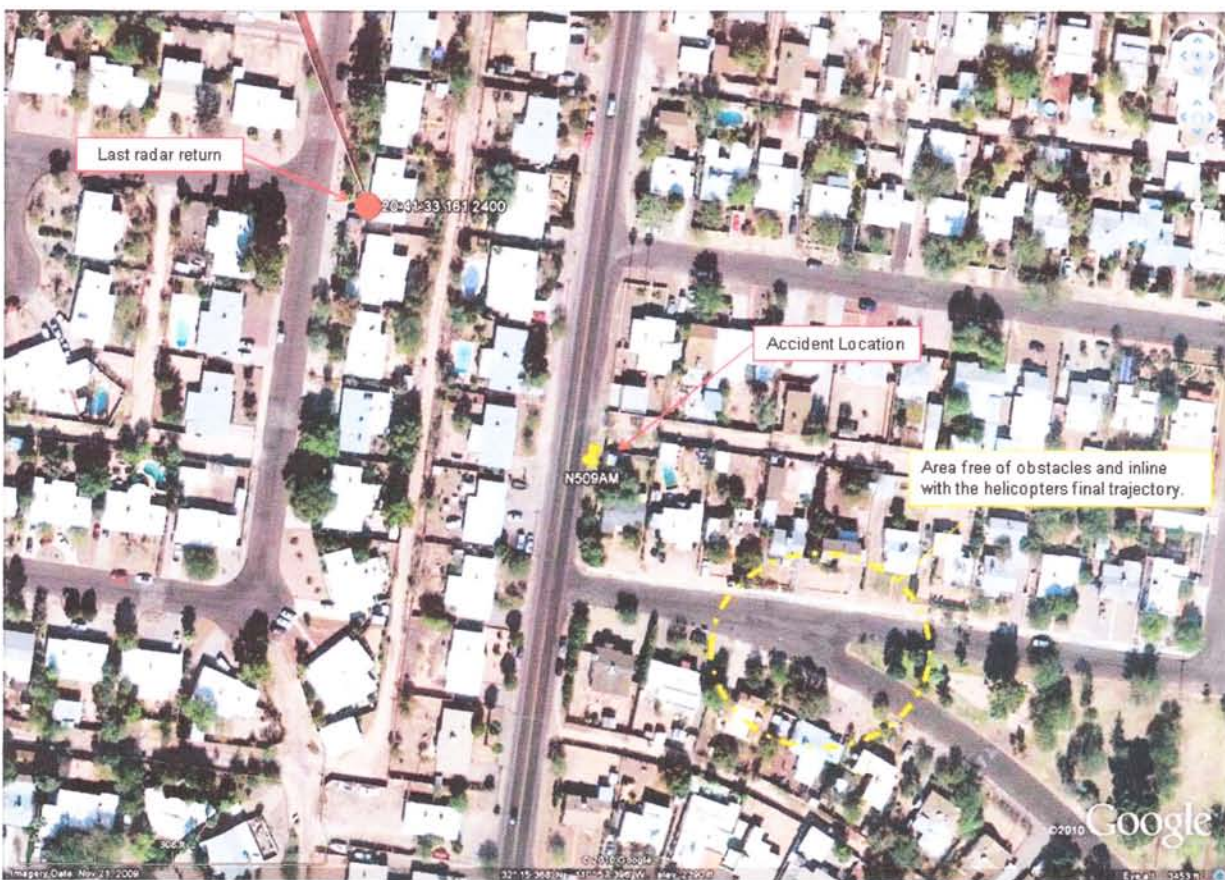
FIGURE 4..

As indicated in both images, there were few suitable emergency landing areas in this urban environment. Inspection of the area revealed numerous power lines and closely placed houses. As Kelley continued toward a possible landing area (depicted by a yellow circle on **FIGURE 4**) it is believed he saw a set of five wires that ran north and south across the flight path on the west side of the accident scene street (See **FIGURE 5**). At this point he flared the aircraft and applied up collective to clear the wire obstacle. This maneuver may have bled the RPM to a very low level that provided reduced controllability. Consequently the helicopter developed a high rate of descent, marginal directional control, possibly coupled with left yaw. This resulted in the aircraft landing very hard, on top of a six foot high brick wall rather than in the street. The main and tail rotors were rotating very slowly, and there was a slight left drift (See **FIGURE 6**). Post impact fire destroyed much of the helicopter. The accident site was on the extreme right east side of a residential street oriented north and south. As indicated above, electrical power lines were connected to wooden poles on the west side of the street.

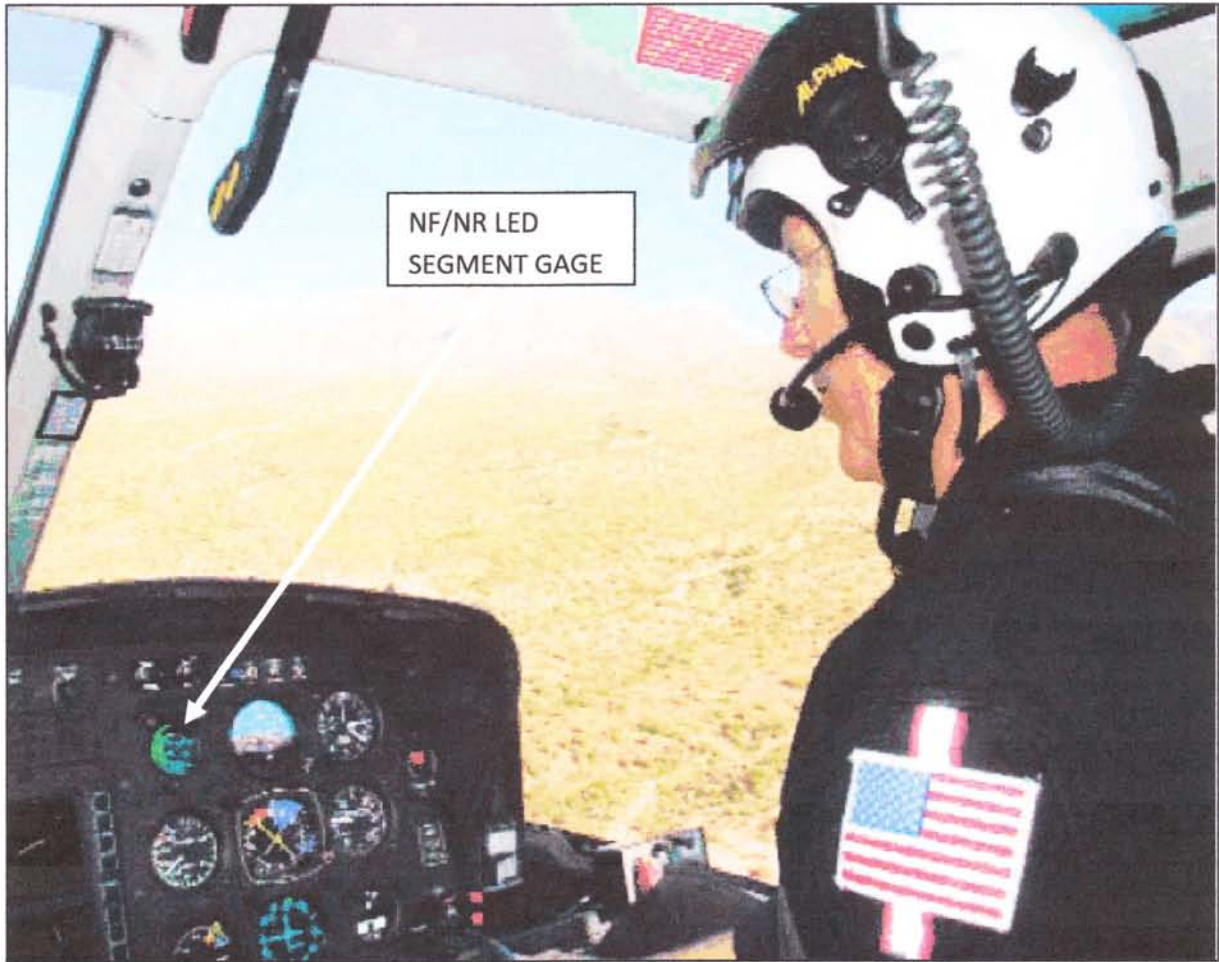
FIGURE 7.

8. Manufacturer cockpit instrumentation for the AS-350 B3 is depicted in **FIGURE 7**. The small gage immediately to the left of the Attitude Indicator is a combination Power Turbine Speed (NF) and Main Rotor Speed (NR) indicator. The NR is not indicated by an analog needle. It is represented by the LED segment lights that go around the inner portion of the gage. Similarly, the NF has LED segment lights that go around the outer portion of the gage. This means that one of the most important indicators (Main Rotor RPM) is arguably the smallest gage in the cockpit. A night vision goggle filter is in place on

the combination gage. During daylight operations this filter may decrease the visibility of those LED segment lights due to light reflection.

8. The main rotor RPM gauge in this cockpit was poorly located and hard to discern.
9. Alex Kelley did not cause this accident to occur, nor did his actions as PIC contribute to the tragic outcome. He was faced with minimal AGL altitude, a heavy helicopter, and few suitable areas to land.

2. EUROCOPTER review the display method and size of the AS-350B3 NF/NR gage depicted in **FIGURE 7**. The traditional “steam gage” display with analog needles for NF & NR has worked well for many years. Developing a display that is difficult to read and interpret is quizzical.

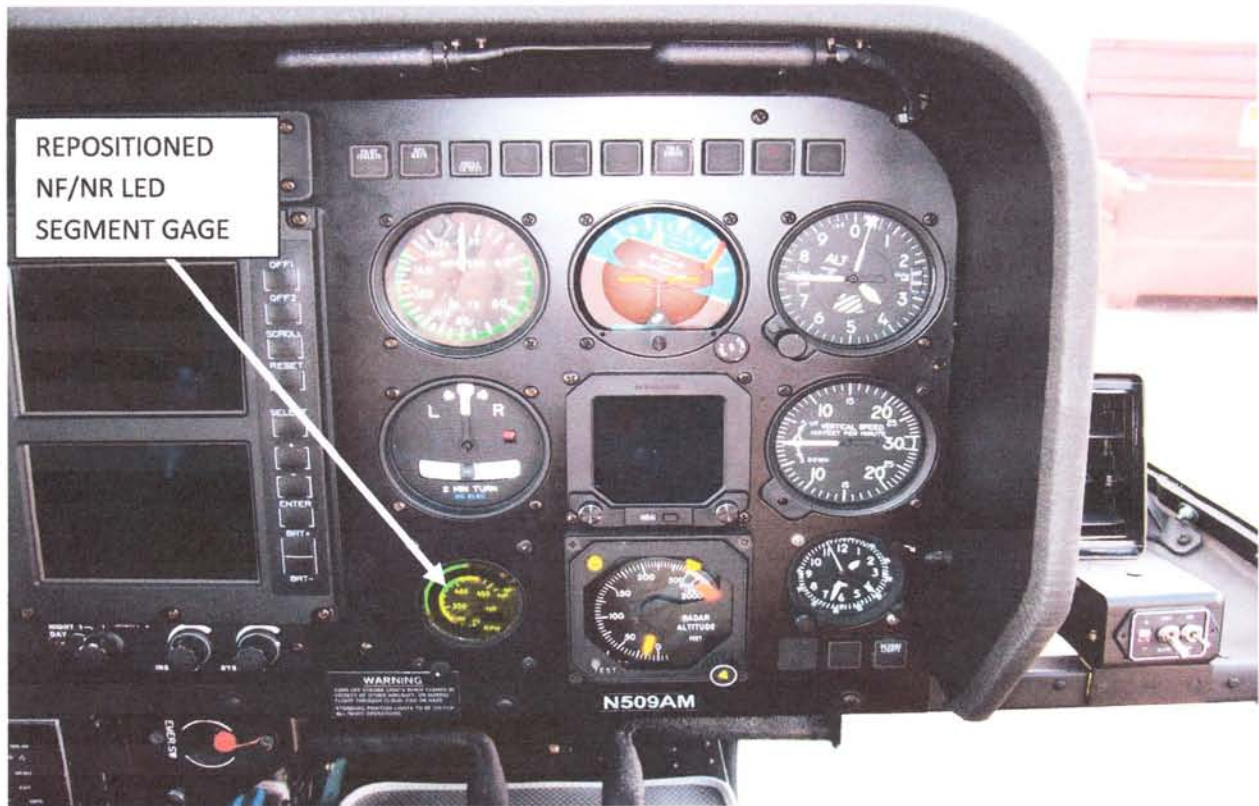
FIGURE 8.

9. Air Methods Corporation is the holder of Supplemental Type Certificate (STC) **SR00617 DE-D**. This STC was developed under Designated Alteration Station (DAS), **DAS-635841-NM**. The DAS was obtained in October, 2005 and permits the Products Division of AMC to approve modifications and repairs to aircraft that it currently supports under its FAA Certified Repair Station, using the Supplemental Type Certification method of approval with only minimal involvement from the FAA. The STC **SR00617 DE-D** is for "Installation of Reduced Instrument Panel, Pedestal and Optional Avionics Systems" for AS350 Models B2 and B3. One of the changes to the AS-350 B3 cockpit instrumentation contained in this STC is the repositioning of the NF/NR gage discussed in Paragraph 8 to a location above the pilot's left knee. This relocation places it in a position that is not in his peripheral view when looking forward and outside, and removes it further from his view when he is looking outside to find a suitable area during an actual engine-out autorotation. Pilots interviewed by Mr. Grandy complained about the gages location and reflectivity during daylight operations(See **FIGURE 8**).

3. EUROCOPTER publish an “engine out” maximum range airspeed for the AS-350 B3.
4. STC **SR00617 DE-D** receive thorough review. The current location and size of this are far from best. The gage is at the bottom of the instrument panel, above the pilot’s left knee. During an actual autorotation pilot’s reference to that gage is difficult at best. This gage presents extremely important information to the PIC. It should be in a prominent position and easy to read.
