Hampton, SC  
SR22T-0884 28 NOV 2014  
N227RR

NTSB IIC: Tim Monville  
NTSB ID: ERA15LA062

Prepared by: Brad Miller  
Revision: Revision 2  
Date: March 22, 2016

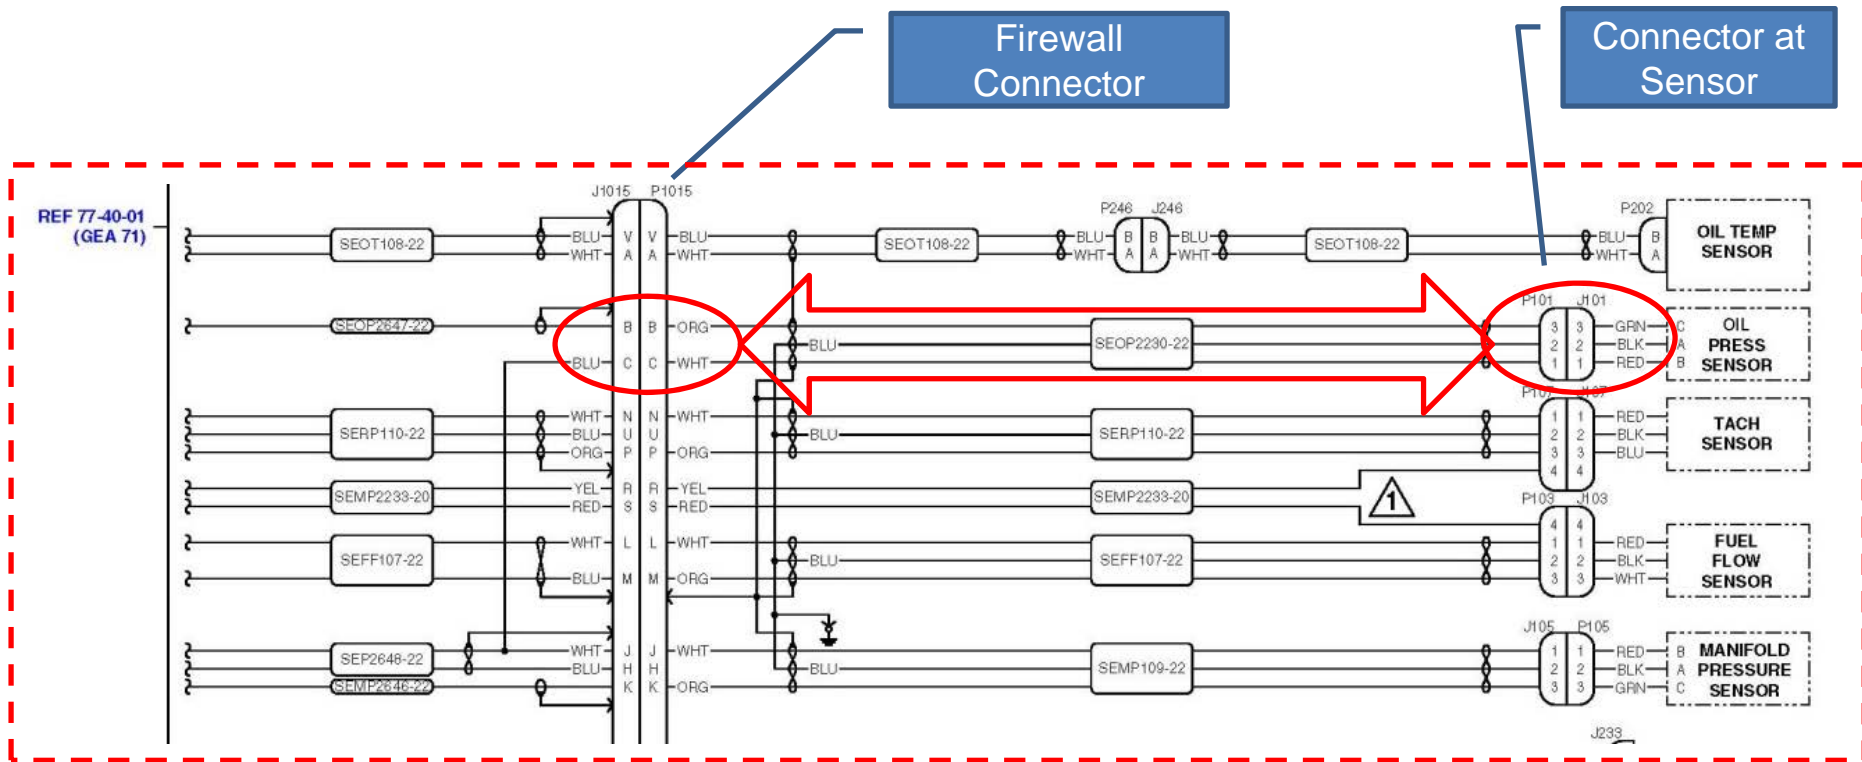
- Continuity check performed between P1015 and P101 (firewall to connector on engine)
  - Connector and pins looked good
  - No damage to wire run noted
- Continuity good on wire on ORG and WHT wires.
- Griffin, GA exam:
  - Unable to obtain continuity on **BLU ground** wire at Griffin, GA
  - physical routing of wire not known at that time
- CMI exam:
  - Continuity verified on BLU ground wire from sensor connector to cut in wire after soldered bundling of MAP, fuel flow, tachometer, and oil pressure ground wires
  - Cut in wire presumed to be made during wire harness removal due to data not showing a malfunction of the other associated gages
