NATIONAL TRANSPORTATION SAFETY BOARD
Vehicle Recorder Division
Washington, DC 20594

On Board Image Recorder

Specialist's Factual Report
By Bill Tuccio, Ph.D.

Location: Dietrich, Idaho
Date: June 29, 2014
Aircraft: Aerospatiale Helicopter AS350B2, N350CR
Operator: Reeder Flying Service
NTSB Number: WPR14LA272

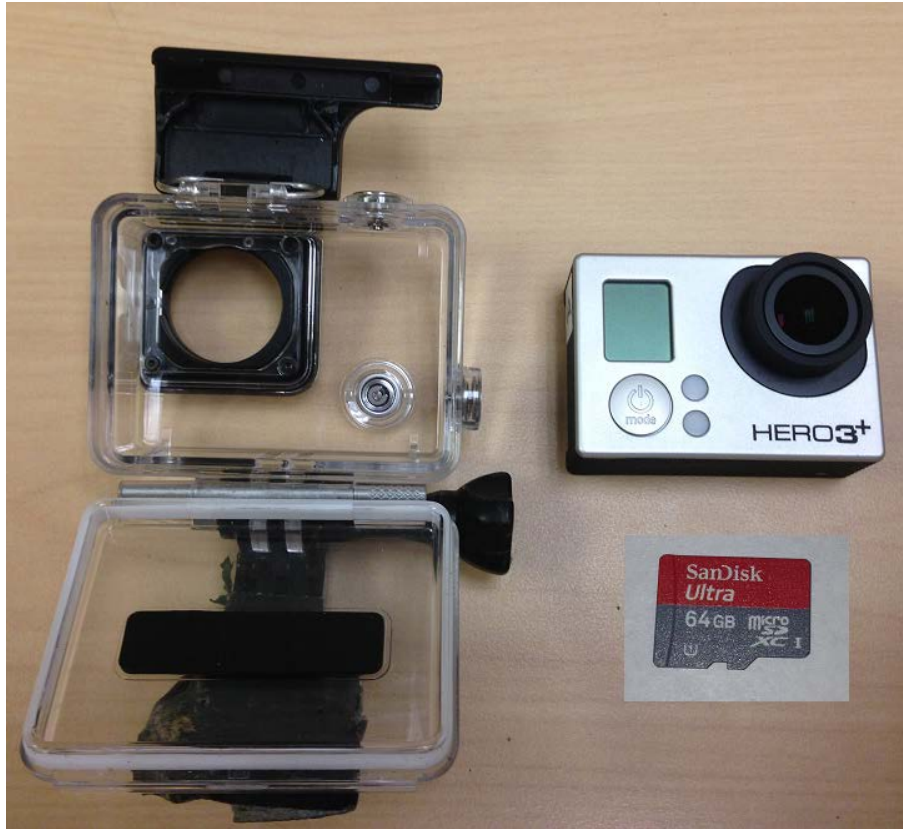
Upon arrival at the audio laboratory, it was evident that the device had not sustained any heat or structural damage, as shown in figure 1. However, only two files were found on the microSD card and neither was the accident flight. The device was powered on and indicated it was set to record at a resolution of 1920 x 1440 at 48 frames per second.

According to GoPro and various support forums, the 64 GB Sandisk Ultra MicroSD card installed in the camera was not fully compatible with the GoPro Hero 3+ Black at the selected high resolution and high frame rate. Some forum users reported file corruption and data loss with incompatible cards and high frame rates.

Figure 1. GoPro Hero 3+, accessories, and microSD card.

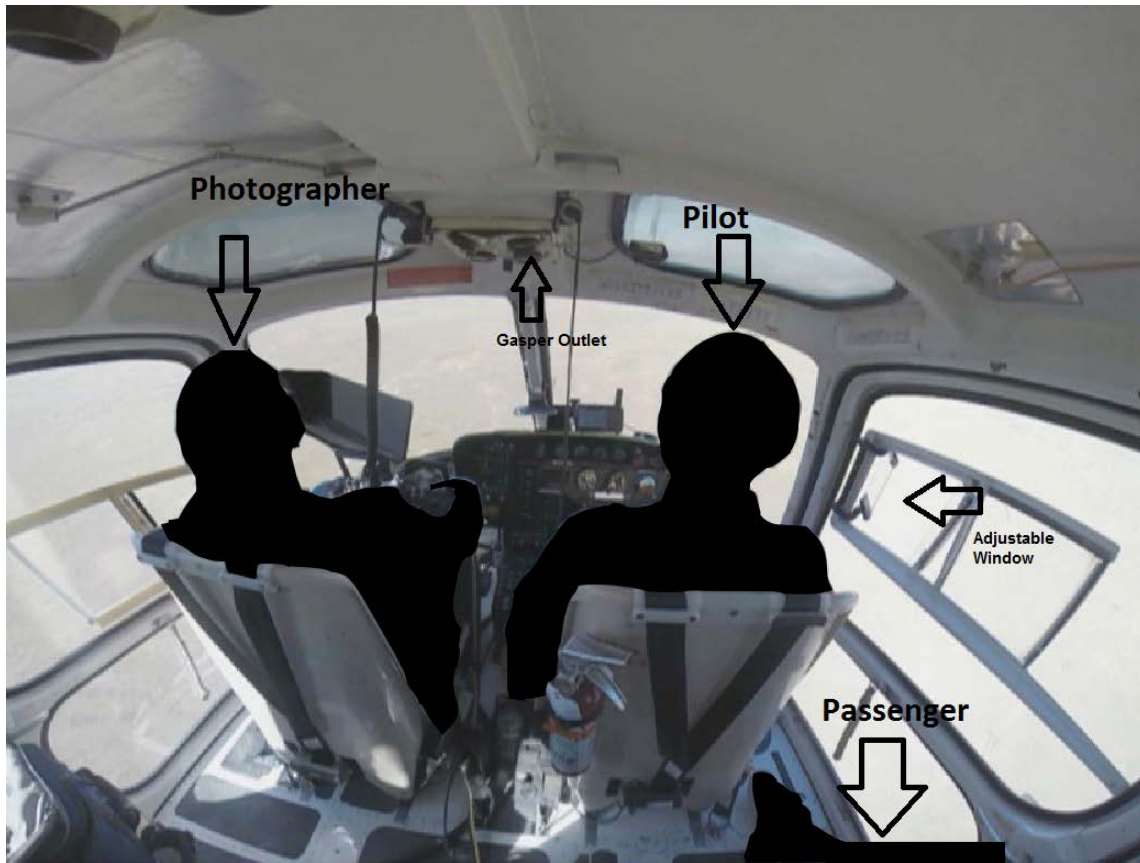
The GoPro camera was mounted behind the pilots capturing the field of view shown in figure 2. The photographer was on the left with a video viewing device in front of him and an electronic device on his lap. The pilot was seated to the right and another passenger was seated in the rear with his feet forward just into the lower right field of view.

Figure 2. GoPro field of view with personnel and select objects annotated.
