NATIONAL TRANSPORTATION SAFETY BOARD
Vehicle Recorder Division
Washington, DC 20594

Onboard Image Recorder and Ground Video

Specialist's Factual Report
By Sean Payne

Location: Summerfield, Florida
Date: April 6, 2014
Aircraft: Vans Aircraft RV-7, N57DC
Operator: Private
NTSB Number: ERA14FA182

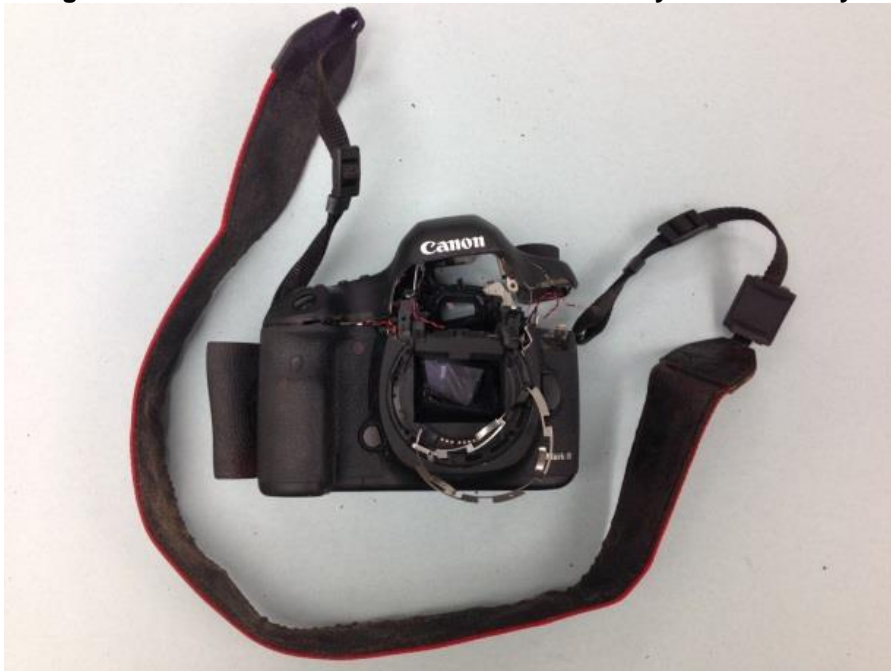
Upon arrival at the NTSB Vehicle Recorder Division, it was evident that the Canon EOS 5D MK III had sustained significant impact damage. Figure 1 shows the condition of the Canon EOS 5D MK III's camera body. The memory card door and battery compartment showed signs of impact damage. The top of the camera body was separated from the main camera's structure at a manufacture line. Numerous internal wires were exposed and damaged. The camera body's lens mount area exhibited deformation from impact. The Canon 70-200mm lens was largely intact (figure 2), however, the lens exhibited binding amongst the

Figure 1. The Canon EOS 5D MK III as received by the laboratory.

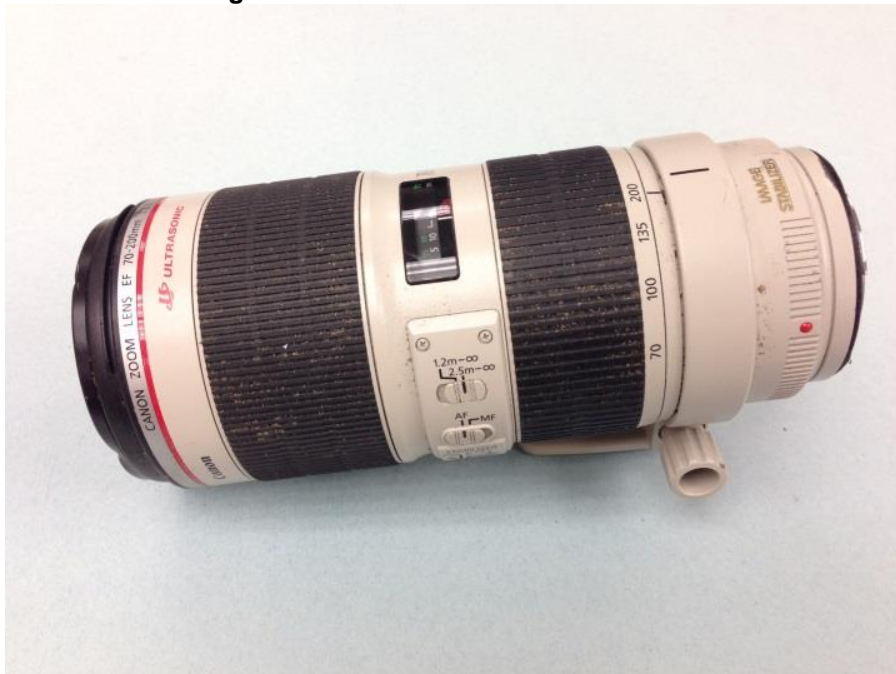
lens's internal glass elements. The recovered CF and SD cards associated with the camera were intact and appeared undamaged (Figure 3).

Figure 2. The Canon 70-200m F/2.8 IS II.

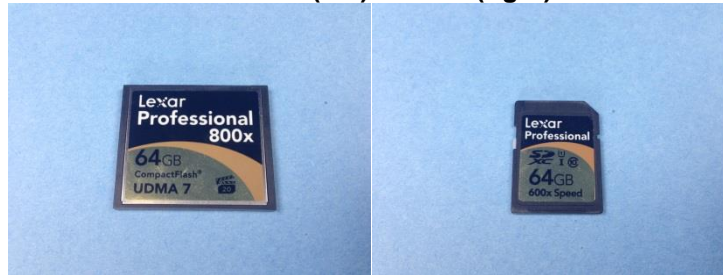
Figure 3. The associated CF (left) and SD (right) cards as received.
