NATIONAL TRANSPORTATION SAFETY BOARD

ACCIDENT SITE EXAMINATION REPORT

WPR14FA243

Location: Overton, Nevada
Date: June 12, 2014
Aircraft: experimental-Dittenber Express Auriga, N55GM, Serial #: 0008
NTSB IIC: Patrick Jones

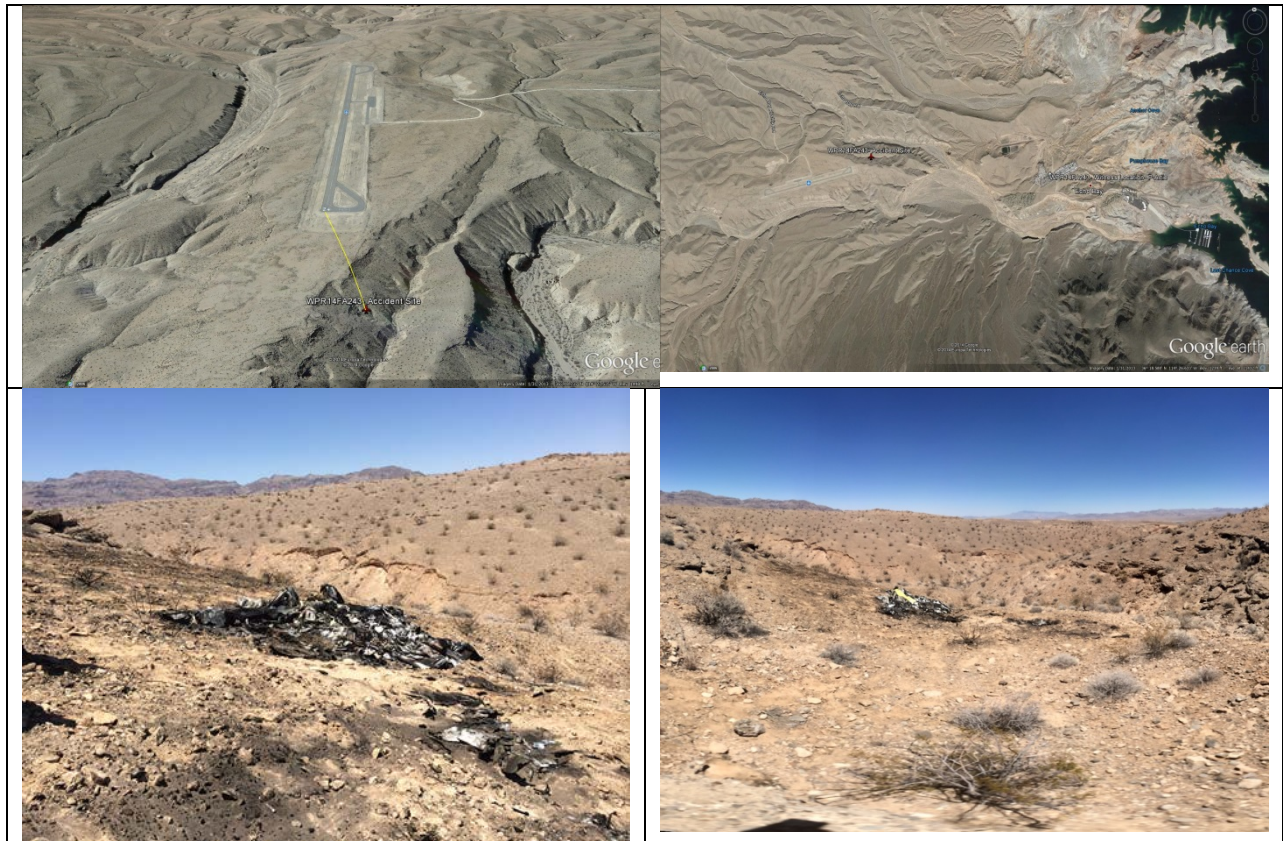
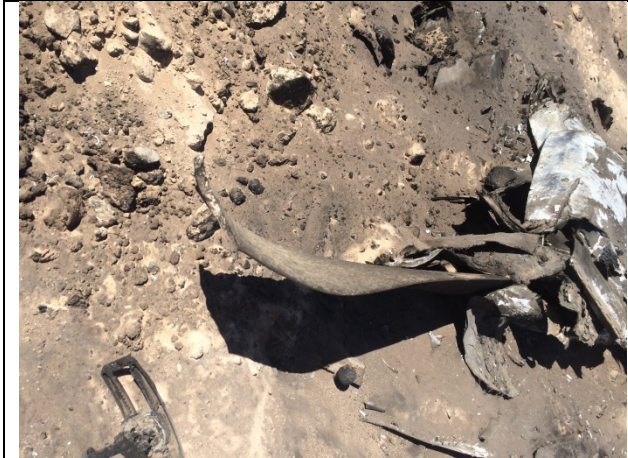
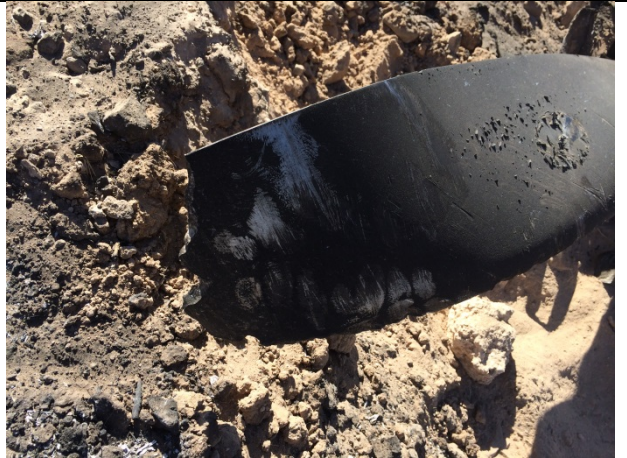
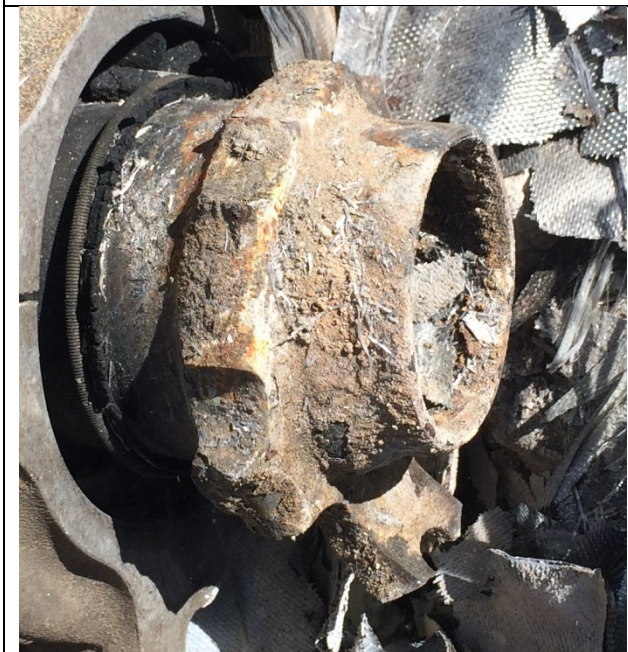
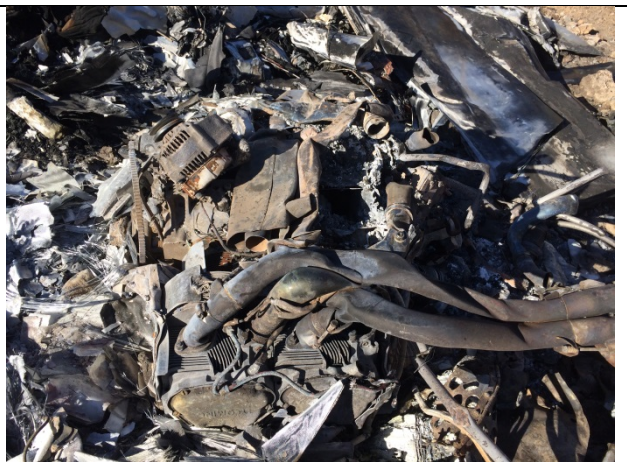
The wreckage was fragmented and thermally consumed by the post impact fire.

The propeller flange was separated from the crankshaft just forward of the engine case. The crankshaft fracture surface exhibited torsional granular features, on a 45-degree conical plane around its circumference.

The propeller showed S-bending, torsional twisting, bending and scaring.

The engine exhaust system was crushed and displayed ductal deformation. The heater shroud was also crushed with ductal signatures.
