NATIONAL TRANSPORTATION SAFETY BOARD

ON SCENE EXAMINATION REPORT

WPR14FA330

Location: Warren, Idaho
Date: August 5, 2014
Aircraft: Exp. Fitzgerald- Zenith CH750, Registration Number: N32FZ, Serial #: 1001
NTSB IIC: Patrick H Jones

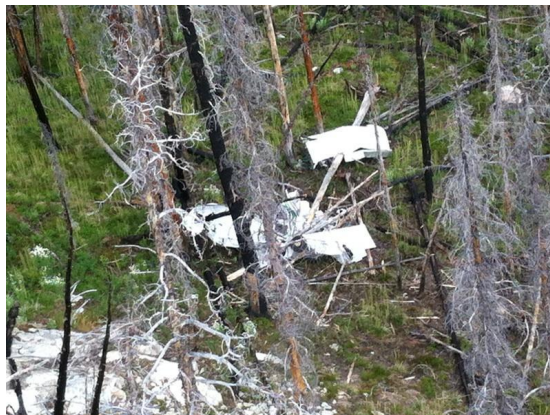
The airplane wreckage was contained in an area of 50 feet. The airplane impacted the ground in a steep nose down attitude.

Examination of the airframe revealed the right wing separated from the fuselage, and was lying across the tail section. The left wing was still attached to the fuselage, with impact damage to the leading edge of the outboard section of the wing.
