## **NATIONAL TRANSPORTATION SAFETY BOARD**

# **ON SCENE OBSERVATIONS**

**WPR18FA074**

Location: Pomeroy, WA  
Date: January 27, 2018  
Aircraft: Hughes 369D, Registration N369TH, Serial #1000830D  
NTSB IIC: Samantha Link

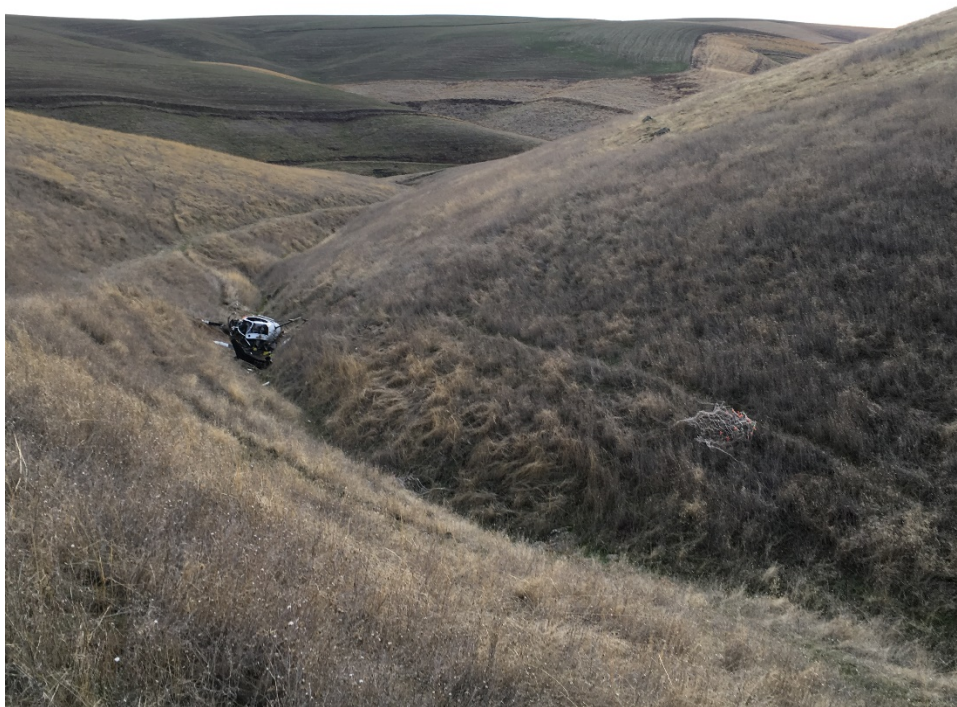
Figure 1: Overall Scene looking South

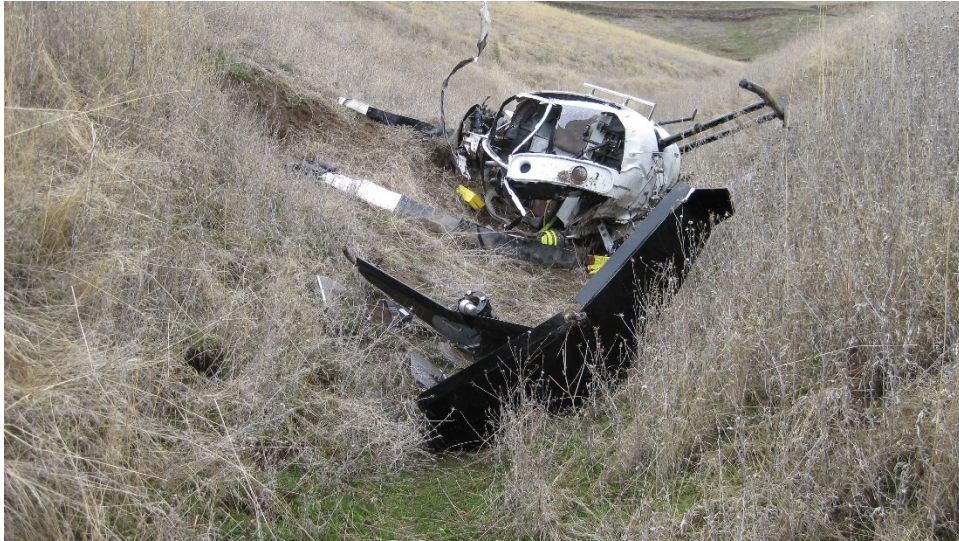
**Figure 2: Main Wreckage looking South**

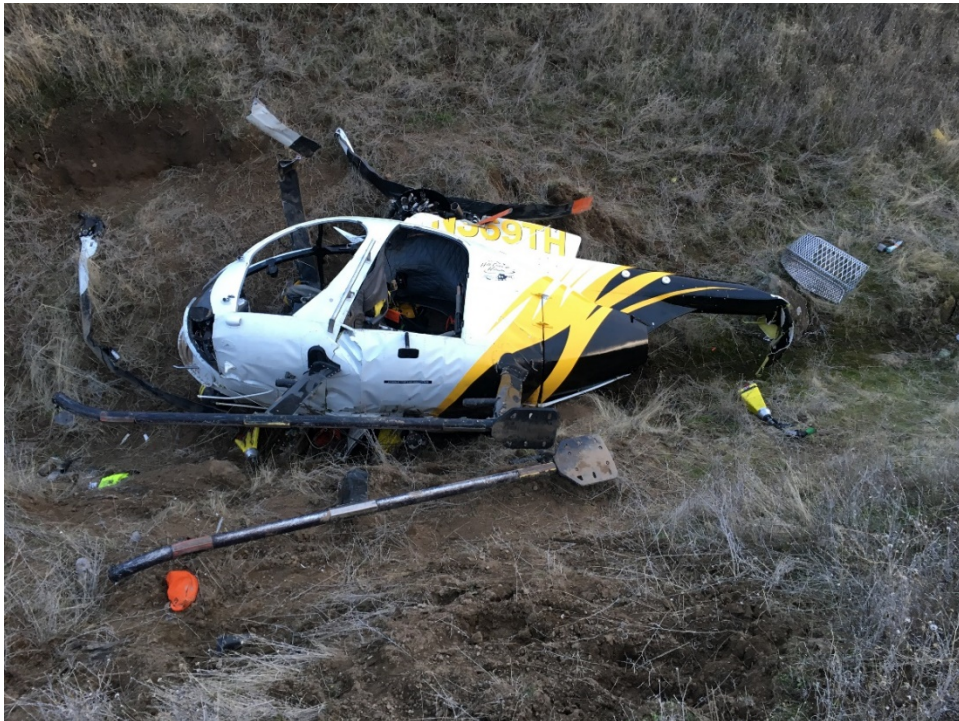
**Figure 3: Left side of Helicopter**

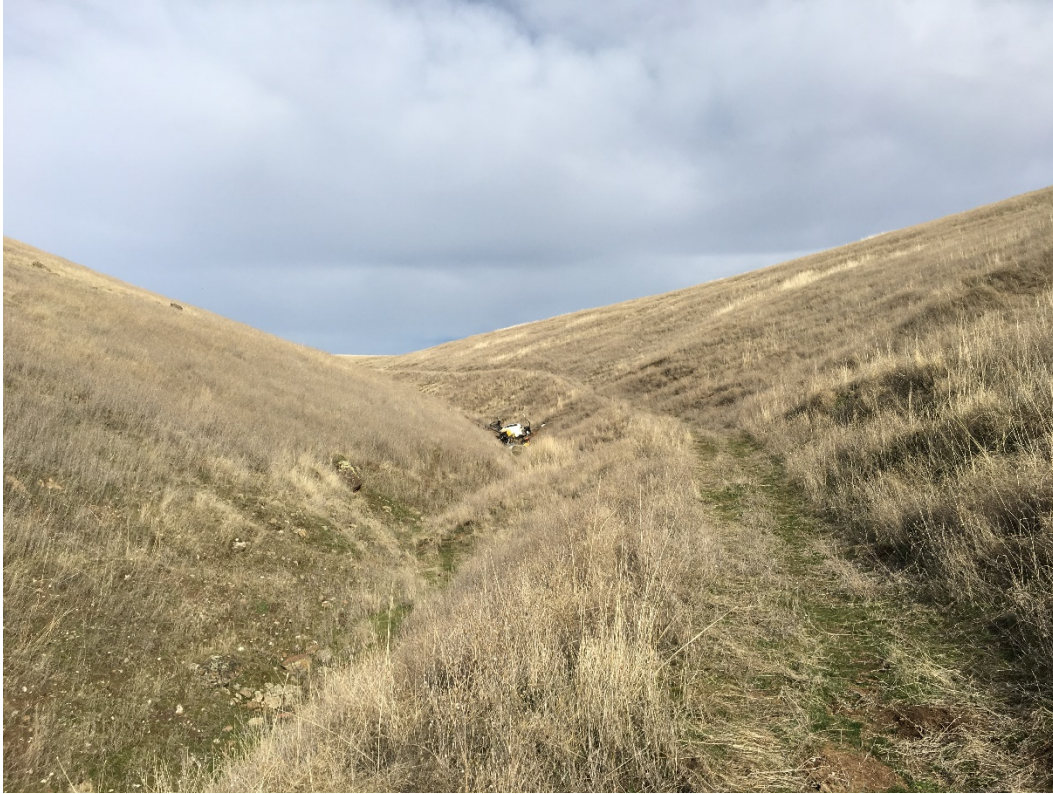
**Figure 4: Overall Scene looking North**

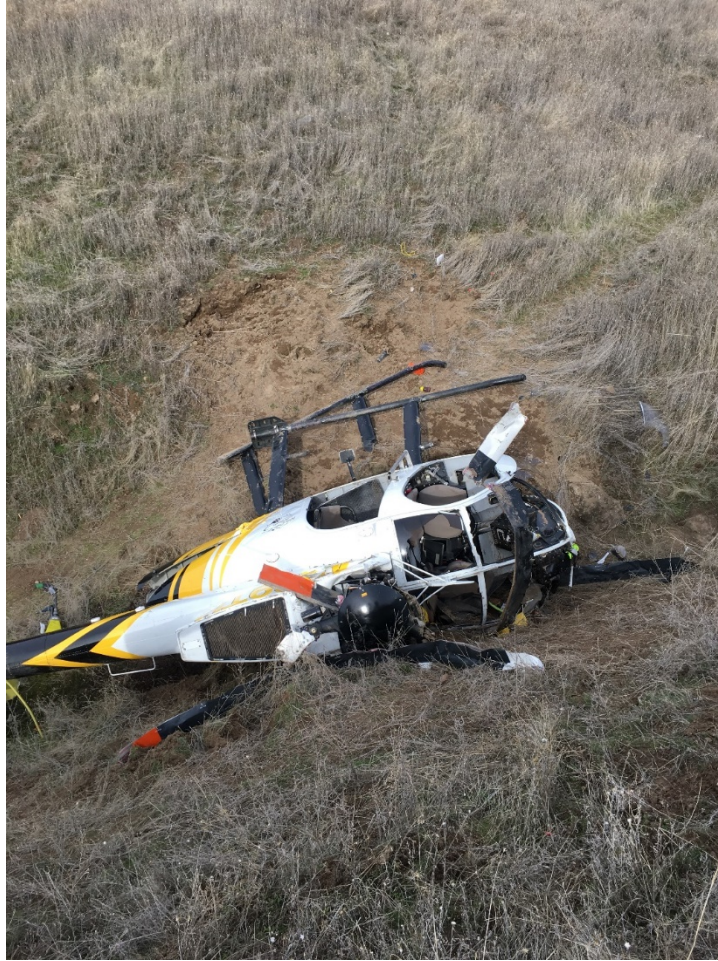
Figure 5: Top Side of Helicopter with Ground Scars

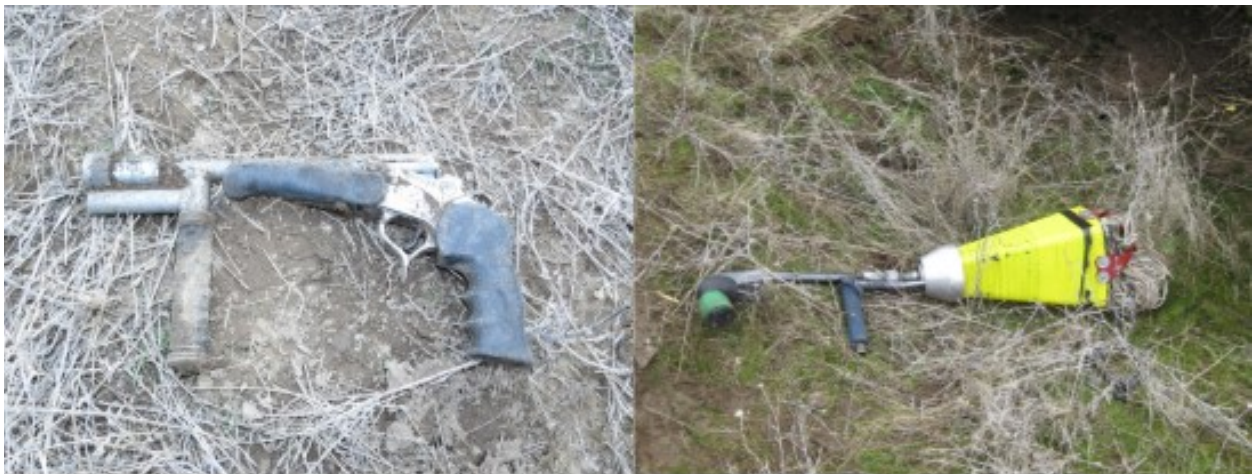
- Two guns were observed on scene
  - One gun was found open with live cartridge in it
    - There was no cone attached

- A second gun was found outside the wreckage near the tailboom fracture
  - The gun was closed with an empty cartridge. A cone with a net was attached
  - The gun/cone assembly exhibited impact related damage and they could not be separated
- The odor of jet fuel was present at the accident site

Figure 6: The Two Net Guns

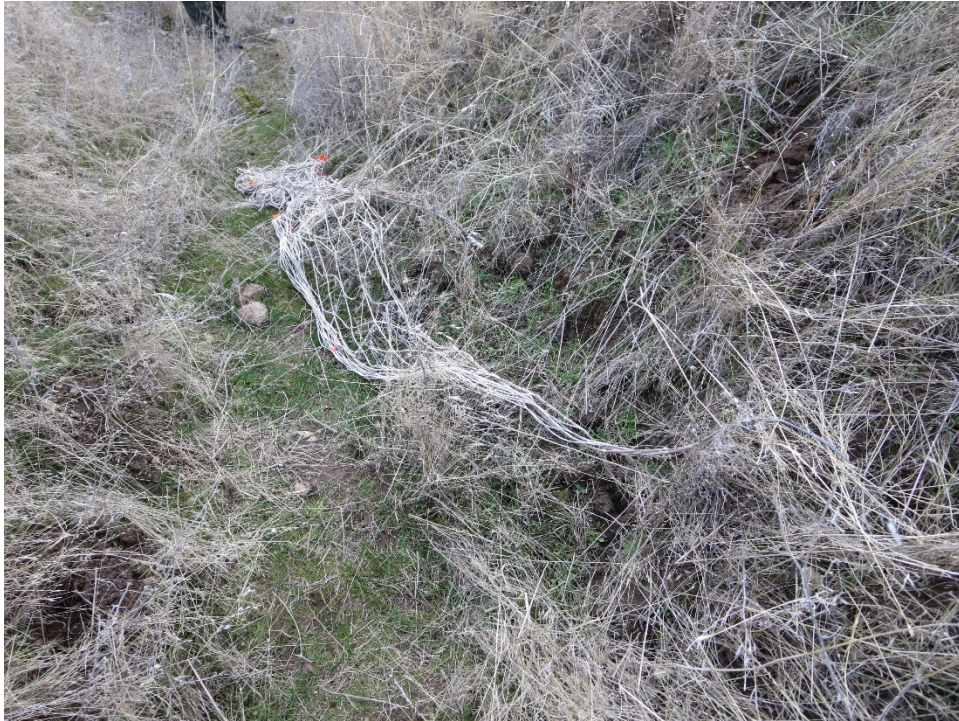
Figure 7: Net Closest to Main Wreckage

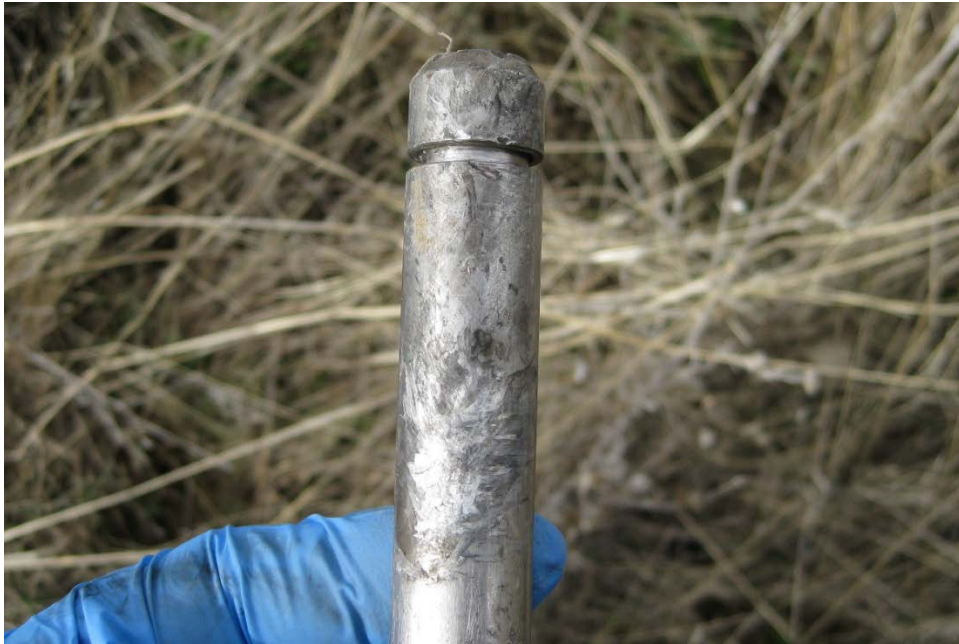
Figure 8: Extended Weight from Net Closest to Main Wreckage

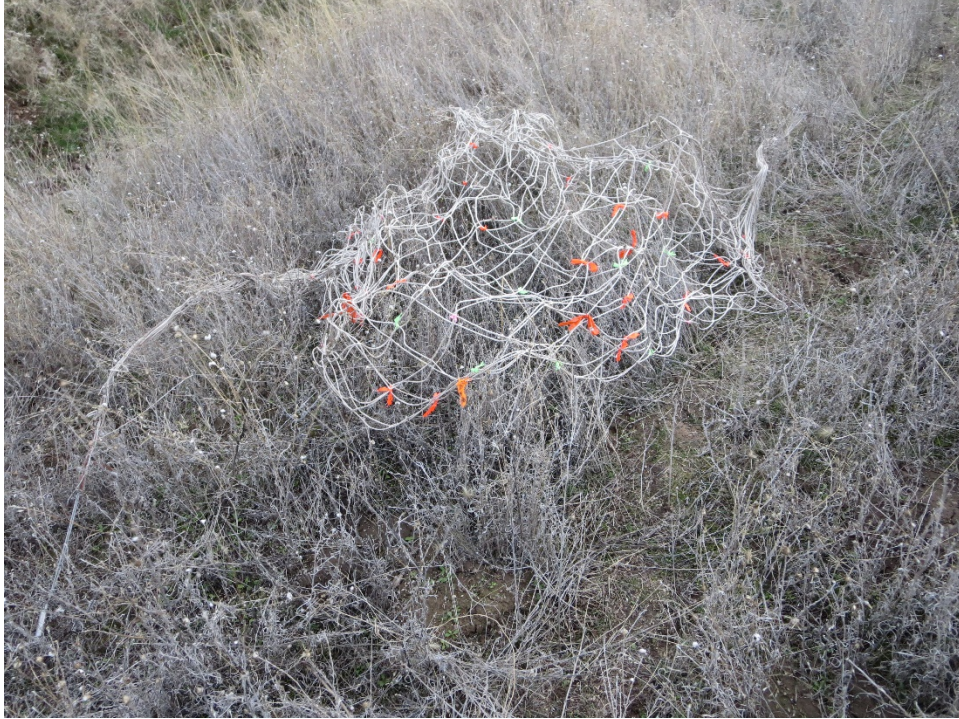
closed at the bottom of the ravine, followed by a second half-opened net about six feet north and slightly up the western ravine wall. About 5 feet further north was a piece of tail rotor skin, and about 15 feet north, and partially up the eastern ravine wall, was a main rotor blade tip cap.

Figure 9: Northernmost Net
