NATIONAL TRANSPORTATION SAFETY BOARD

ON SCENE and POST RECOVERY INFORMATION

**NTSB Accident: WPR13FA244
Accident Date: May 28, 2013**

Location: Mountainaire, Arizona
Date: May 28, 2013
Aircraft: Beech A36, N999PK, Serial # 3380
NTSB IIC: Michael Huhn

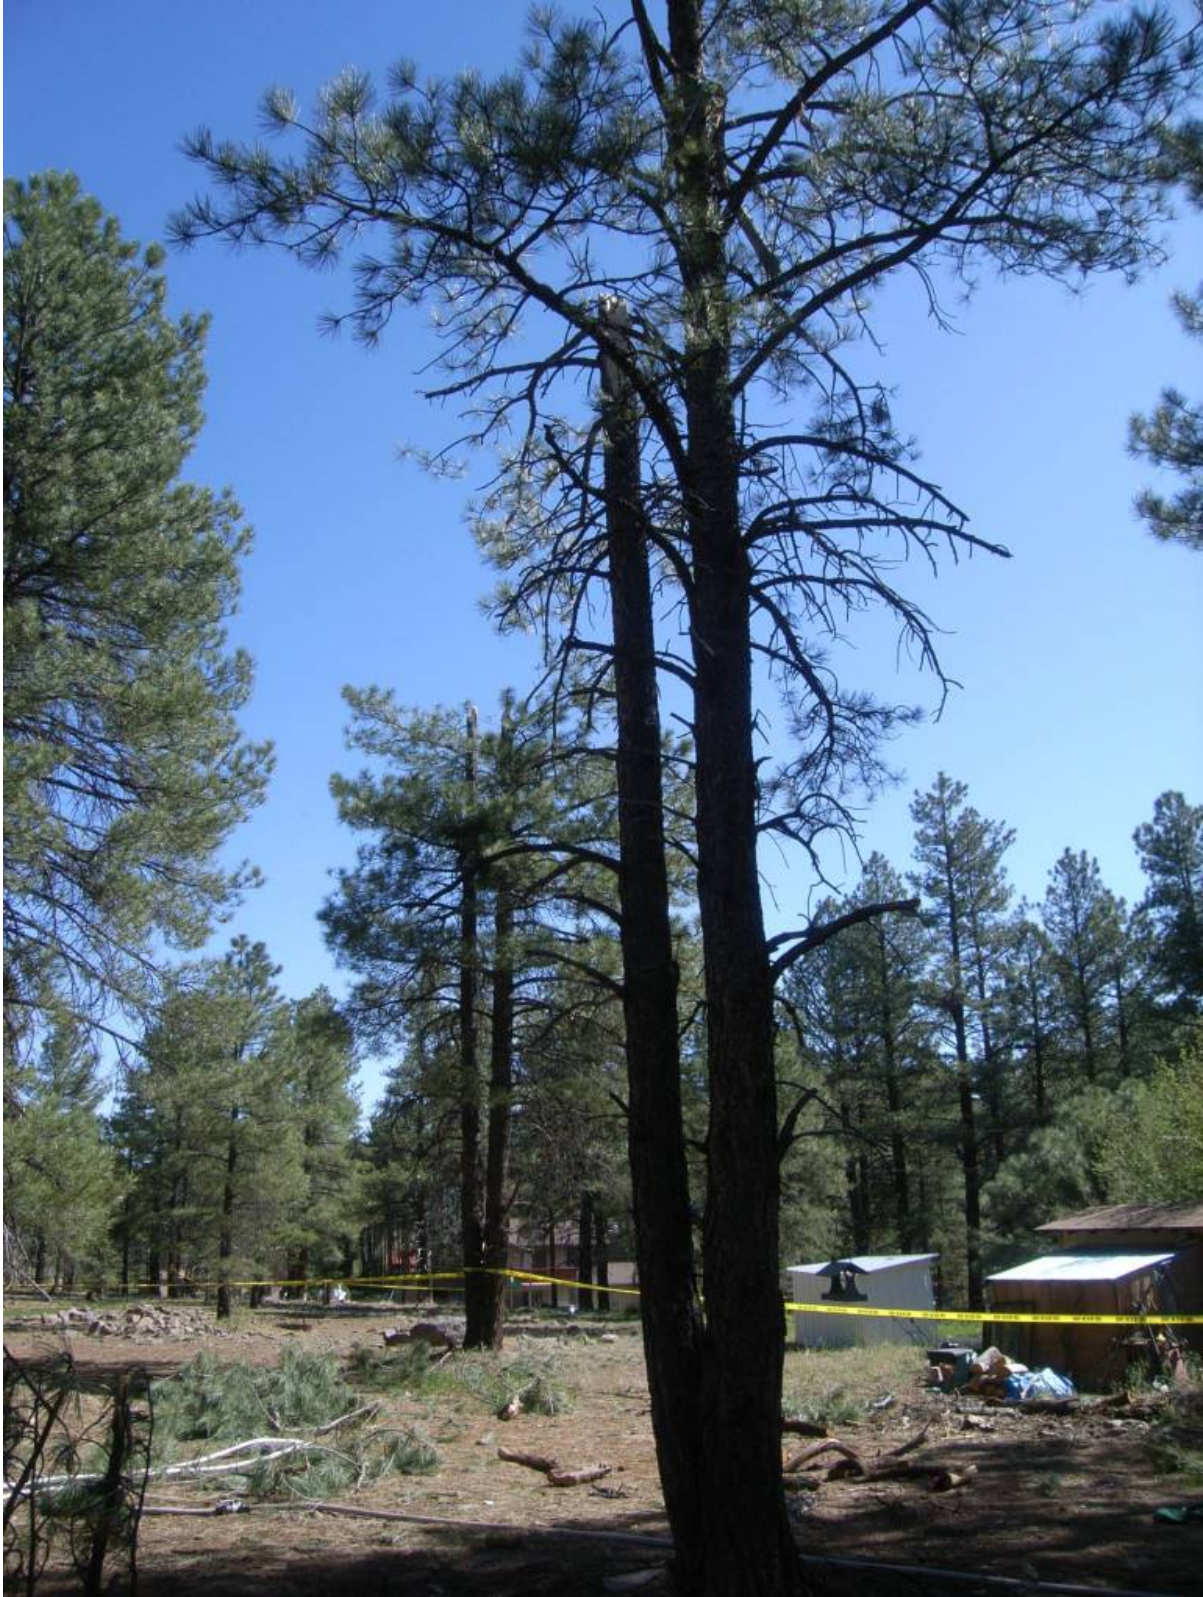
Figure 2 - Tree Strikes (view north; back along flight path)

- The first tree strike occurred at a group of three trunks, which were fractured about 40 feet above ground level (agl)
 - The trunks at the fracture locations were about 12 to 18 inches in diameter

- The GPS-indicated geographic coordinates of the first tree strikes were
 - Latitude: 35° 04' 59.2" N
 - Longitude: 111° 40' 06.6" W
- The second tree strike occurred at single trunk, which was fractured about 23 feet agl

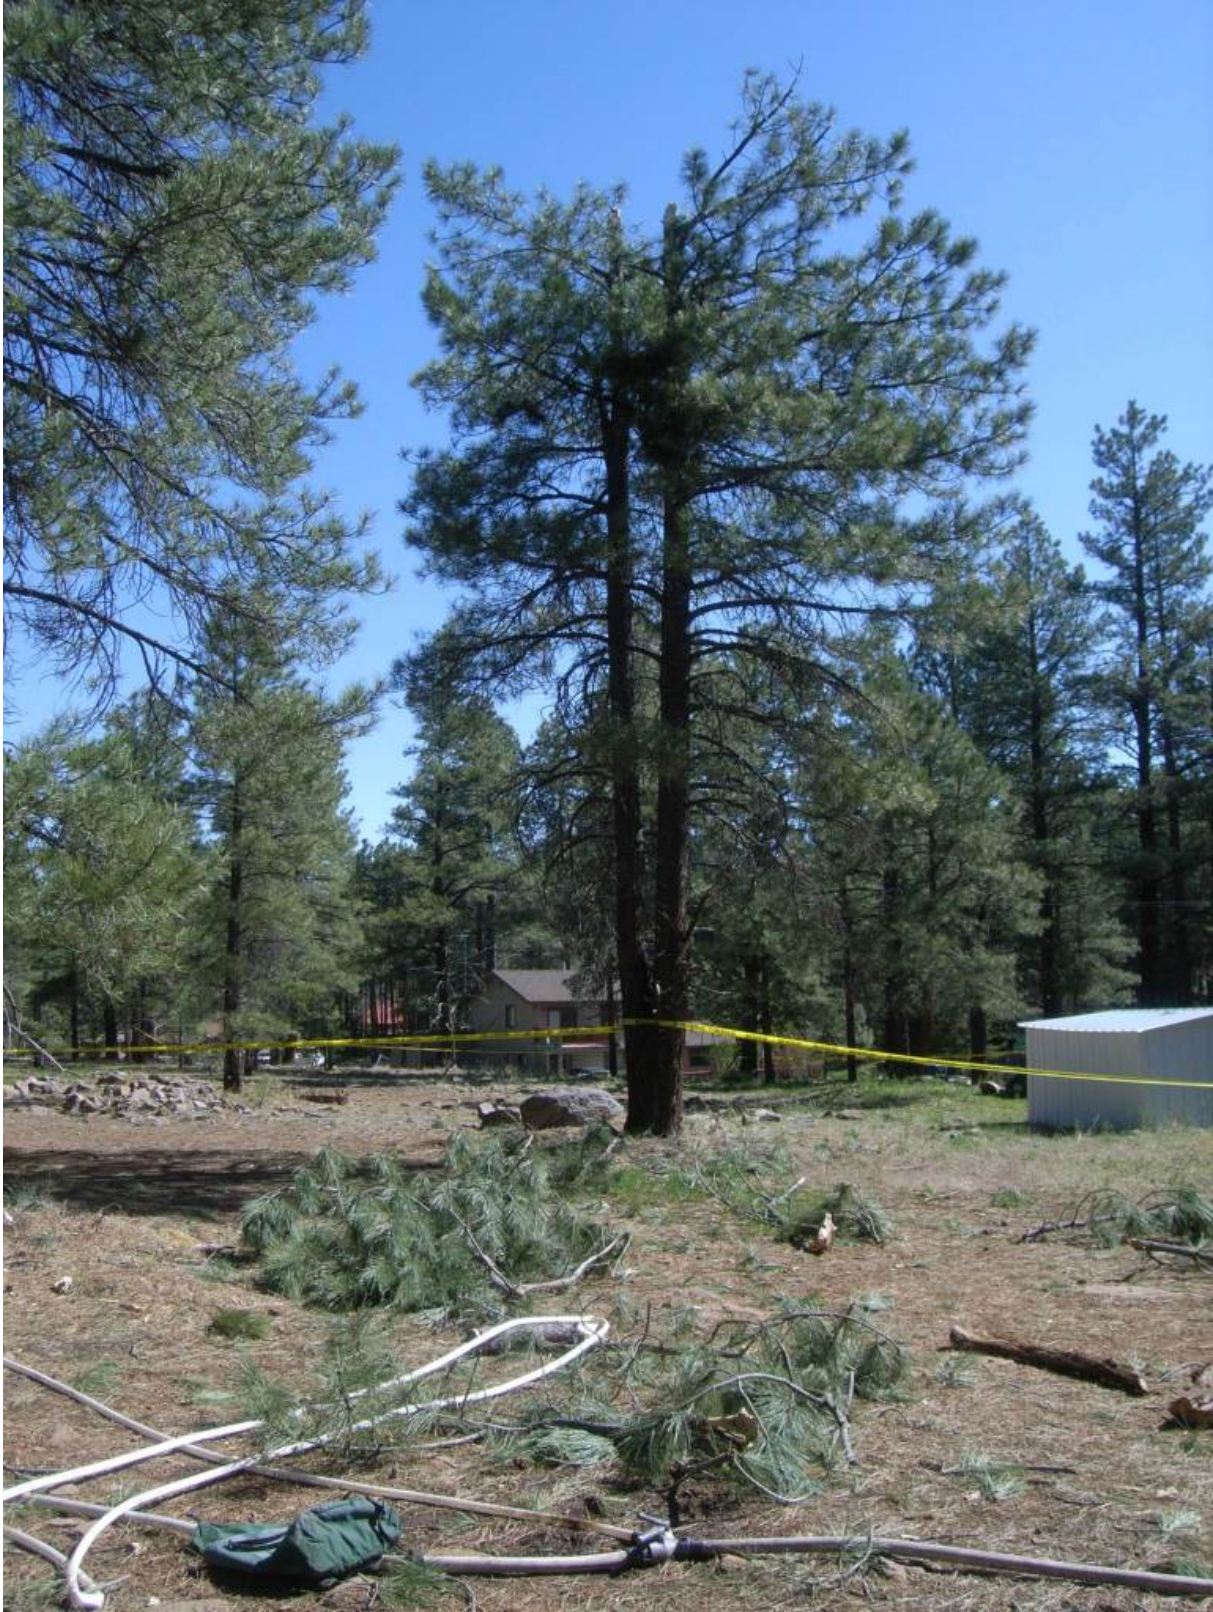
Figure 3 - Tree Strikes (View north)

- Longitude: 111° 40' 06.7" W
- The third tree strike occurred at cluster of trees, which were fractured and uprooted
 - The trunks had fractured about 15 feet agl; the lower trunks fell in the direction of the wreckage path, while the upper portions trunks 'folded' back in the opposite direction of the wreckage path

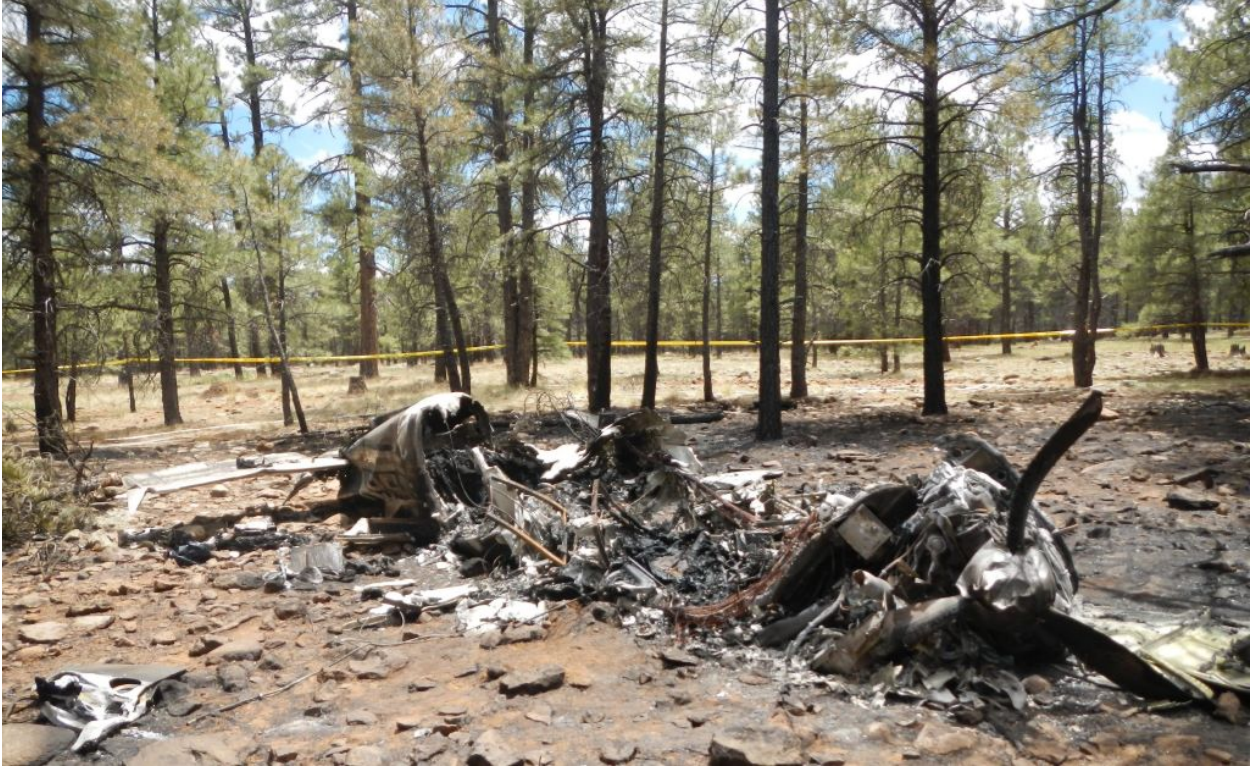
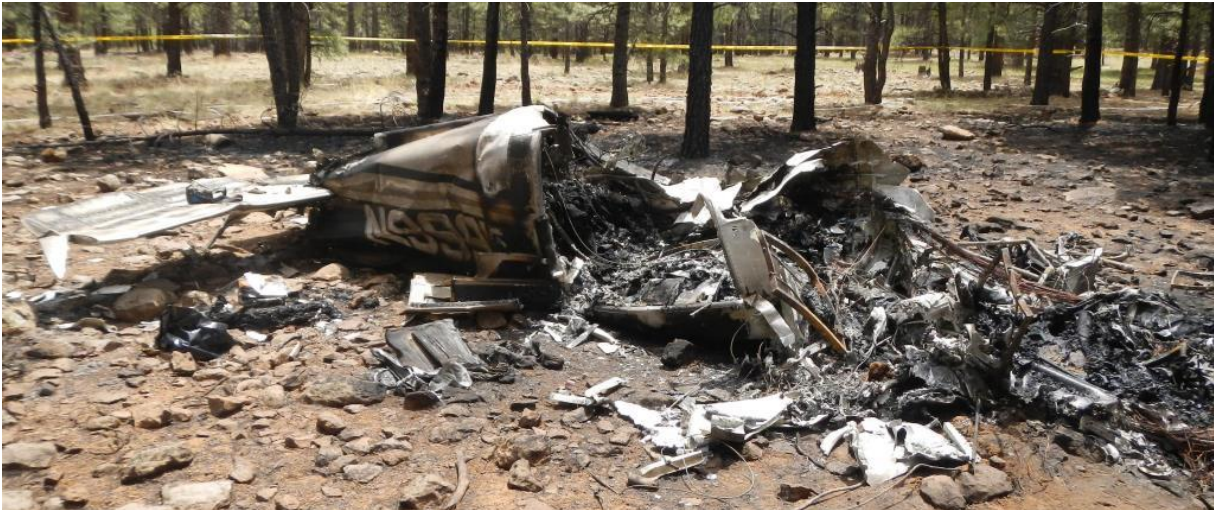
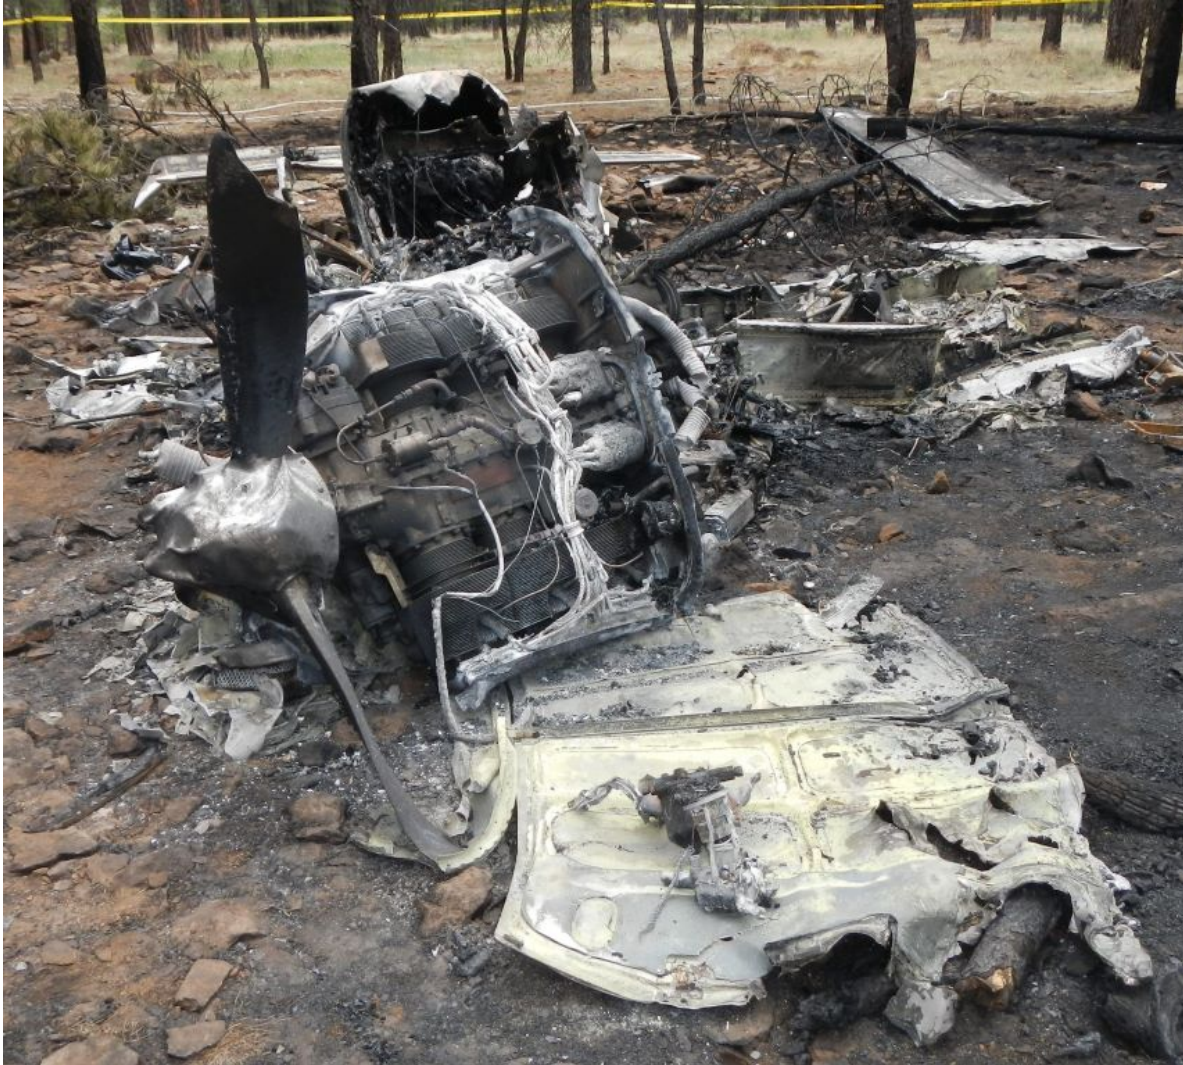
- Consisted of the fuselage from the propeller to the empennage
 - Significantly fire damaged or consumed
 - Oriented upright
 - Longitudinal axis oriented on a magnetic heading of approximately 310 degrees

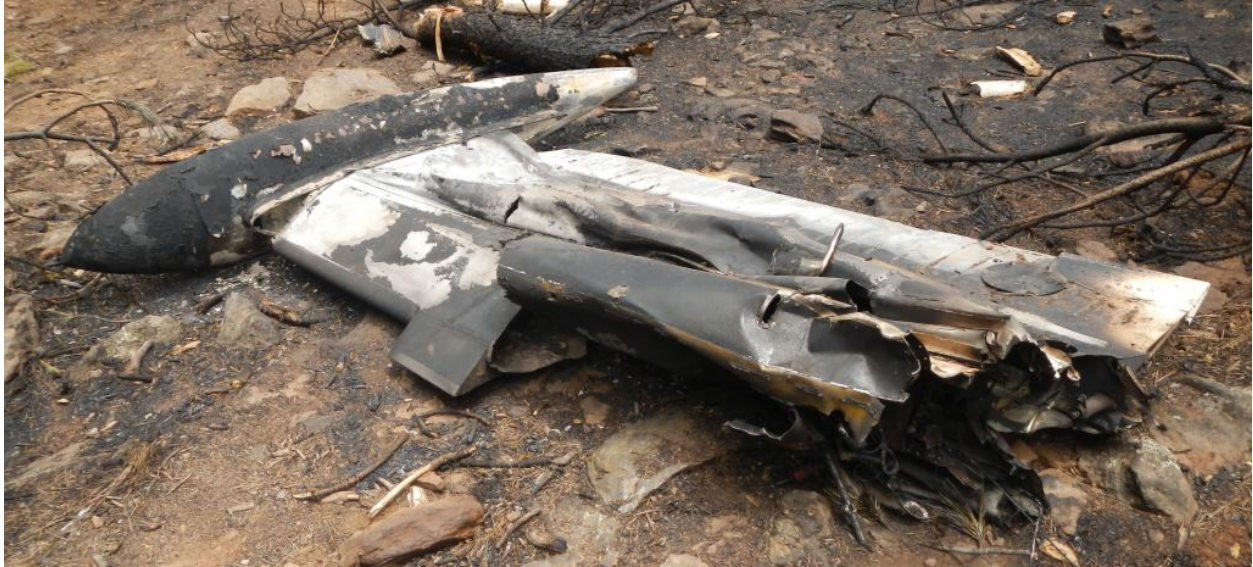
Figure 7 - Left Wingtip and Tank (inverted)

Approximately 91 inches of the outboard end of the left wing, including the left aileron, separated from the wing and was resting inverted. This portion of the wing displayed post-impact fire damage. The leading edge of this portion of the wing displayed compression damage just inboard of the leading edge wedge. The stall warning vane mounted on this portion of the wing remained in place, and was free to move. The pitot tube was separated from this portion of the wing, and was found near the separated mounting location. The leading edge wedge remained intact and attached to the leading edge of the wing. The wing tip was equipped with an Osborne (STC modification) fuel tip tank. The tip tank did not contain any fuel and did not display any signatures of hydraulic deformation.

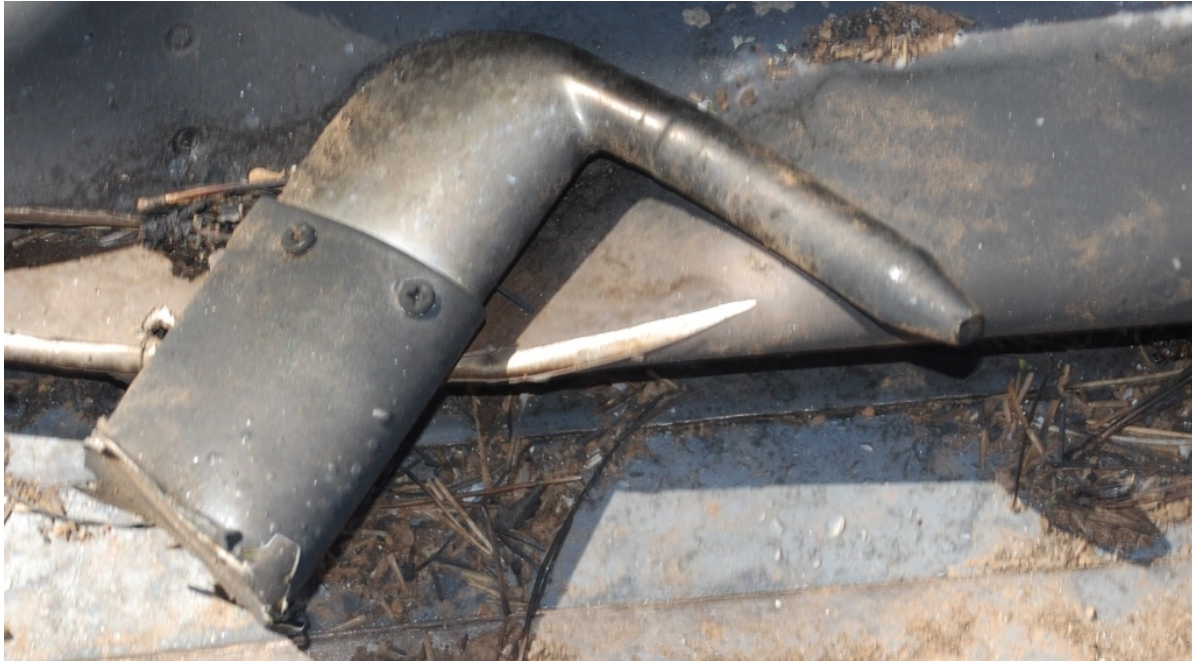
Figure 9 - Pitot Tube

The pitot tube was observed in the wreckage. It did not bear any evidence consistent with it being covered during the impact or fire.

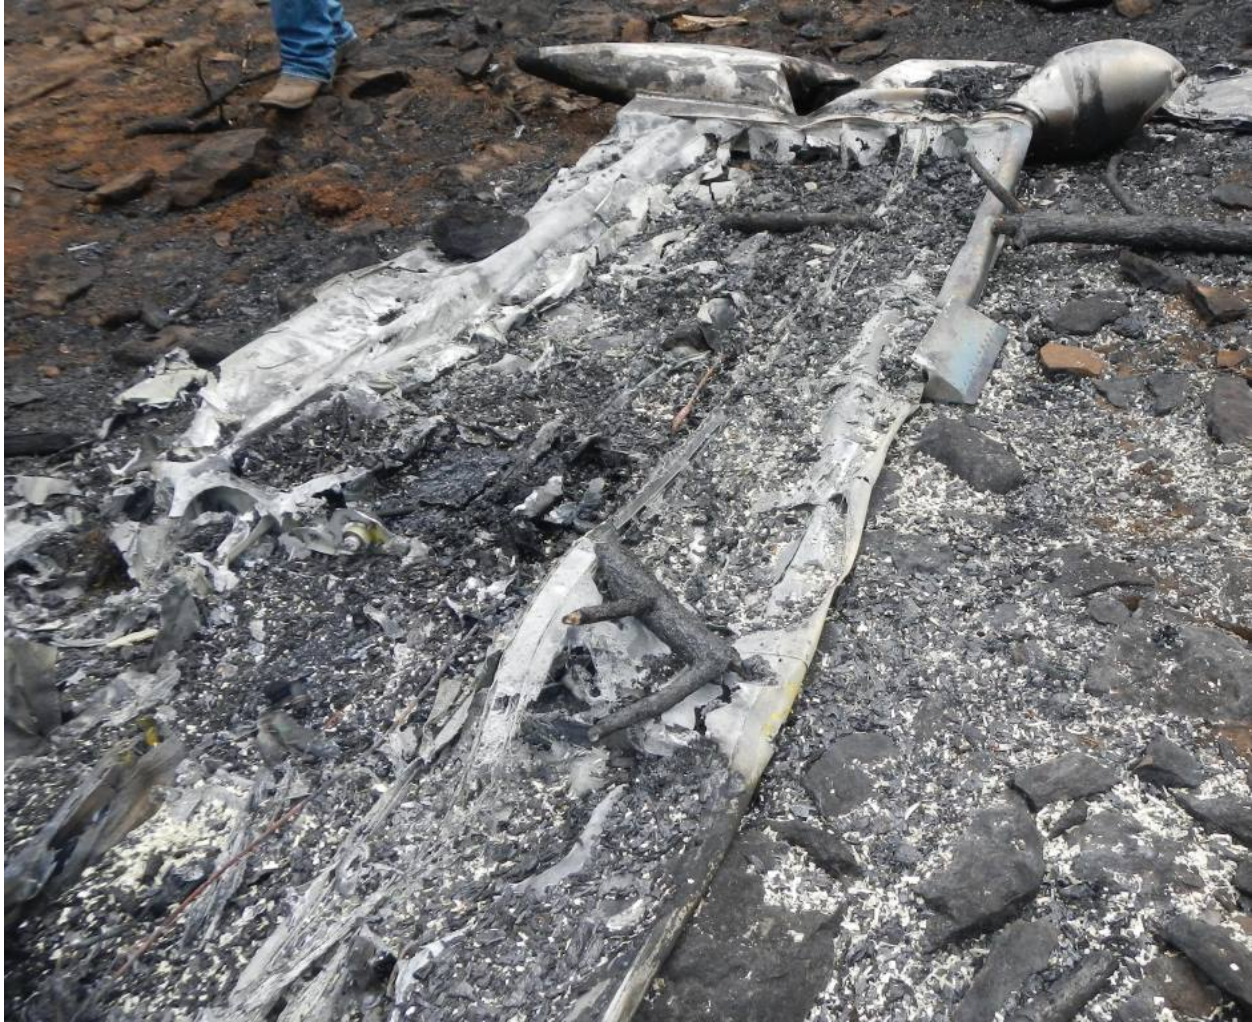
Figure 10 - Right Wing (inverted)

The right wing separated from the airframe just outboard of the front and rear spar / carry-thru spar attachment locations. The right wing was located at N 35 04 58.0 and W 111 40 07.4 along the wreckage path. The wing came to rest inverted, adjacent to the engine and propeller ground scar. The wing was thermally reduced to remnants of the original structure and skin which appeared in the original configuration of the wing. It was lying beneath 4+ pine trees that were struck by the airplane during the impact sequence. The wing was equipped with an Osborne fuel tip tank. The tank was breached and did not contain any fuel. The tank did contain some liquid that appeared clear and did not emit any odor of fuel. Emergency fire personnel indicated that the entire wreckage site had been drenched with water during their initial response to the accident. The metal tank did not reveal any hydraulic deformation. The fuel tank bladder was completely consumed by post-impact fire.

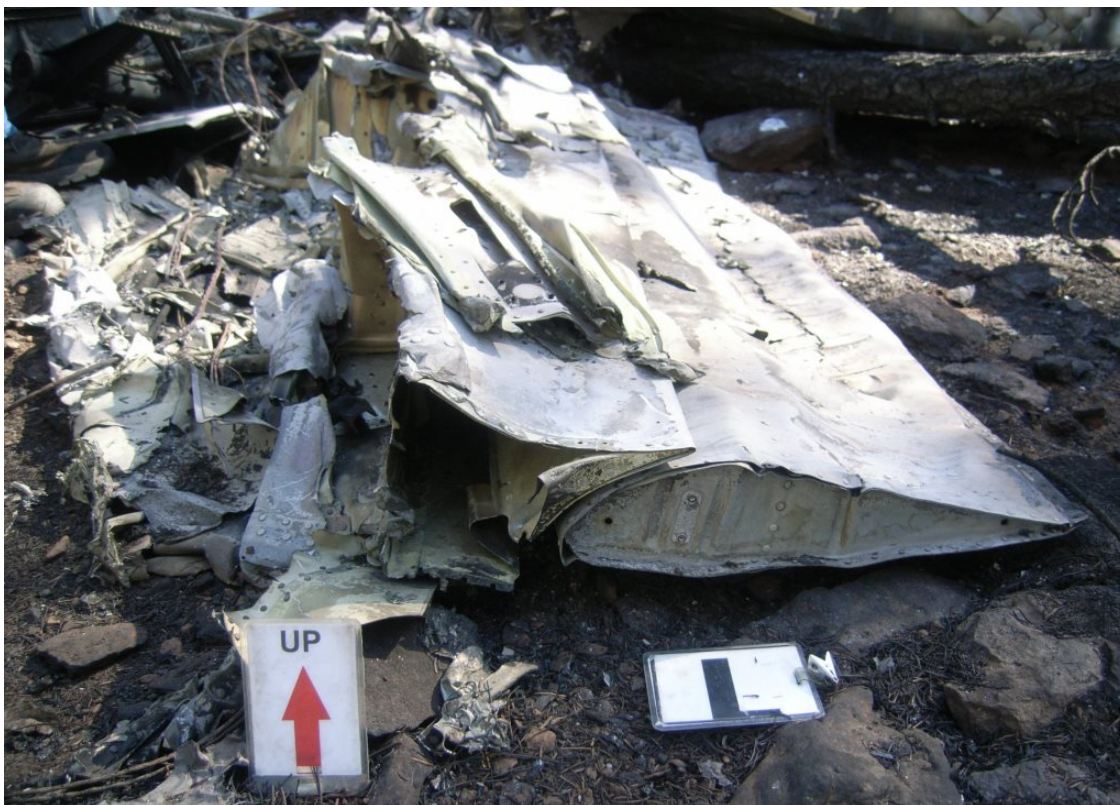
Figure 11 - Flap in Retracted Position

The left flap was post-impact fire damaged and remained in place at the flap tracks. The left flap actuator remained attached to the mounting location. It remained attached to the flap surface and to the flap flex drive cable. The left flap actuator extension measured 1.7 inches. This measurement equated to a flaps retracted position.

The right flap was damaged by post-impact fire and remained attached to the wing at the flap tracks. The right flap actuator was burned away from the flap surface and had separated from the flex drive cable. The right flap actuator extension measured 1.7 inches, which equated to a flaps retracted position.

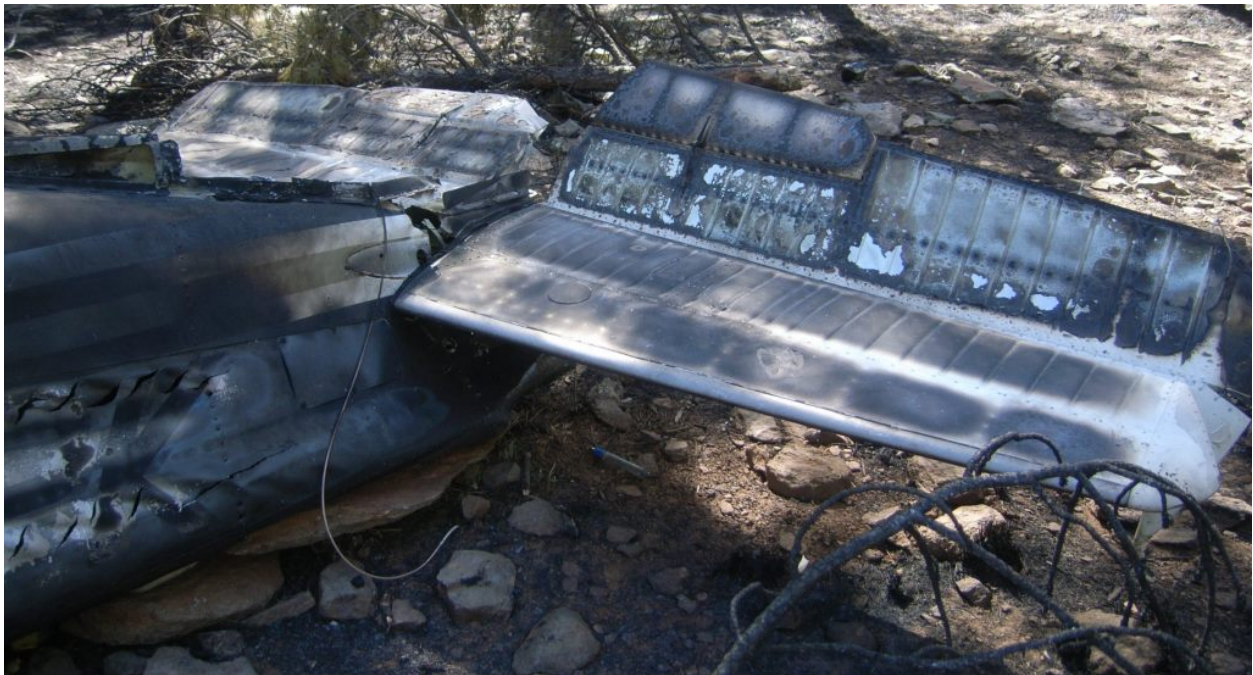
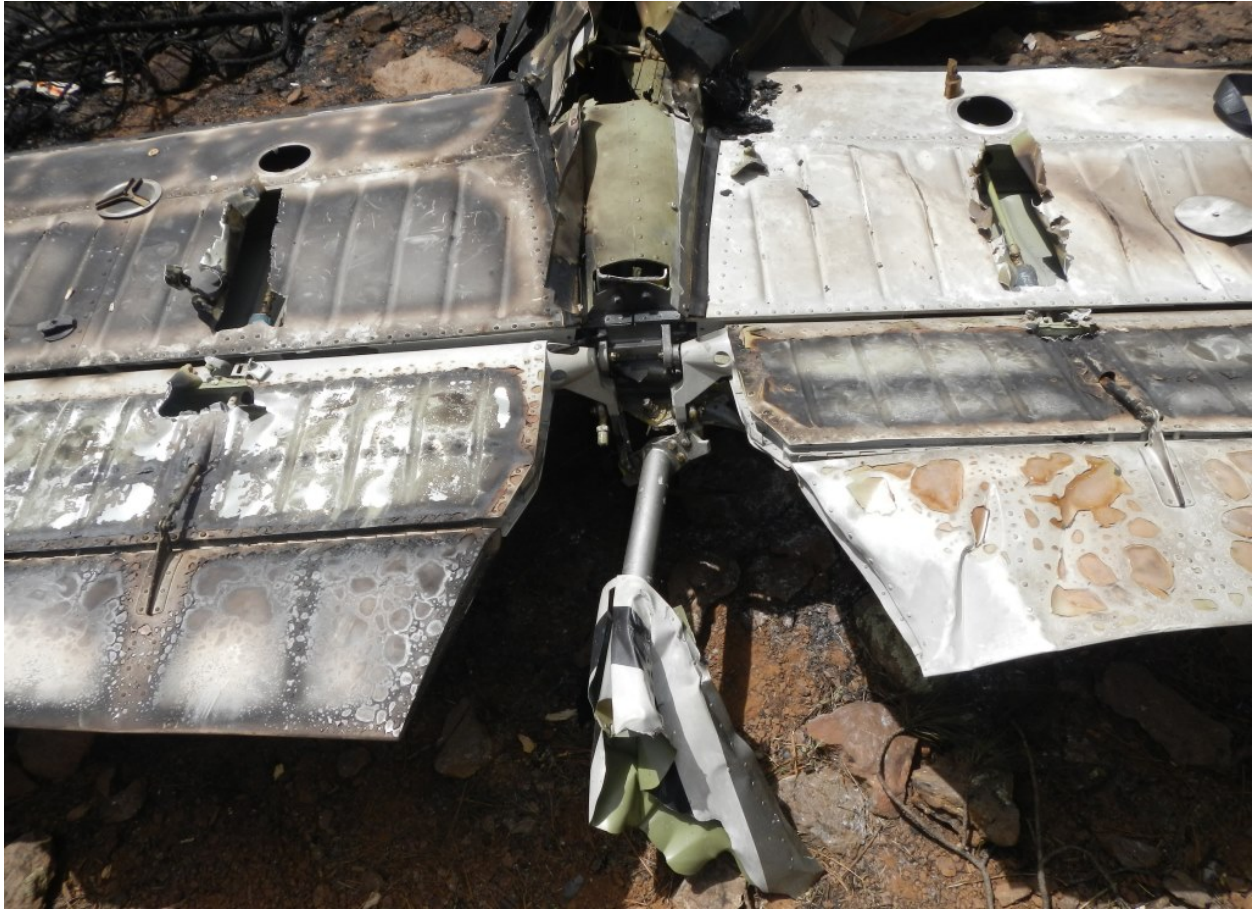
The horizontal stabilizers remained attached to the aft fuselage and displayed post-impact fire exposure. The left and right elevators remained attached to the horizontal stabilizers at the hinges. The left and right elevator trim surfaces remained attached to their respective elevators at their hinges. The left and right elevator pushrods were separated near the elevator control horns. The right elevator control horn displayed impact damage which separated the horn from the bearing. The left and right elevator balance weights remained attached to the elevators. The left elevator balance weight was deformed in an inboard direction, and was in contact with the left horizontal stabilizer.

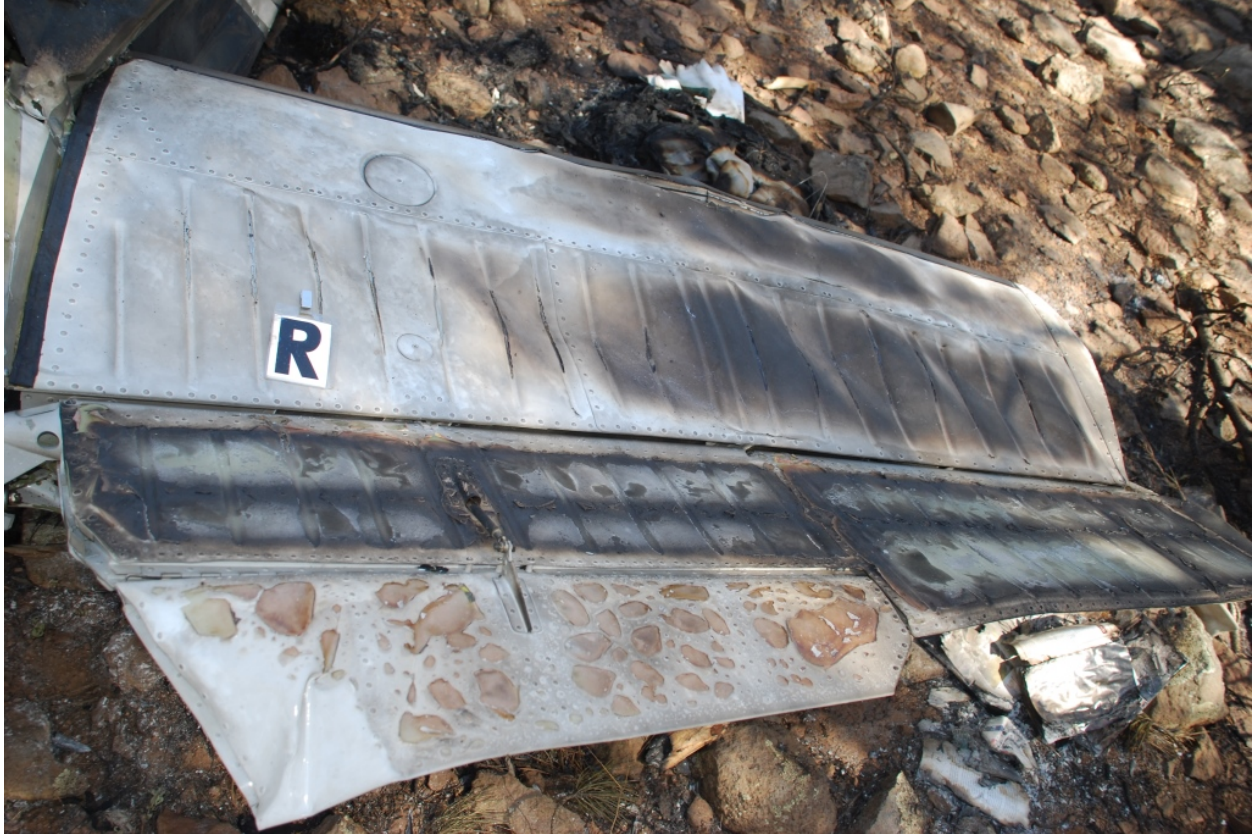
Figure 15 - Right Elevator Tab

The left elevator trim actuator extension (from actuator face to centerline of attach bolt) measured 1.4 inches, which equated to approximately 5 degrees tab trailing edge down. The right elevator trim actuator extension measured 1.5 inches, which equated to approximately 7 degrees tab trailing edge down.

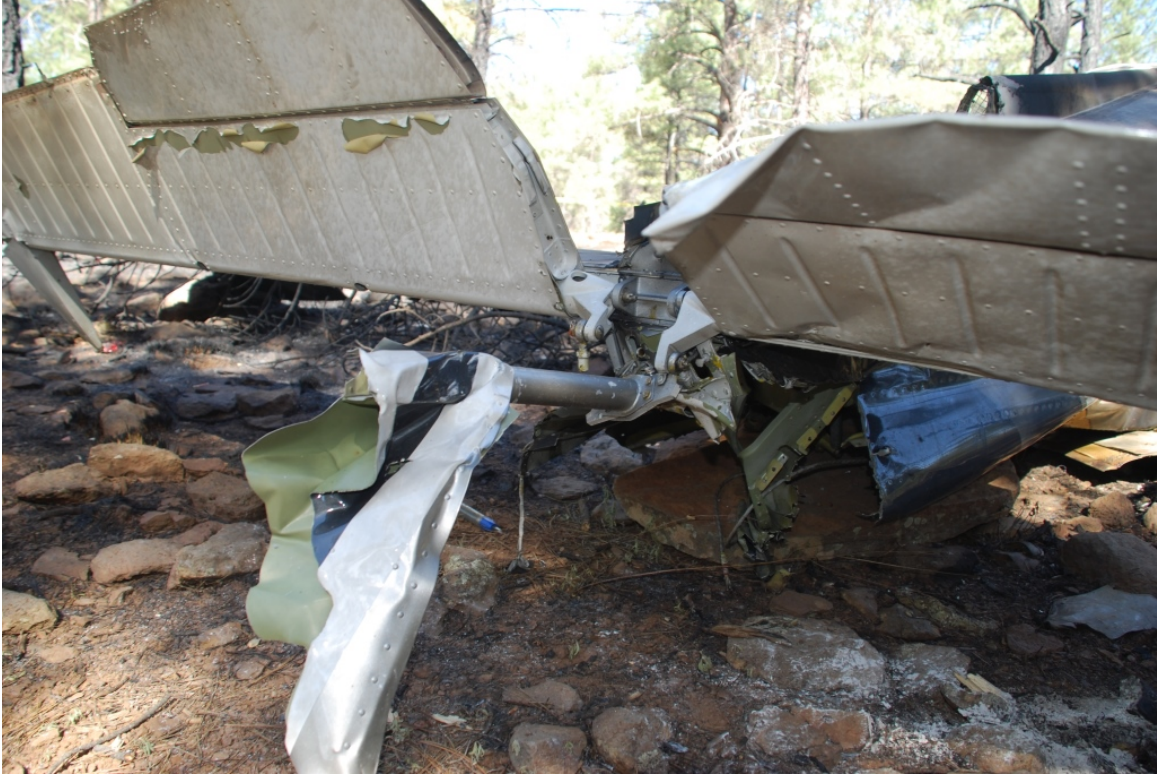
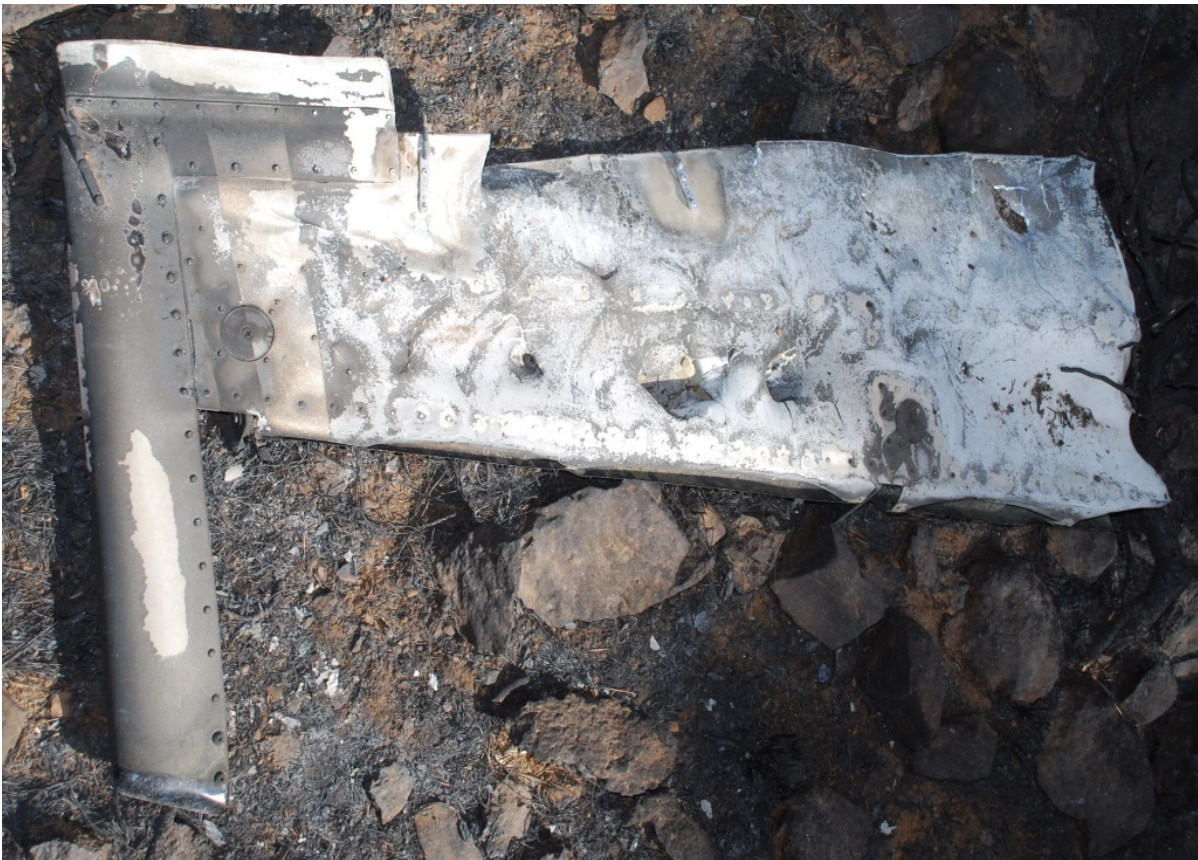
The vertical stabilizer was fracture-separated from the aft fuselage at the roots of the front and rear spars. The surface displayed some leading edge compression damage and had been exposed to post-impact fire. A portion of the rudder torque tube, the rudder bellcrank, and fragments of the rudder remained attached to the aft fuselage by the rudder cables. The remainder of the rudder, including the rudder balance weight, was found resting near the aft fuselage and vertical stabilizer on the left side of the airplane. The rudder was fracture-separated from the vertical stabilizer at the mounting hinges and displayed compression damage.

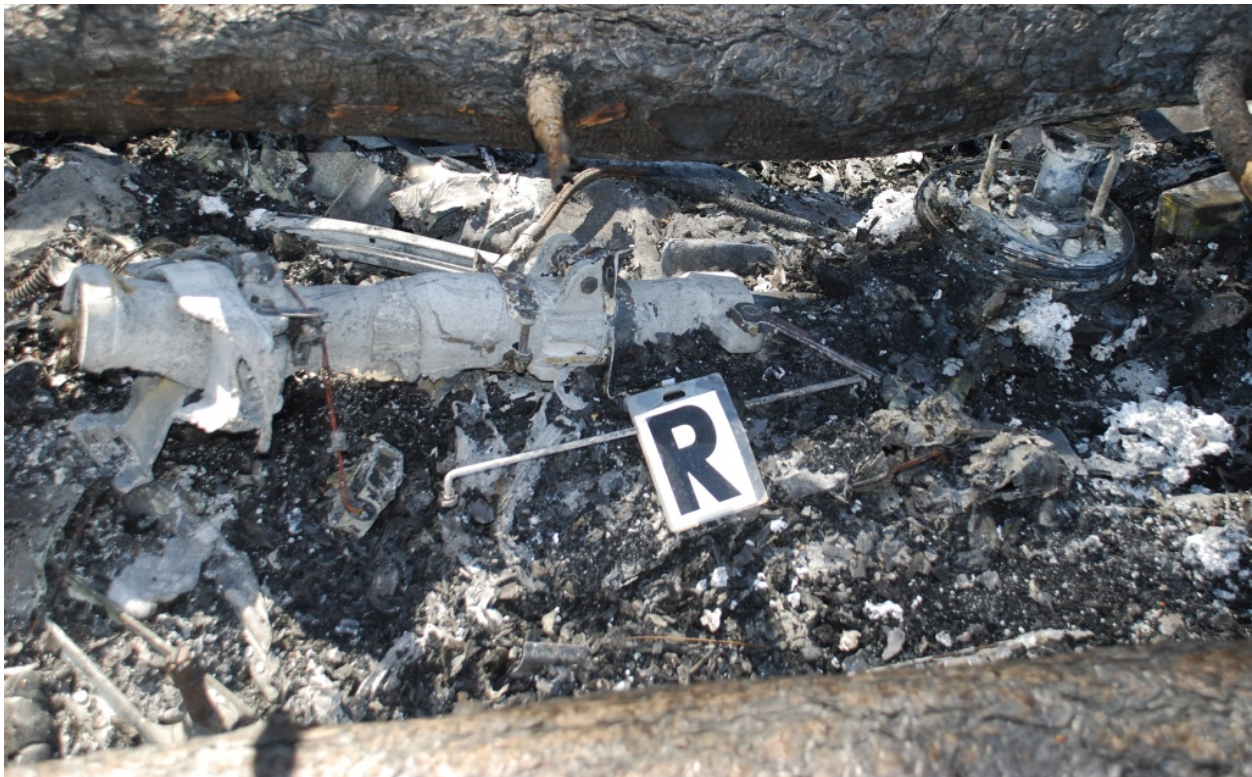
Figure 18 - Right MLG

All three landing gear were exposed to post-impact fire. Both main landing gear assemblies were found in a retracted position. The nose landing gear was deformed, and appeared to be in a near-retracted position. The landing gear actuator housing was burned away. The left main landing gear actuator rod and the nose gear actuator rod were positioned in the retracted position relative to the main actuator drive gear, which was exposed due to thermal damage. The right actuator rod separated from both the actuator and the right main landing gear, and was located near the separated right wing. The right tire was partially consumed by post-impact fire.

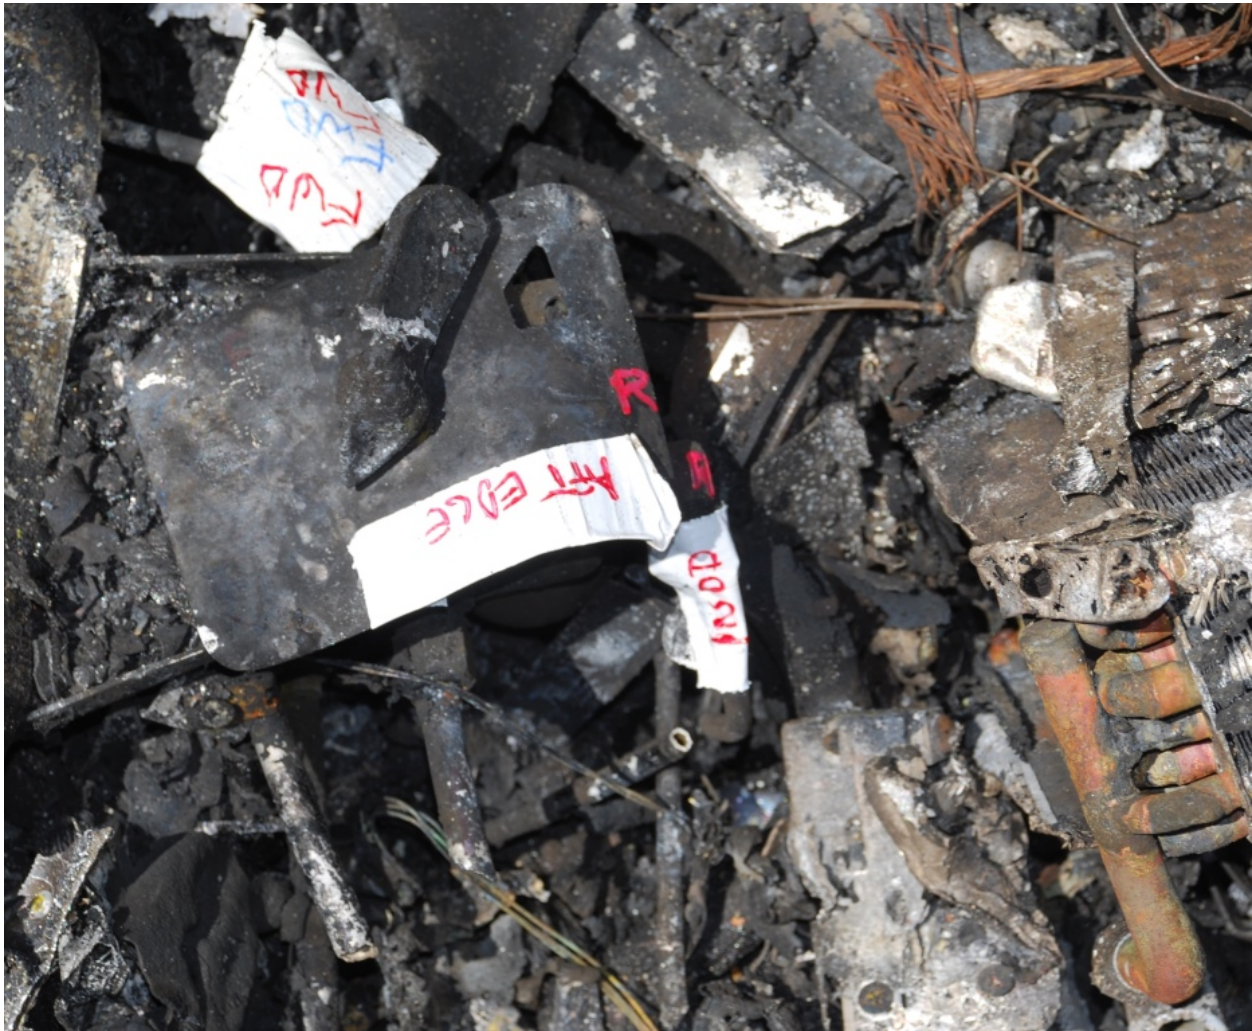
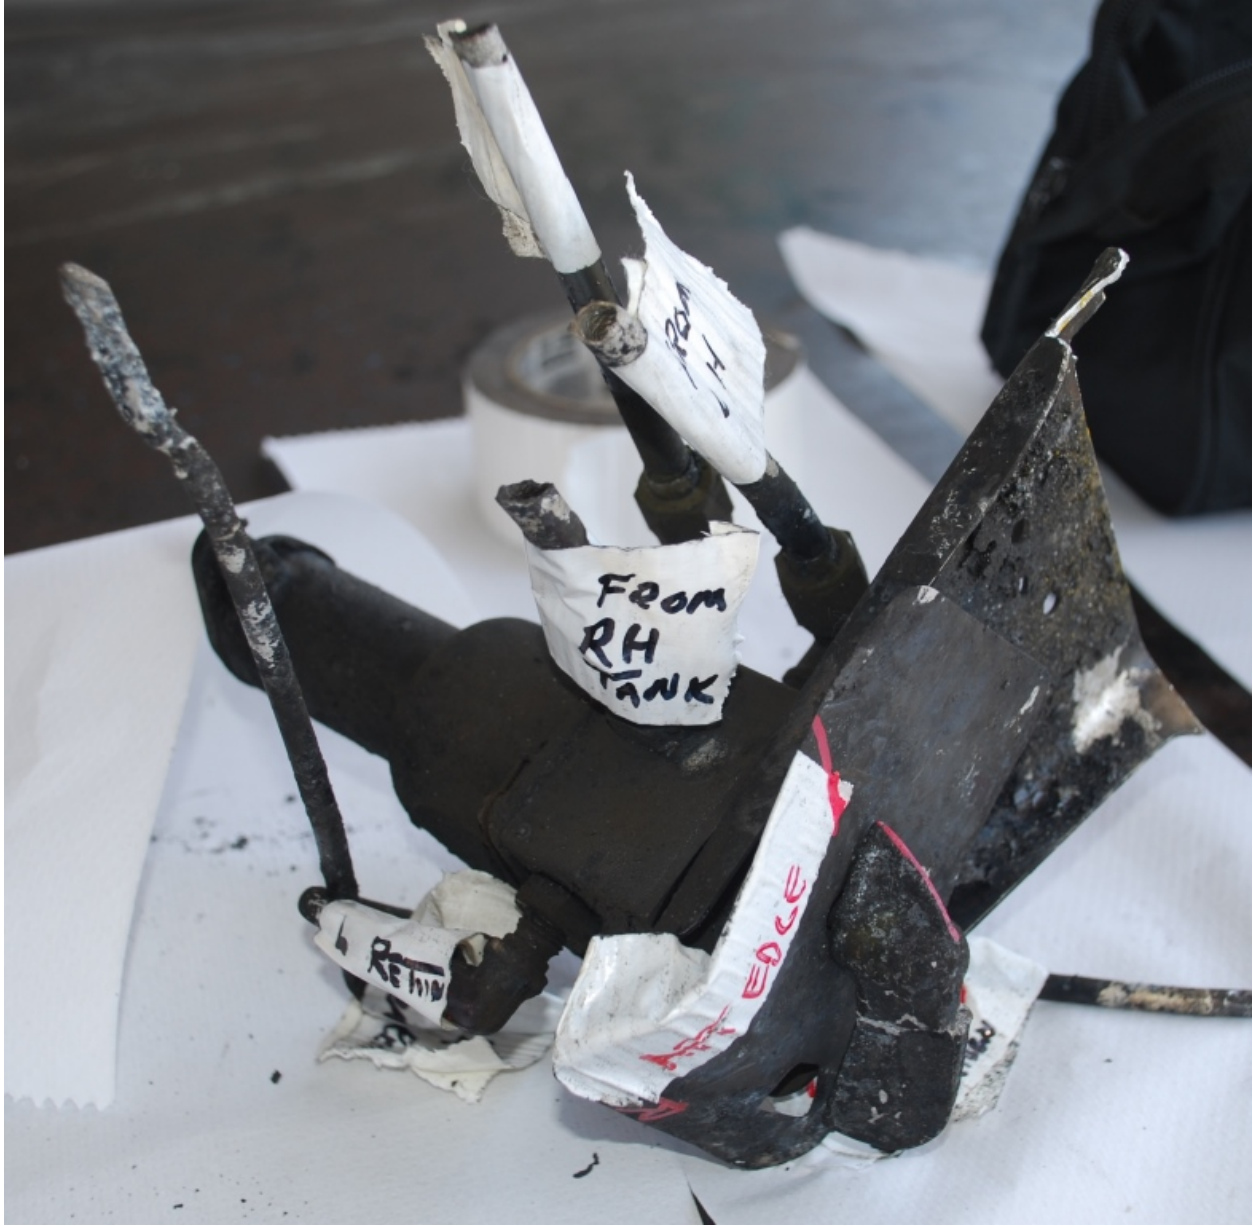
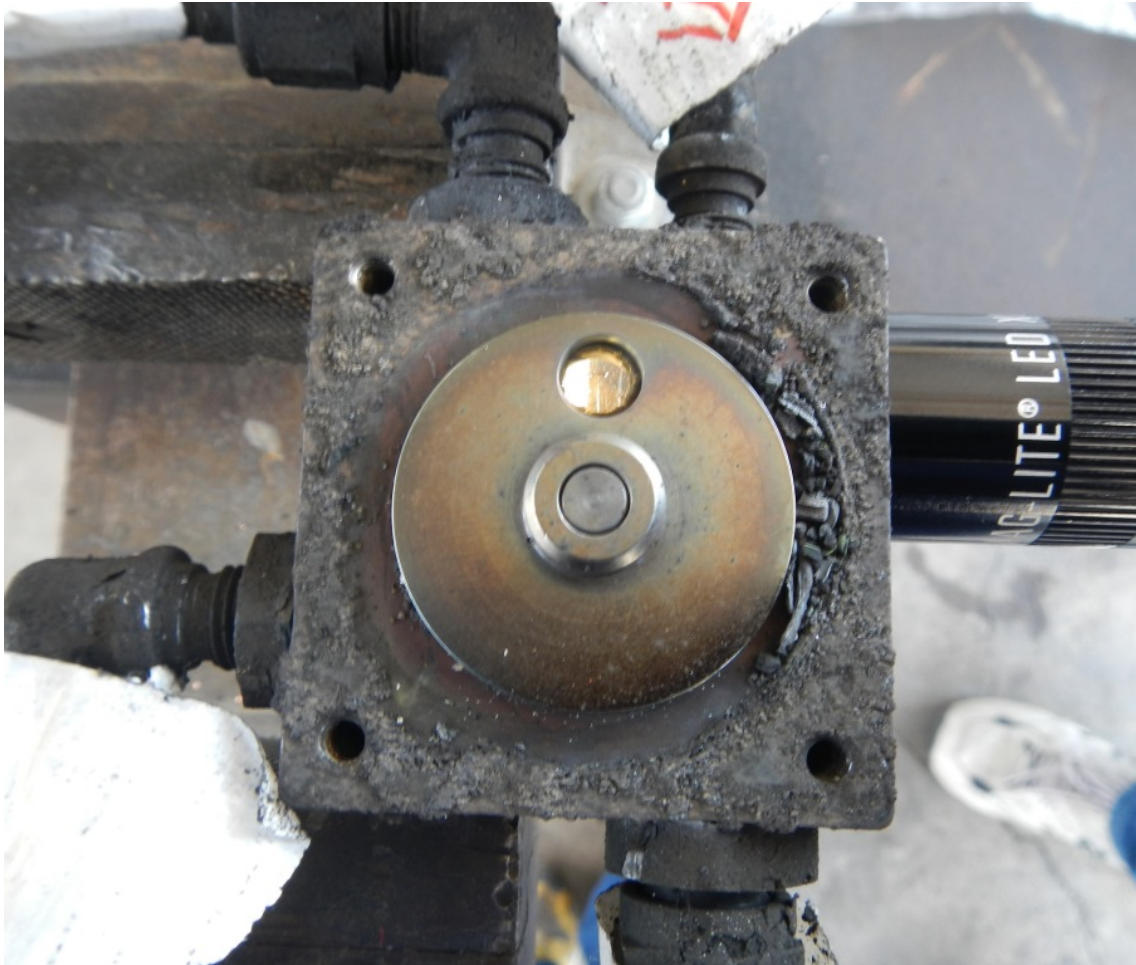
The fuel selector valve remained attached to the left front cockpit mounting location. The valve was exposed to post-impact fire. The selector valve placard was burned away. The selector valve handle was found pointing toward the left main tank selected position, and was within its corresponding detent. The valve and attached fuel strainer were photographed and labeled prior to removal from the wreckage at the impact site. All safety wires were found in place prior to

Examination of the fuel selector valve revealed that the valve was selected to the left main tank. The port from the left main fuel tank was open to the port leading to the engine. Air blown through the valve passed from the left fuel tank port to the engine port freely. Further disassembly revealed no obstruction in the valve and no ability to flow air from the right fuel tank port to the engine feed port. The selector valve design is such that when the selector handle is in a detent (which was the as-found condition), the valve is completely aligned with the ports, enabling unrestricted fuel flow.
