NATIONAL TRANSPORTATION SAFETY BOARD

ON SCENE and POST RECOVERY INFORMATION

**NTSB Accident: WPR13FA244
Accident Date: May 28, 2013**

Location: Mountainaire, Arizona
Date: May 28, 2013
Aircraft: Beech A36, N999PK, Serial # 3380
NTSB IIC: Michael Huhn

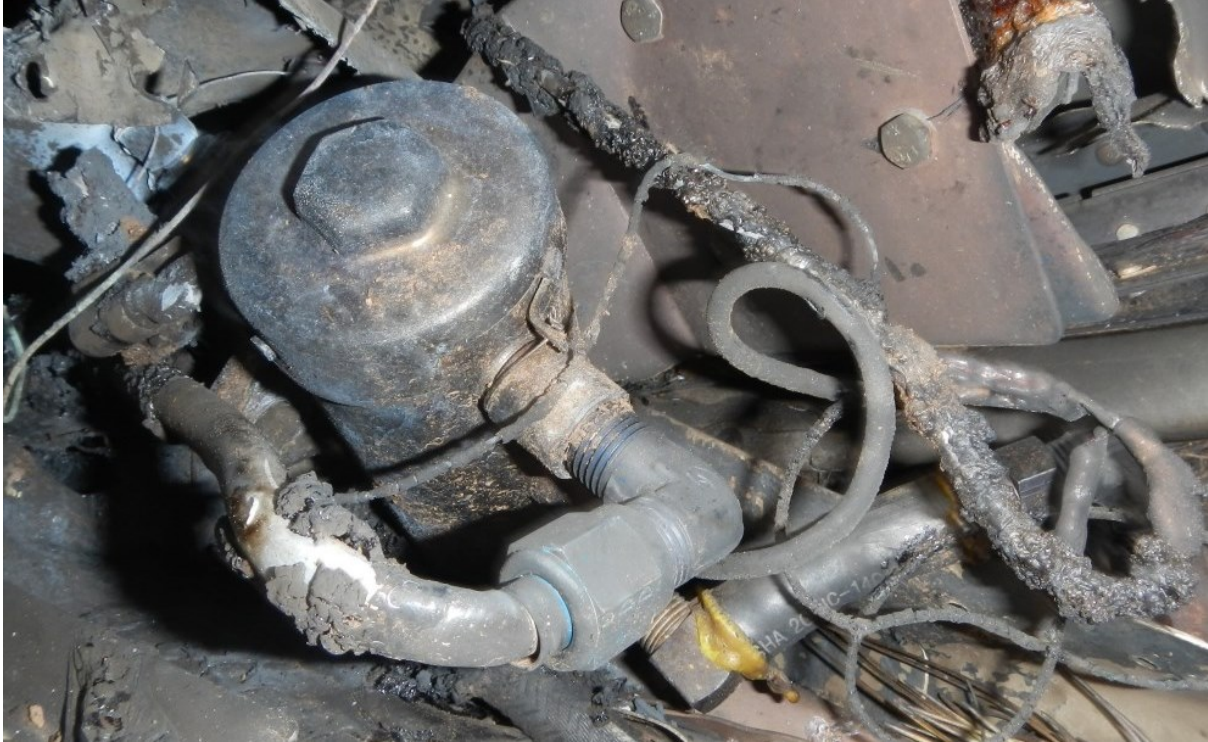
Figure 22 - Left Tip Tank Fuel Pump

One fuel boost pump (of two installed) from the Osborne tip tank installation was recovered intact from the left wing. The right wing pump for the tip tank installation was not recovered.

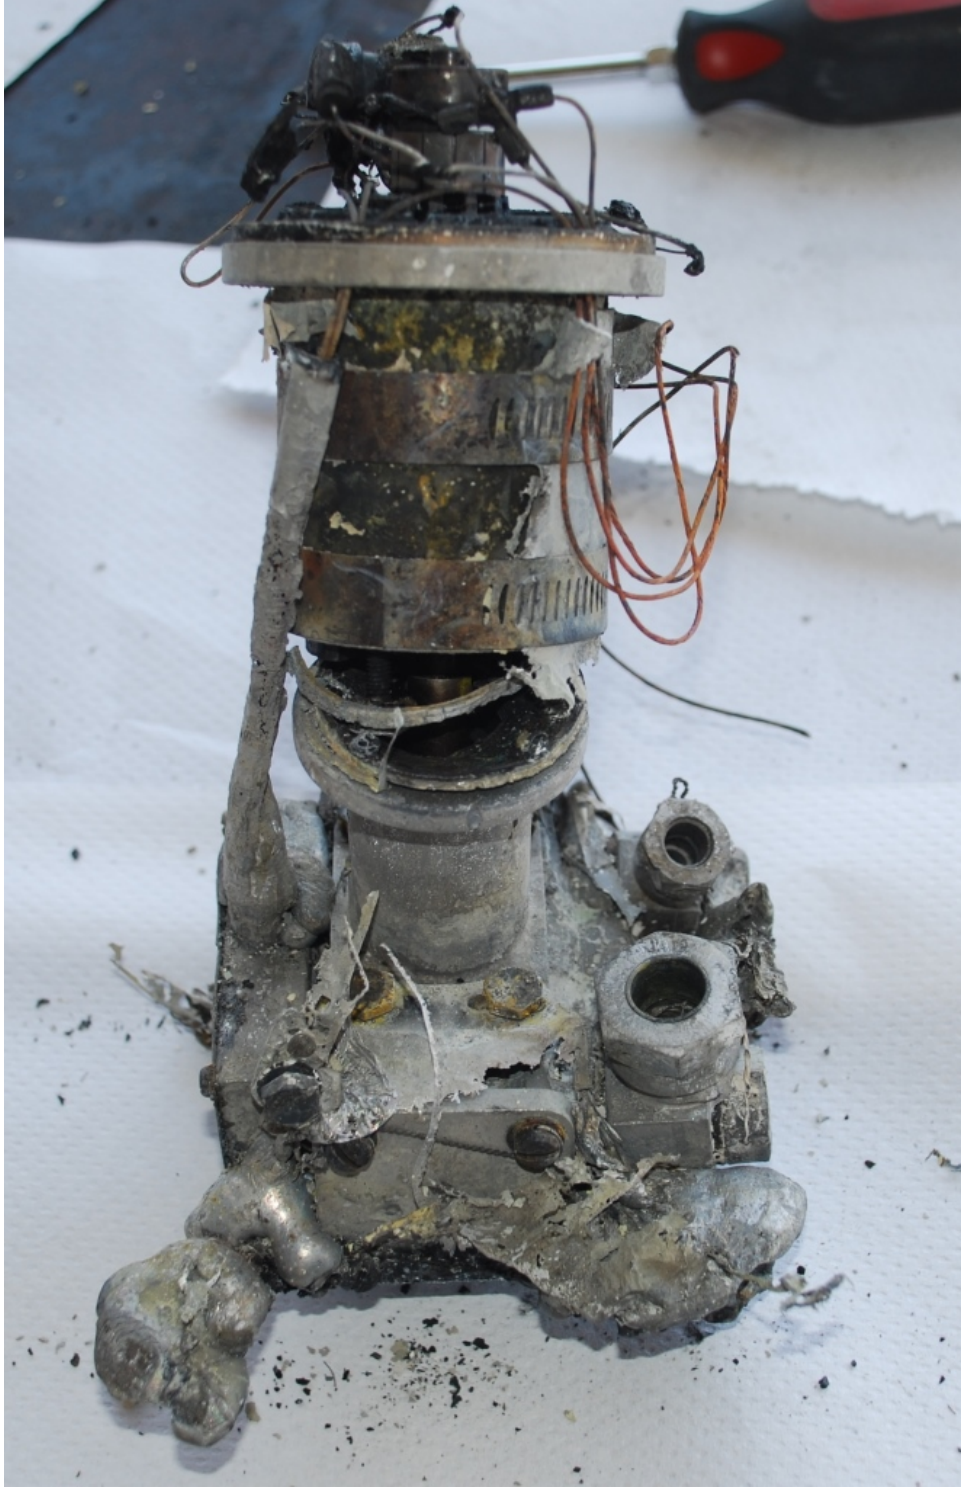
Figure 23 - TKS Pump

The TKS system pump was found in the left wing. Initially it was incorrectly identified as the fuel boost pump during the on-scene and post recovery examinations. The TKS pump was exposed to post-impact fire, was impact damaged and was found near the separated right wing. The electric motor was impact damaged and bent. The drive rod from the motor to the pump remained engaged to the pump rotor, and the blades that sit within the rotor were not visible. The pump housing was partially melted and solidified around the rotor. The rotor could not be rotated by hand. The rotor did not reveal any rotational scoring.

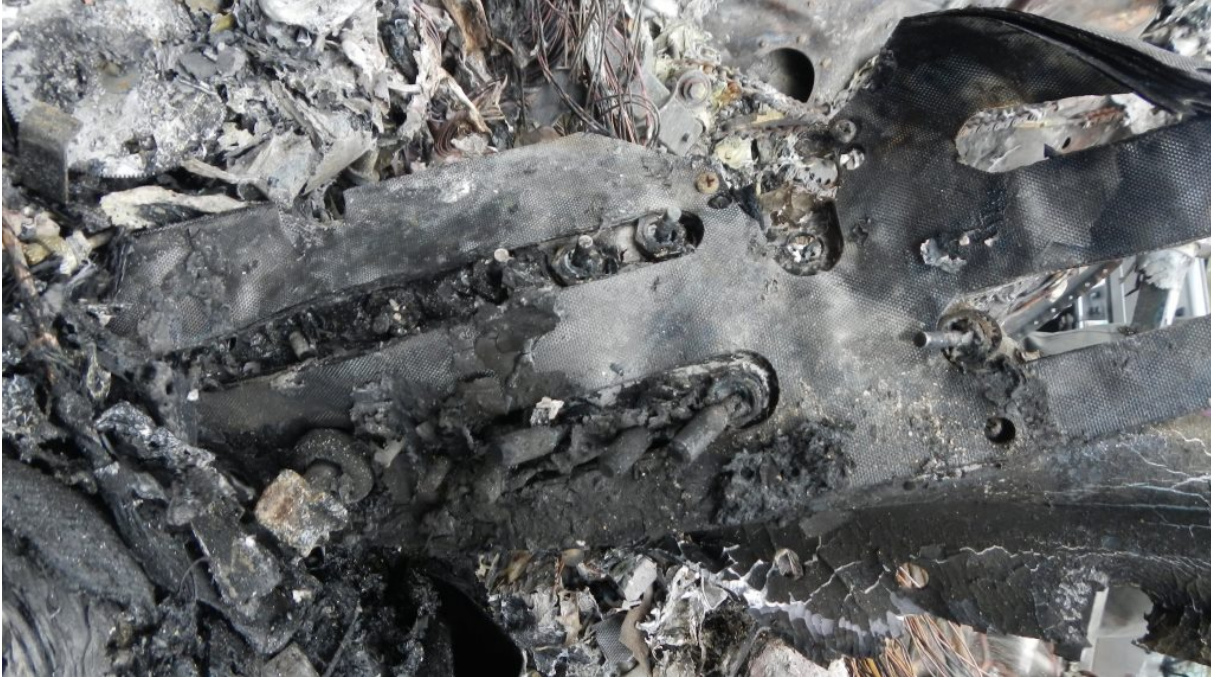
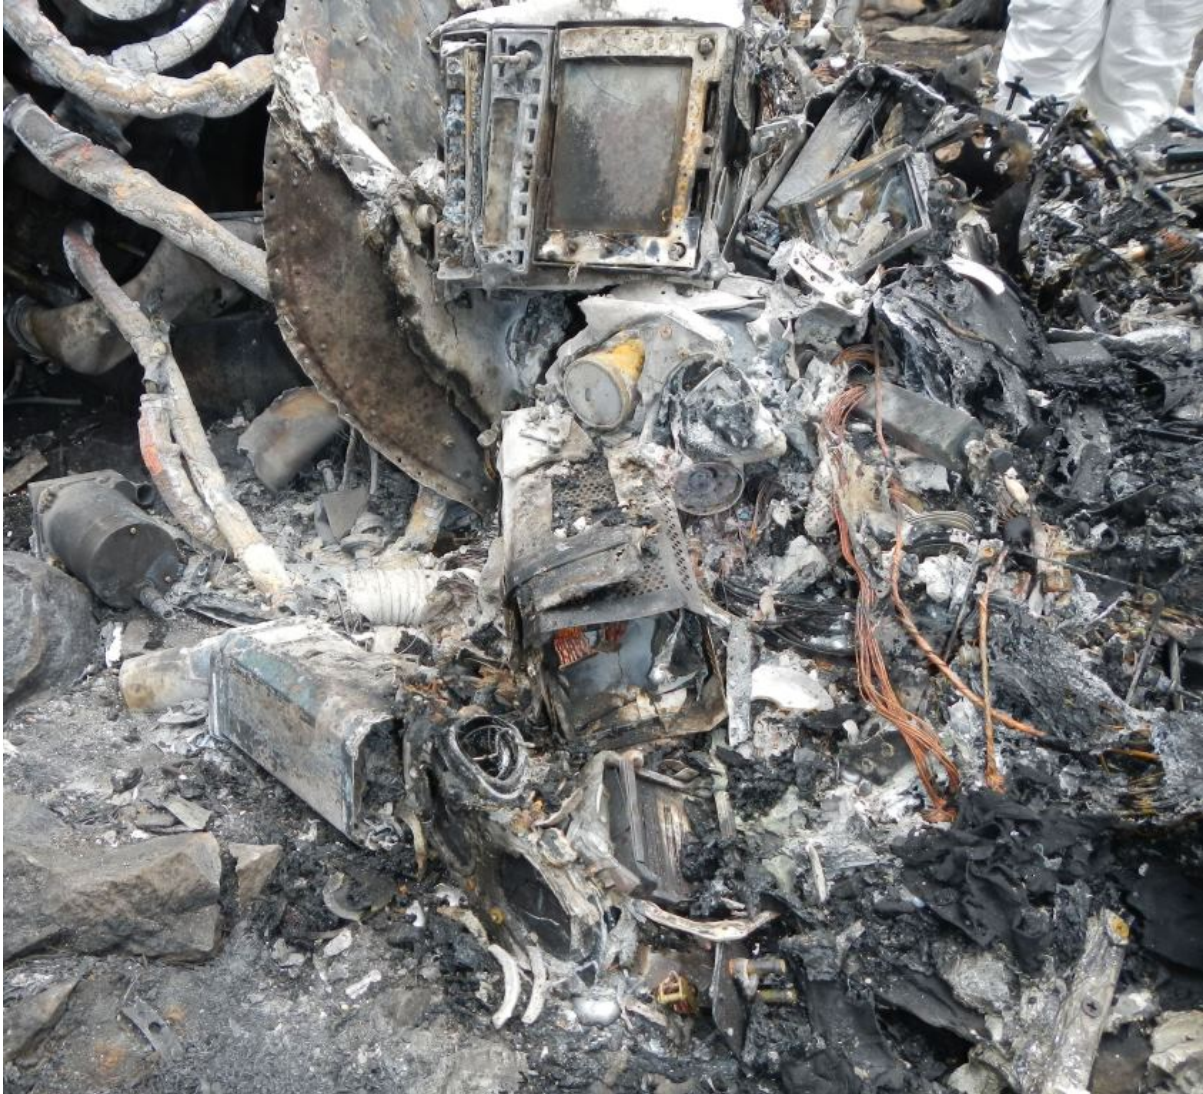
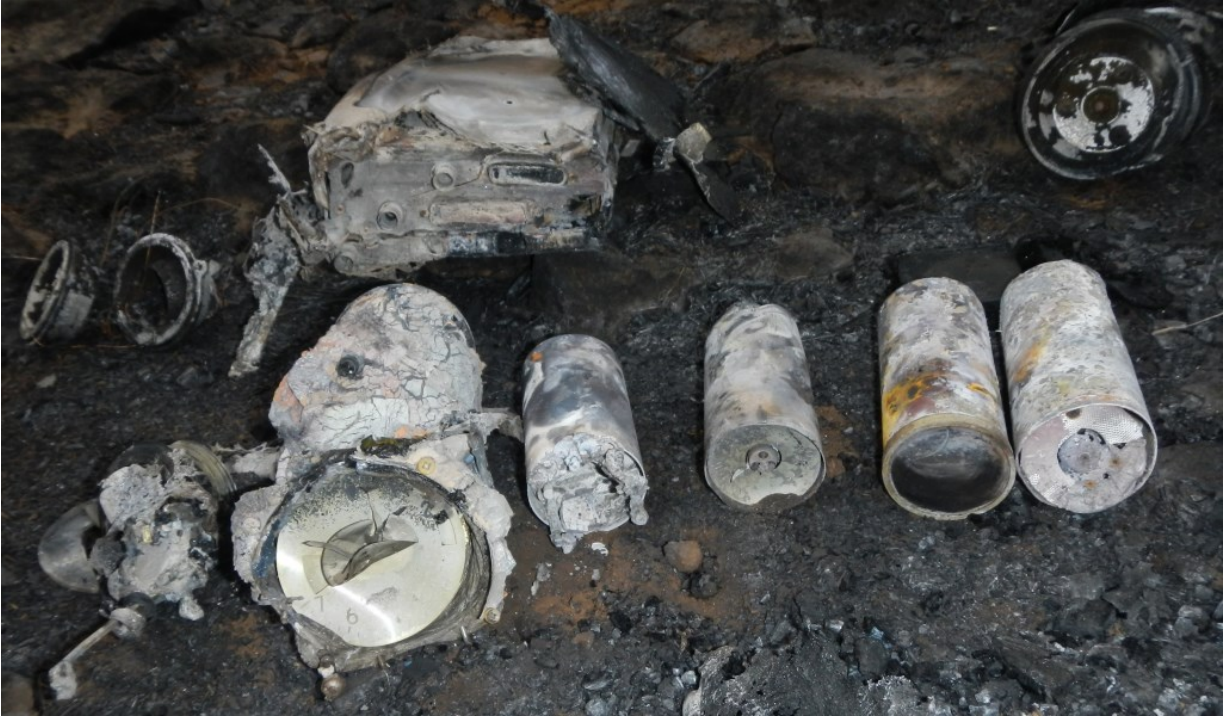
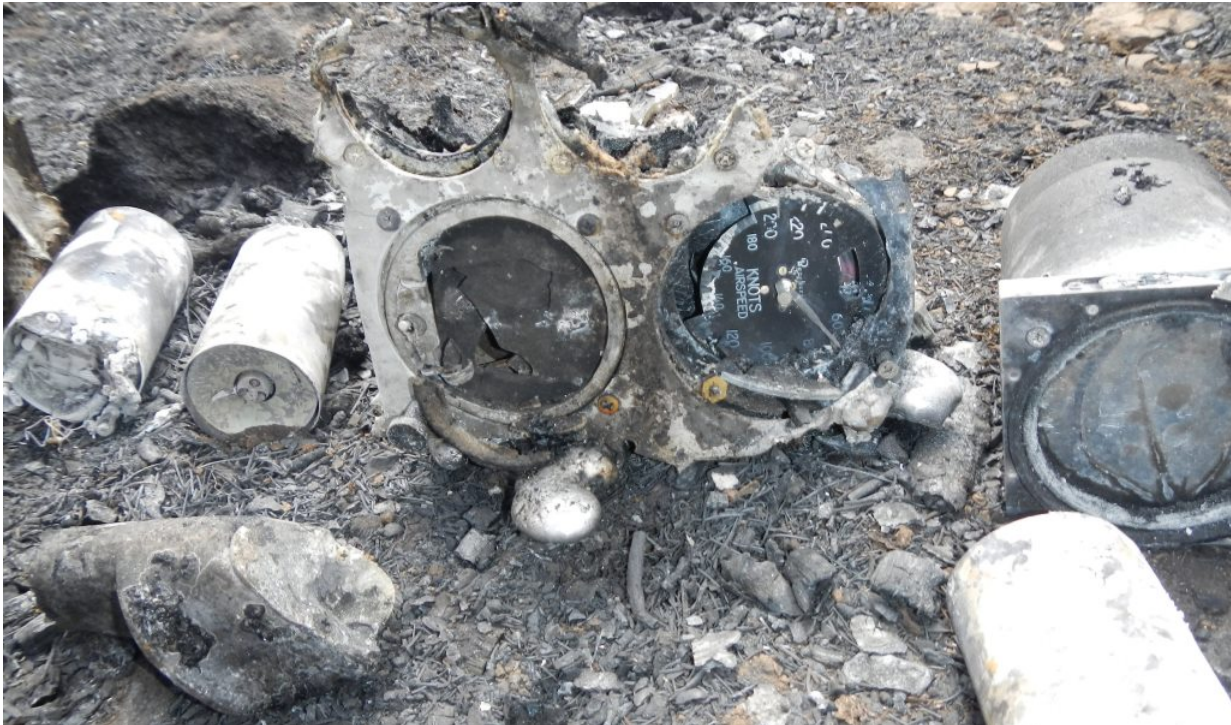
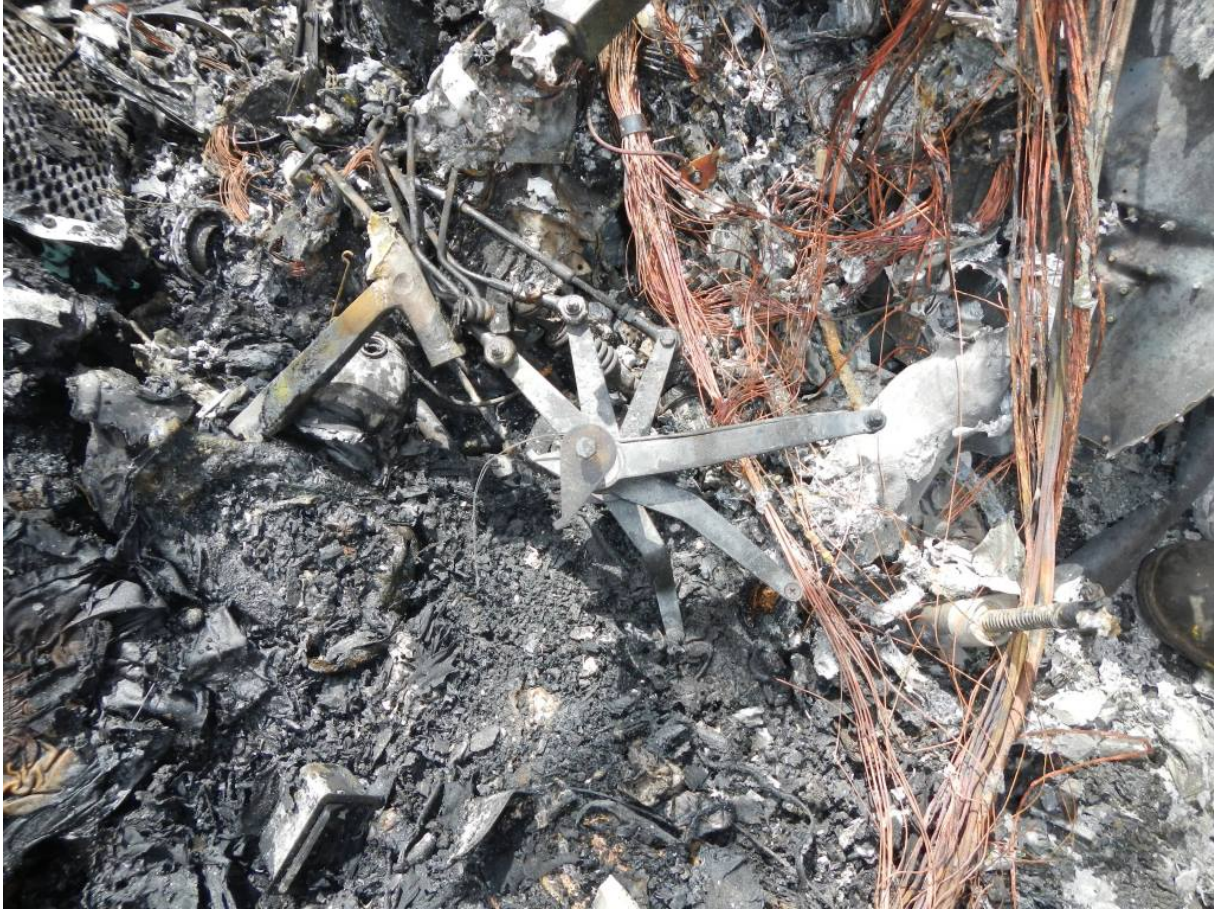
The cockpit/cabin was significantly damaged or consumed by the post-impact fire. No useful information was able to be obtained from the instruments, switches, circuit breakers, or engine controls.

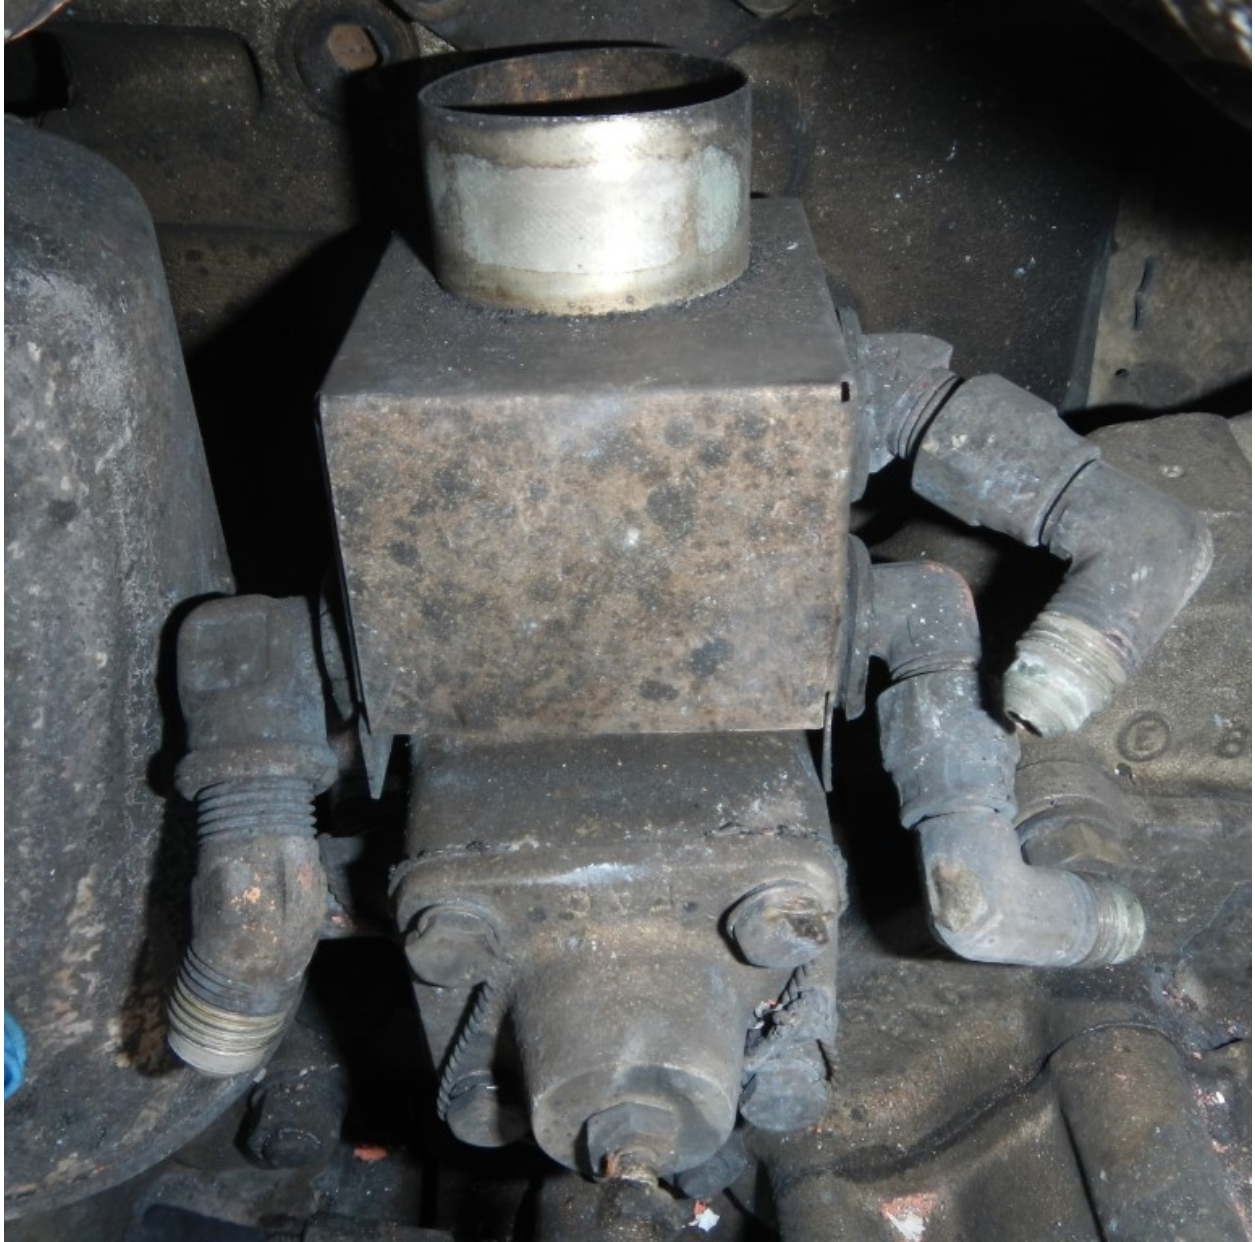
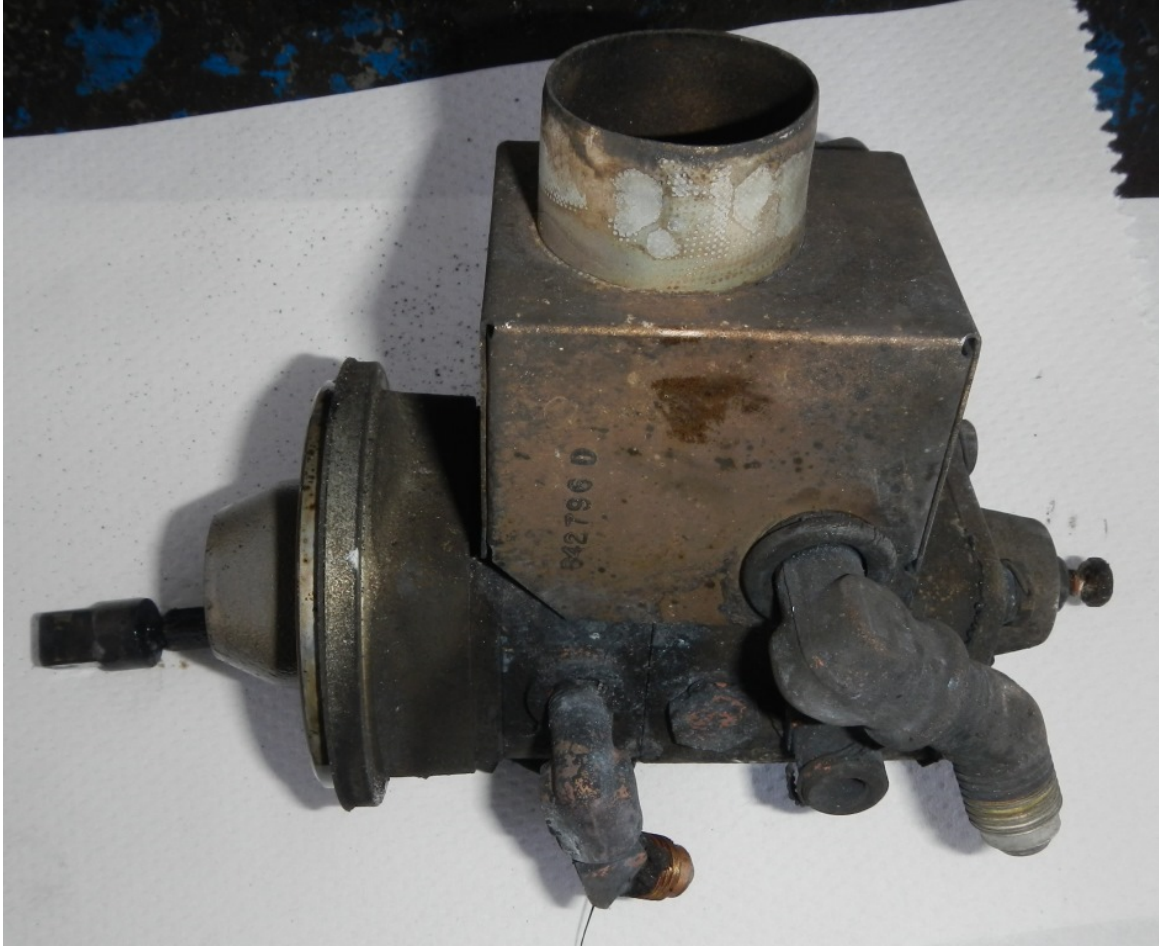
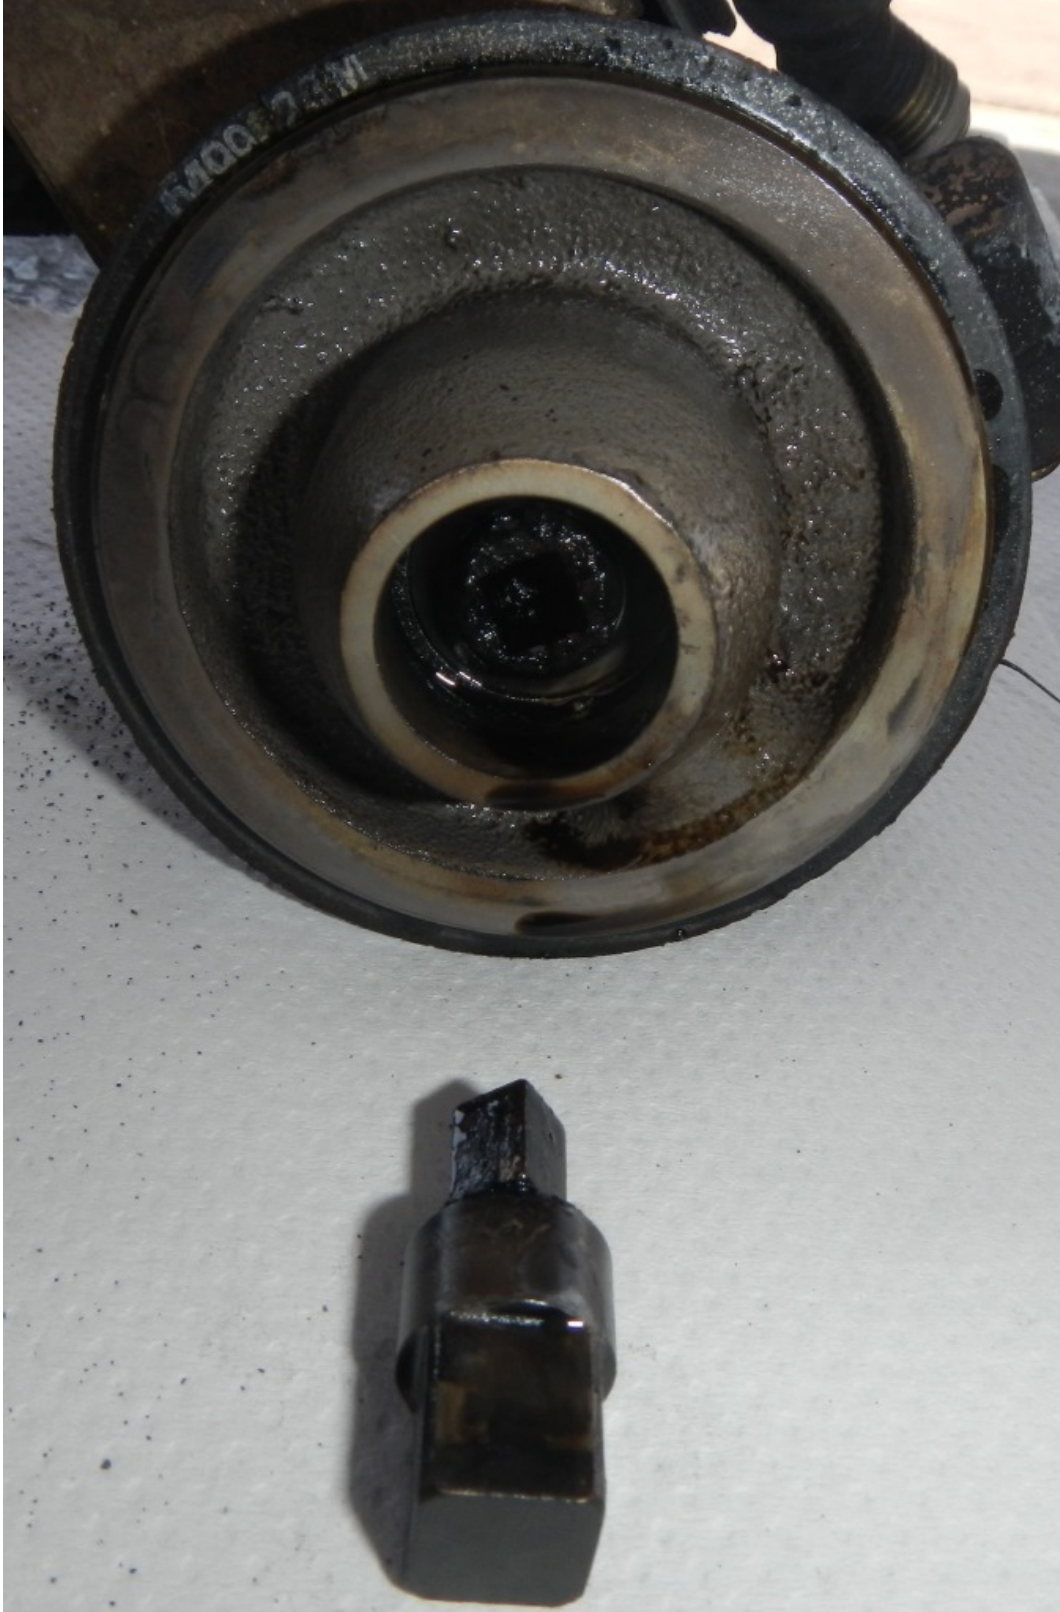
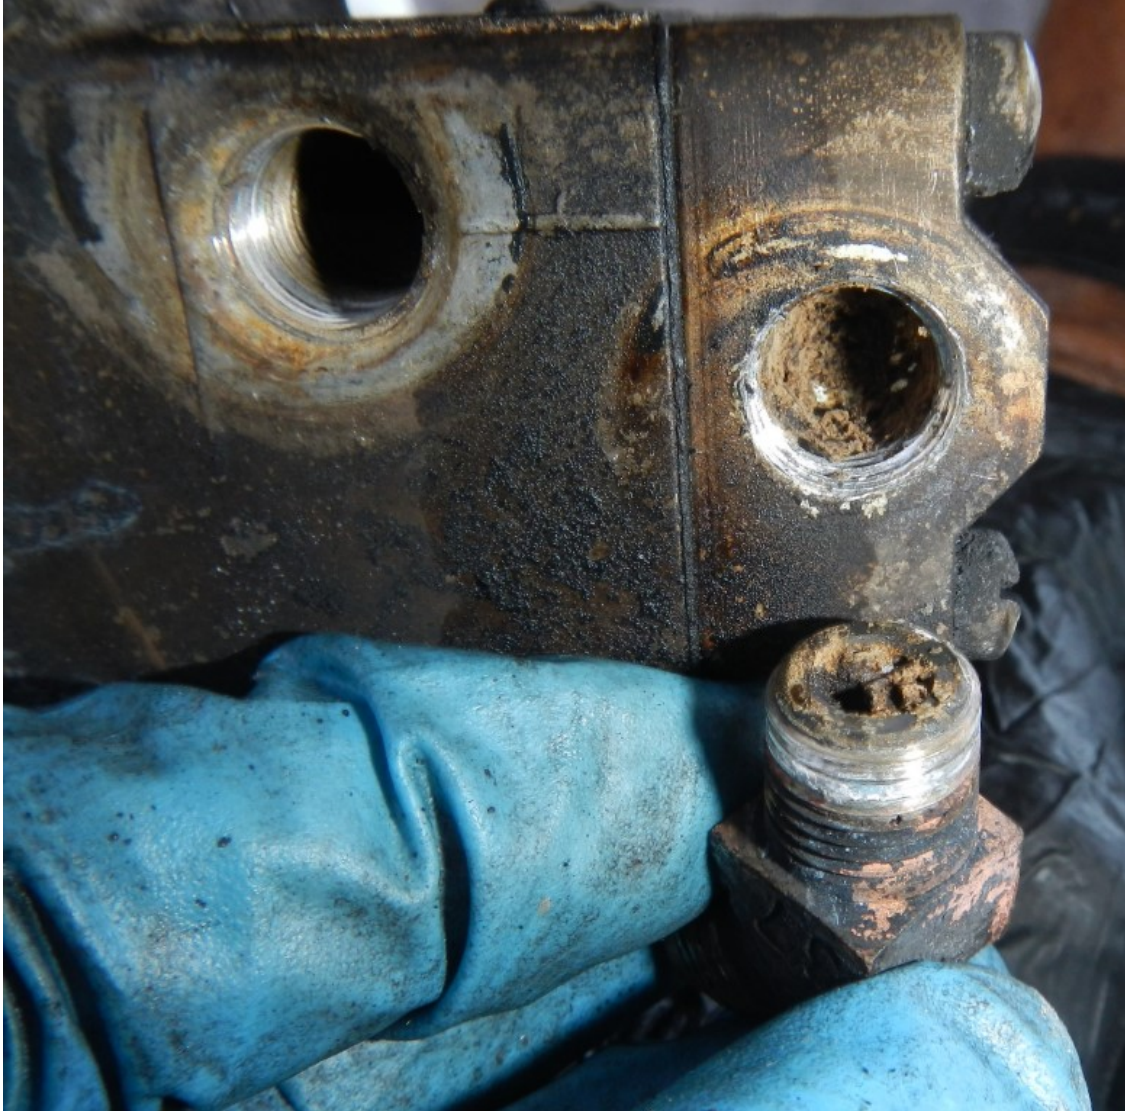
The engine driven fuel pump (EDP, CMI Part Number: 646212-18, Serial Number: B00HA286) remained attached and secured to the backside of the engine with its fuel lines/fittings in place. The pump cooling shroud and scat tubing remained in place. The fuel lines to and from the pump were removed. The fuel pump was removed from the engine, and its drive coupling was found in place and intact. Manual rotation of the drive coupling while installed in the fuel pump drive shaft resulted in rotation of the shaft; however, there was some binding noted (likely due to internal coking from intense thermal exposure). The fuel pump safety wire was in place and was secured with the original lead seal. The fuel lines were thermally damaged, but their fire sleeves remained in place. Removal of the fuel lines resulted in charred hose matter pouring from some of the lines. Removal of the fuel line fittings from the fuel pump revealed a significant amount of material accumulated in the vapor return outlet area (no other ports contained similar material). The material was partially removed and bagged for further examination by the NTSB Materials Laboratory. No other anomalies were noted with the fuel pump besides thermal damage. The pump will be shipped to CMI where it will remain in bonded storage until an examination with federal oversight can be scheduled.

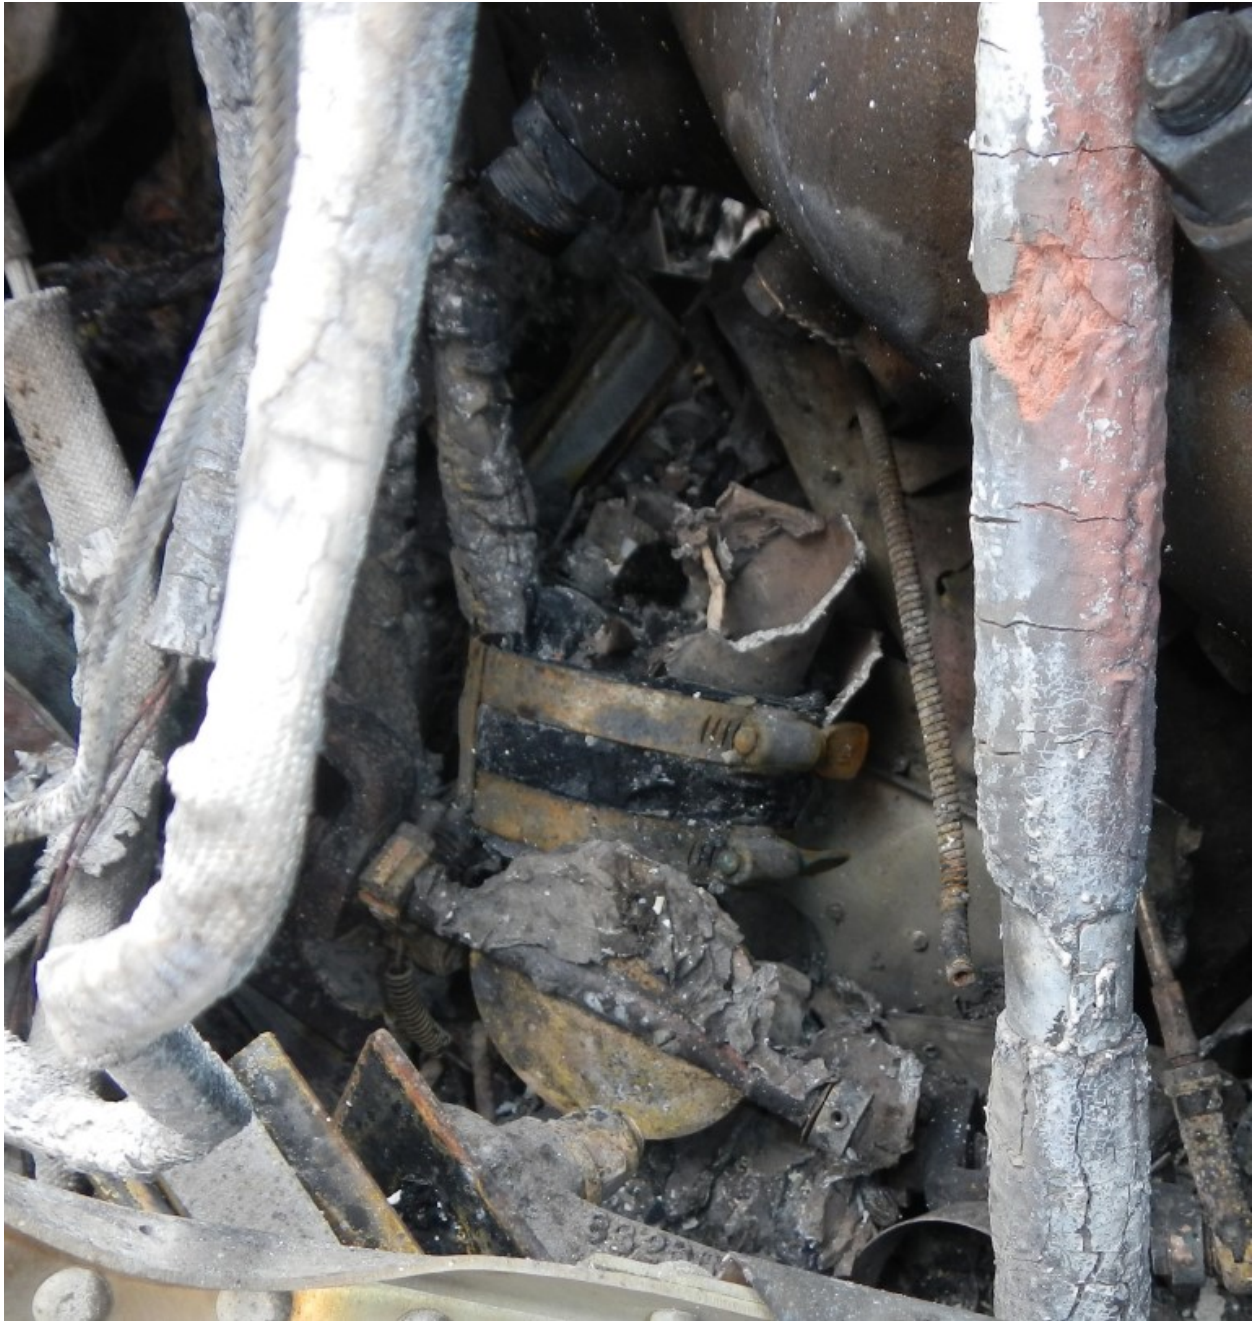
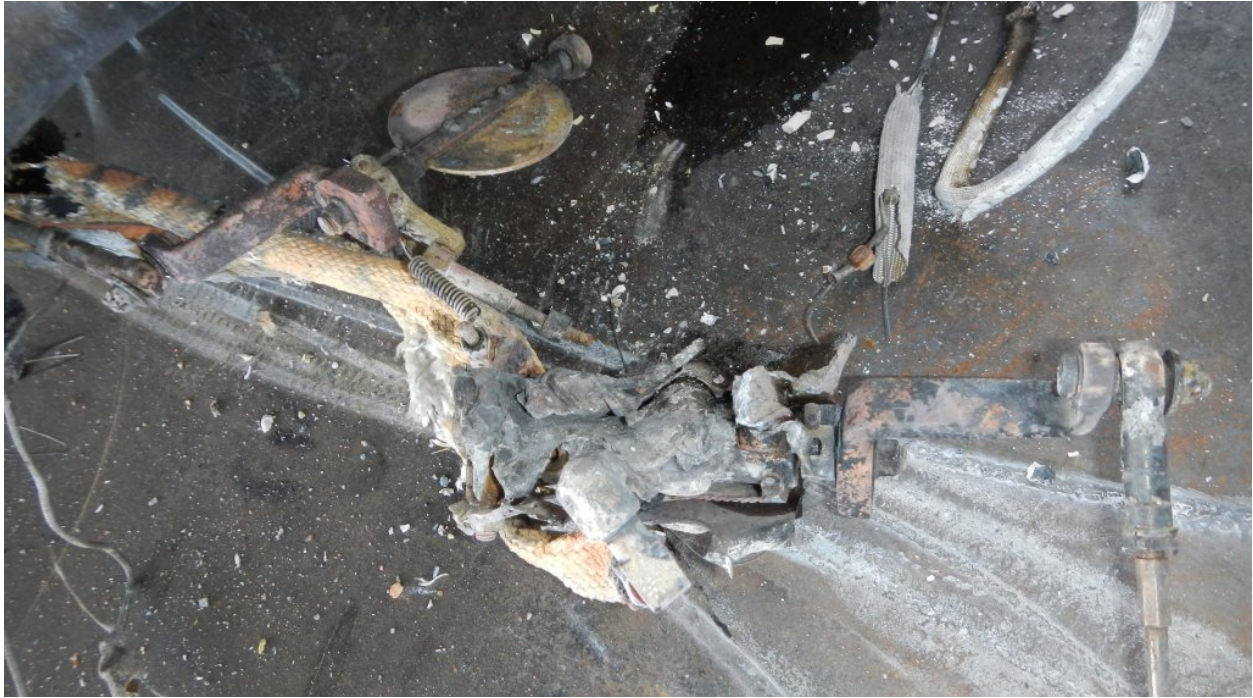
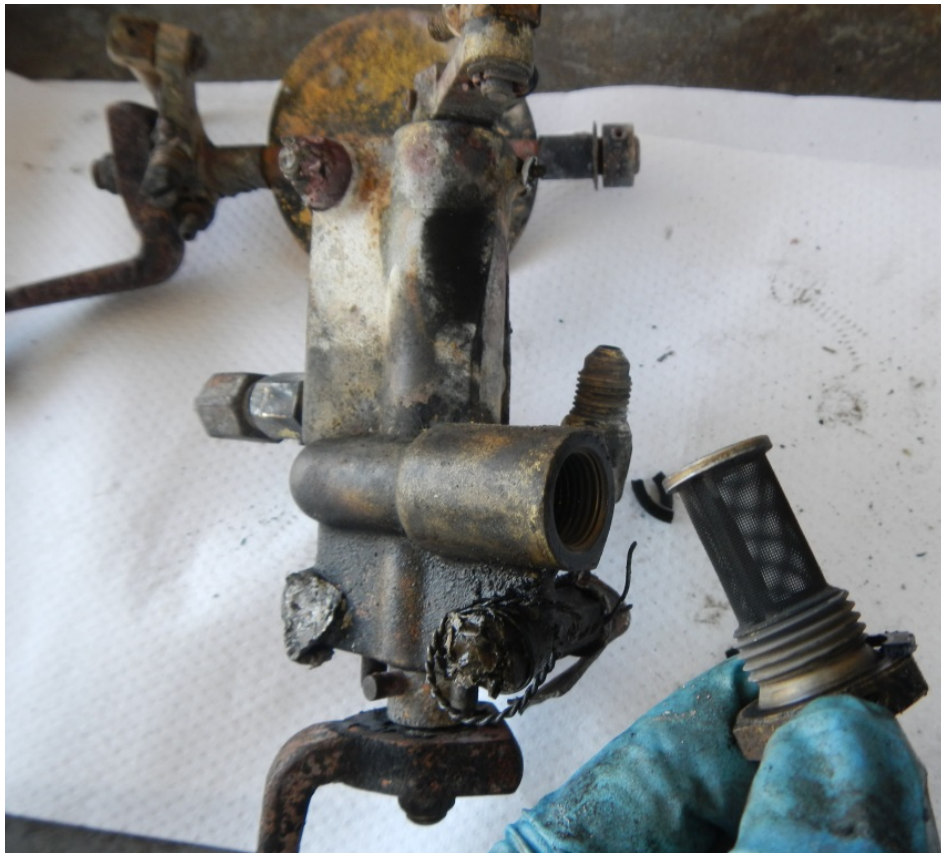
The throttle body/fuel metering unit (CMI Part Number: 649468-2, Serial Number: A00HA381) was normally positioned on the bottom side of the engine, which is where it was located during the on-scene examination. The fuel inlet and return fittings remained attached to the metering unit; however, the fuel outlet fitting was fractured within the fuel metering unit body. The idle mixture adjustment linkage was fractured with bending deformation damage being observed at the threaded portion of the linkage. The throttle and mixture control levers remained attached and secured to their respective control shafts and no slipping was noted between the shafts and levers. The fuel inlet screen was removed and found clear and unobstructed. The mixture control shaft could not be rotated with a manual manipulation of the mixture control lever. Examination of the mixture control shaft through the fuel inlet port revealed charred debris adhering to the shaft and walls of the metering unit. None of the throttle body remained intact. The throttle plate remained attached to the throttle shaft and lever.

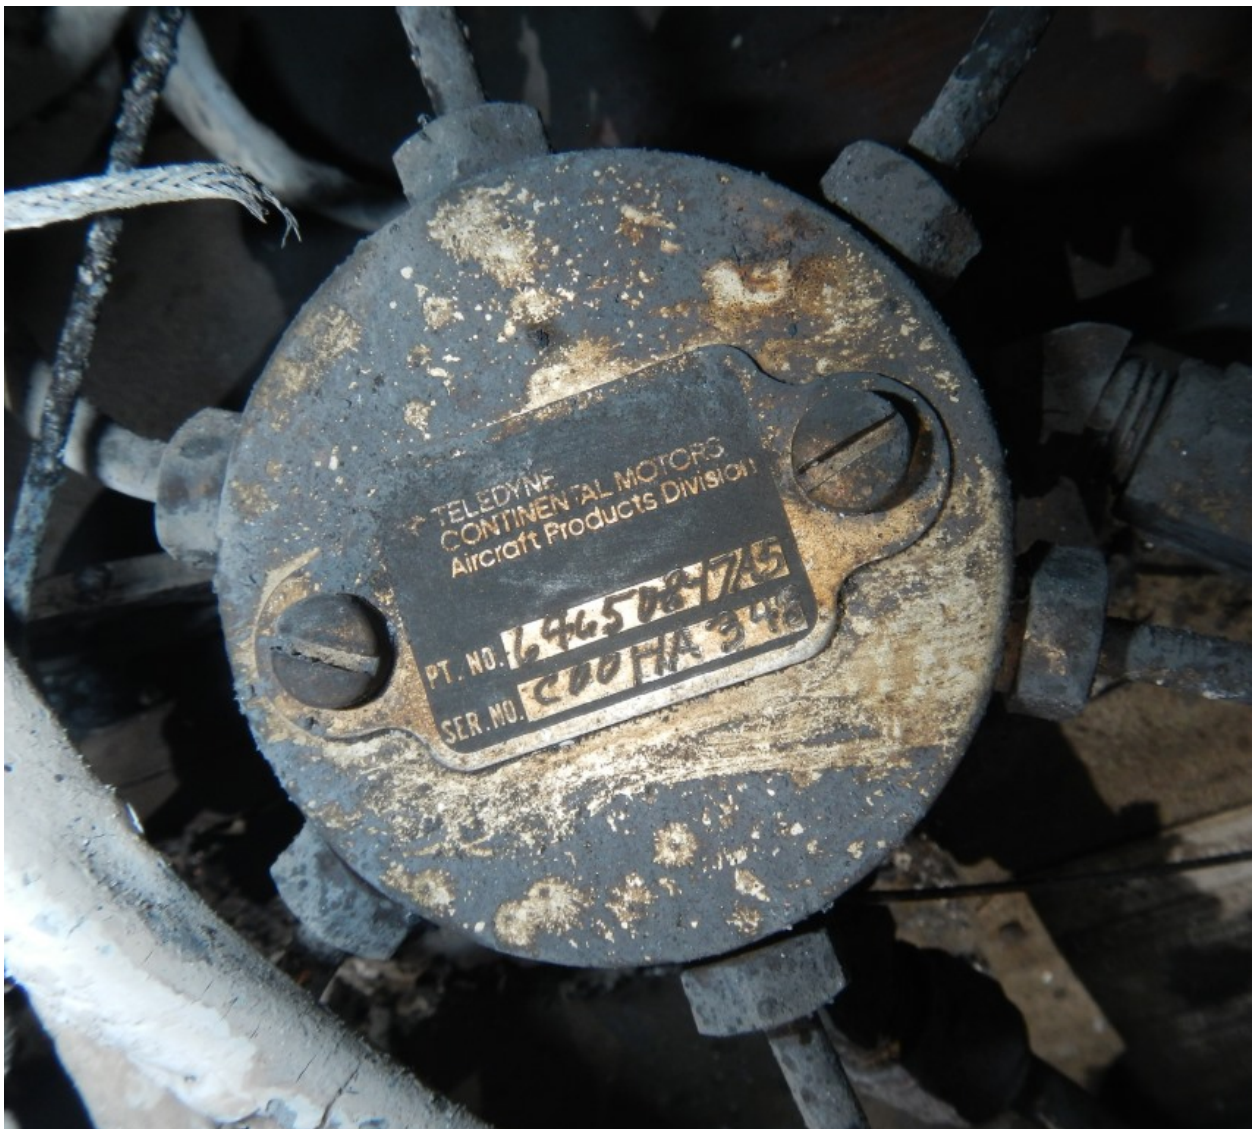
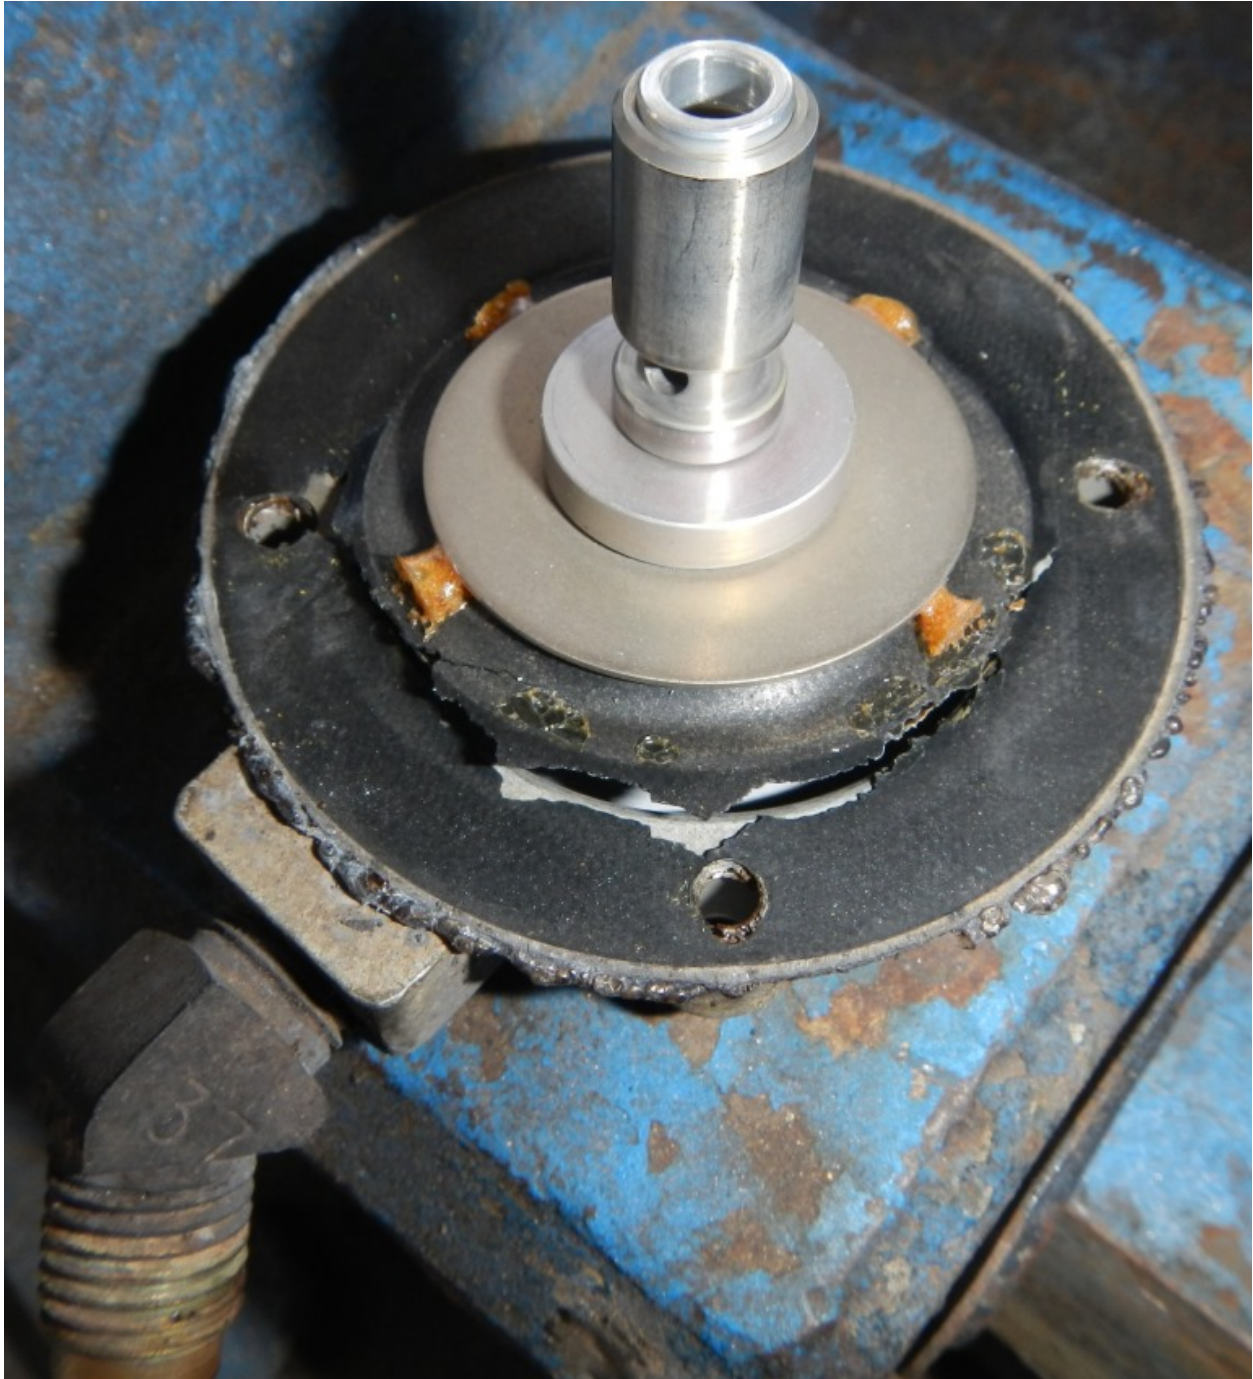
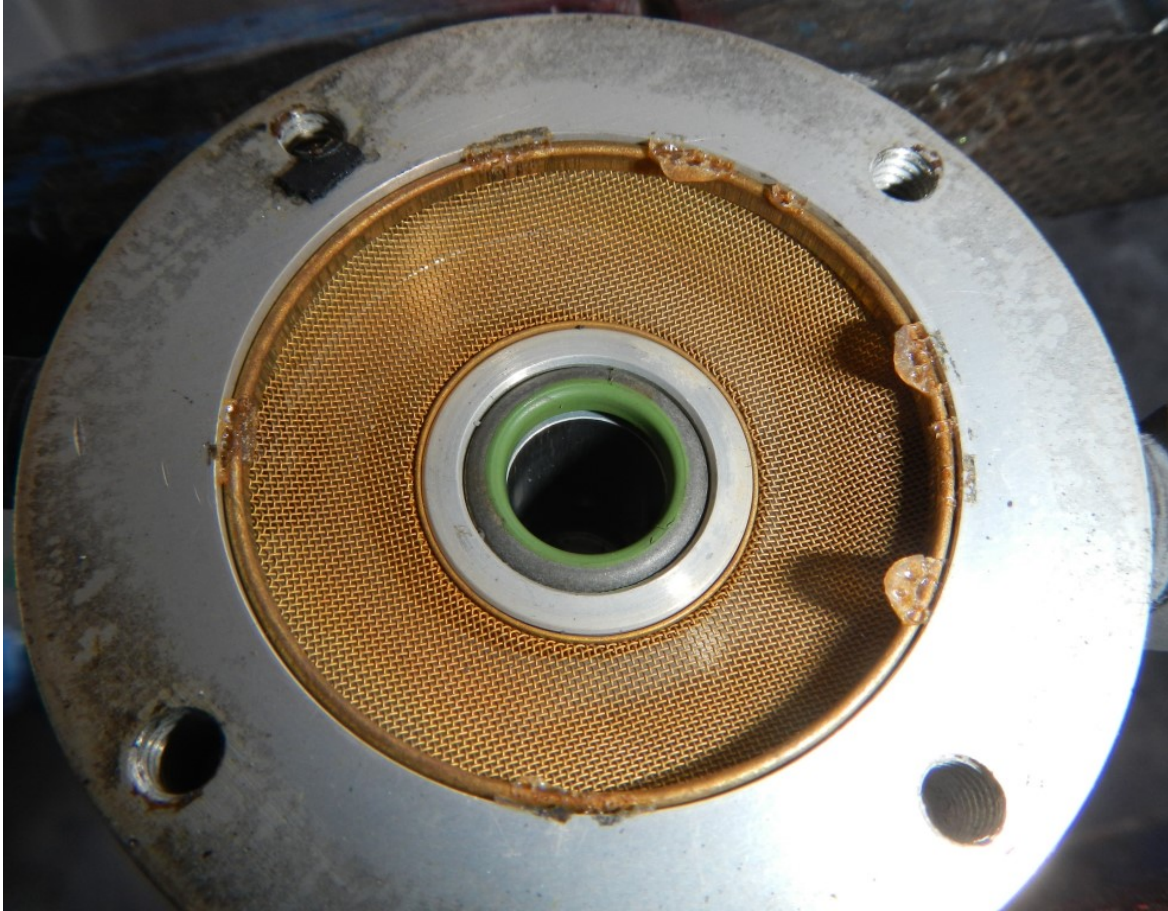
The fuel manifold valve (CMI Part Number: 64650847A5, Serial Number: C00HA348) remained intact and attached to the topside of the engine. The fuel injector lines remained attached to the manifold valve. The fuel injector lines remained intact. The lines were removed and the manifold valve was detached from its mounting bracket. The fuel manifold valve's safety wire remained in place, intact, and secured with its lead seal. The manifold valve was disassembled and the diaphragm was stuck to the cap and the housing of the manifold valve. To remove the diaphragm cap a hammer had to be used to dislodge the cap from the diaphragm. The diaphragm was brittle (likely due to the excessive thermal exposure from the post-crash fire as opposed to dry rot) and tore when the cap was removed. The spring was in place between the cap and the diaphragm. The plunger was secured to the diaphragm and the screen was clear. No obstructions were noted.
