NATIONAL TRANSPORTATION SAFETY BOARD

ON SCENE and POST RECOVERY INFORMATION

**NTSB Accident: WPR13FA244
Accident Date: May 28, 2013**

Location: Mountainaire, Arizona
Date: May 28, 2013
Aircraft: Beech A36, N999PK, Serial # 3380
NTSB IIC: Michael Huhn

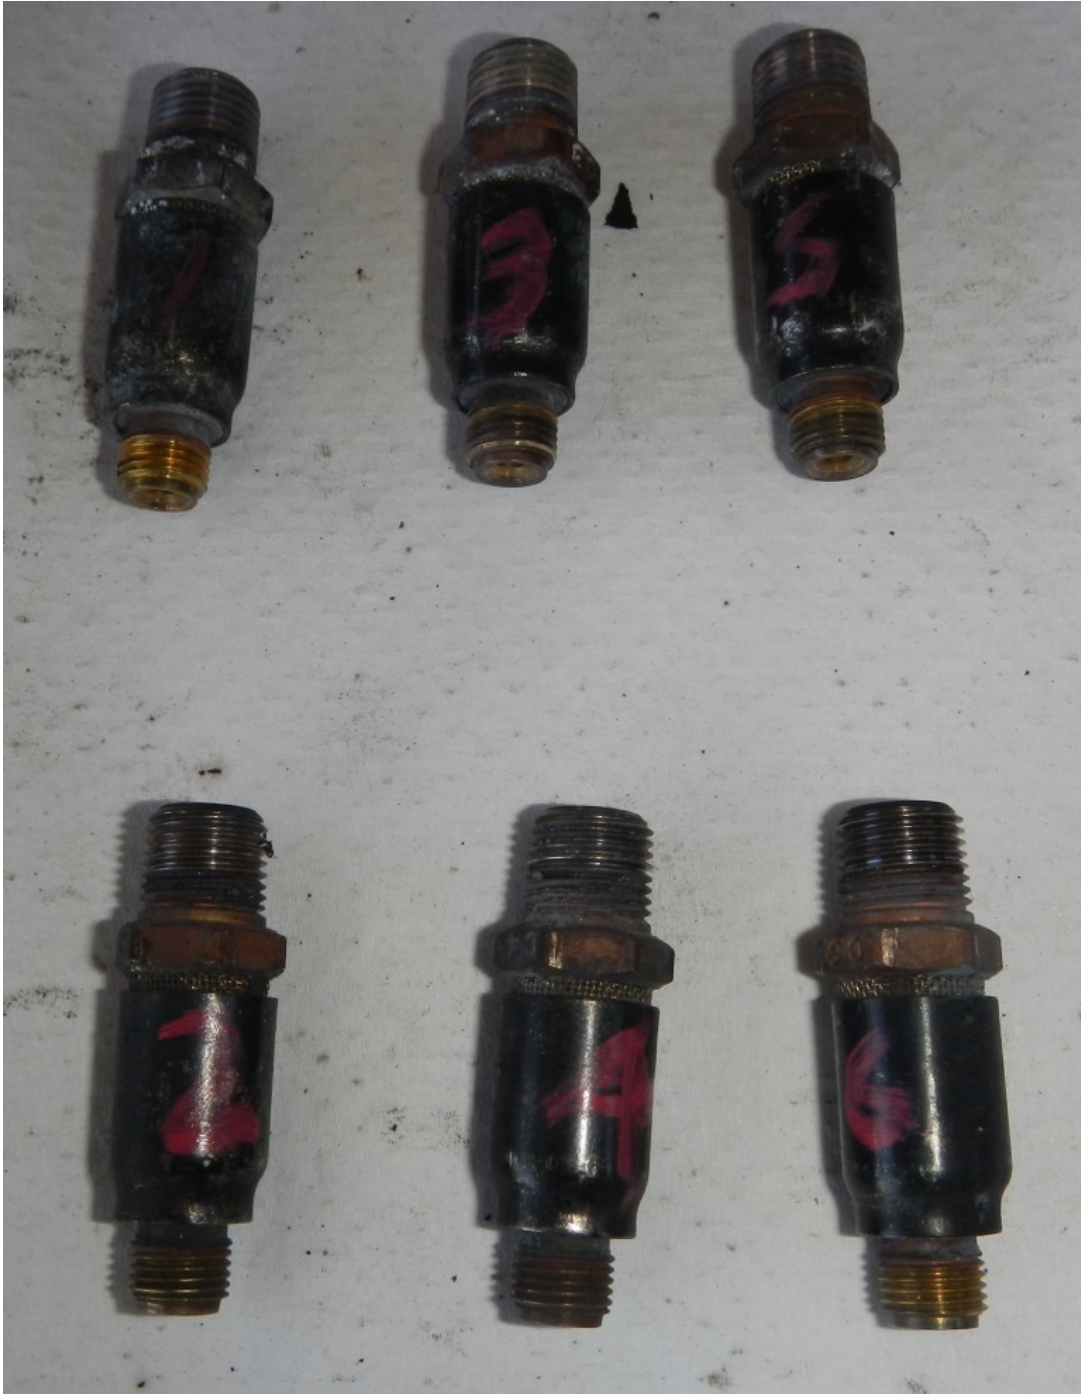
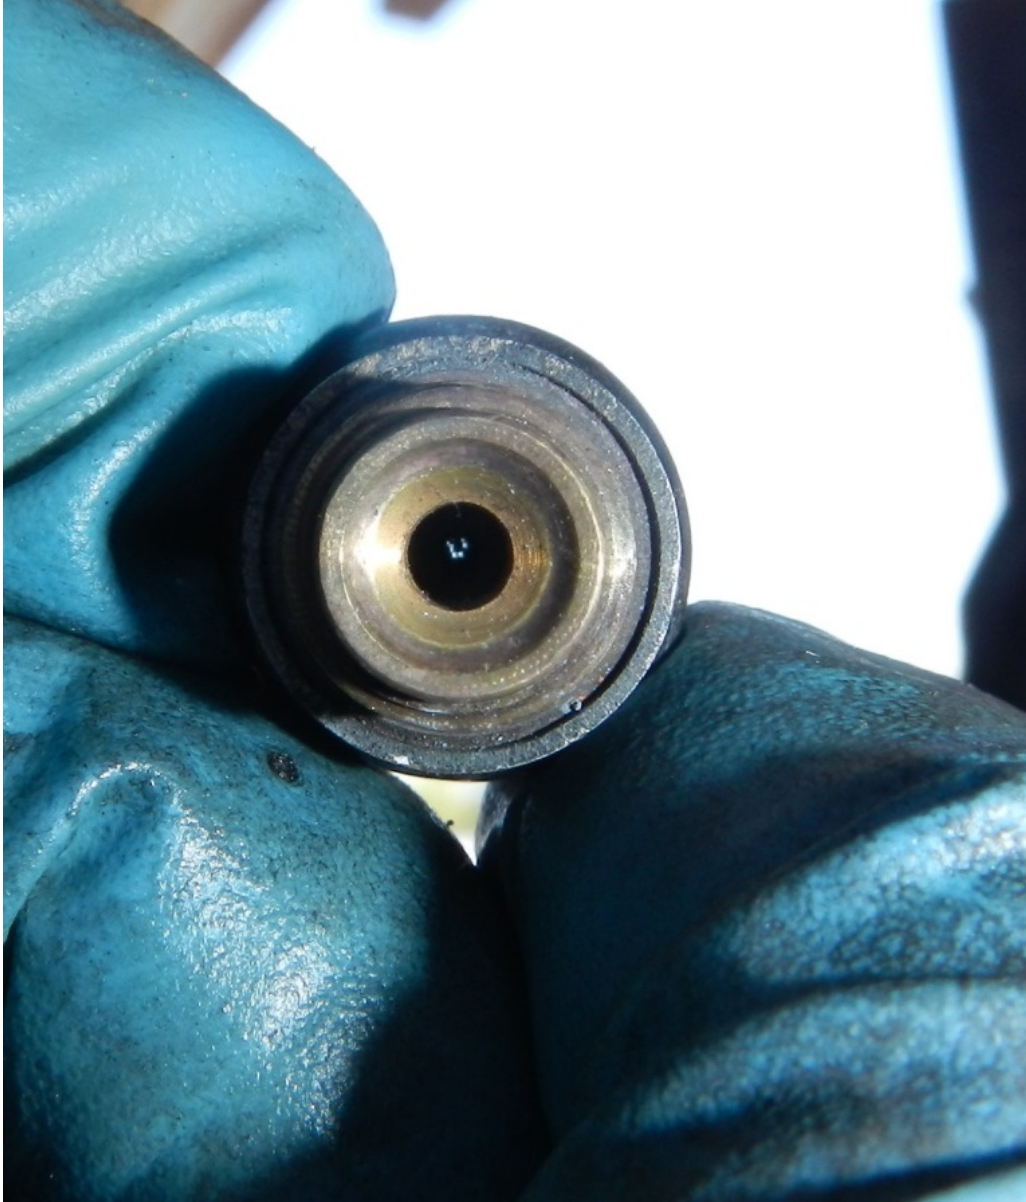
The fuel nozzles were removed from their respective cylinders. None of the nozzles were blocked; however, the #5 nozzle displayed some debris within its discharge orifice.

Figure 44 - Injector Nozzle from No. 5 Cylinder (note partial obstruction)

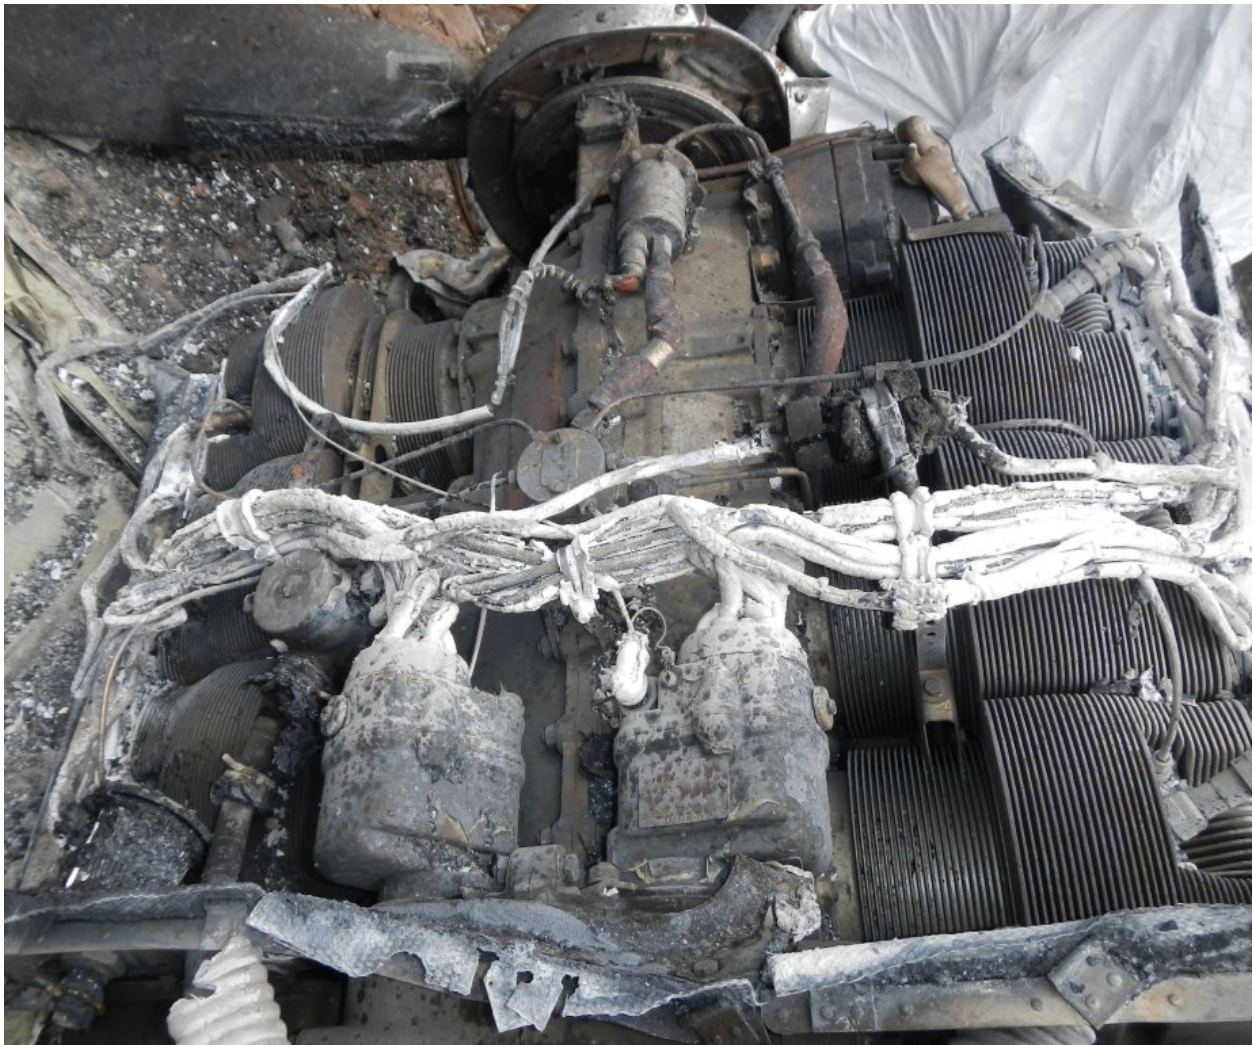
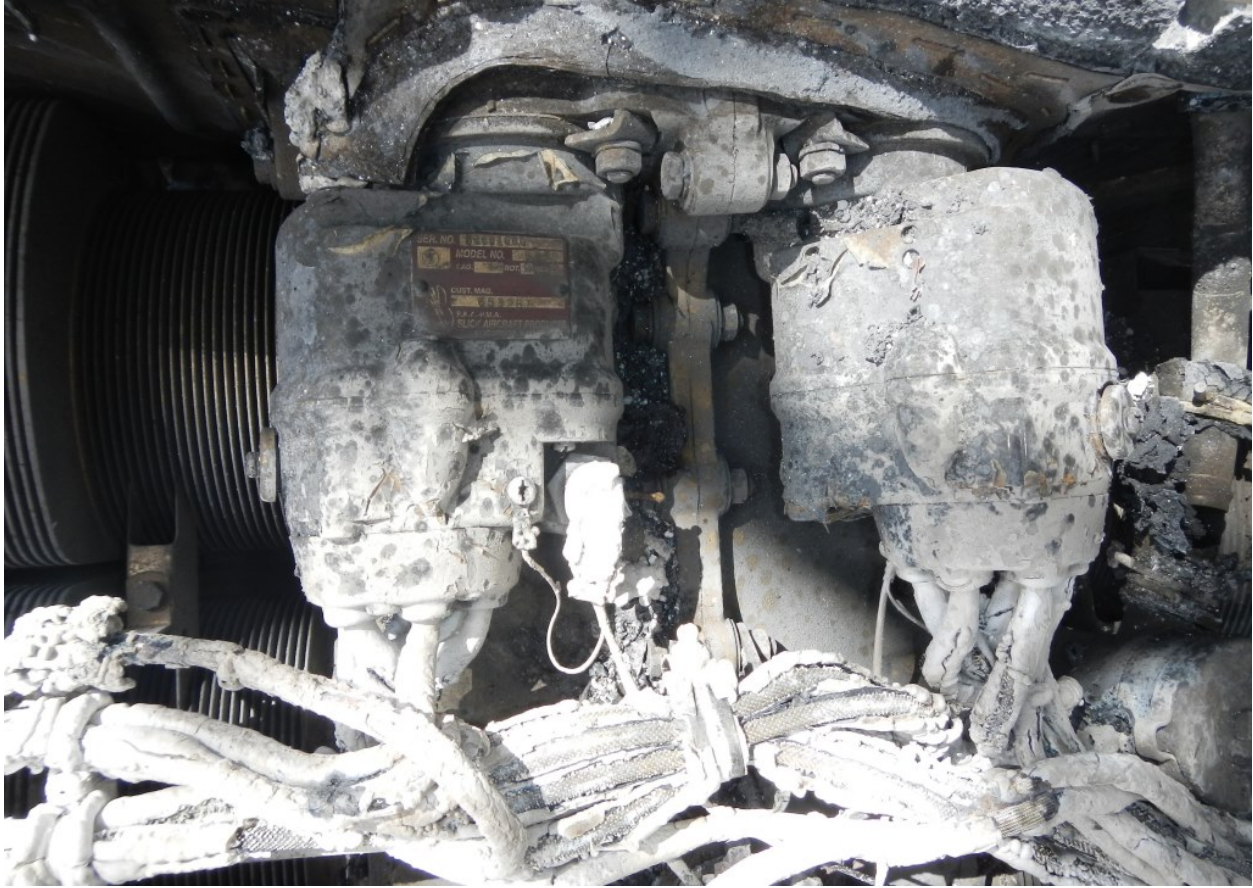
Examination of the ignition system revealed that the magnetos were in place and secured to their mounting pads on the topside of the engine (LH Magneto: Slick, Part Number: 6310, Serial Number: 00091583; RH Magneto: Slick, Part Number: 6310, Serial Number: 00091606). There was no evidence of magneto slippage (with respect to the engine) and manual manipulation of the magnetos did not result in any rotation of the magnetos relative to the engine.

The ignition harnesses remained attached to the magnetos but they sustained significant thermal damage. The ignition leads remained attached to their respective spark plugs (Champion RHB32S). The ignition leads were removed from the spark plugs and both the top and bottom

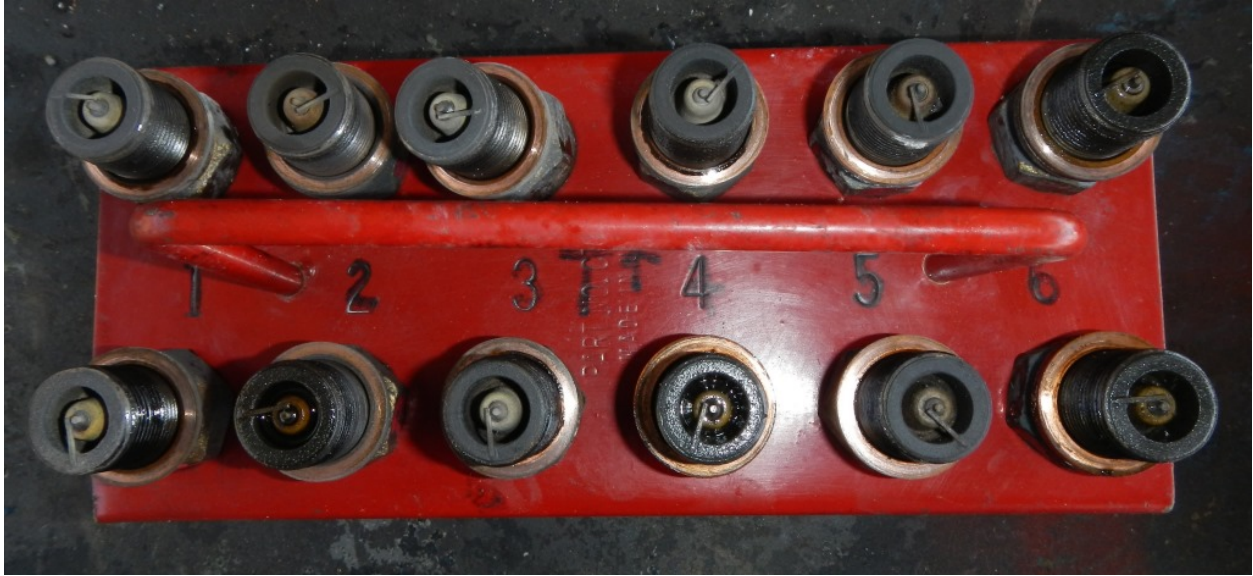
Figure 47 - Spark Plugs

spark plugs from each cylinder were removed. Comparing the spark plugs to the Champion Aviation Service Manual (AV6-R) revealed that the fine-wire spark plugs displayed a normal worn condition with light carbon soot on the #5 cylinders top and bottom spark plugs. The #5 top spark plug also displayed a globule of solidified lead down in the barrel at the base of the insulator; however there was no evidence of lead fouling on any of the spark plugs. The #2 bottom, #4 bottom, and #6 top and bottom spark plugs displayed oil coating (the engine was resting with the even side cylinders low).

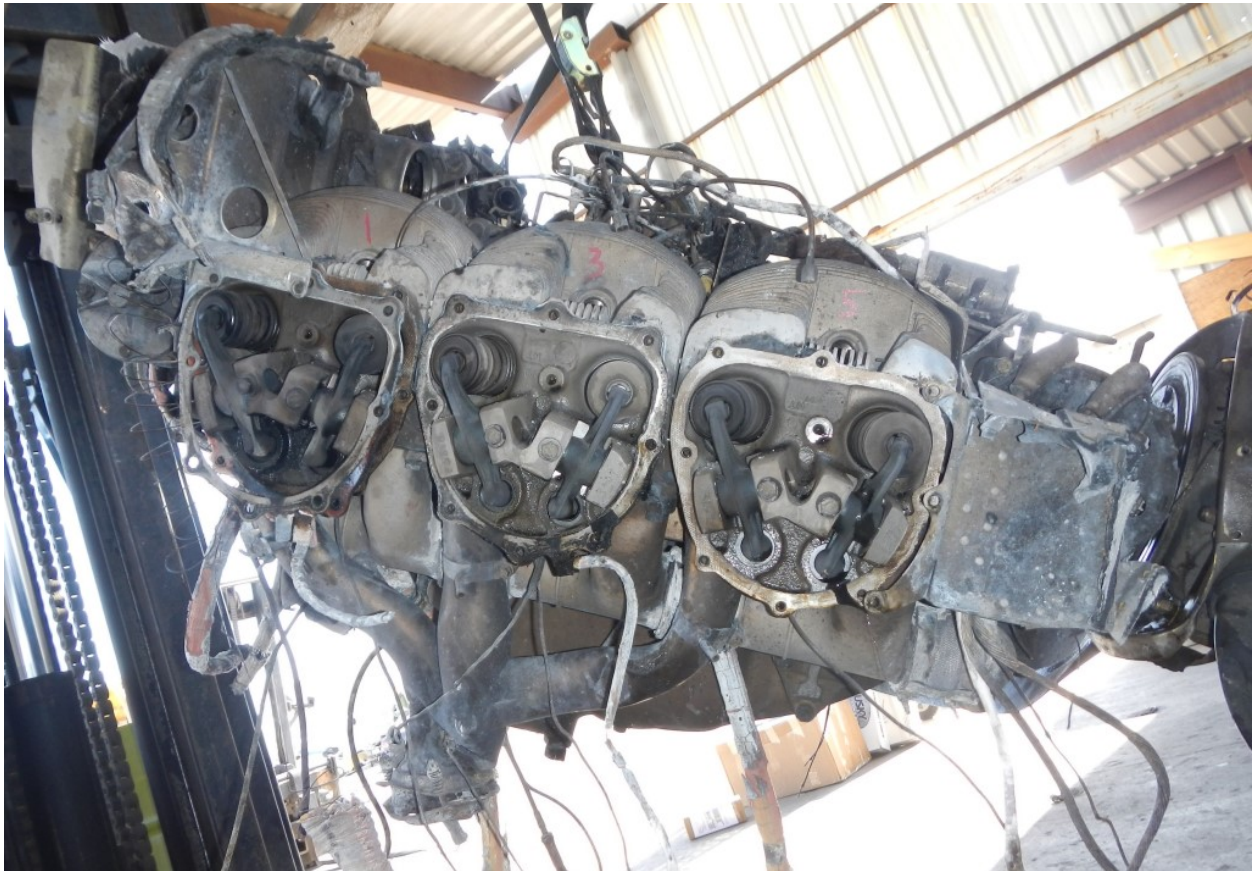
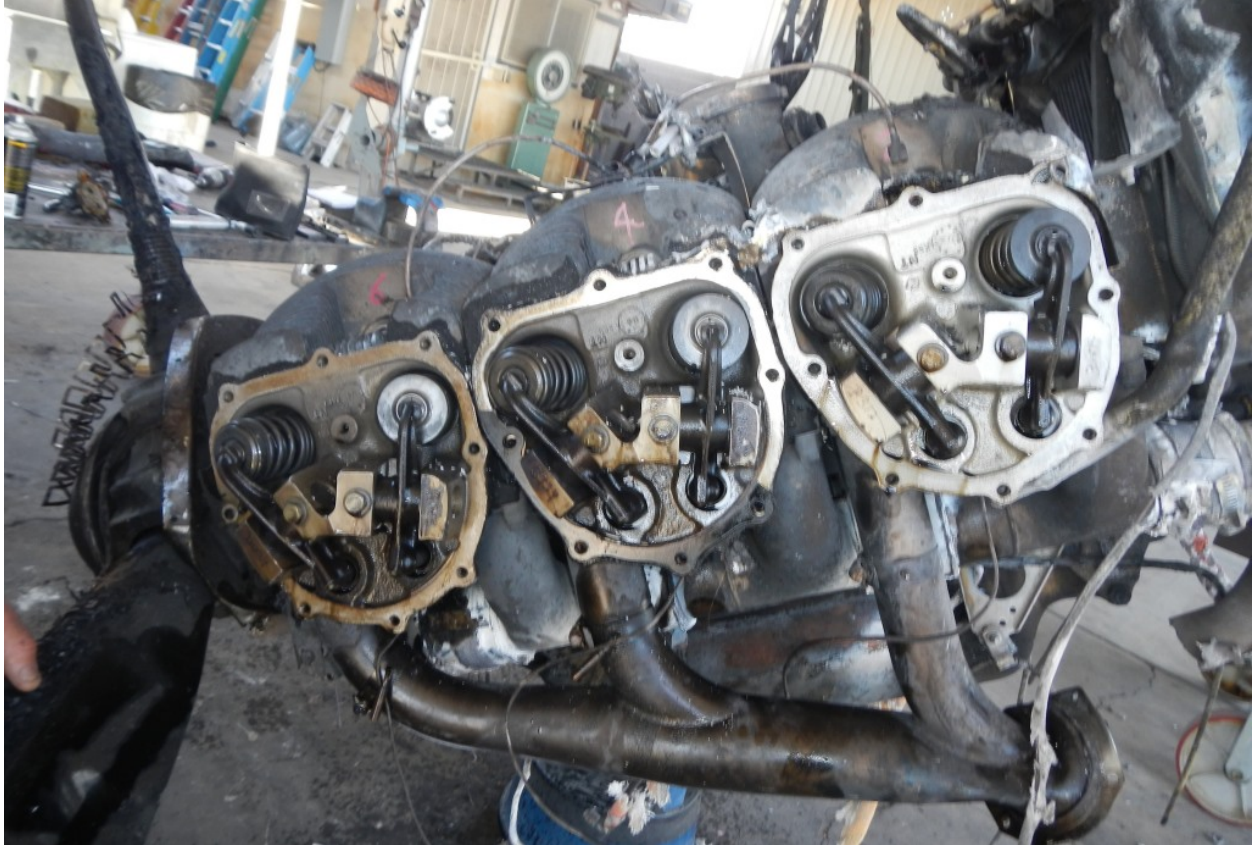
An examination of the cylinders with a lighted borescope was conducted. There were no anomalies noted with the cylinder barrels, pistons, valves, or valve seats. Only light deposits (consistent with the combustion process) were noted in each of the cylinders. A thumb compression test was conducted, and compression was obtained on all six cylinders, verifying crankshaft and connecting rod continuity. Manual rotation of the propeller also resulted in movement of all of the rocker arms, verifying camshaft continuity.

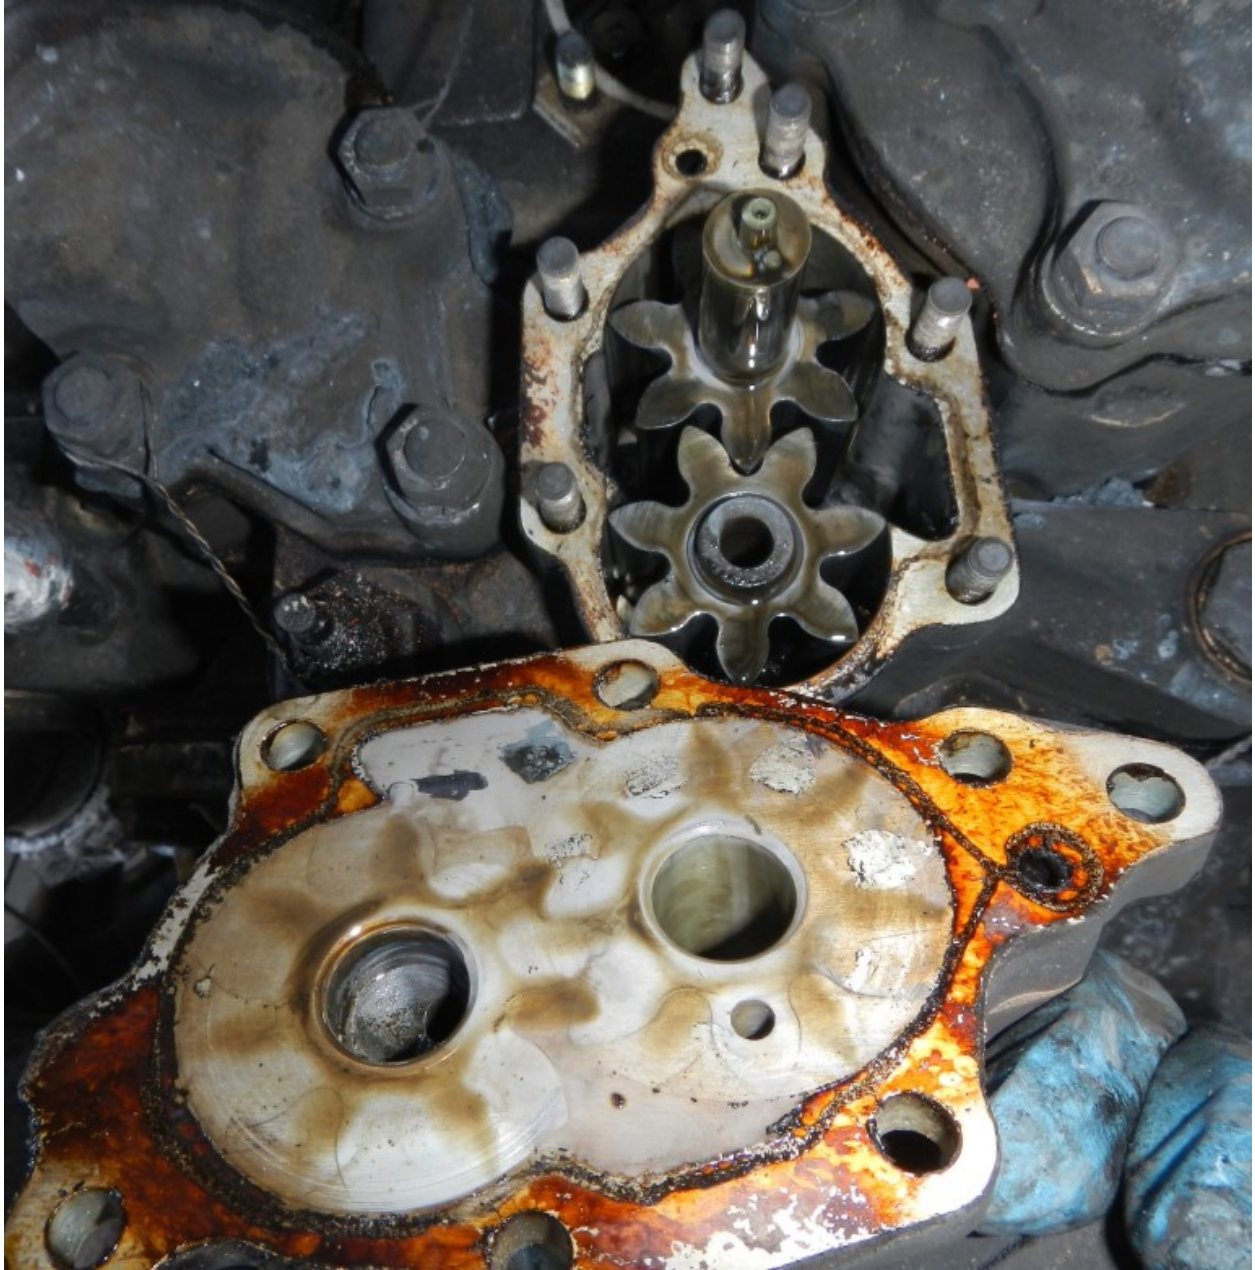
Figure 50 - Oil Pump

The oil filler cap/dipstick was removed from the oil filler neck while the engine was in a near level attitude, and 10 quarts of oil registered on the dipstick. The oil cooler remained intact and secured to the aft left end of the engine. The oil filter was removed from the oil filter adapter and was cut open using an oil filter cutting tool. The filter element sustained thermal damage and was brittle; however, no metallic debris was noted within the folds of the filter element. The oil pump housing cap was removed and the oil pump gears were found intact and undamaged. Some thermal coking/discoloration was noted on the gears due to thermal exposure from the post-accident fire. Removal of the drive and idler gears did not reveal any anomalies to the gears or housing walls. Rotation of the propeller with the oil pump housing cap removed revealed normal rotation of the oil pump gears.

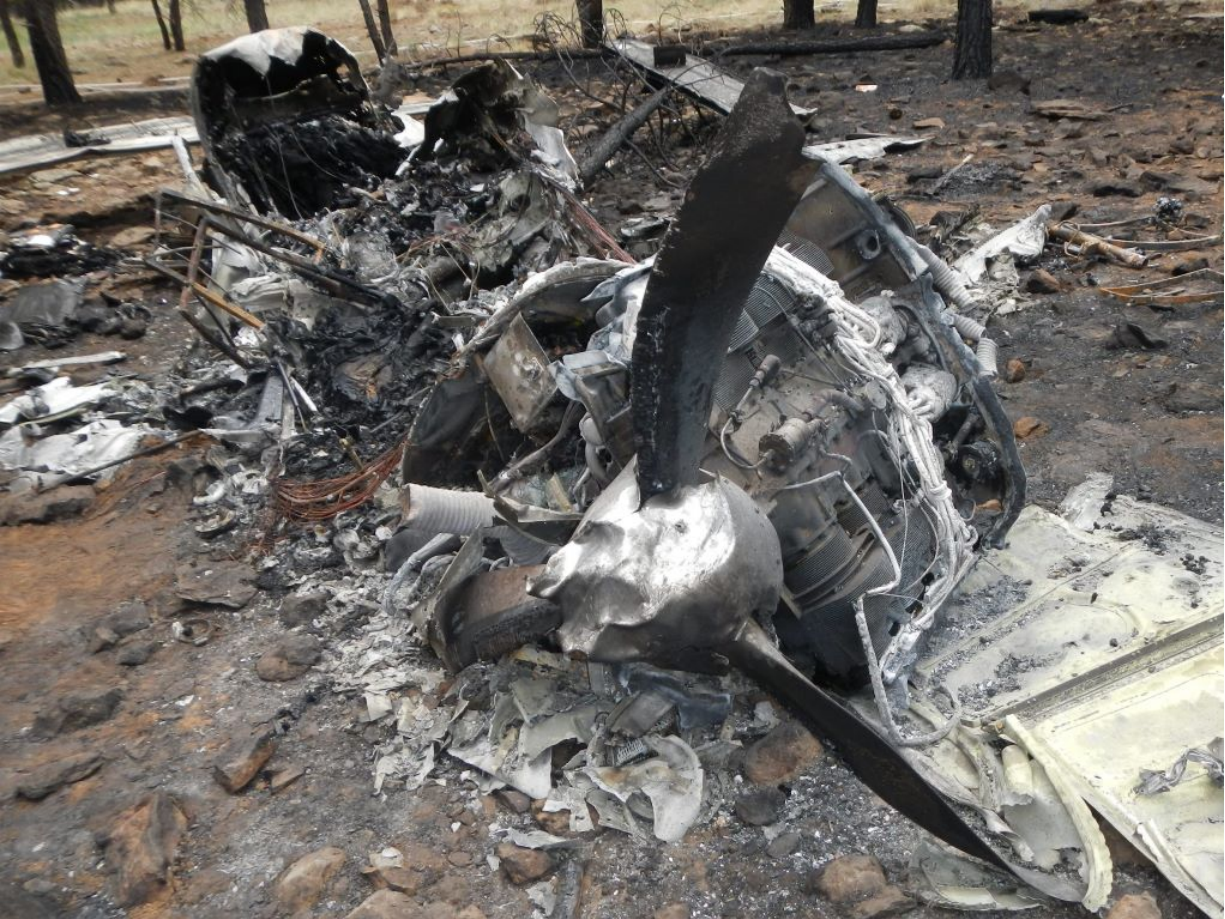
Figure 52 - Propeller

The three-bladed Hartzell propeller (Serial Number: EE37473) remained attached to the crankshaft's propeller flange. The blades were arbitrarily labeled A, B, and C for the purposes of the examination. All three propeller blades remained attached to the propeller hub, but two of the blades (blades A and B) were separated from their pitch change links, as evidenced by the fact that they could be rotated within the hub without affecting the other blades.

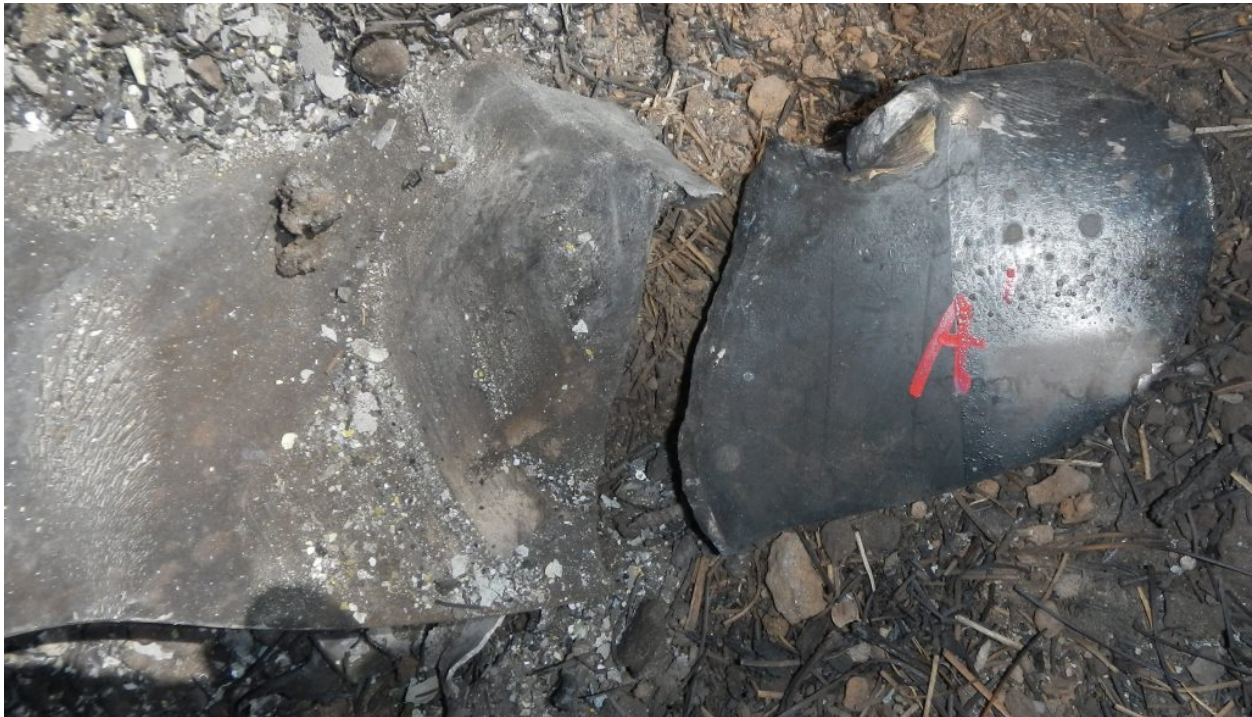
Figure 53 - Blade 'A' with Tip Fragment

Blade A was rotated in the hub about 180 degrees from its normal orientation, or about 50 degrees from the plane of rotation; the de-icing element was positioned away from the direction of normal rotation. Blade A was bent forward about 40 degrees beginning about its mid-span point. The tip of blade A separated from the blade approximately 30 inches from the hub. The separated section, identified as A', was found in the disturbed earth/rock adjacent to the depression attributed to the propeller/engine impact. Blade A displayed some deep leading edge gouges.

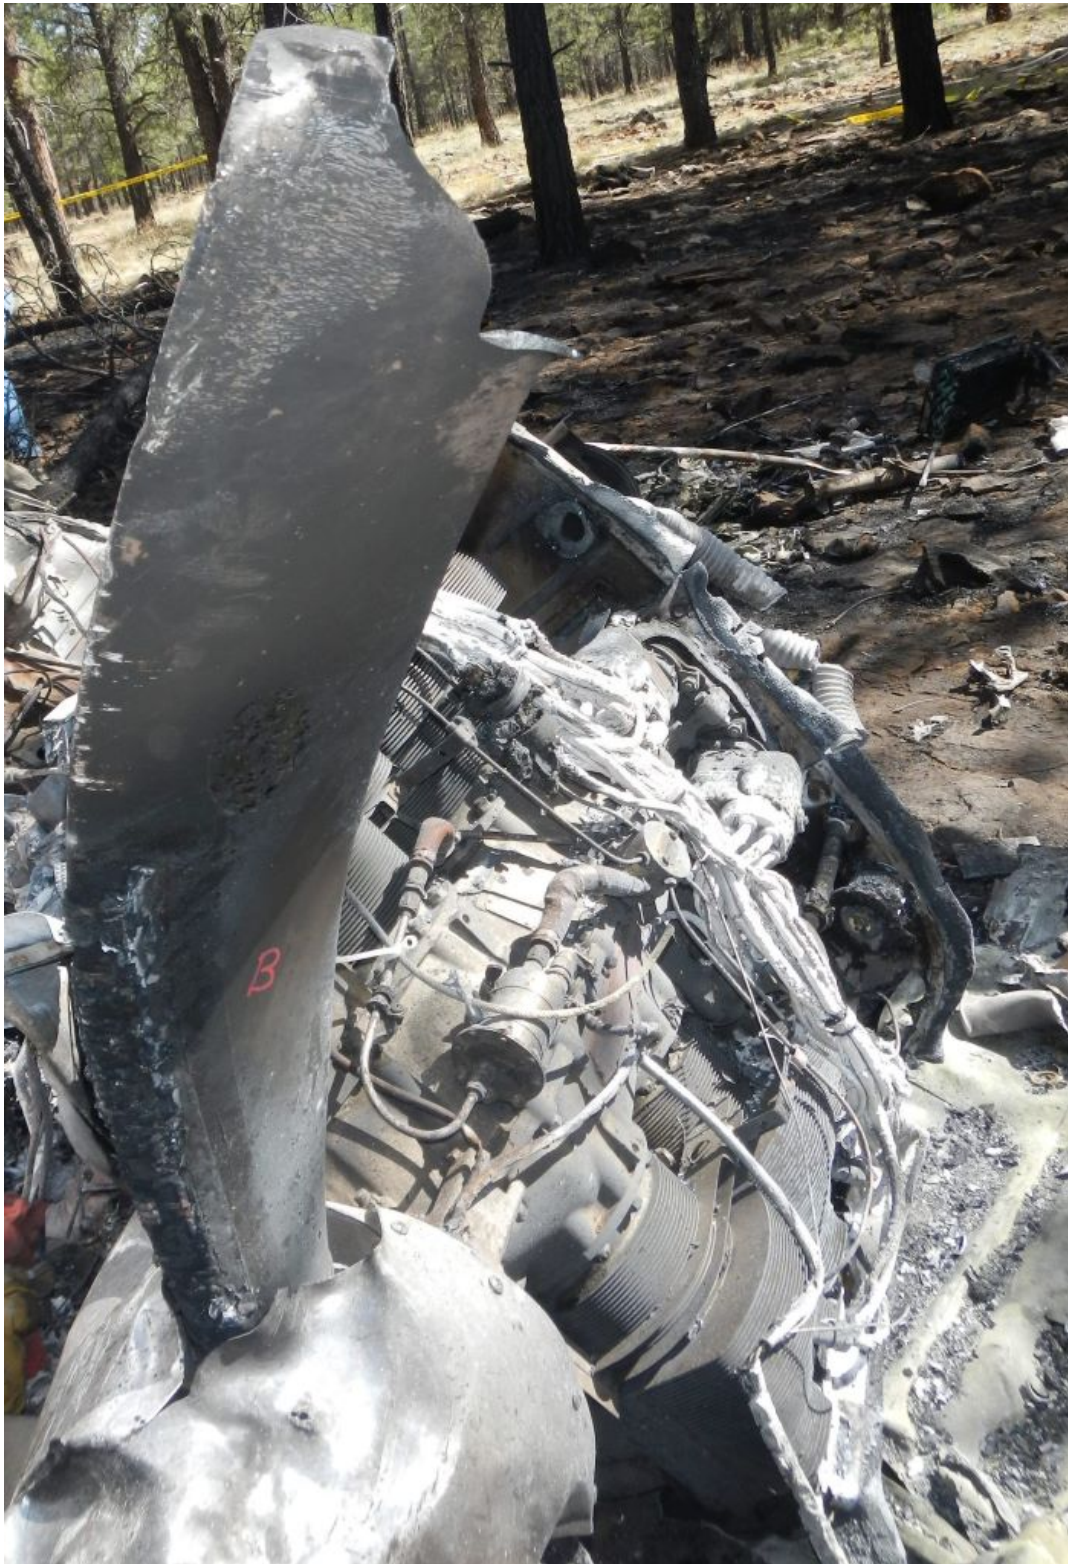
Figure 54 - Blade 'B' with Missing Tip

Blade B was bent forward about 20 degrees, beginning about the mid span point. The tip of propeller blade B separated approximately 28 inches from the hub. The inboard portion of the separated tip section, identified as B', was found about 115 feet, on an approximate bearing of 115 degrees magnetic, from the main wreckage. That segment was not sooted or fire-damaged. Exclusive of the separated outboard section, blade B displayed some light to moderate leading edge gouging.

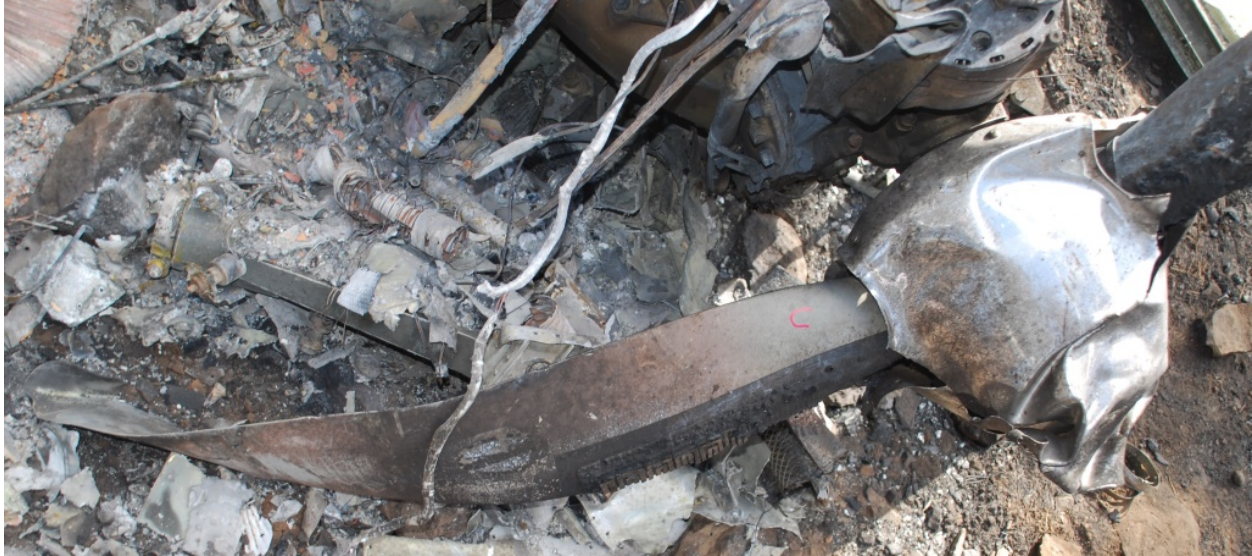
Figure 55 - Blade 'C'

Blade C was bent aft about 30 degrees at its midpoint and twisted toward low pitch. Its tip remained attached, but was curled aft more than 180 degrees. Blade C displayed heavy leading edge gouging, mostly on the outboard span section.

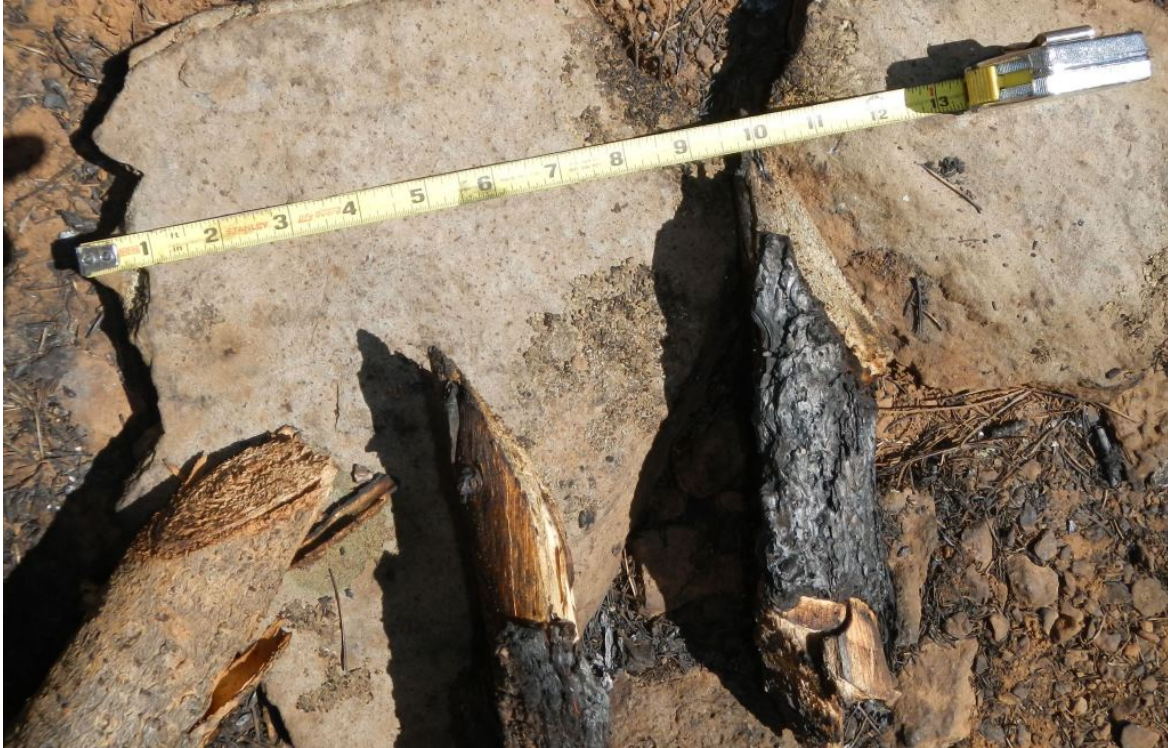
Figure 57 - Cut Tree Sections

Three 2.5-inch diameter branches and one 4-inch diameter tree displayed fresh cuts consistent with propeller blade strikes. The propeller governor remained attached and secured to its mounting pad and the propeller control cable remained attached to the control lever.
