NATIONAL TRANSPORTATION SAFETY BOARD

NTSB ON SITE EXAMINATION NOTES

WPR13FA388

Location: Desert Center, CA
Date: August 26, 2013
Aircraft: Grumman AA-1A, Registration Number: N61VT, Serial #: AA1A-0047
NTSB IIC: Howard Plagens

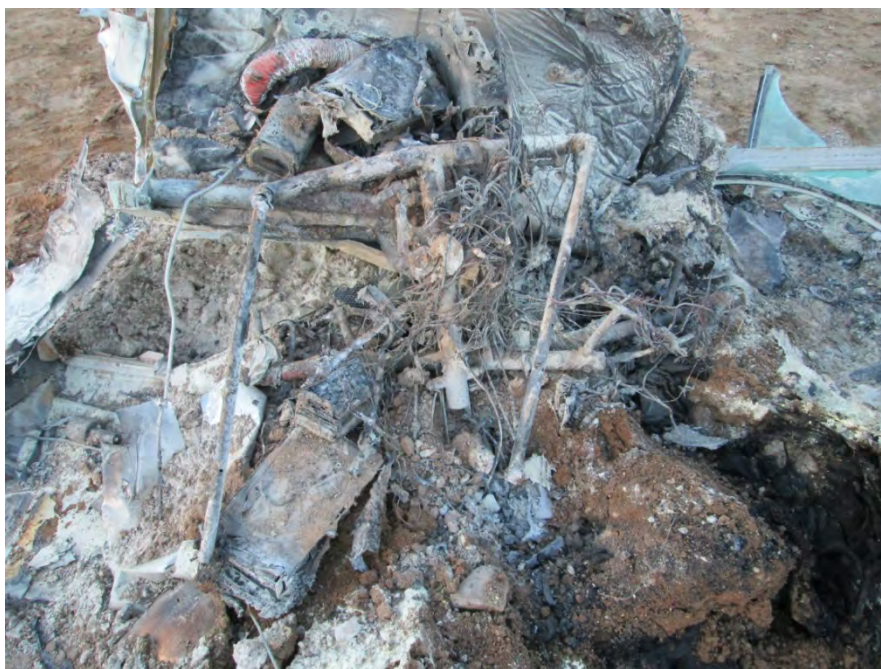
Photo 1 Cabin Area

The airplane burned, and fire consumed the cabin top and side structure. Wing and fuselage components around the cabin area sustained severe thermal damage. The IIC established control continuity on scene for the elevator and rudder. Debris prevented examination of the aileron system.

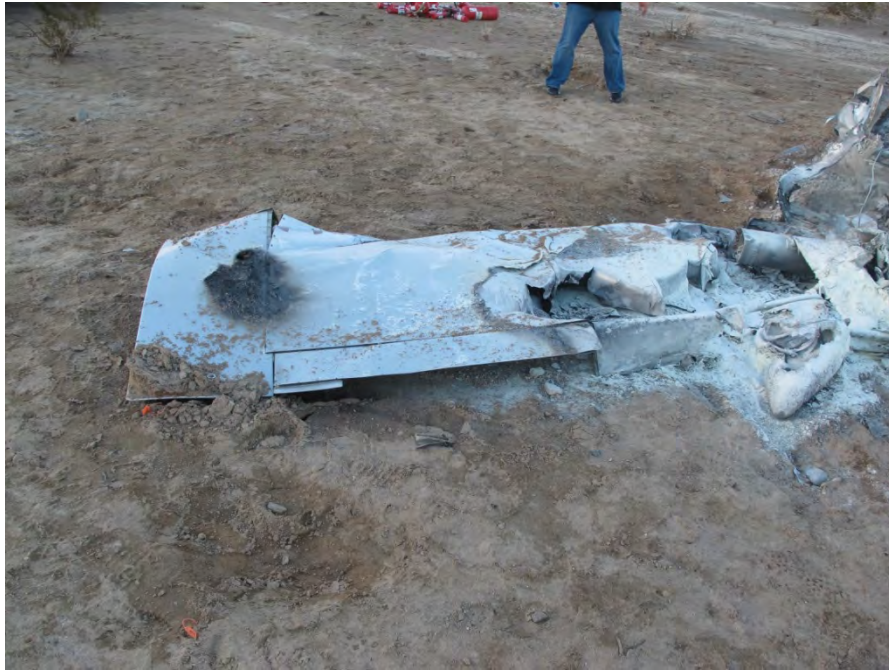
Photo 4 Left Wing

The left aileron remained attached to the wing. The left flap remained attached at the outboard fitting, but separated at the inboard fitting. Fire consumed the inboard portion of the wing in this area.

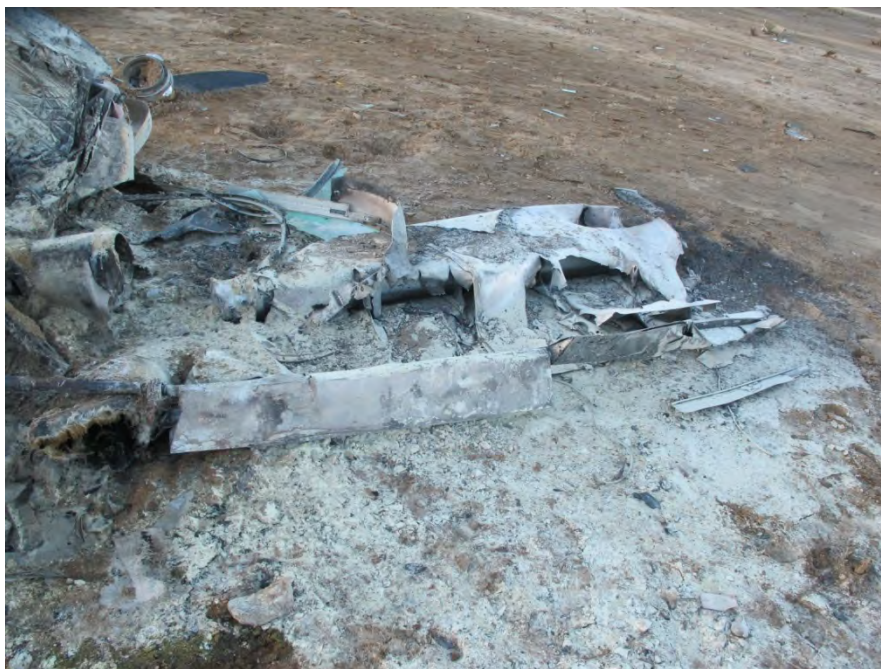
Photo 5 Right Wing

The right aileron separated at the outboard attachment point; this area was consumed by fire. It remained attached at the inboard fitting. The right flap remained attached at both the inboard and outboard fittings.

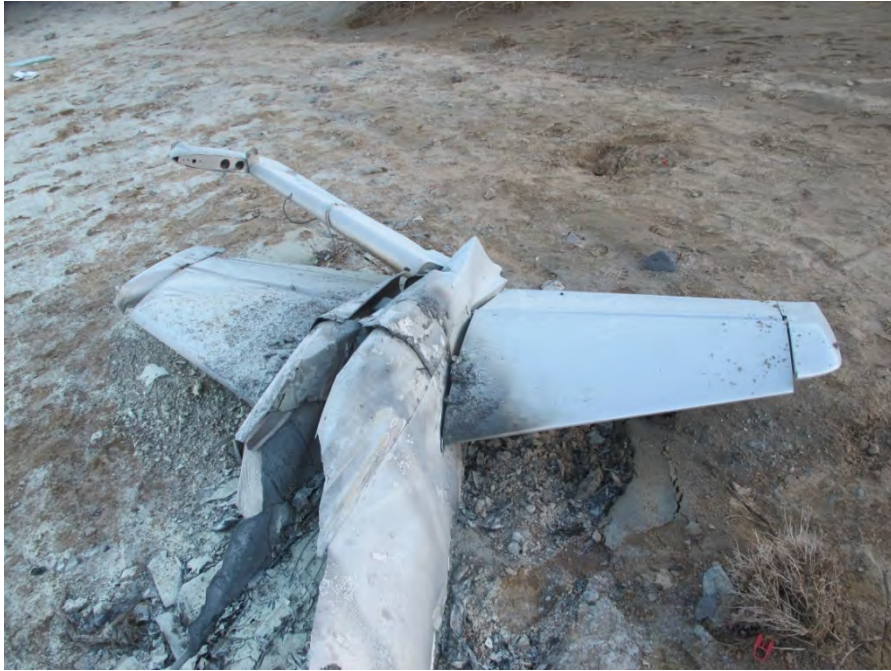
Photo 6 Empennage

The leading edges of the horizontal stabilizers did not have dents or gouges. The inboard portion at the fuselage was scorched. The rear white navigation light remained in place.

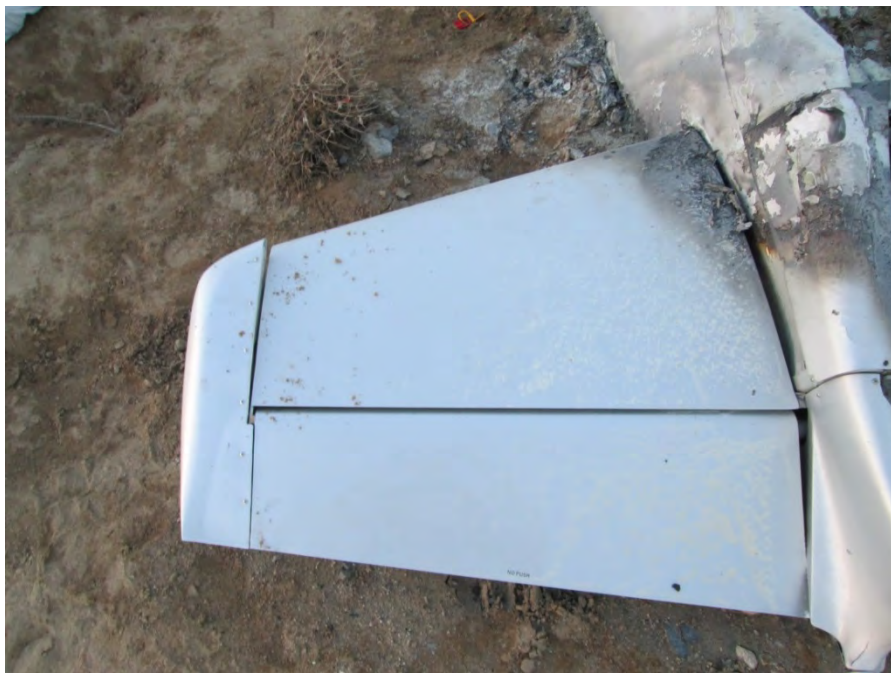
Photo 7 Top of Left Horizontal Stabilizer and Elevator

The left elevator was intact, and remained attached. The forward inboard portion was charred.

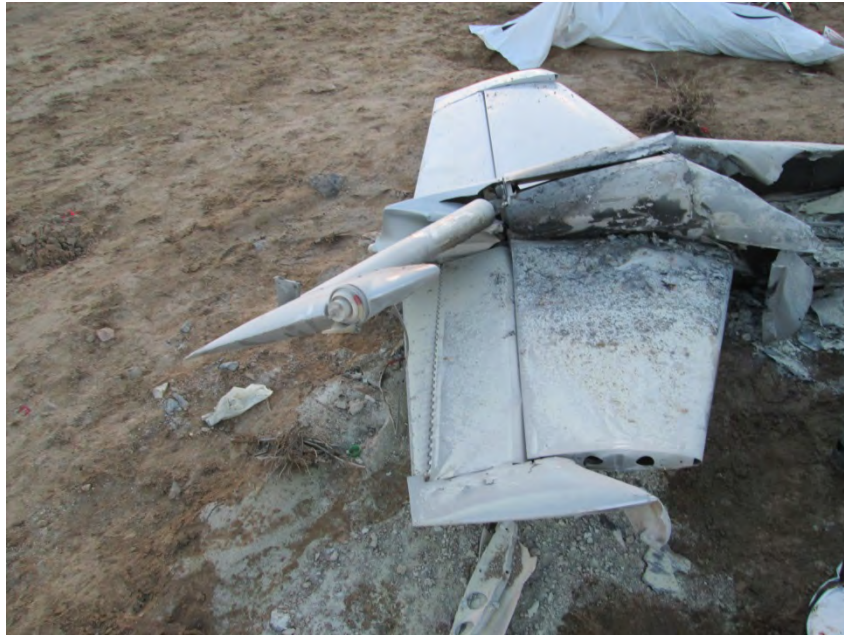
Photo 8 Right Horizontal Stabilizer, Elevator, and Elevator Trim

The right horizontal stabilizer was attached, and in position; the inboard portion was charred. The right elevator remained attached, and in position, but the forward half of the elevator tip was hanging vertically. The elevator trim tab was in position.

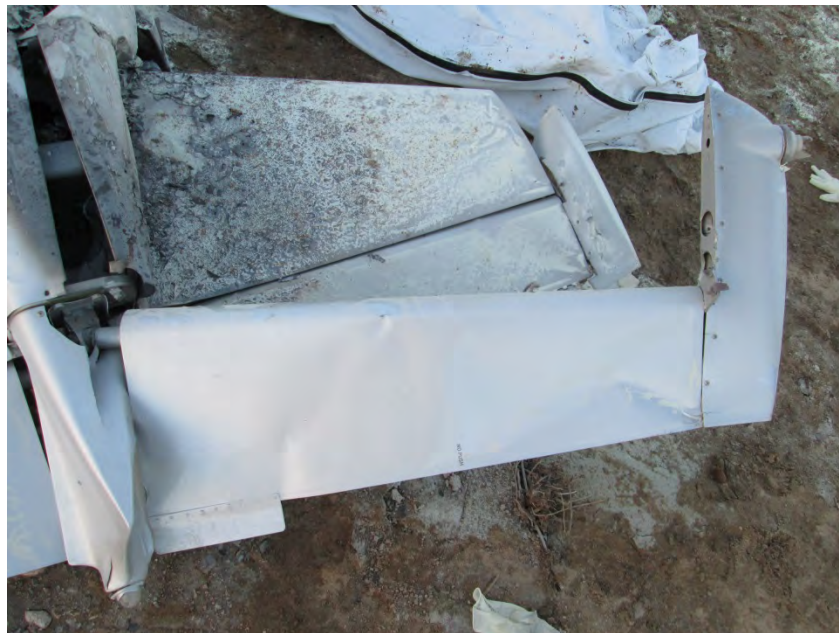
Photo 9 Rudder

The rudder remained attached to the airframe at its base. It was canted to the right about 70 degrees. The rotating beacon remained in position.

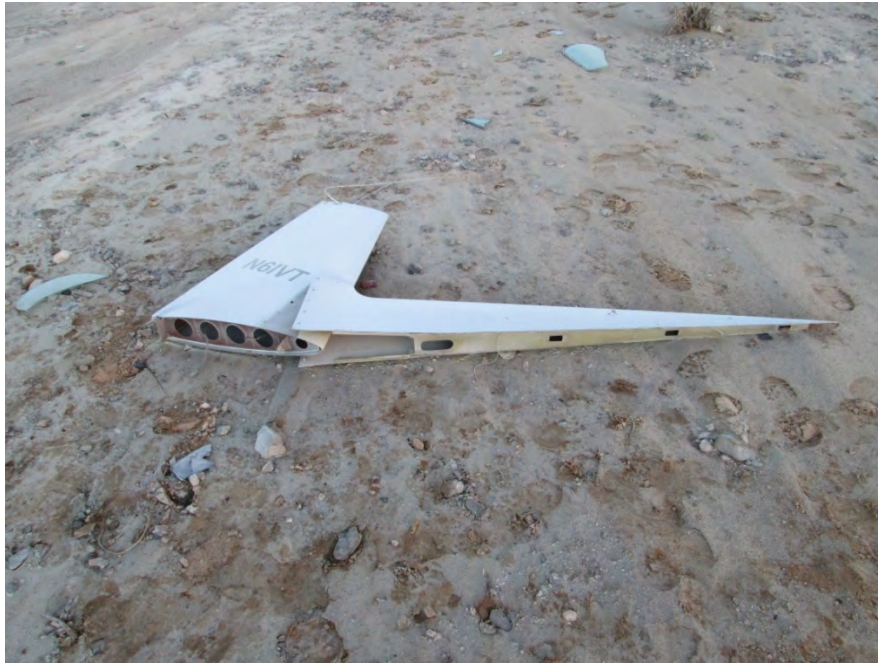
Photo 10 Fin and Vertical Stabilizer

The fin and vertical stabilizer separated; they were about 30 feet aft of the main wreckage. They were not charred or sooty. The fracture surfaces at the separation points were jagged and angular.

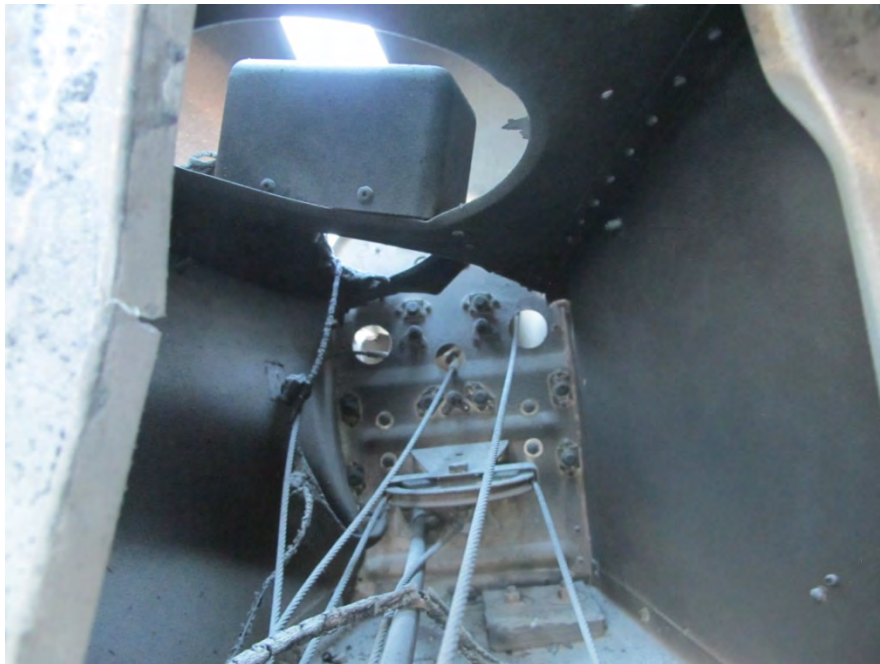
Photo 11 Control Cables in Empennage

Control cables and pulley remained connected in the empennage. This area was charred.

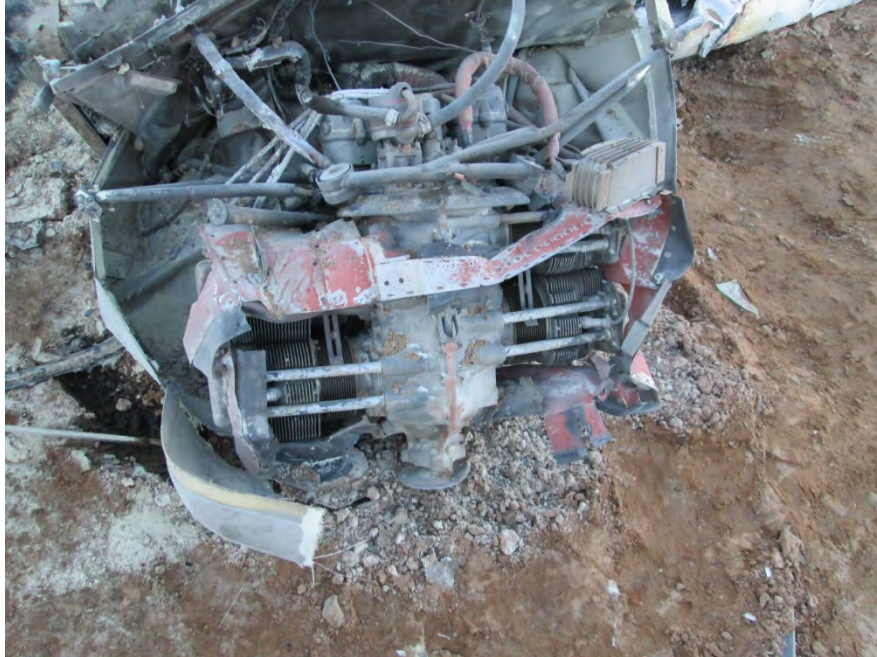
Photo 12 Top of Engine

The engine did not display evidence of catastrophic failure. It was in a nose down attitude.

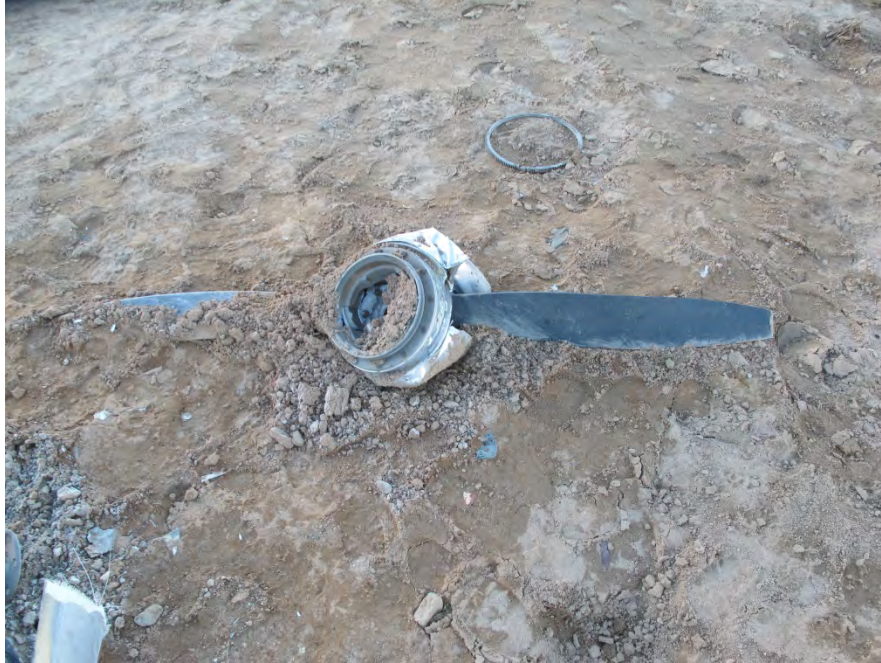
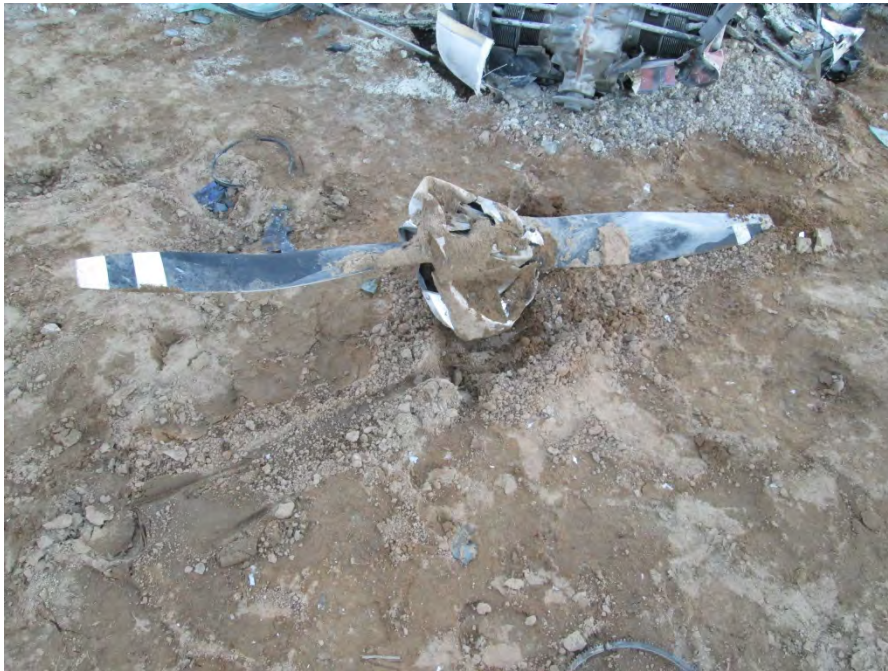
The propeller separated, and was nose first into the ground a couple of feet in front of the engine. One blade was partially buried in the soft sandy soil. After being pulled from the ground; investigators observed that the spinner was crushed aft. The partially buried blade was polished on the front face.
