NATIONAL TRANSPORTATION SAFETY BOARD

ON SITE INFORMATION

**NTSB Accident: WPR14FA132
Accident Date: March 8 or 9, 2014 (Actual date/time uncertain)**

Location: Near Carson City Nevada
Date: Unknown
Aircraft: Cessna 120, N76856, Serial # 11290
NTSB IIC: Michael Huhn

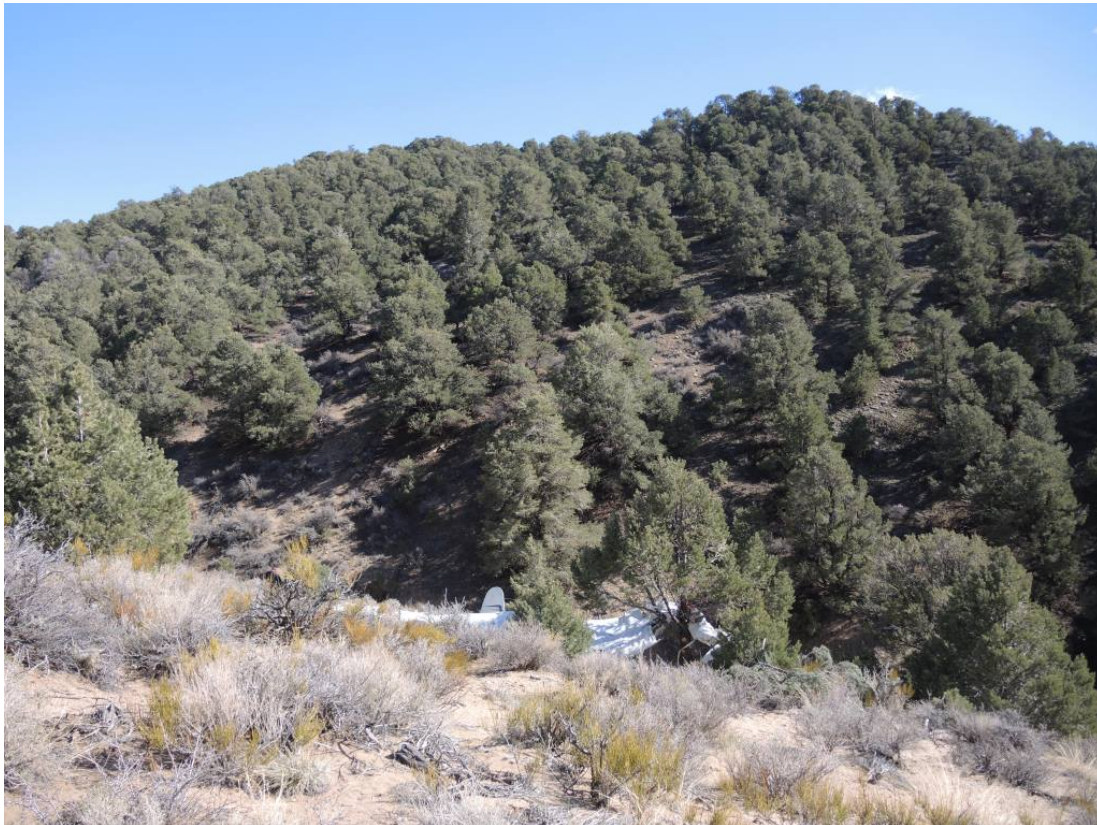
- The wreckage was on the roughly north side of a roughly east-west valley that opened to the west
- The valley width did not change linearly with east-west travel, it narrowed rapidly in the easternmost section
- Lat/Long: 39° 5.880' North; 119° 39.899' West
- Elevation 6,219 feet msl
- According to Google Earth information:
 - The impact site was 6.06 nm on a true bearing of 145° from the center of CXP
 - The impact site was offset about 7,300 (1.2nm) feet southwest of a direct line between CXP and NV33
 - At the impact site elevation and location, the valley was about 300 feet wide
- Wreckage was upright, on sandy slope with partial vegetation
- Slope was approximately 30 degrees, downslope was 160 degrees magnetic
- The wreckage was about 100 feet downslope from a jeep trail

Figure 1 - Wreckage In Situ (looking SE)

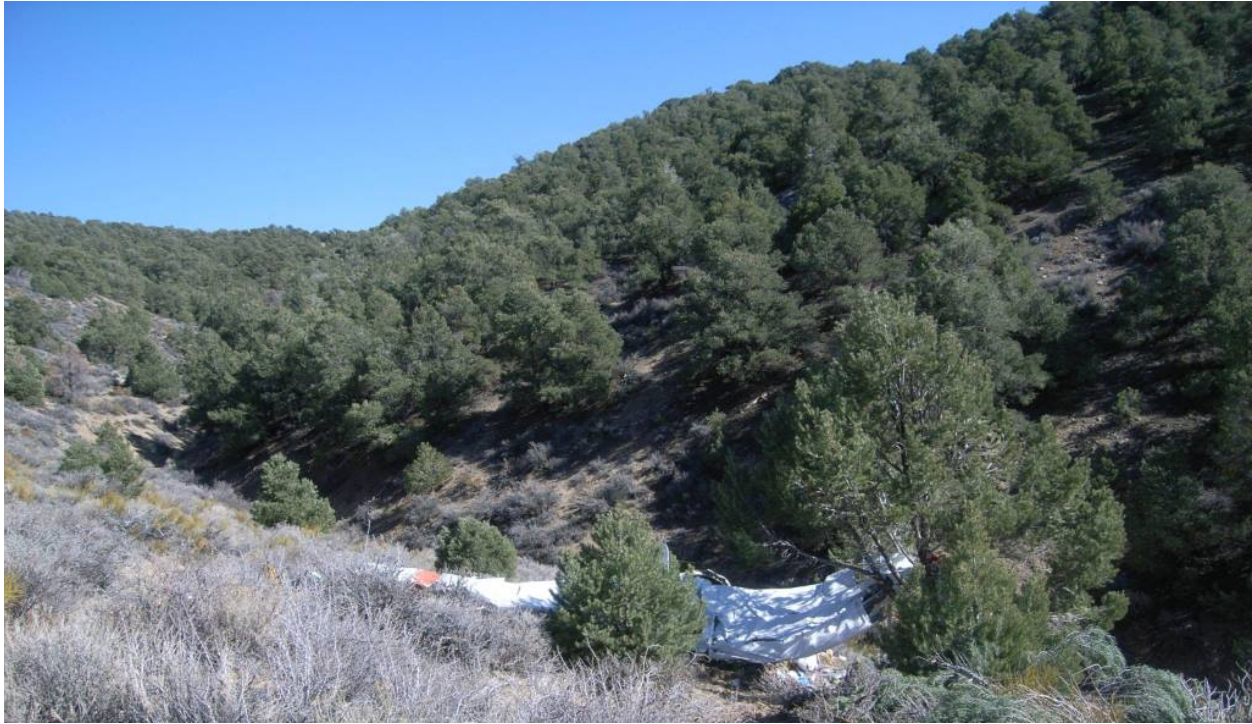
Figure 2 - Closer View of Wreckage (looking ESE)

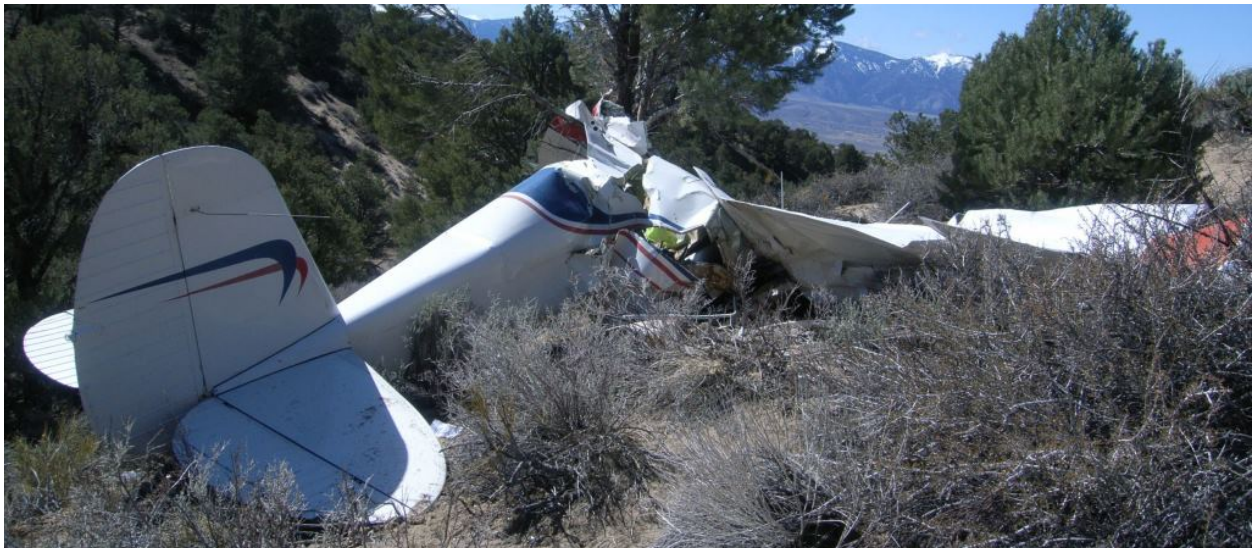
- Tail did not “scorpion over”; similar crush damage on both top and bottom fuselage skins near baggage area
- No structural damage to tailcone/aft fuselage (aft of baggage area) or to empennage

Figure 4 - Empennage (looking WSW)

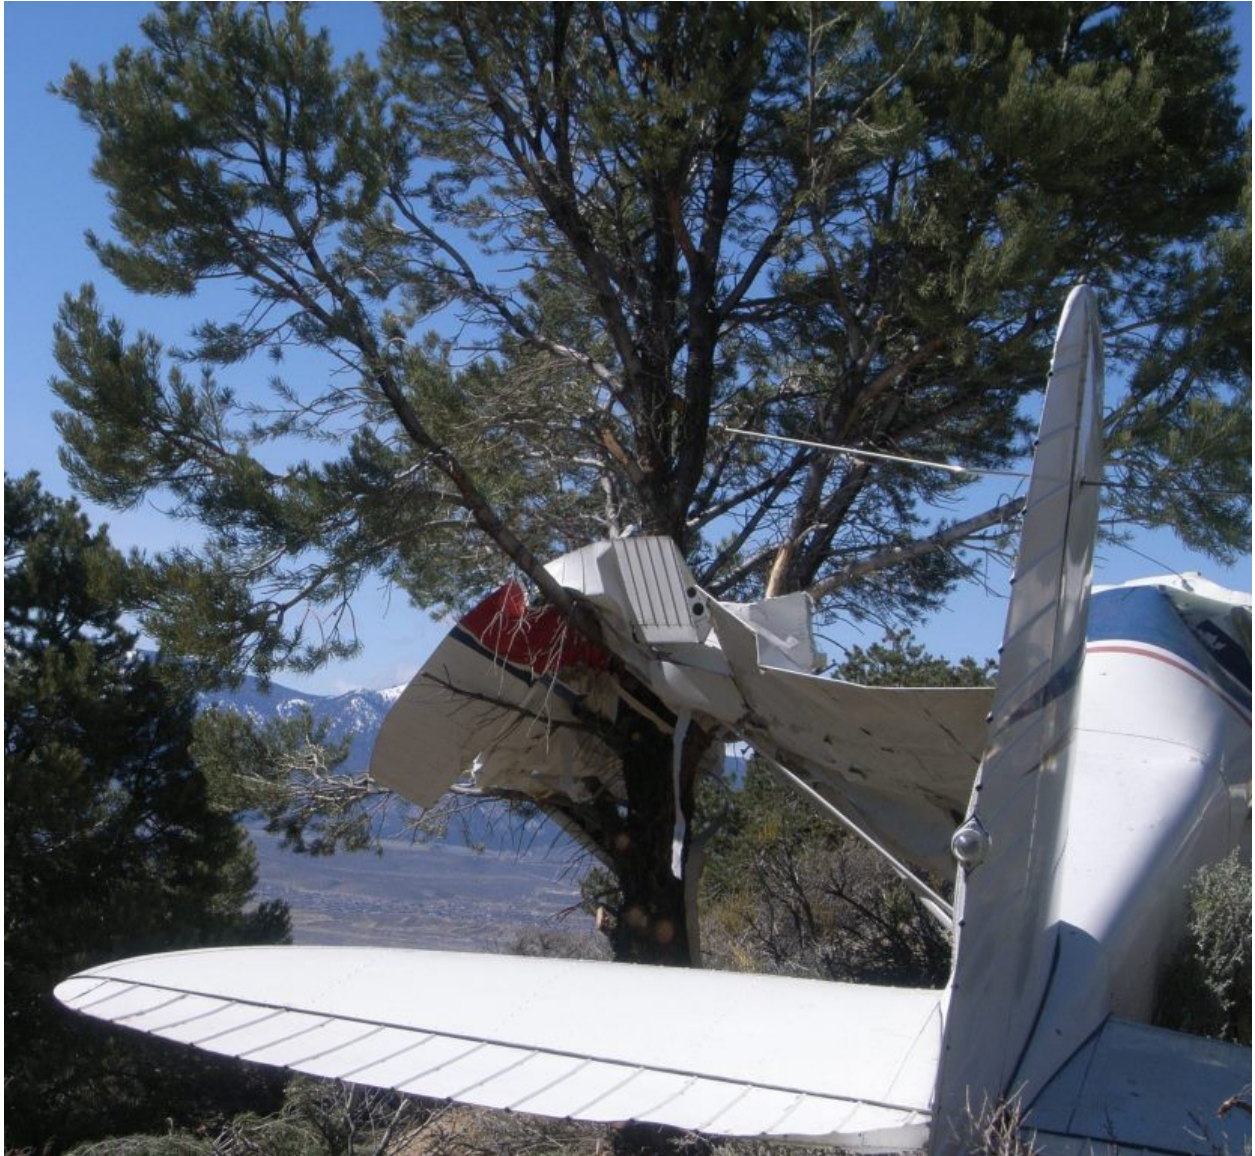
- Tree damage was consistent with a 50 to 70 degree descent trajectory (relative to local horizontal)
- No evidence of fuselage rotation (spin) at impact

Figure 5 – Empennage and Left Wing in Tree (Note undamaged branches)

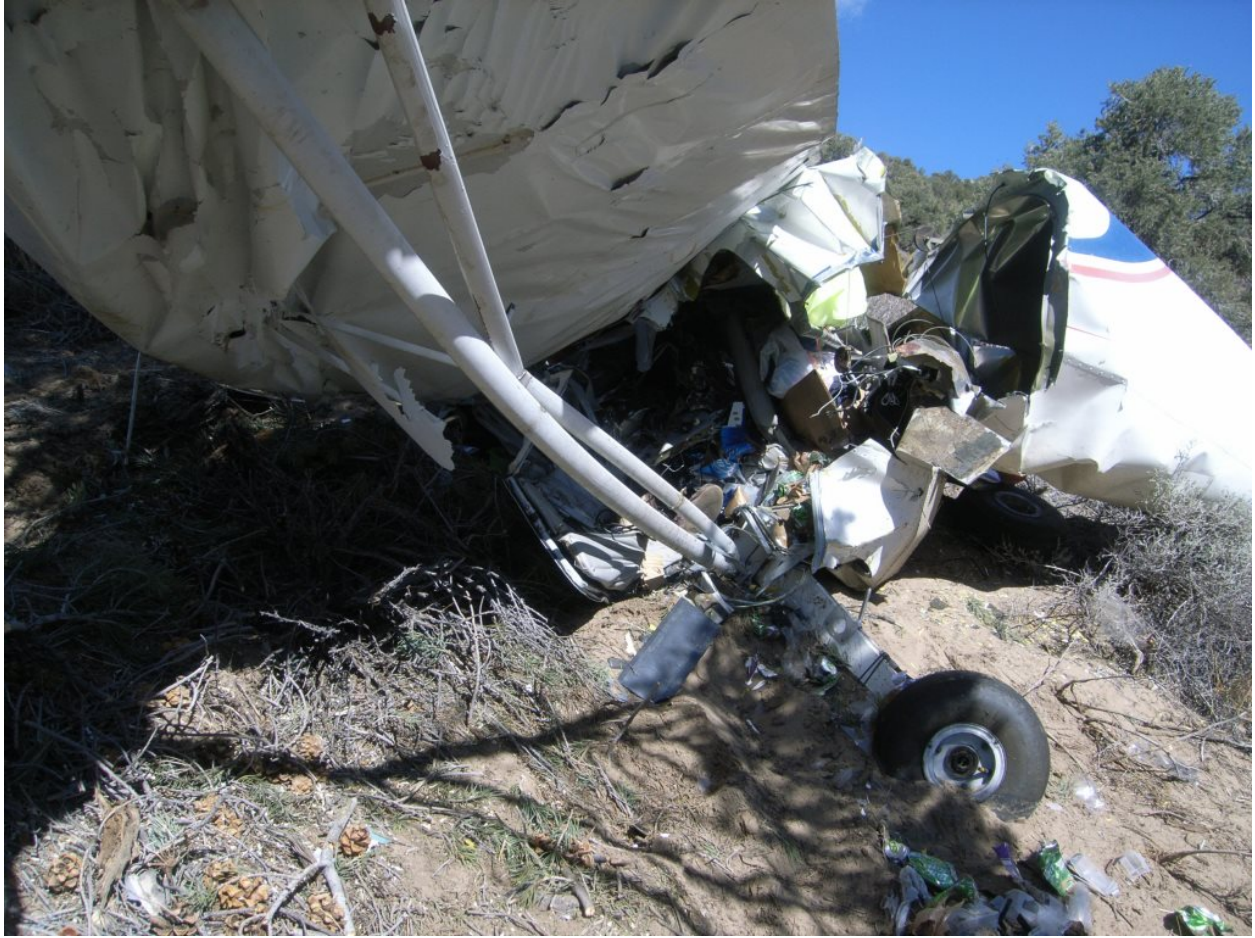
Figure 6 - Left View of Cabin Area

- Fuselage extensively crushed in the up and aft direction until just aft of cabin
- Front of fuselage exhibited significant accordion-style aft crushing

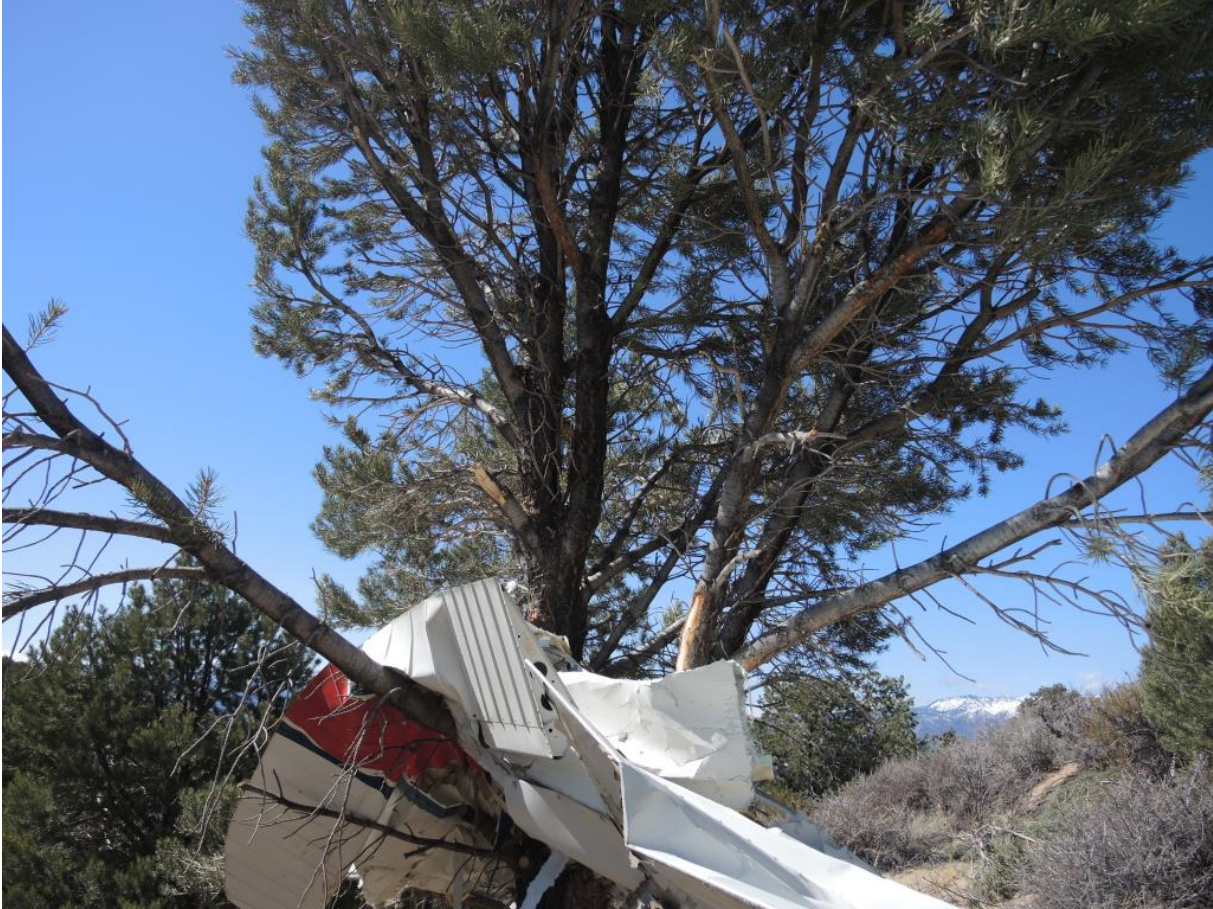
- Wing assembly translated forward and down w/r/t normal position
 - Wing LE was forward of firewall (or vice versa)
- Left wing impacted tree at the span position of the landing light

Figure 7 - Closeup of Left Wing in Tree

- Engine intruded aft into cabin/cockpit
- Instrument panel severely deformed
- Right wing leading edge crushed aft along its full span
- Left wing significant crush damage isolated to area where wing impacted tree

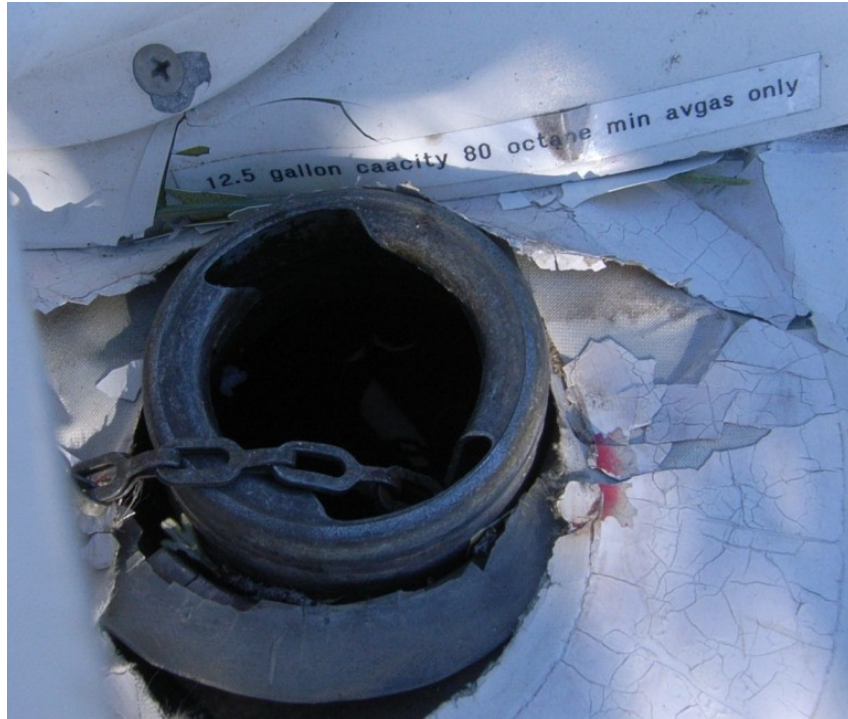
- Both fuel tanks placarded "12.5 gallon capacity 80 octane min avgas only"
- Fuel caps were found securely installed
- An undetermined amount of fuel was observed in both fuel tanks
- The fuel tested negative for water
- The fuel strainer glass bowl was fractured into multiple pieces
- Dirt from the accident site was on the strainer screen
- Fuel was observed dripping out of the fuel supply line to the fuel strainer
- The fuel handle was in the "left" position and trapped in a fold of the cabin floor
- The handle had separated from the selector valve
- The position of the fuel selector valve could not be determined due to aircraft damage and the fracture-separated handle
- The handle did not appear to be OEM

Figure 10 - Fuel Filler Neck with Placard (Cap removed by investigators)

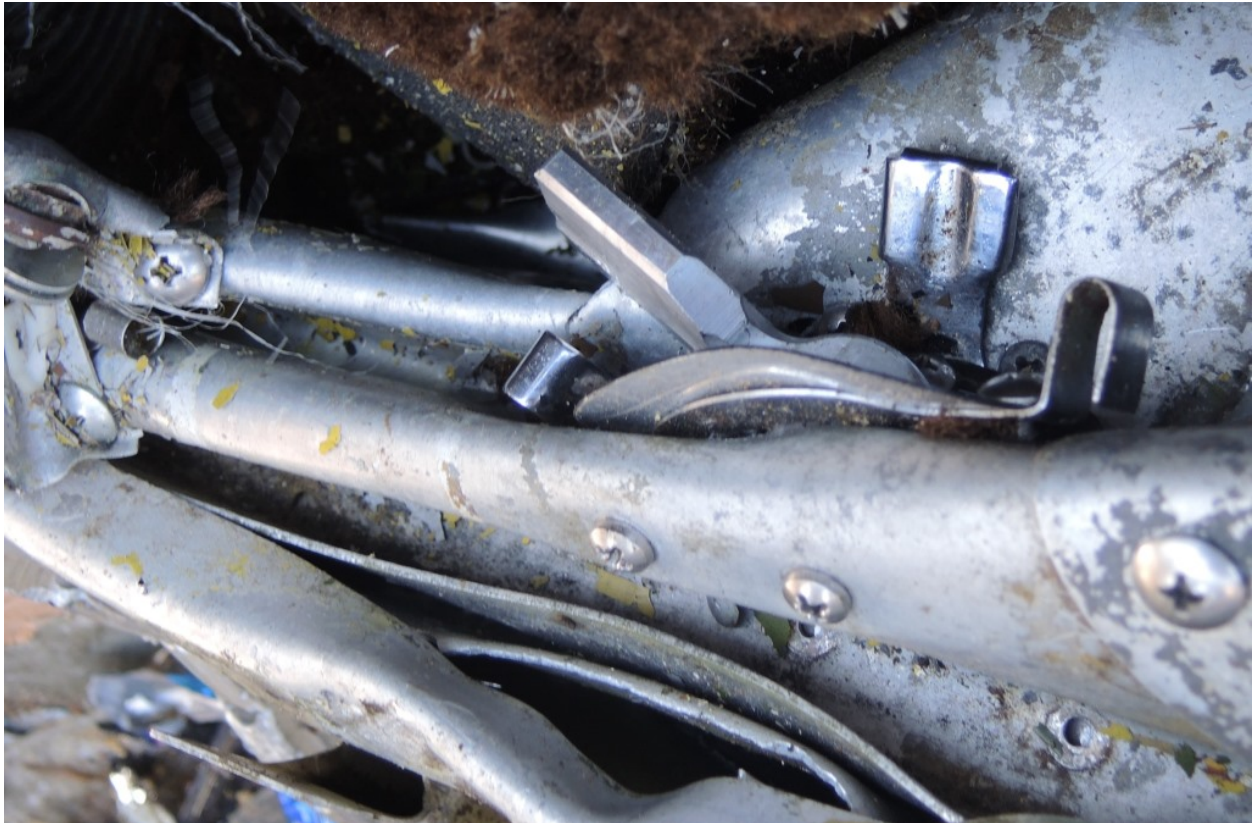
Figure 11 - Cockpit Fuel Selector (Folded in floor)

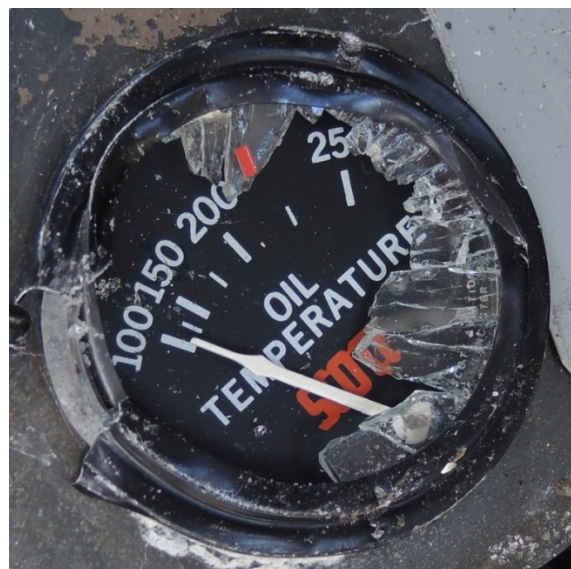
Figure 12 - Oil Temperature Gauge

- Oil temperature – 110 degrees (no units F or C)
- Five flight instruments were recovered (all faceplate glass shattered/missing) loose in wreckage
 - VSI – 1200 FPM down

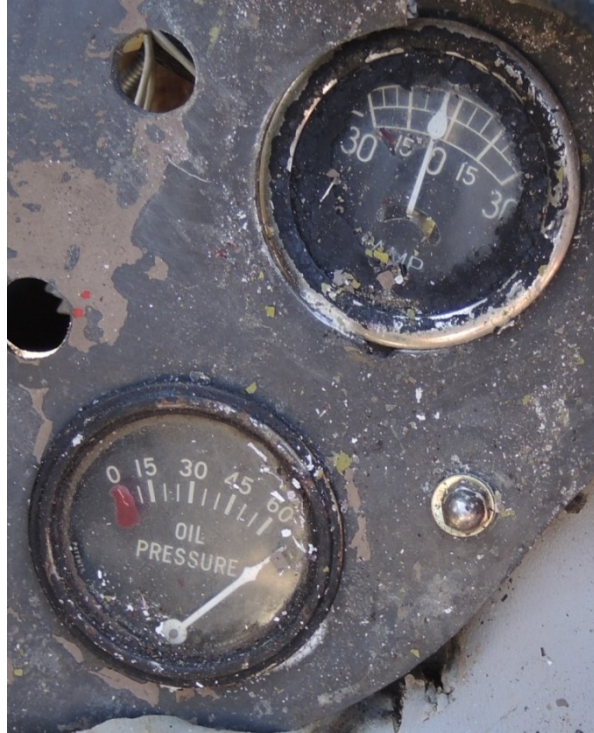
- Two instruments remained undamaged in panel
 - Ammeter – 5 amps discharge (minus)
 - Oil pressure – off scale high
- One instrument remained in panel (fractured face glass

Figure 13 - Ammeter and Oil Pressure Indicators

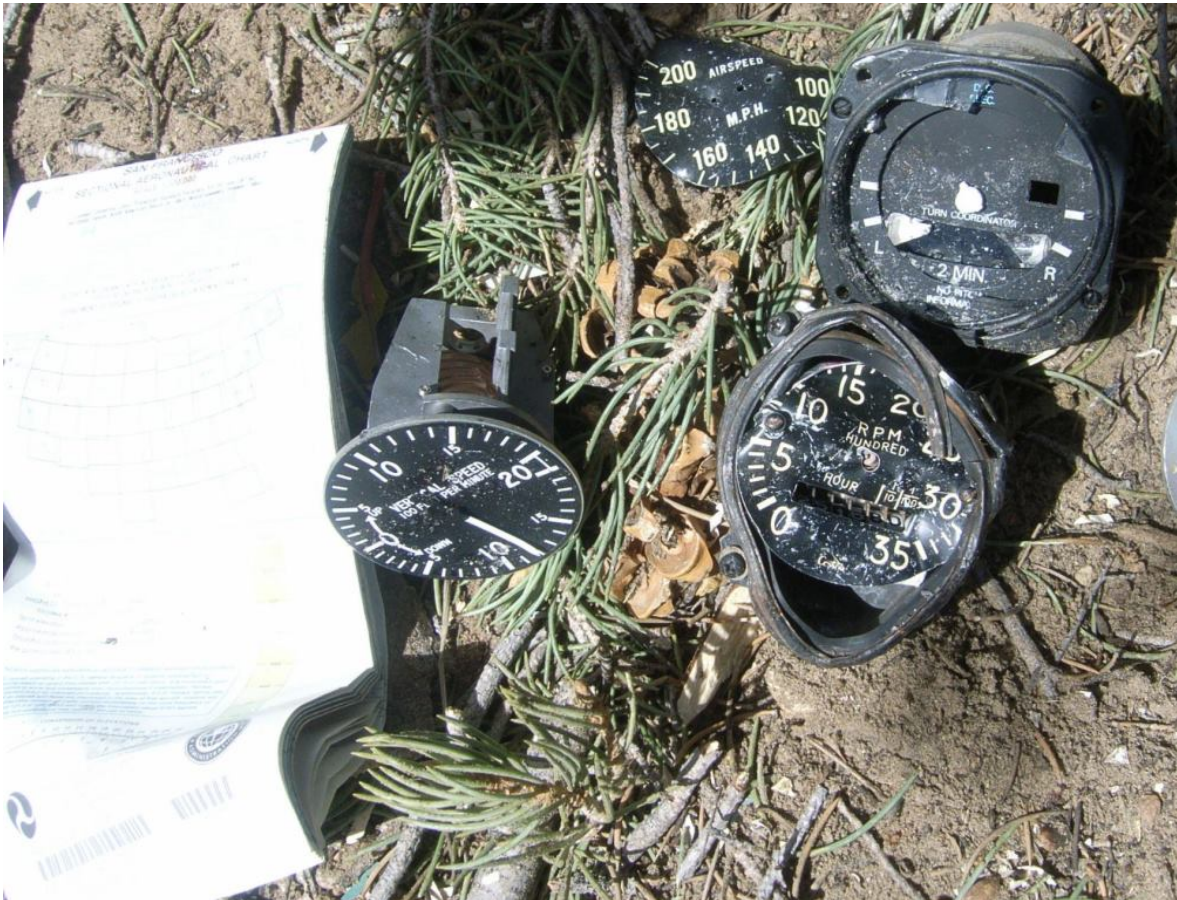
- Tachometer - no needle. 3627.91 indicated on hour wheel
 - Turn coordinator – no usable information discernible
 - Airspeed indicator - face plate only. No needle marks or speed arcs

Figure 14 - Flight Instruments and Exemplar Folded Chart

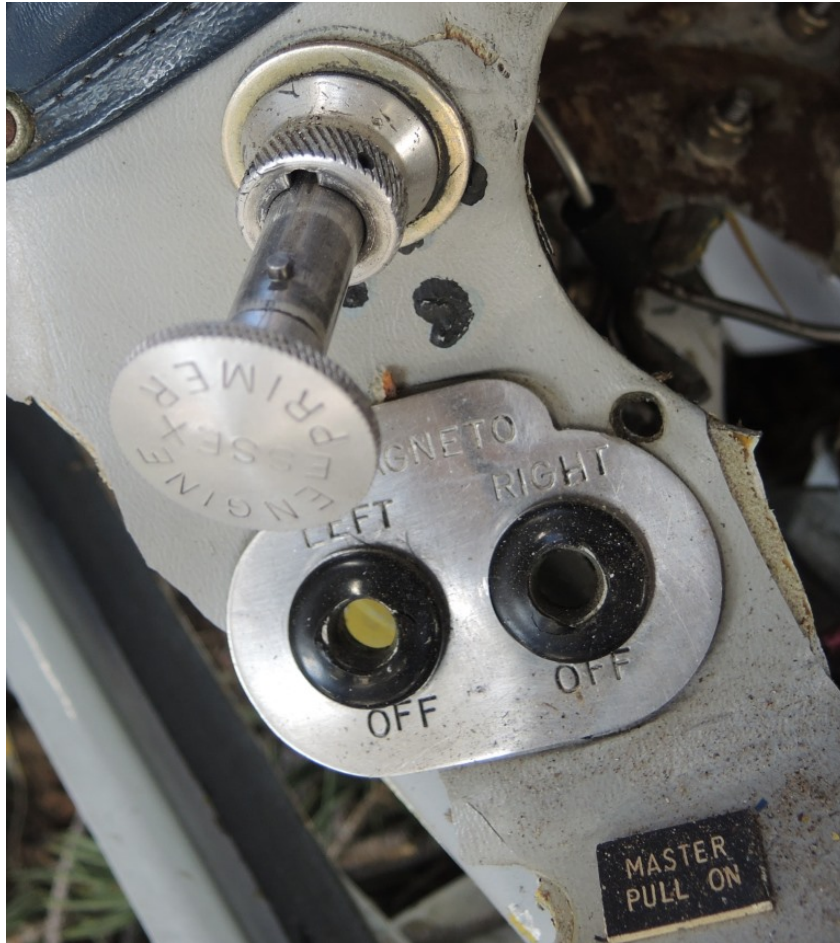
- Primer handle found at full aft position
 - FAA observed this condition also, prior to recovery of pilot
 - Primer could be locked
- Mixture and Carburetor heat full forward (full rich; off)

Figure 15 - Primer as Found (note aft/out position)

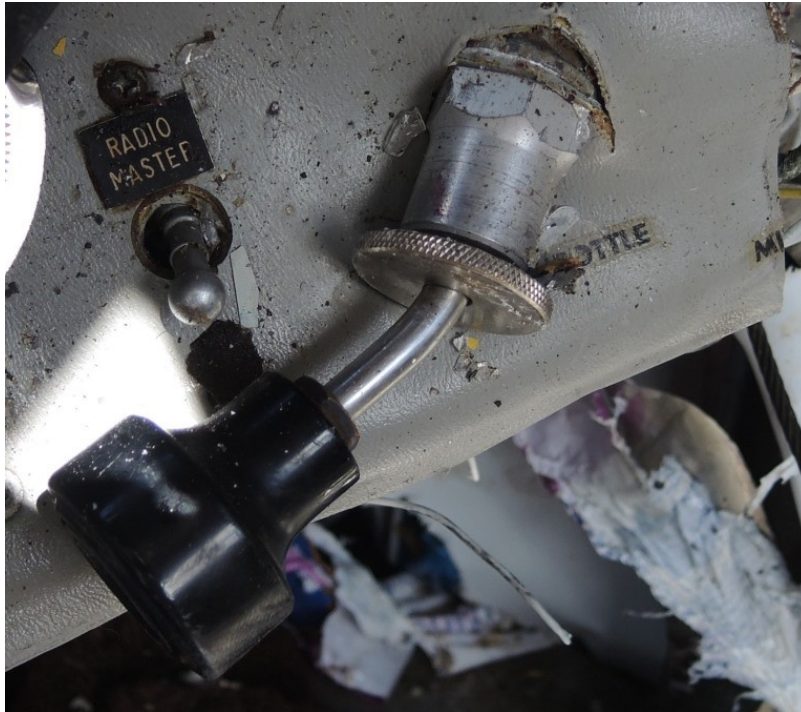
Figure 16 - Throttle Control

- Altimeter – altimeter setting wheel/faceplate only
- Throttle control: 1” out/aft and bent over
 - Note: Rigging requires that carburetor stops be reached prior to cockpit control stops, which typically results in throttle control being about 1 inch out /aft from panel at full throttle setting

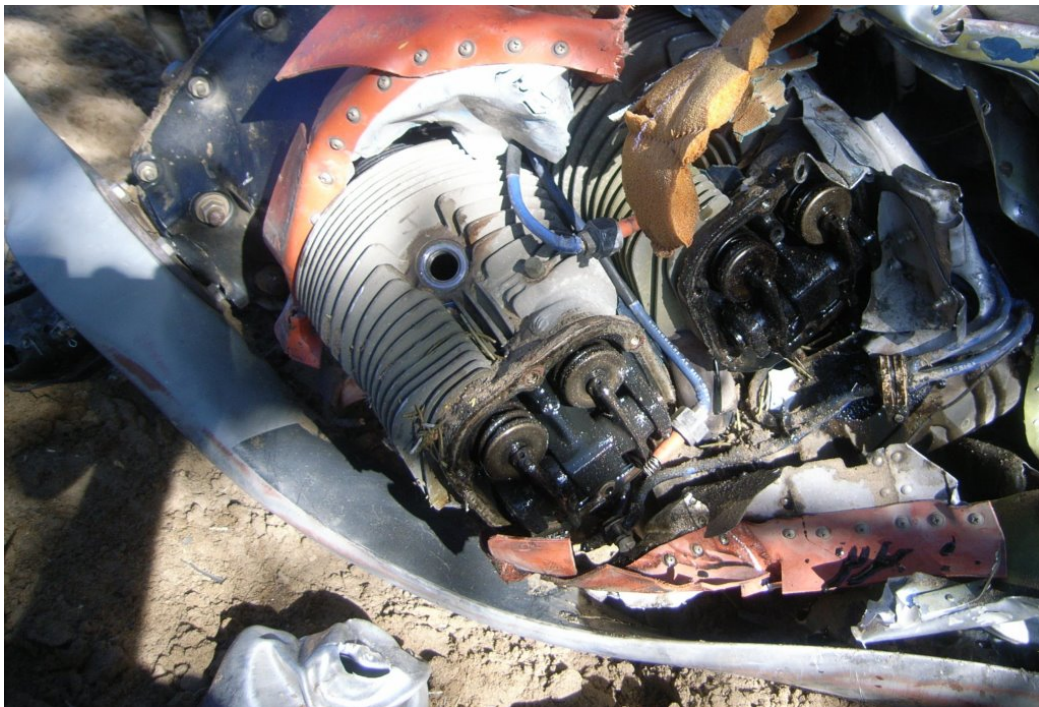
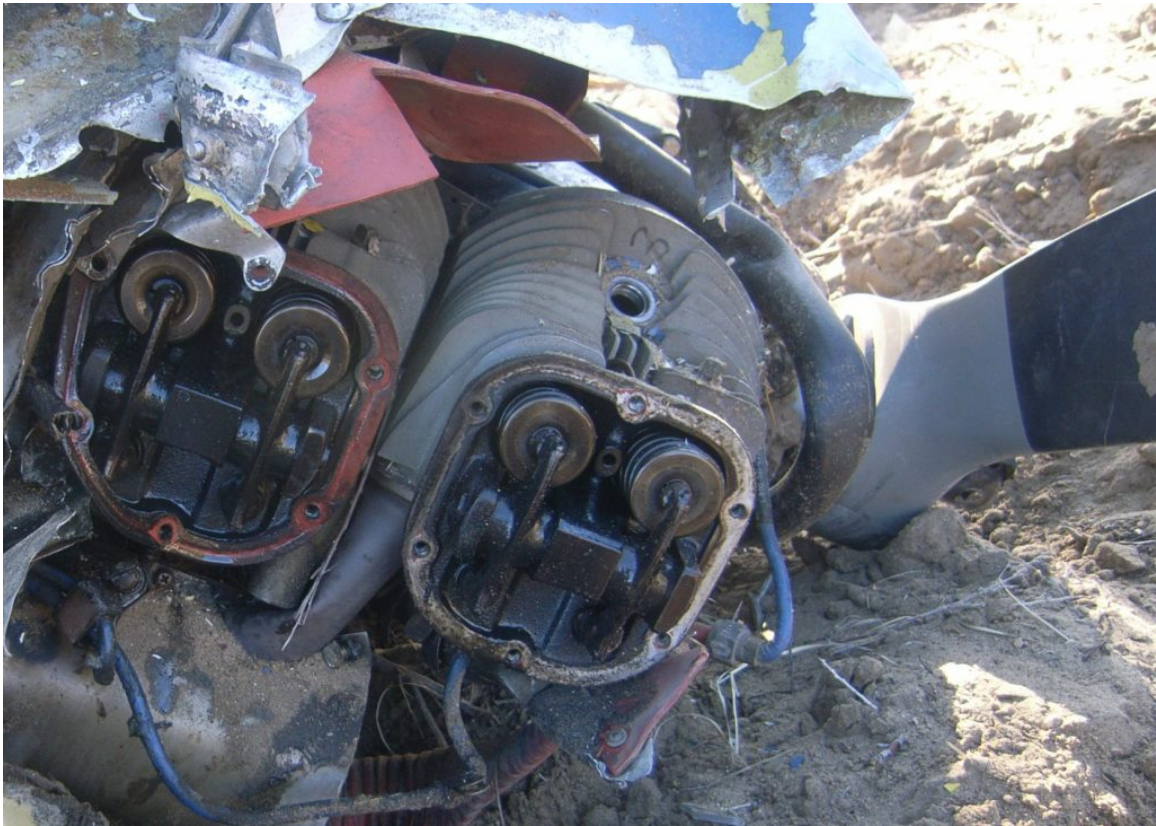
- All valve covers were removed
 - all rocker arms and assemblies were observed to be intact
 - No anomalies observed
 - All assemblies were oil-coated
- The condition of the propeller limited the amount of engine rotation possible to approximately 60 degrees

Figure 19 - Left Cylinder Bank (Valve covers removed)

Figure 20 - Right Cylinder Bank (Valve covers removed)

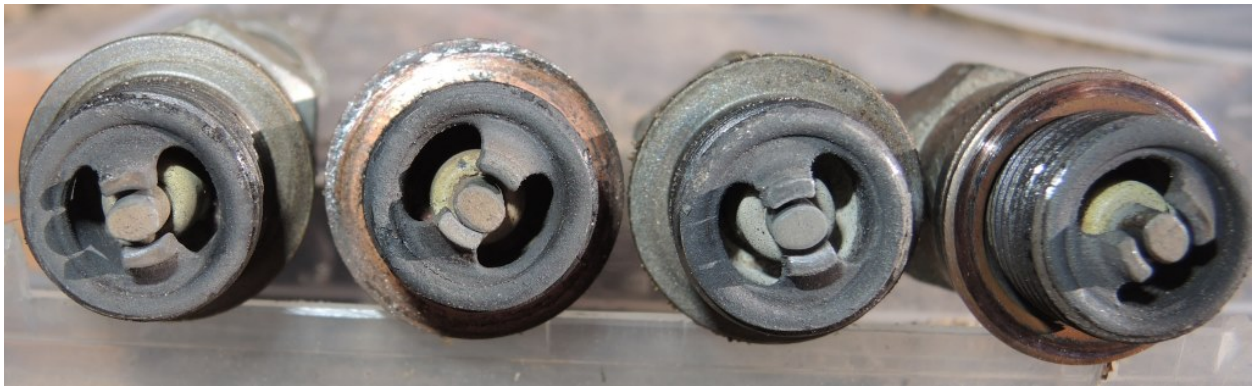
- All 4 top spark plugs were removed; electrodes were light tan in color, consistent with normal operation and mixture
- The number 2 spark plug body was bent and one side electrode had an abnormally small gap (was pushed towards center electrode tower)

Figure 21 - Spark Plugs (#1 to #4, left to right)

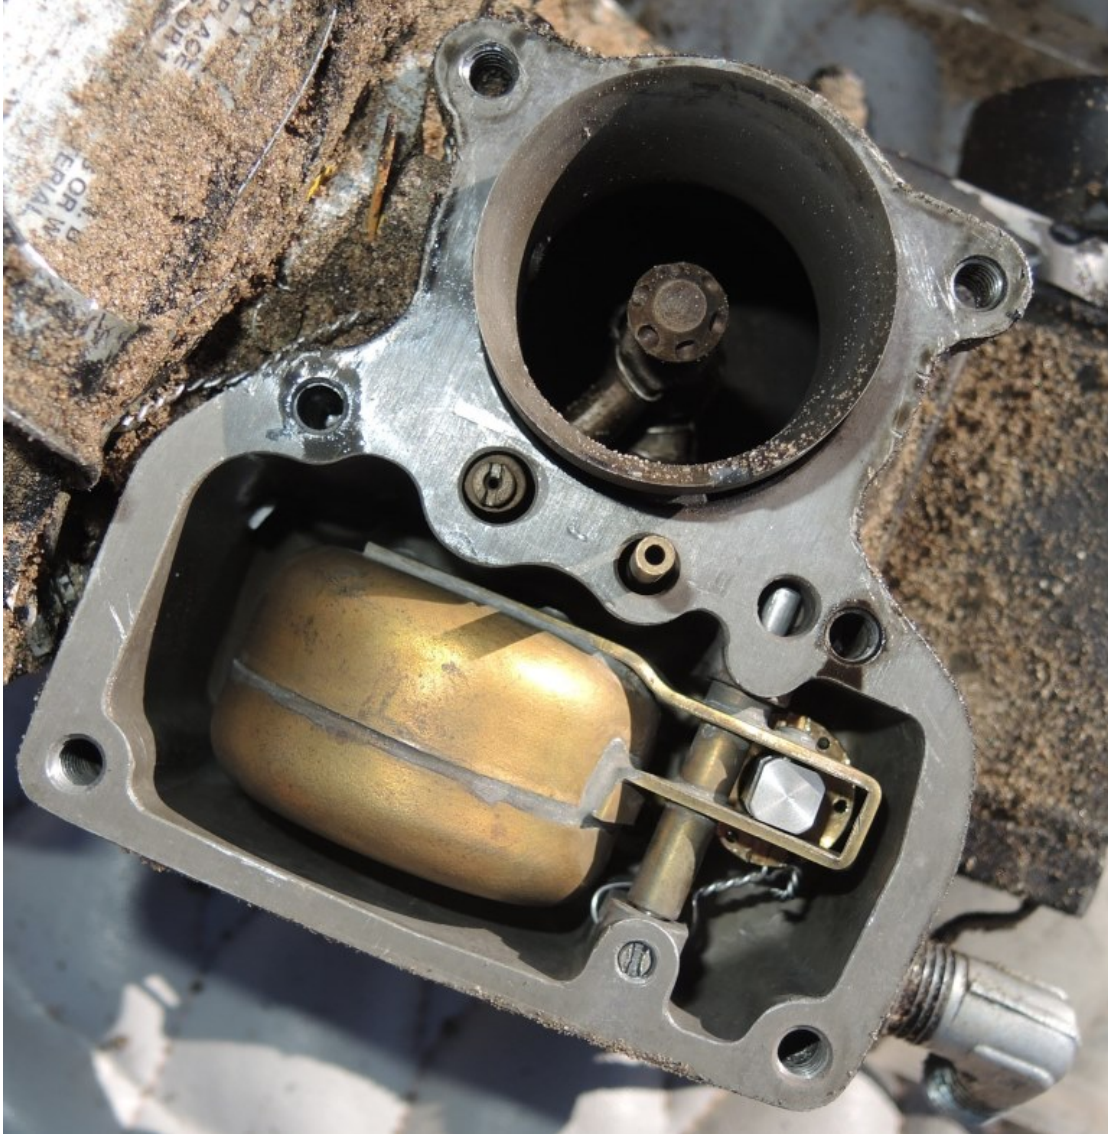
- Carburetor was fracture-separated from engine at top of carburetor
- Damage precluded checking of engine control cable continuity
- Investigators cut throttle and mixture cables at carb for removal from engine

- Some fuel was found in the carburetor bowl
 - Carburetor fuel screen clear
 - Carburetor equipped with metal float

Figure 22 - Carburetor Throat and Bowl

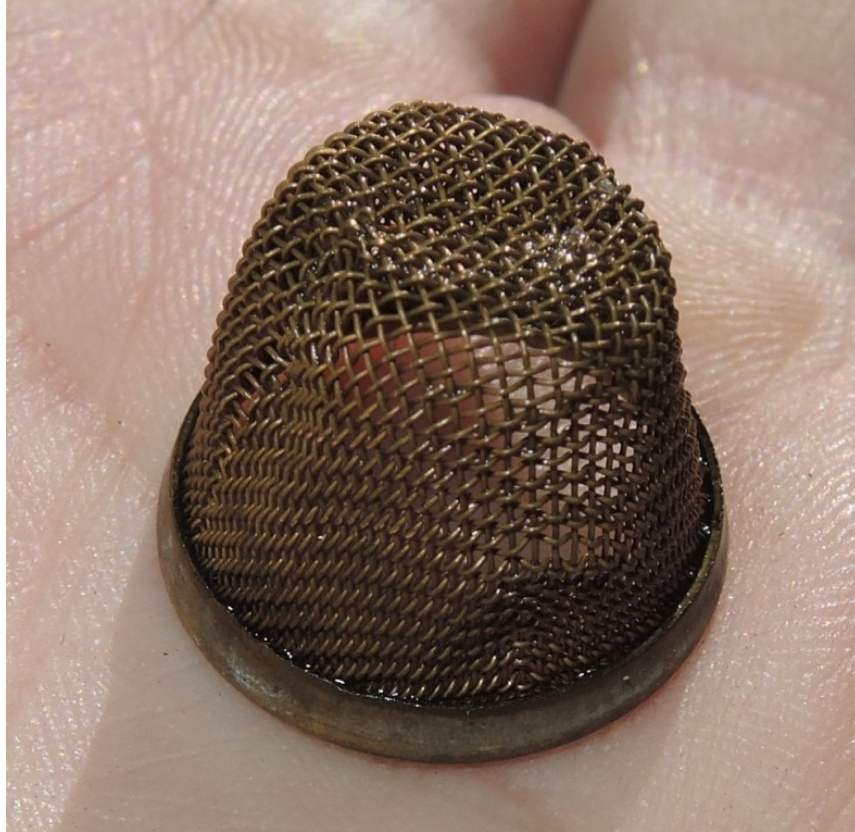
Figure 23 - Carburetor Fuel Screen

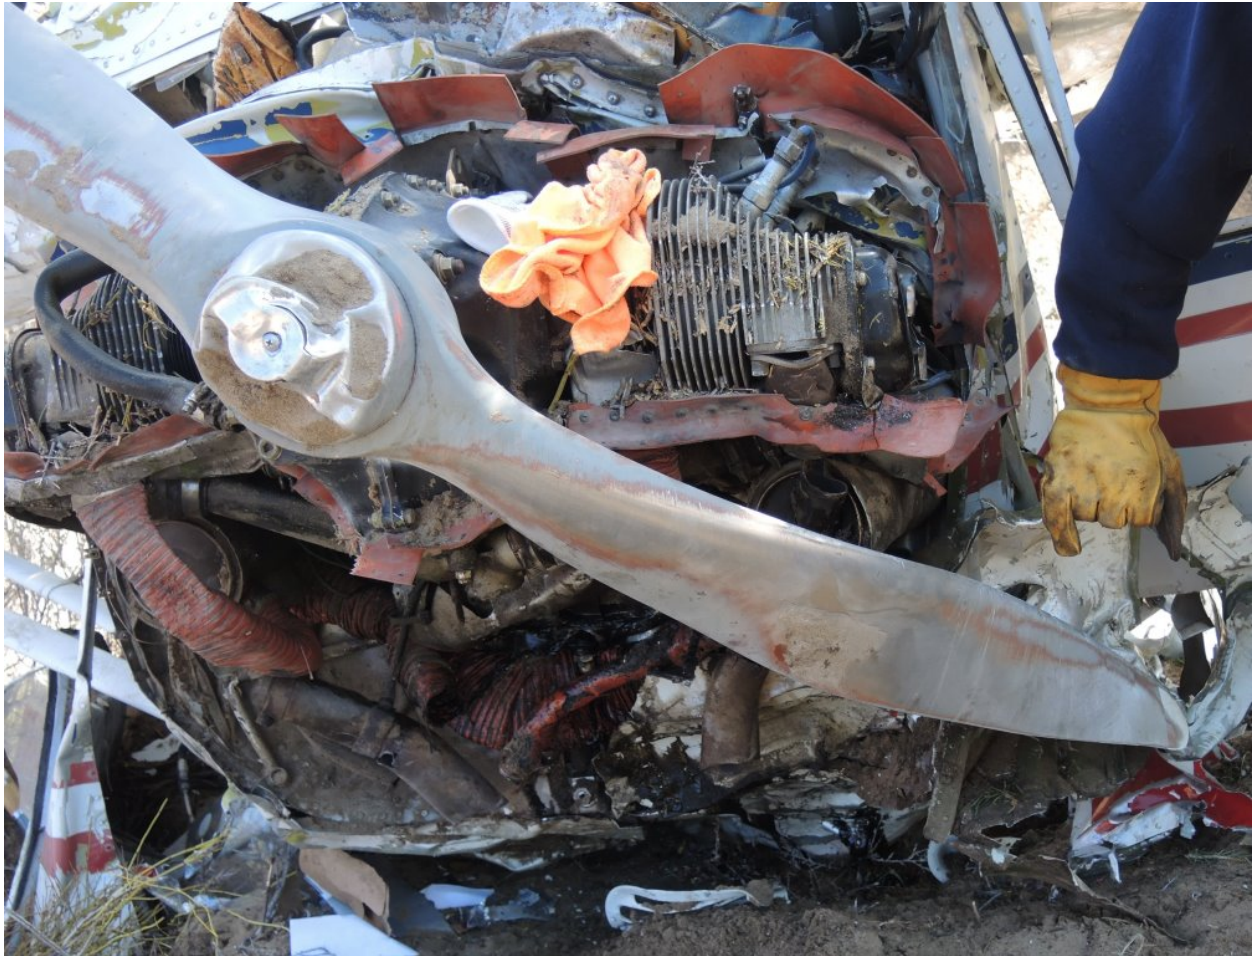
- Propeller was fixed pitch 2 blade metal
- Sensenich, serial number 37949, model 6?K -2 -44
- Propeller leading edges and cambered side of blades exhibited significant chordwise scouring of paint, consistent with being driven in rotation through sand
- One blade was relatively straight
- One blade was bent aft at mid span at least 45 degrees and twisted at tip
- Spinner/hub cover was compressed aft

Figure 24 – Bent Propeller Blade (Note scouring)

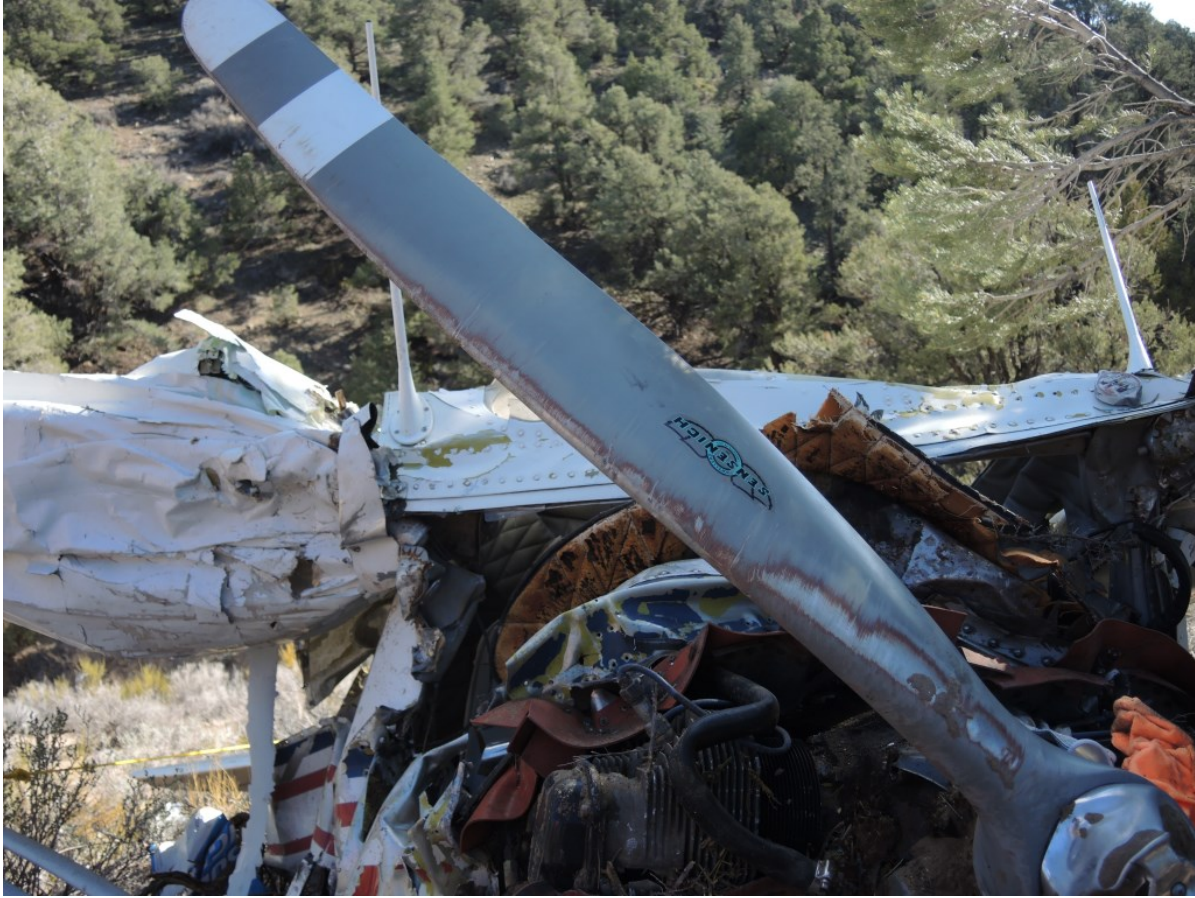
Figure 25 - Straight Propeller Blade (Note scouring)

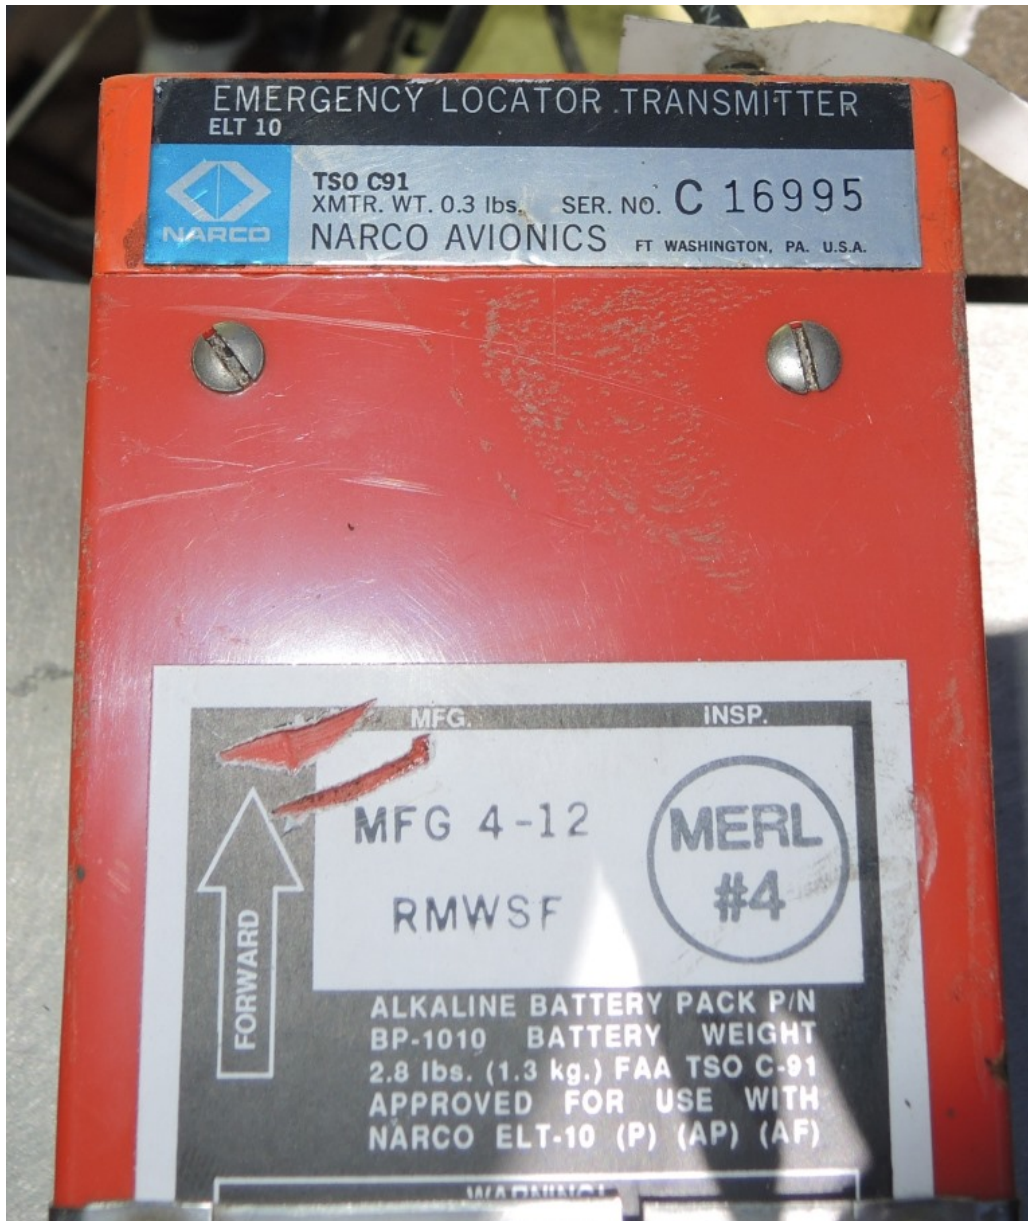
Figure 26 - ELT

- NARCO ELT-10 TSO C-91 121.5 MHZ
- Battery manufactured 4/12
- The ELT and bracket was found removed from the airframe and the switch was in the off position
- According to the FSDO manager, he turned off the ELT
- According to the FSDO manager, SAR personnel on the ground and CAP personnel in the air did receive intermittent ELT signals
- No other reports of an ELT signal were received
