**NATIONAL TRANSPORTATION SAFETY BOARD**  
Vehicle Recorder Division  
Washington, DC 20594

## **On-Board Image Factual Report**

Location: Red Oak, Iowa  
Date: April 17, 2011, 0700 Central Daylight Time (CDT)  
Operator: Burlington Northern-Santa Fe Railroad  
NTSB Number: DCA11FR002

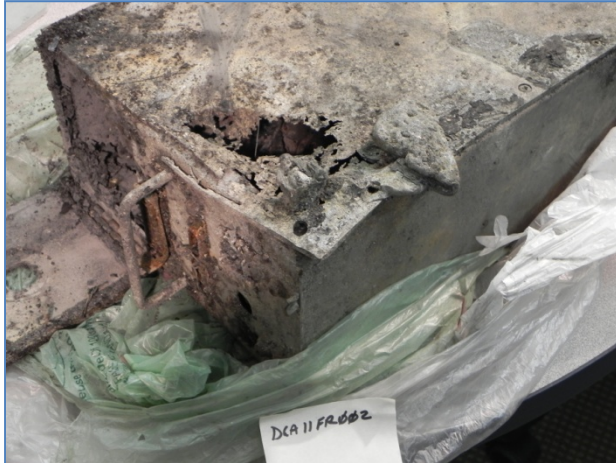
Upon arrival in the lab, the hard drive enclosure was found to be heavily fire damaged (Figures 1 & 2). The hard drive caddy (Figure 3) and hard drive itself (Figure 4) were extracted and found to have suffered heavy fire damage as well.

Figure 1. Fire damage to exterior of unit.

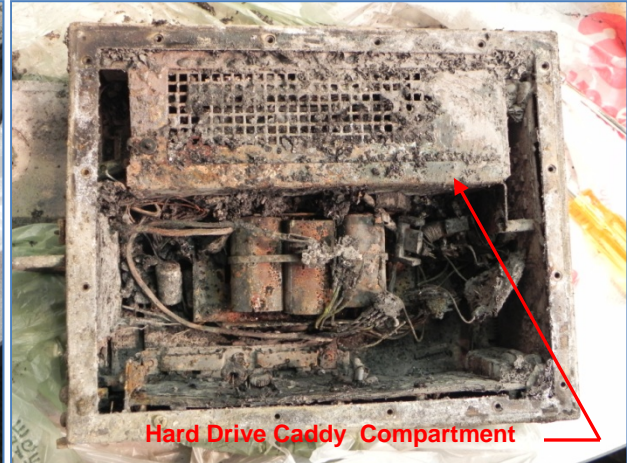
Figure 2. Interior of unit shown with side panel removed.

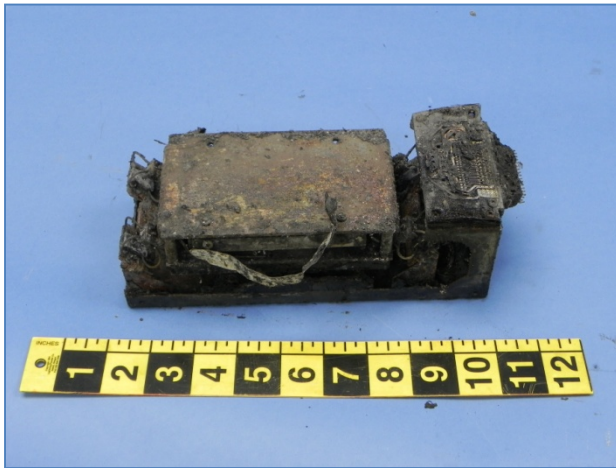
Figure 3. Hard drive caddy.

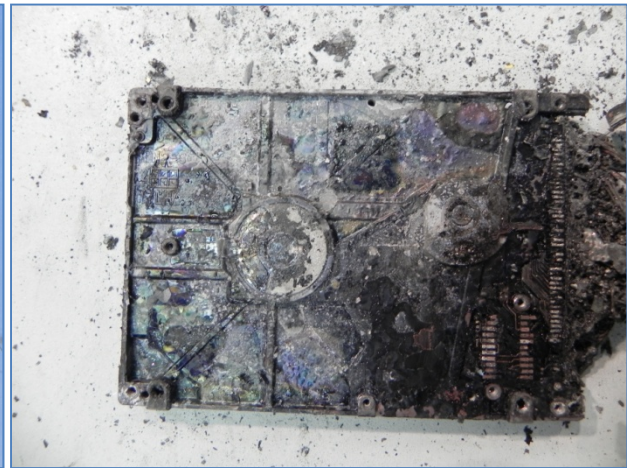
Figure 4. Damaged hard drive.

The hard drive was transported to an outside vendor specializing in hard drive data recovery. After examination and attempting to repair the damaged hard drive, the vendor reported the hard drive was damaged beyond repair and its contents were unrecoverable.
