**GROUP CHAIRMAN'S FACTUAL REPORT OF INVESTIGATION
On-Board Video Recording
DCA10MM017**

**NTSB Accident Number
DCA10MM017**

Location: New York, NY
Date: May 8, 2010
Time: 0919 Eastern Daylight Time
Vehicle: Staten Island Ferry Andrew J. Barberi
Vessel Number 629314

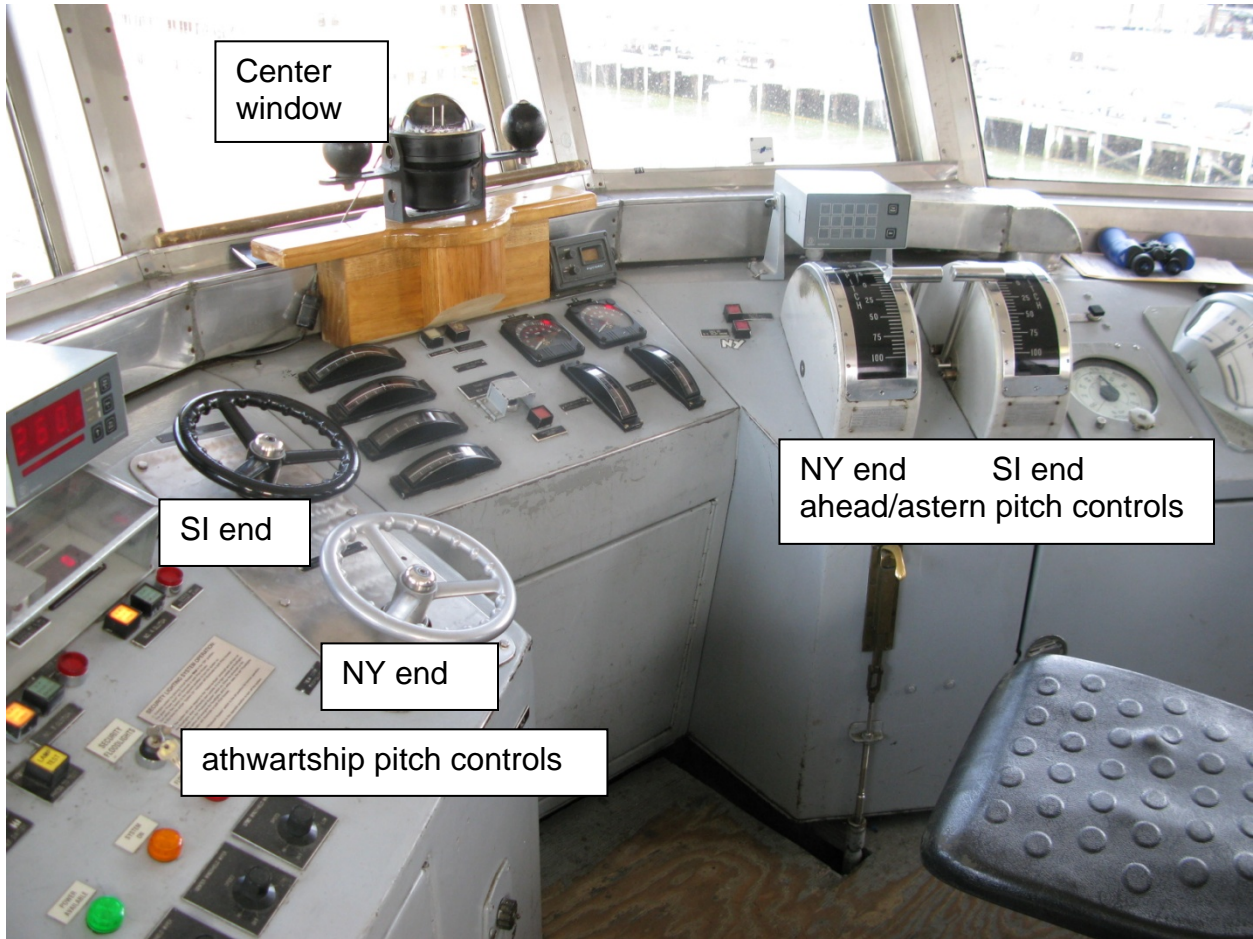
Figure 1 - Control Station Area

The camera view was from the portside of the Staten Island pilot house². The camera was located near the rear of the pilot house viewing forward toward the center window in front of the control station. The control station was in the center of the view, and all main controls could be seen (except when obscured by the crew). Figure 1 is a photograph of the control station area for reference.
