NATIONAL TRANSPORTATION SAFETY BOARD
Vehicle Recorder Division
Washington, DC 20594

On-Board Image Recorder

Specialist's Summary Report
By Christopher Babcock

Location: New York, New York
Date: January 9, 2013, 0841 eastern standard time (EST)
Operator: Seastreak
NTSB Number: DCA13MM005

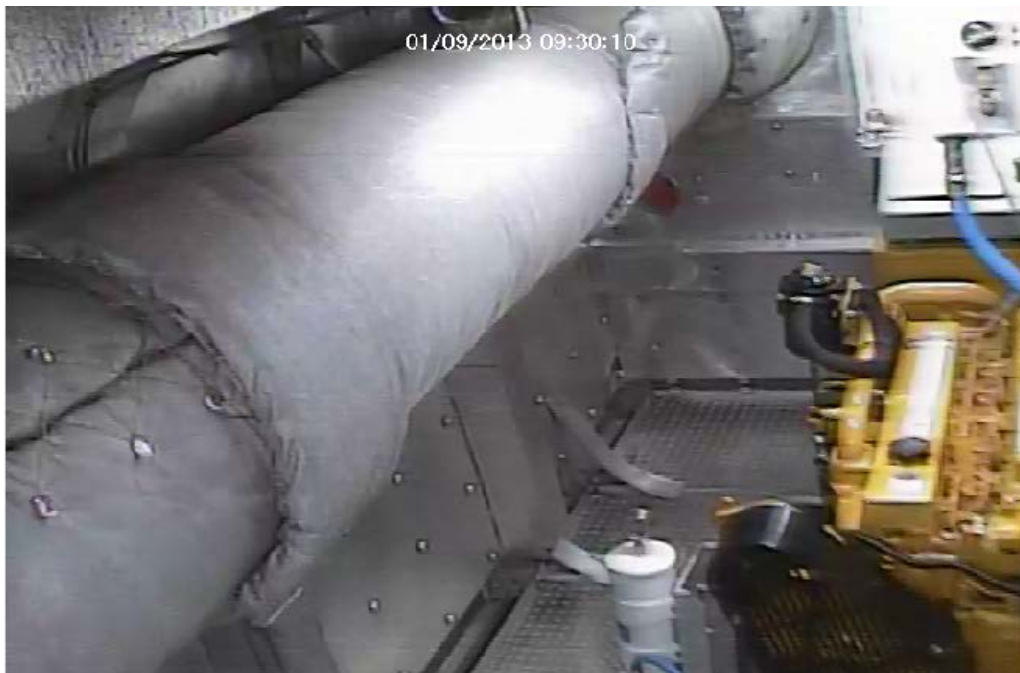
Figure 1. Field of view for camera in CH1.avi.

Figure 1 shows the field of view from this camera. When the video started at 0930:01, the camera was slightly vibrating. At 0935:27, the image jumped sharply. At 0935:49, the vibration picked up in intensity for approximately 30 seconds and then stopped at about 0936:35. At 0939:06 the vibration began increased for about 20 seconds and then returned to the lower level of vibration. This caused the camera to rotate slightly to the left at 0939:16. The video ends at 1029:58.

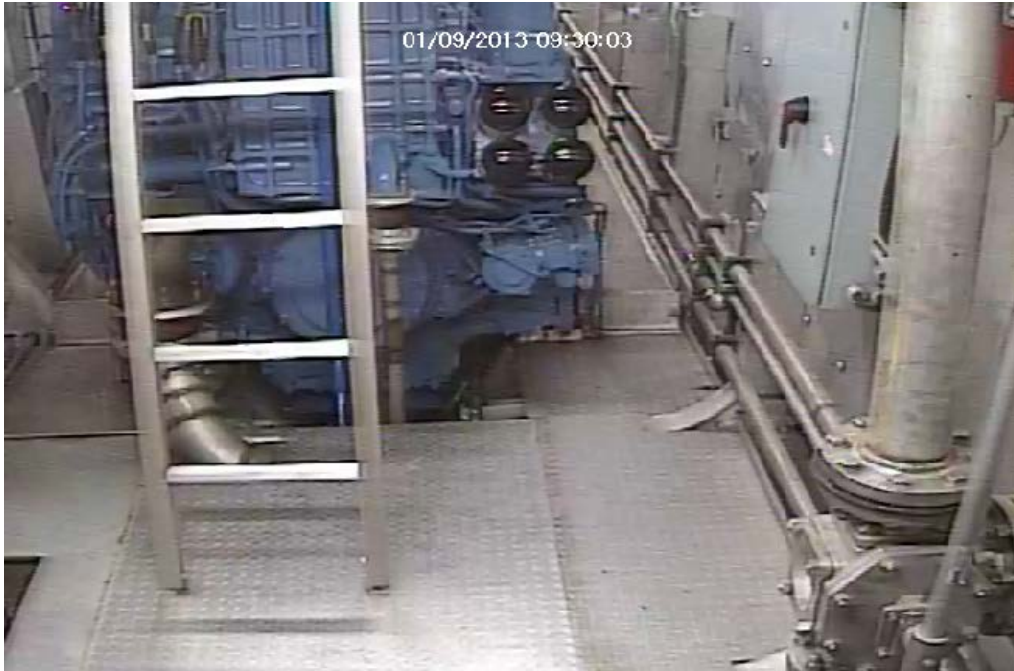
Figure 2. Field of view for camera in CH02.avi.

Figure 2 shows the field of view from this camera in the port engine room looking aft toward the port engine. The video started at 0930:01. The image frame was vibrating slightly. At 0935:12, the vibration of the image increased for approximately 15 seconds. At 0935:27, the bottom of the ladder was flung toward the camera. At 0936:35 the vibration stopped. At 0938:09, an individual wearing a blue zip-up jacket

with a blurry logo over the right breast, black pants, and a dark cap with horizontal white stripes descended the ladder and tended to something outside of the camera's field of view to the left. At 0938:34 the individual returned up the ladder and out of view of the camera. At 0939:09 the camera began vibrating heavily for approximately 24 seconds before returning to a lower level of vibration. The video ended at 1029:58

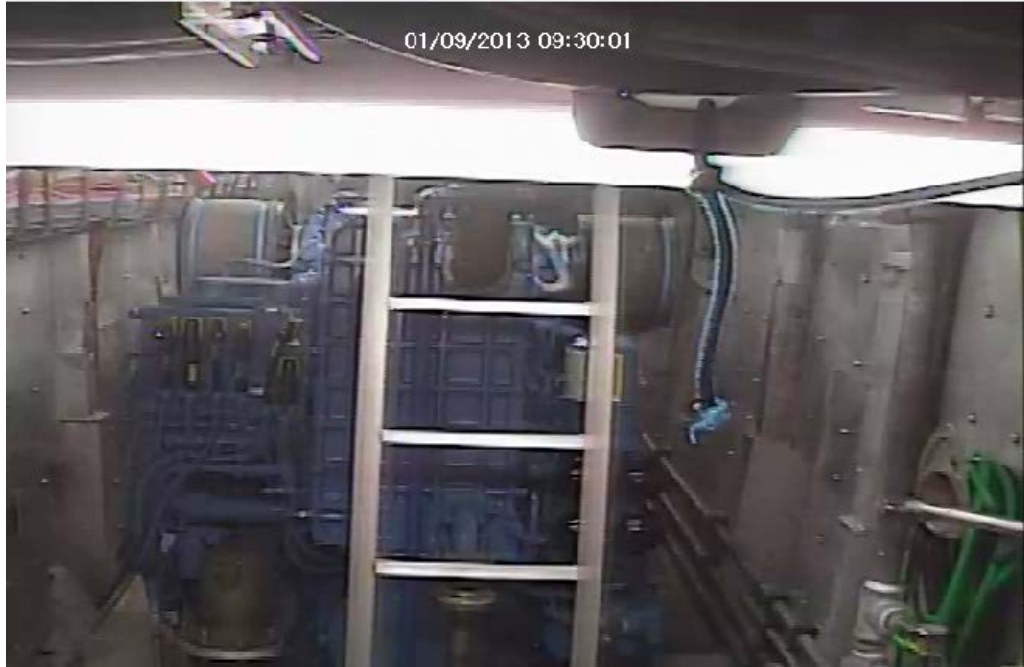
Figure 3. Field of view for camera in CH03.avi.

Figure 3 shows the field of view from this camera in the starboard engine room, facing aft at the starboard engine. The video began at 0930:01 with the image vibrating slightly. At 0935:27, the bottom of the ladder was flung toward the camera. At 0936:35, the vibration of the image stopped. At 0939:13, the vibration began again. At 0939:30, the same person described in section 4.2.2 descended the ladder and tended to something outside the camera's field of view to the left. At 0939:39, the vibration stopped. At 0940:16, the vibration in the image picked up again. At 0941:30, the individual moved to the right of the engine in the frame and disappeared from view behind the engine. At 0942:35, the individual returned to view from the left side of the engine and ascended the ladder and disappeared from view at 0943:00. At 1011:34, at least one person was present behind the engine with a flashlight. A crash-rescue helmet was visible above the engine. The video ended at 1030:00

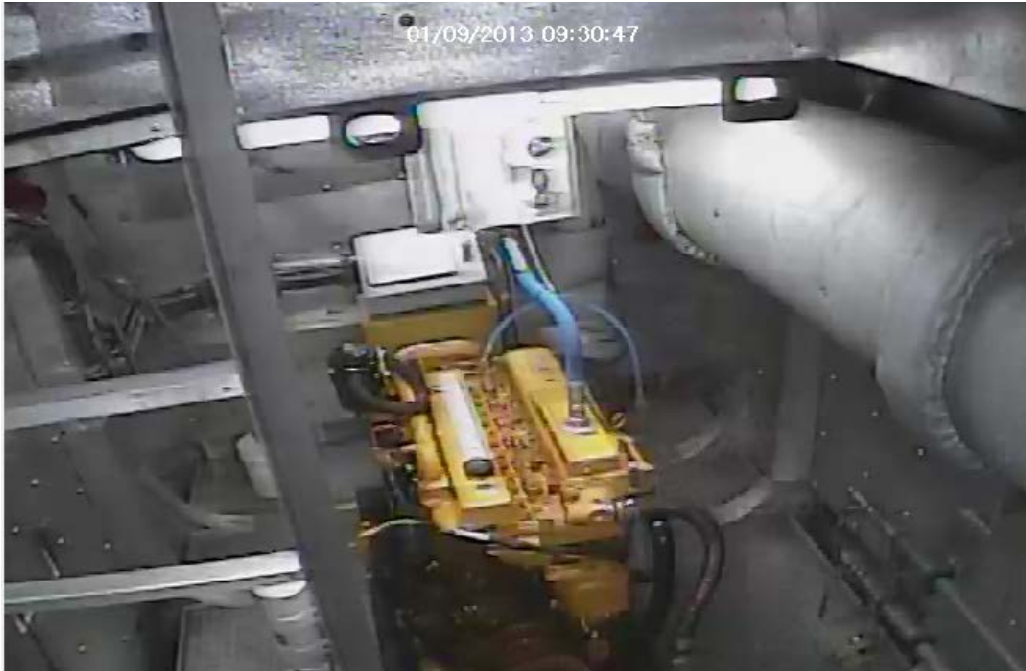
Figure 4. Field of view for camera in CH03.avi.

Figure 4 shows the field of view from this camera in the starboard engine room facing aft at the starboard generator. The video began at 0930:01. The image was vibrating as the video began. At 0935:27, the bucket and pole against the bulkhead moved toward the camera several feet due to a shock. At 0936:35, the vibration stopped. At 0939:13 the vibration started again. At 0941:41, the same person described in section 4.2.2 appeared from beneath the camera and ascended the ladder. At 0942:22, he descended the ladder and moved out of view under the camera. At 1011:35, a first responder with a flashlight wearing an orange life vest and a crash-rescue helmet with "Chief Rescue Battalion" logo descended the ladder and moved out of view under the camera and to the right. At 1011:49, another responder wearing an orange life vest and blue baseball cap with red lettering and an FDNY marine unit patch on his shoulder descended the ladder and conversed with the battalion chief. At 1012:30, the chief ascended the ladder out of view while the other responder appeared to take photos or video with his phone. At 1029:00, a firefighter descended the ladder and disappeared from view beneath the camera. He returned to view and ascended the ladder at 1029:30. The video ended at 1029:58.

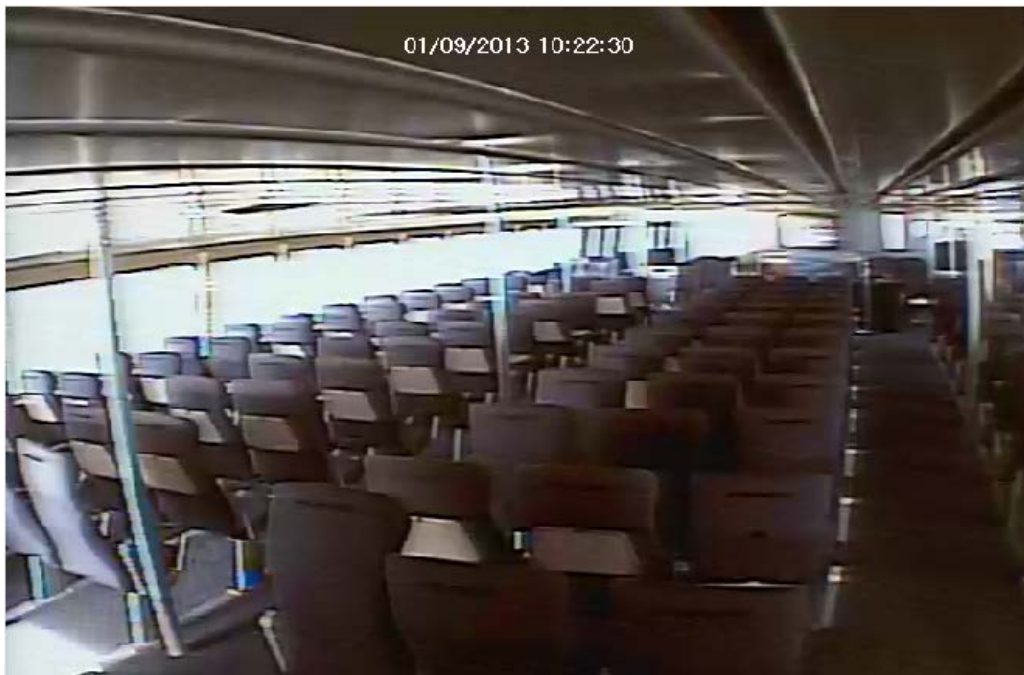
Figure 5. Field of view for camera in CH06.avi.

This camera was installed on the rear of the upper passenger deck facing forward over the passenger seating area. The two left seating columns, the center seating column, and a small part of the right passenger seating areas were visible. Figure 5 shows the field of view of this camera. No passengers are visible in the sample frame. The video begins at 0930:01.

At 0930:04, the bridge door opens and a crewmember in an orange jacket exits the bridge. At approximately 0930:30, several passengers began to gather belongings and three passengers move aft, towards the rear of the upper passenger deck. The majority of passengers were still seated at this point. At 0934:03, the bridge door opens and a crewmember wearing a dark jacket left the bridge and walked down the forward staircase. At 0934:40, approximately 9 more passengers stood up and began moving aft. Approximately 3 descend down the forward staircase. At 0935:27, passengers were thrown forward when the ferry allided with the pier. Of the 6 passengers standing in the frame, 4 are knocked forward off their feet and an additional passenger is thrown forward into the frame from the right. An occupied seat in the fore ground of the frame was displaced forward by a standing passenger thrown into the back of the seat. By approximately 0937, most passengers rose to their feet unassisted and one was assisted to her feet by other passengers. At 0942:10, about 10 passengers begin moving aft, out of the frame of the camera. At approximately 0943, a large group of passengers gathered near the forward staircase in the aisle to the left of the center column of seats. At 0945:30, most passengers began moving down the forward staircase. At 0946:50, about 7 passengers began moving aft down the aisle on the port side of the vessel. At 0951:00, firefighters began arriving on the upper deck and assisting with evacuation. At 0956:30, the first uniformed NYPD officer became visible in the frame. At 0958:30, FDNY transported a passenger on a backboard down the right side aisle toward the rear of the deck. At 1008:45, FDNY transported a passenger

on a backboard down the left side aisle toward the rear of the deck. At 1011:00, FDNY transported the last passenger visible on the upper deck on a backboard down the left aisle towards the rear of the deck. The video ended at 1029:58.
