MEMORANDUM OF RECORD

June 11, 2015

Subject: On-Scene Examination of Airframe and Engine – ERA14FA168

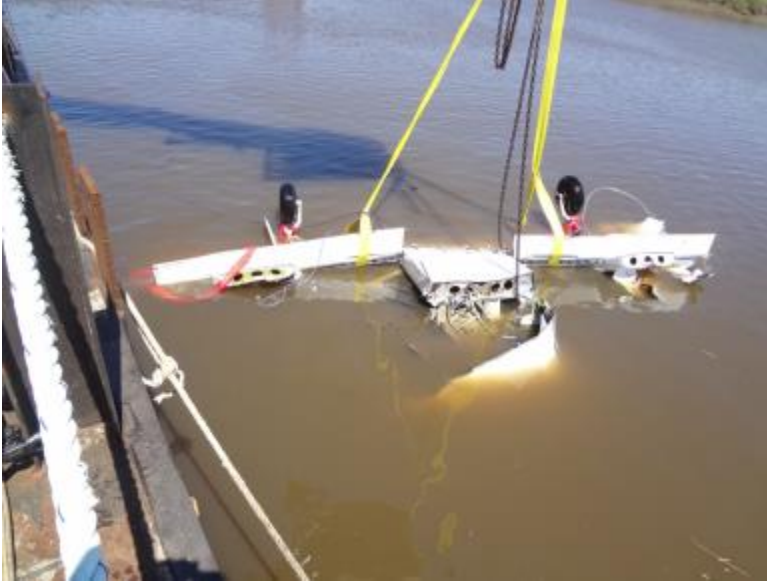
Photo 2: Aircraft Being Lifted out of Water - As Found

The fuselage assembly with inboard wing sections, engines and propellers was located inverted in about 16 feet of water. Recovery was facilitated by first partially raising it by the main gear so straps could be secure around the inboard wing sections. The entire assembly was then lifted out of the water and placed on a barge for transport to a secure facility for investigation.

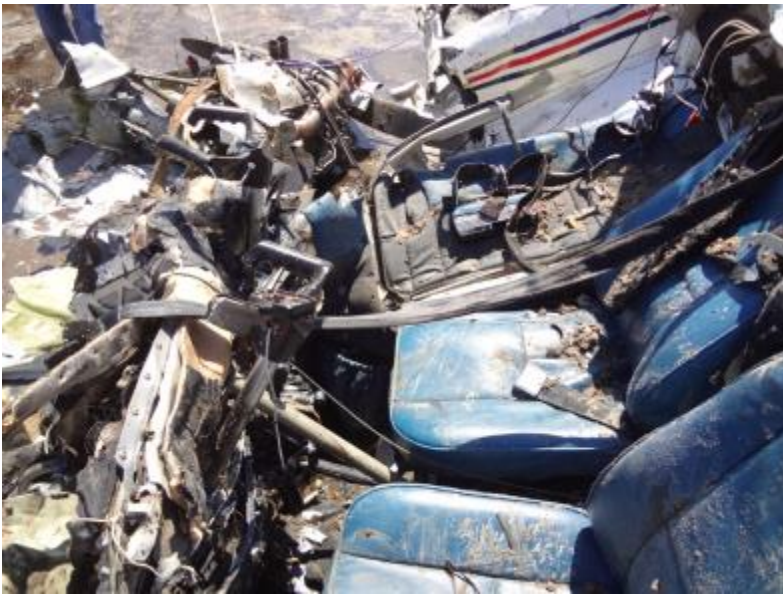
The flap handle was in the up (retracted) position. The fuel selectors were both in the ON positions. The engine controls were in the forward position.

Photo 3: Cockpit Area Post Recovery

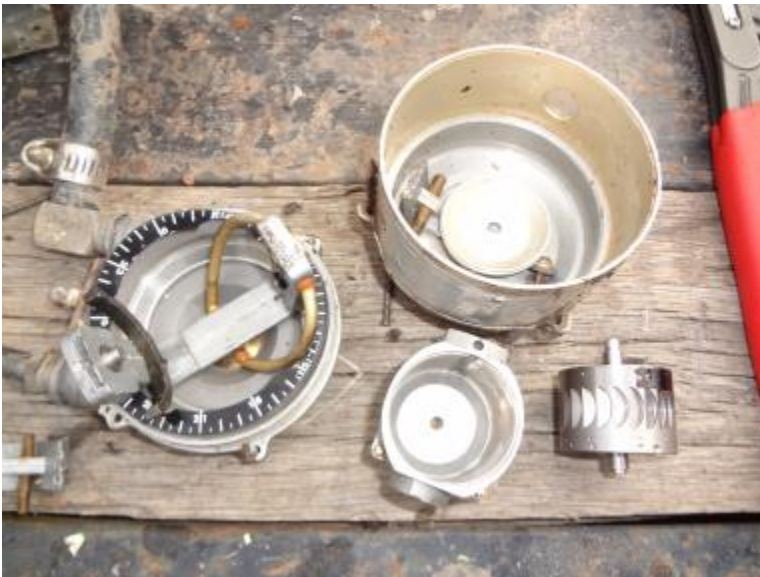
Numerous instruments could not be located. The only recovered air driven gyro was the pilot side HSI directional gyro. Disassembly of the gyro found no scoring or rotational damage to the pendulous vane housing or rotating assembly. It should also be noted that although no scoring was noted, the housing of the instrument contained minimal damage and no evidence of crush damage was noted.

Photo 4: HSI - Post Disassembly

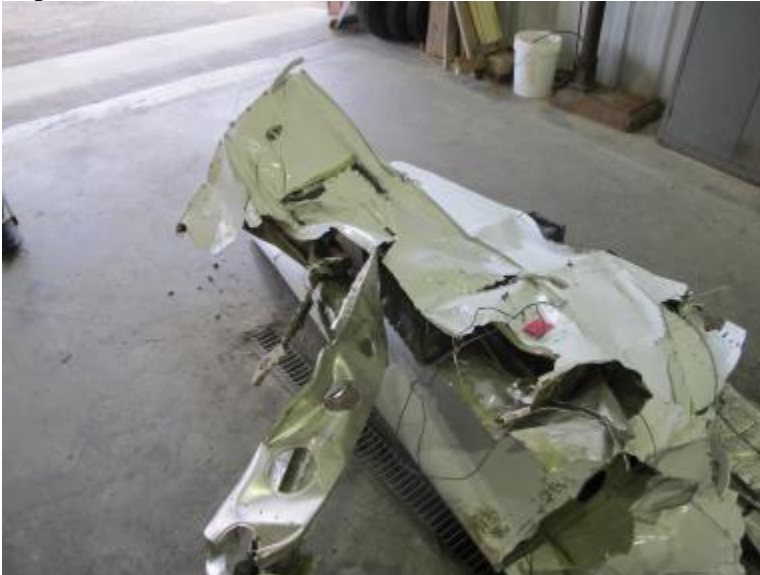
The outboard section of the left wing, about 6 feet 6 inches, was separated and found along the debris path. Examination of the separation found structural deformation consistent with positive overload. Additional damage was noted to the trailing edge with blue paint transfer in several places including the flap hinge and bottom skin. The impact damage was consistent in size and shape to the vertical stabilizer. The aileron and wingtip were separated and not recovered. Both aileron control cables were in place and secured to the bellcrank. One control cable measured 17 feet 6 inches and the other measured 5 feet to the separation. Both cables were broomstrawed at the end. The remaining portion of the control cable was secured to the control wheel chain and the remaining portion of the balance cable secure to the right side aileron bellcrank.

The inboard section of the wing was recovered still in place, secure to the fuselage and displayed compression impact damage to the top surface. The forward portion of the nacelle was separated from the wing. The engine mount and engine were attached to the firewall and connected to the nacelle by the control cables and wires. The fuel bladder was ruptured. The left main gear was extended but not locked when found. The flap was in place, retracted and secure.

Photo 5: Left Wing - Post Recovery (Courtesy of Piper Aircraft)

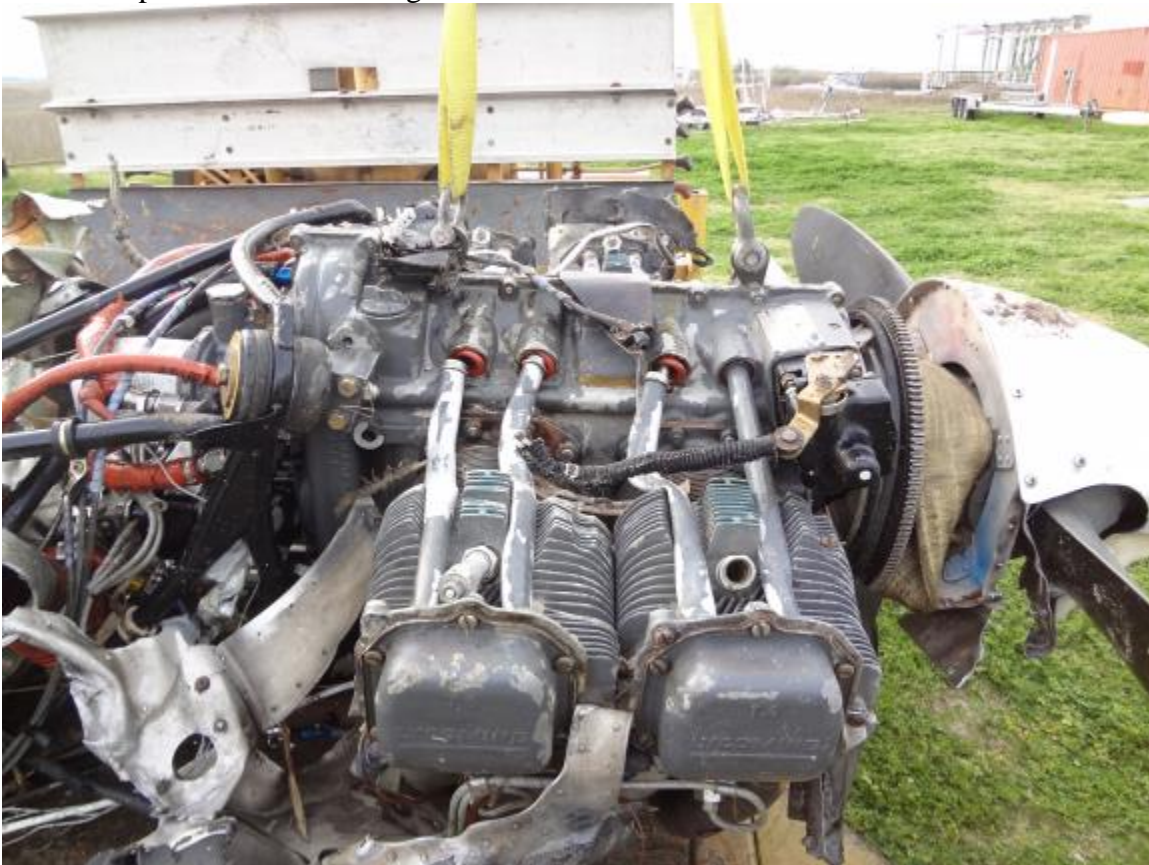
The oil dipstick was secured and in place; however, no oil was present on the dipstick but water was present within the engine.

Photo 6: Left Engine after Removal from Airframe

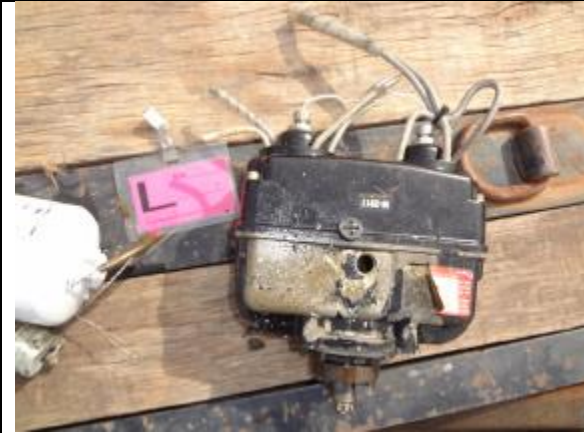
spun utilizing a cordless 20-volt drill, spark was observed on one lead. No others leads produced spark and during the testing, and the one that did produce spark ceased emitting a spark. The engine driven fuel pump was removed and disassembled the diaphragm was normal and free of debris, and no abnormalities were noted.

Photo 7: Left Magneto - Post Recovery

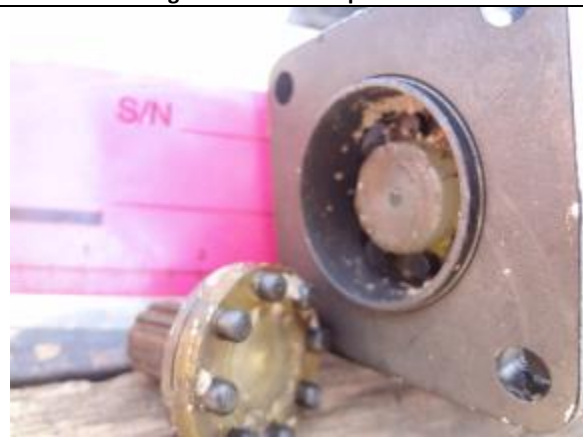
The vacuum pump was removed; however, the shaft exhibited a shear fracture but no other external damage was noted, it was noted that the engine was rotated during the recovery process, as well as during the initial examination. The vacuum pump indicated a recorded time of 1207.8 hours of total flight time since overhaul and was installed on May 13, 2011.

Photo 10: Left Engine Vacuum Pump with Sheered Shaft

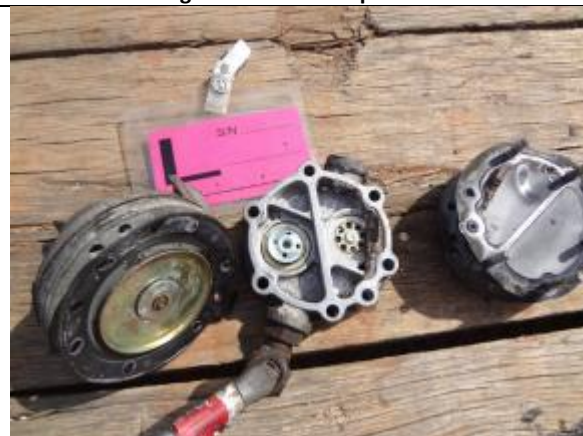
Photo 12: Left Engine Driven Fuel Pump - Post Disassembly

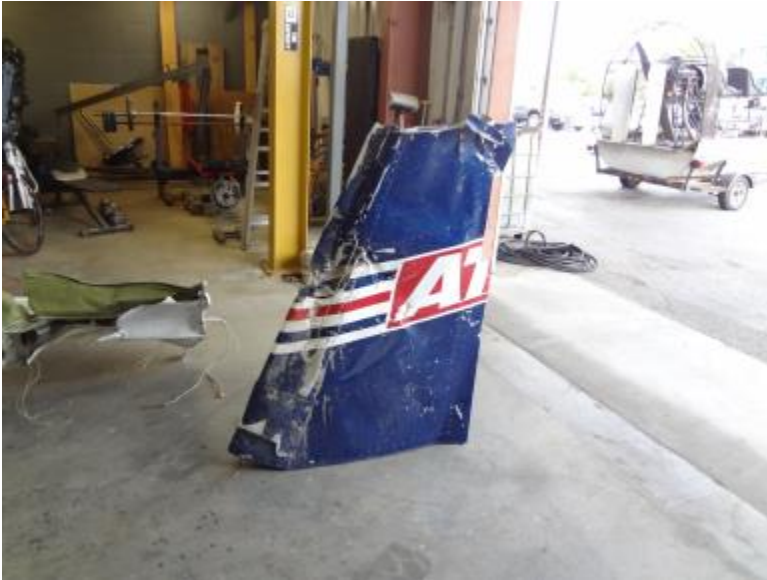
The empennage assembly was separated from the fuselage. The forward vertical attachment bolt was pulled through the mounting bracket. The aft attachment bracket was in place but all attach rivets to the vertical were sheared. The vertical was found along the debris trail and displayed substantial impact damage along the leading edge. The rudder was not recovered during the on-site investigation. The rudder cable was in place, secure and continuous to the rudder bar in the cockpit. The rudder stops were in place and secure.

Photo 17: Left Side of Vertical Stabilizer - Post Recovery

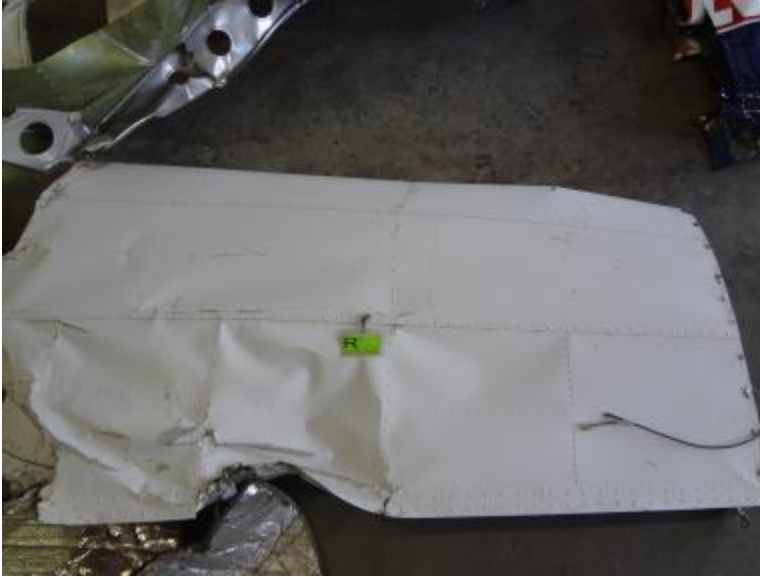
The outboard section of the right wing, measuring approximately 6 feet 9 inches, was separated and found along the debris trail. Examination of the separation found structural deformation consistent with positive overload. Impact damage with blue paint transfer was noted in several places on the separated outboard wing section. The aileron and wingtip were separated and not recovered. Both aileron control cables were secure to the aileron bellcrank. Both cables measured about 5 feet and were broomstrawed on the ends.

The inboard section of the wing was recovered still in place, secured to the fuselage and displayed compression impact damage to the top surface. The forward portion of the nacelle was separated from the wing. The engine mount and engine were attached to the firewall and connected to the nacelle by the control cables and wires. The fuel bladder was ruptured. The right main gear was extended but not locked when found. The flap was in place, retracted and secure.

Photo 20: Right Wing as Viewed - Post Recovery

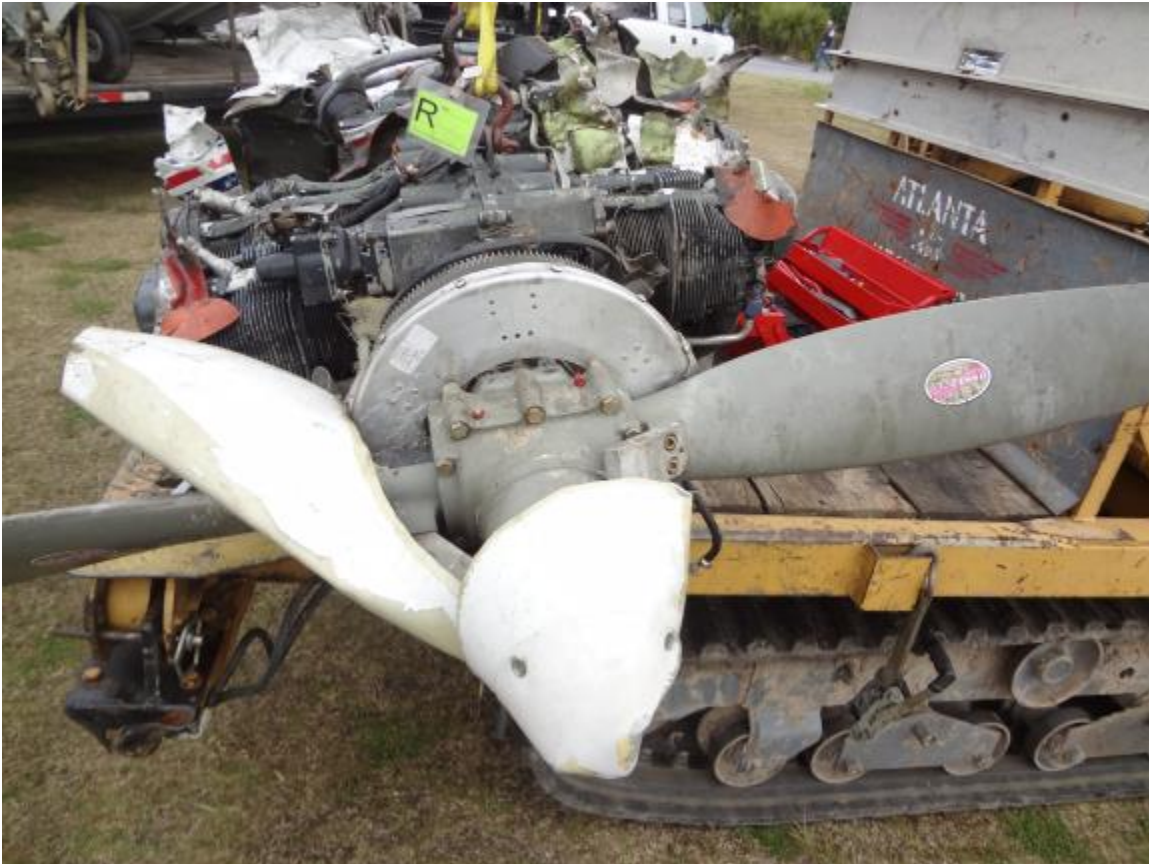
The engine was rotated by hand utilizing the propeller and it rotated smoothly. Thumb compression was observed on Cylinders 1 and 2; however, no compression was observed on Cylinders 3 and 4. The cylinder caps were removed and movement of the lifter arms was noted during rotation. The piston face was observed moving within the cylinder. The lift rods exhibited crush damage on the exterior of the engine cylinder and continuity was observed to the rear accessory pad.

The oil dipstick remained secured and in place; however, was devoid of oil and water was present.

Photo 21: Right Engine

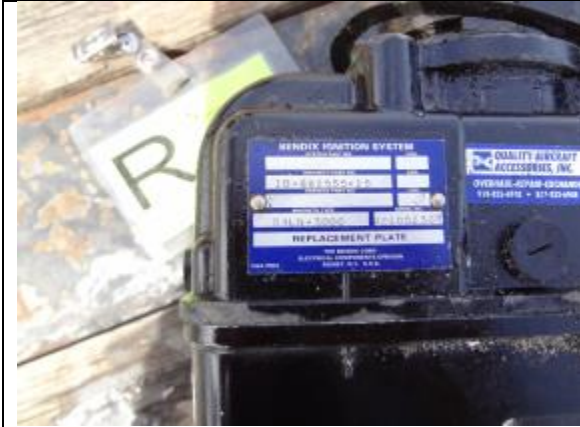
The right engine remained attached to the airframe via cables and wires. The engine was an LO-360-E1A6D, Serial Number RL-572-72T 180 hp. The propeller remained attached to the propeller hub which remained attached to engine. The carburetor was a Marvel Schebler Model HA-6 Part Number 10-6019, it remained attached to the engine and when removed exhibited no damage. The carburetor was disassembled and fuel was present with water visible with the fuel. The float remained attached, was operated by hand, and exhibited no damage. The fuel inlet screen was removed and was free of debris. The butterfly valve operated smoothly with no abnormalities noticed. The top spark plugs were removed and appeared normal in wear with a dark oily film on the even spark plugs. The magnetos were removed and when spun utilizing a cordless 20-volt drill spark was observed on one lead. No others leads produced spark and during the testing the one that did produce spark ceased emitting a spark.

Photo 22: Right Engine Magneto - Post Removal

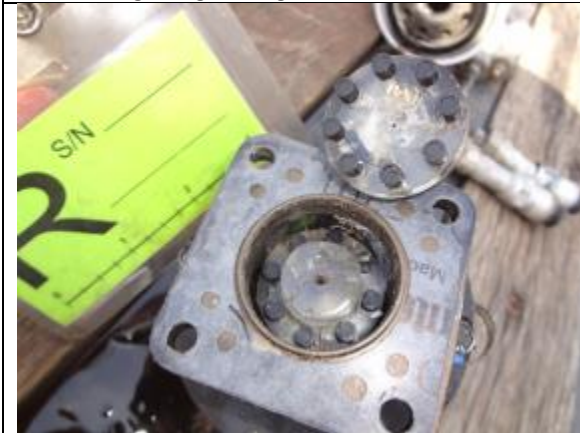
The vacuum pump was removed. The shaft exhibited a shear fracture and would not rotate, the unit was retained for further testing and examination. The vacuum pump at 172.5 hours of total flight time since overhaul; however, the serial number of the pump installed on the right engine was not the same serial number noted in the records.

Photo 24: Right Vacuum Pump with Sheered Shaft – as Viewed Post Removal

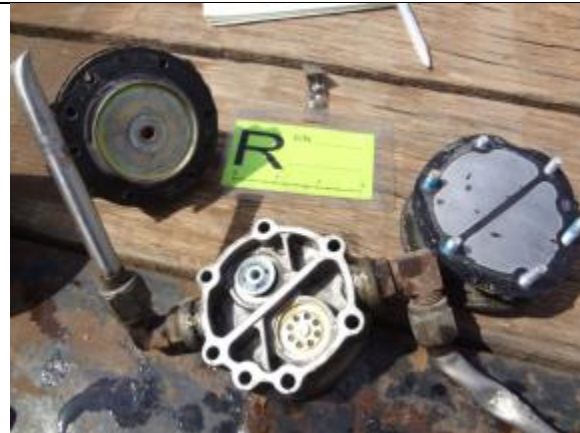
The engine driven fuel pump was removed and disassembled. The diaphragm was normal, free of debris, and no abnormalities were noted.

Photo 25: Engine Driven Fuel Pump - Post Disassembly

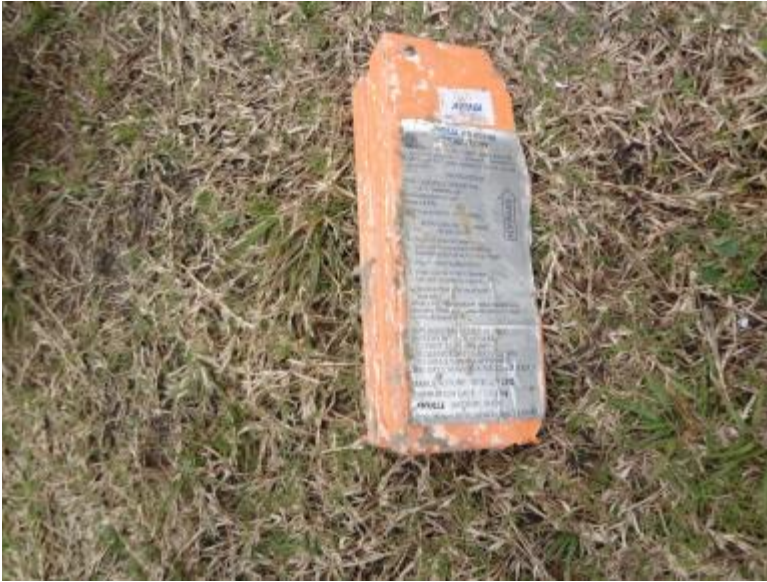
The ELT cover was located in the tail section; however, was impact damaged and no battery was located.

Photo 28: ELT Battery cover
