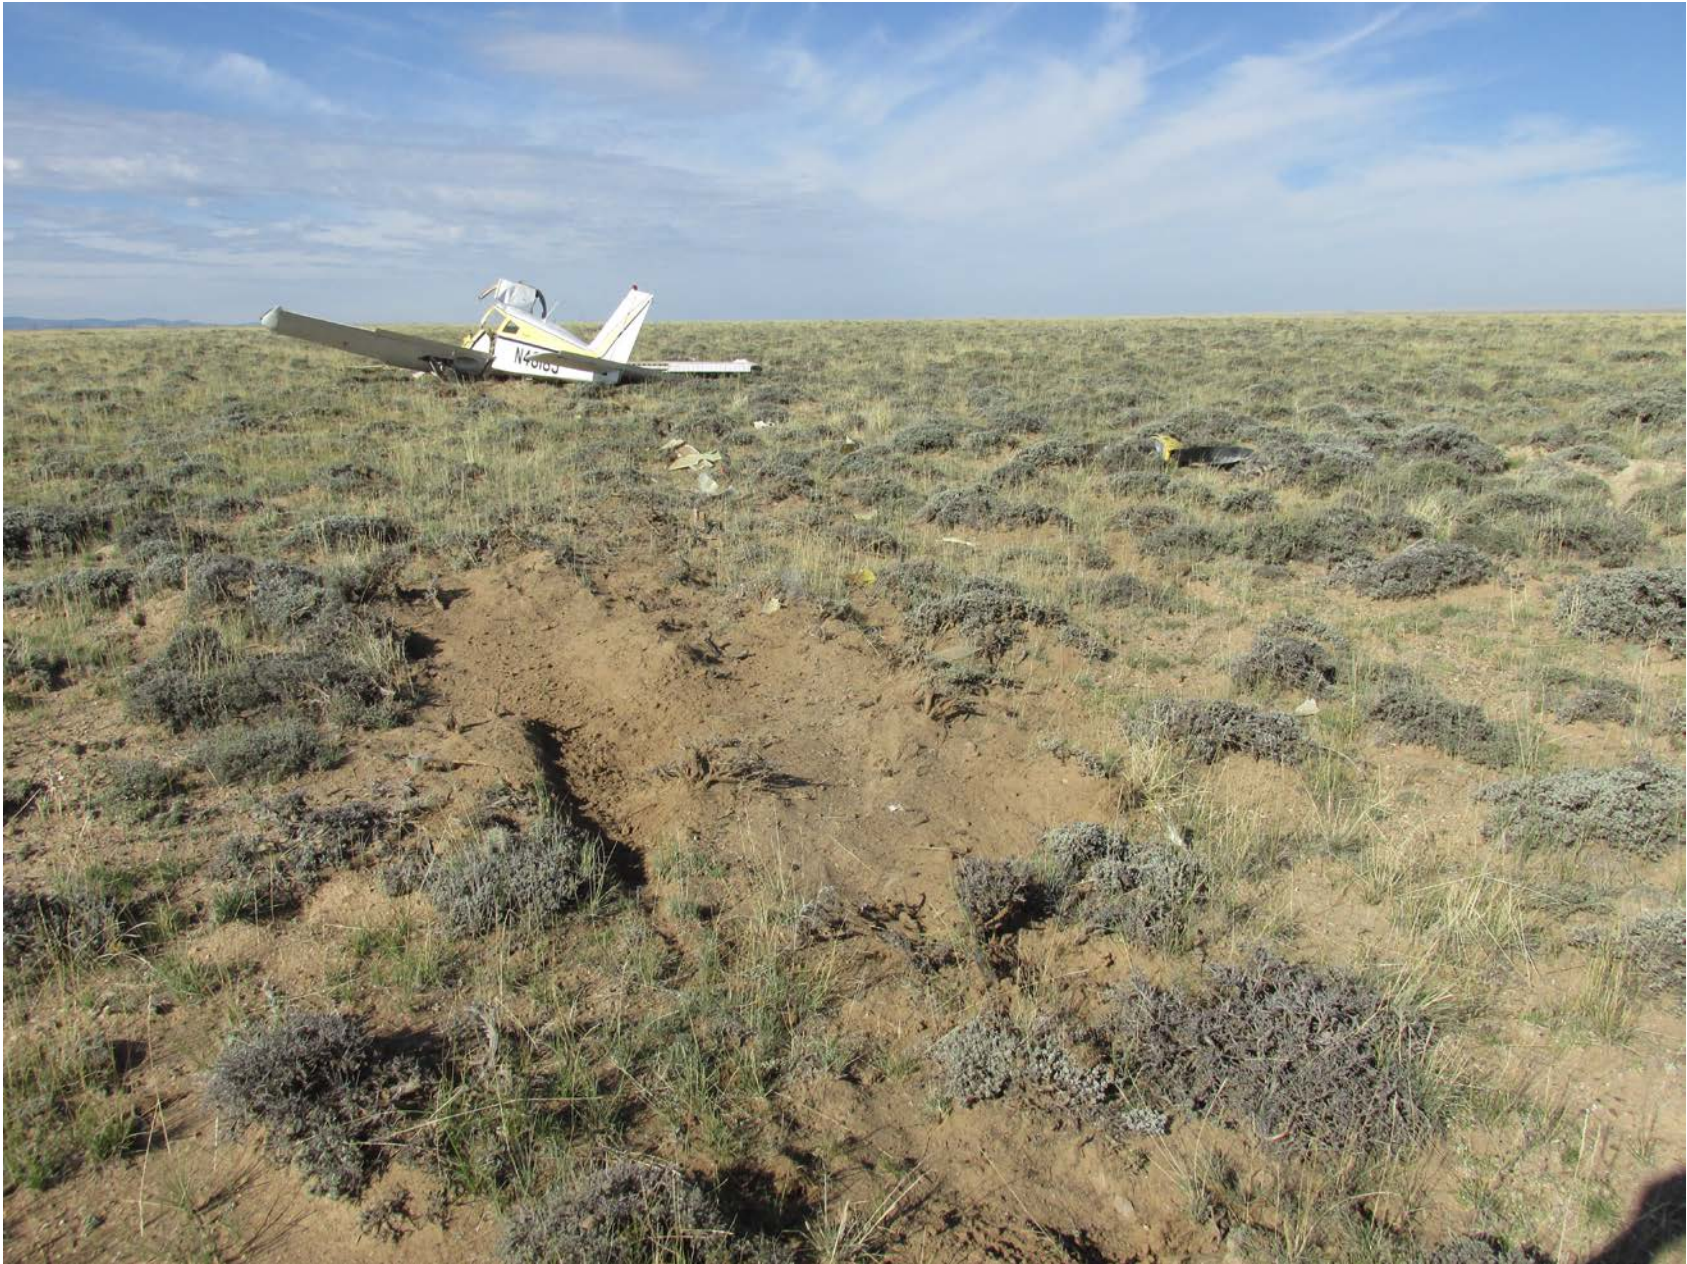
Photo 1 – Initial point of ground contact and main wreckage (Carbon County Sheriff photo)

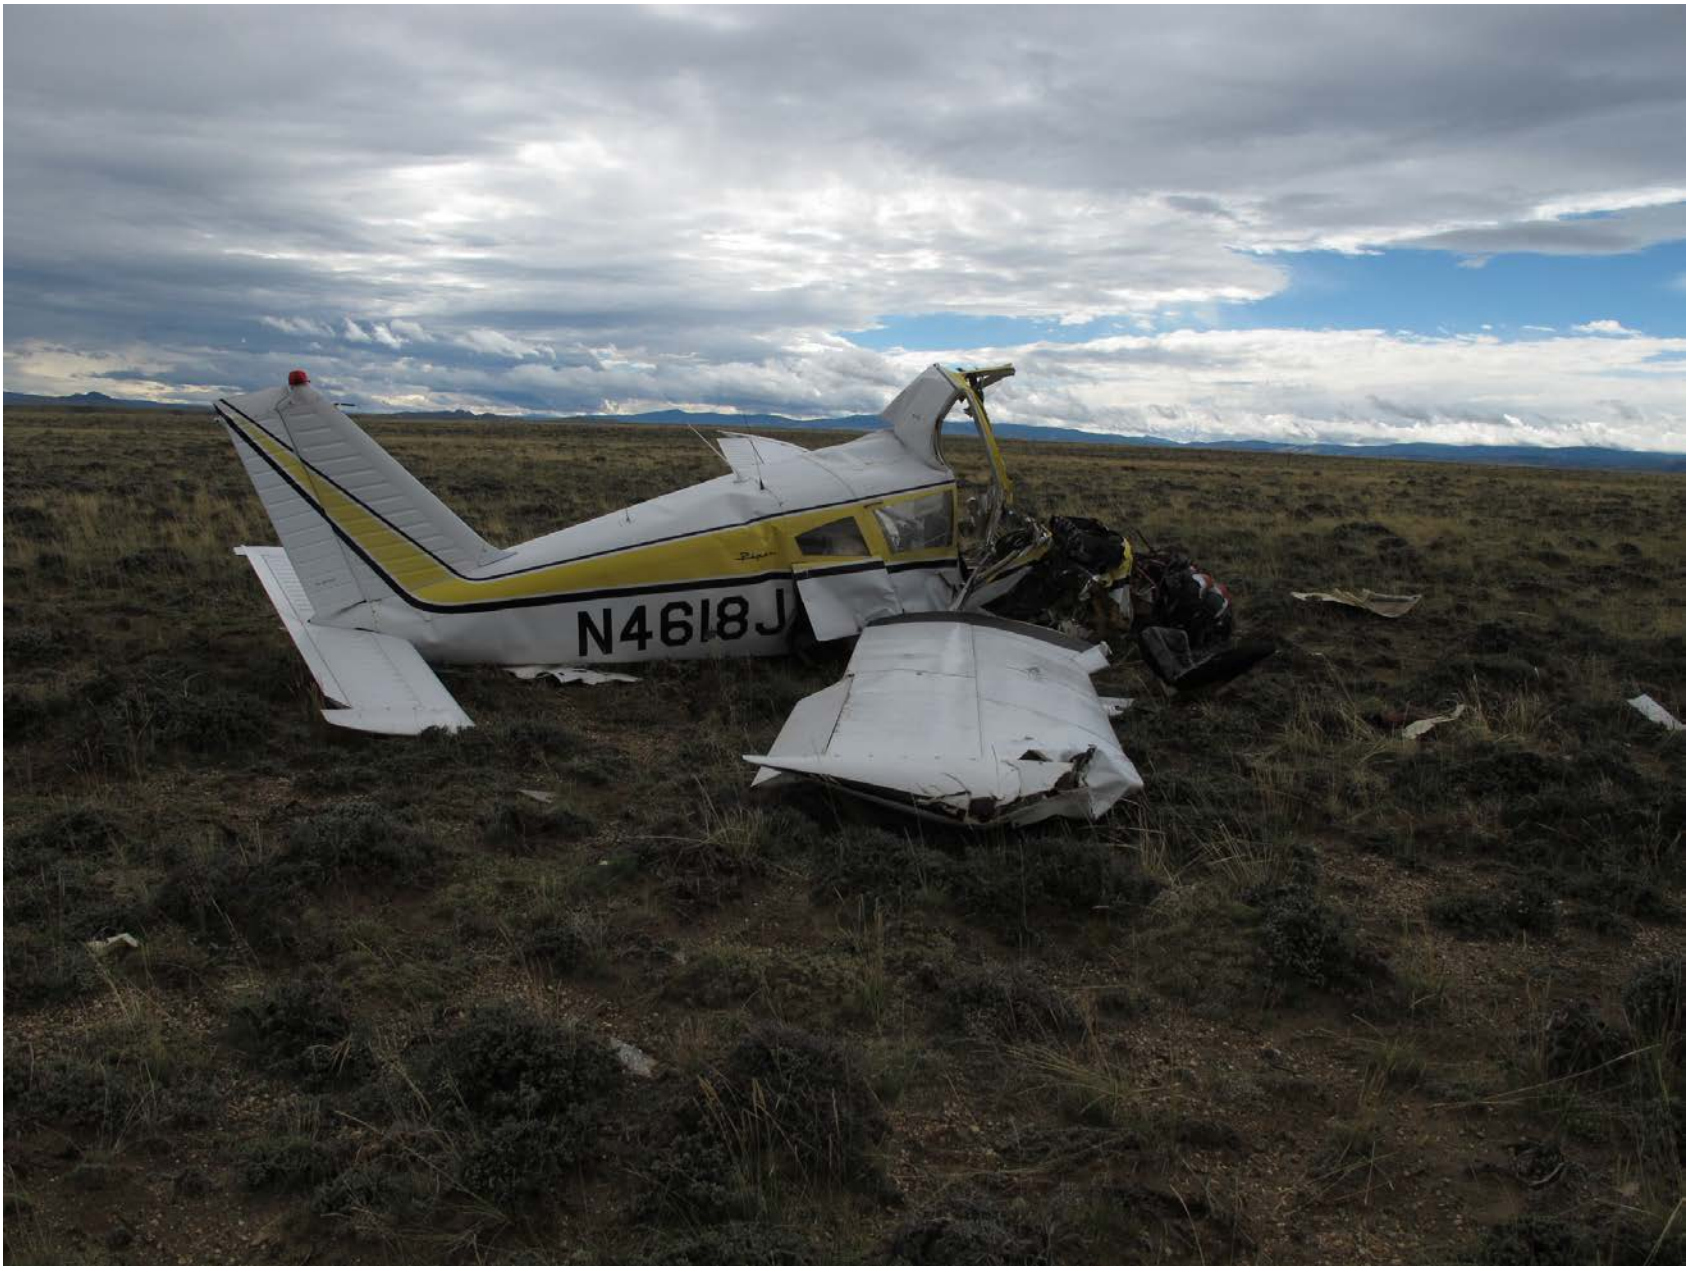
Photo 2 – Main wreckage, right side.

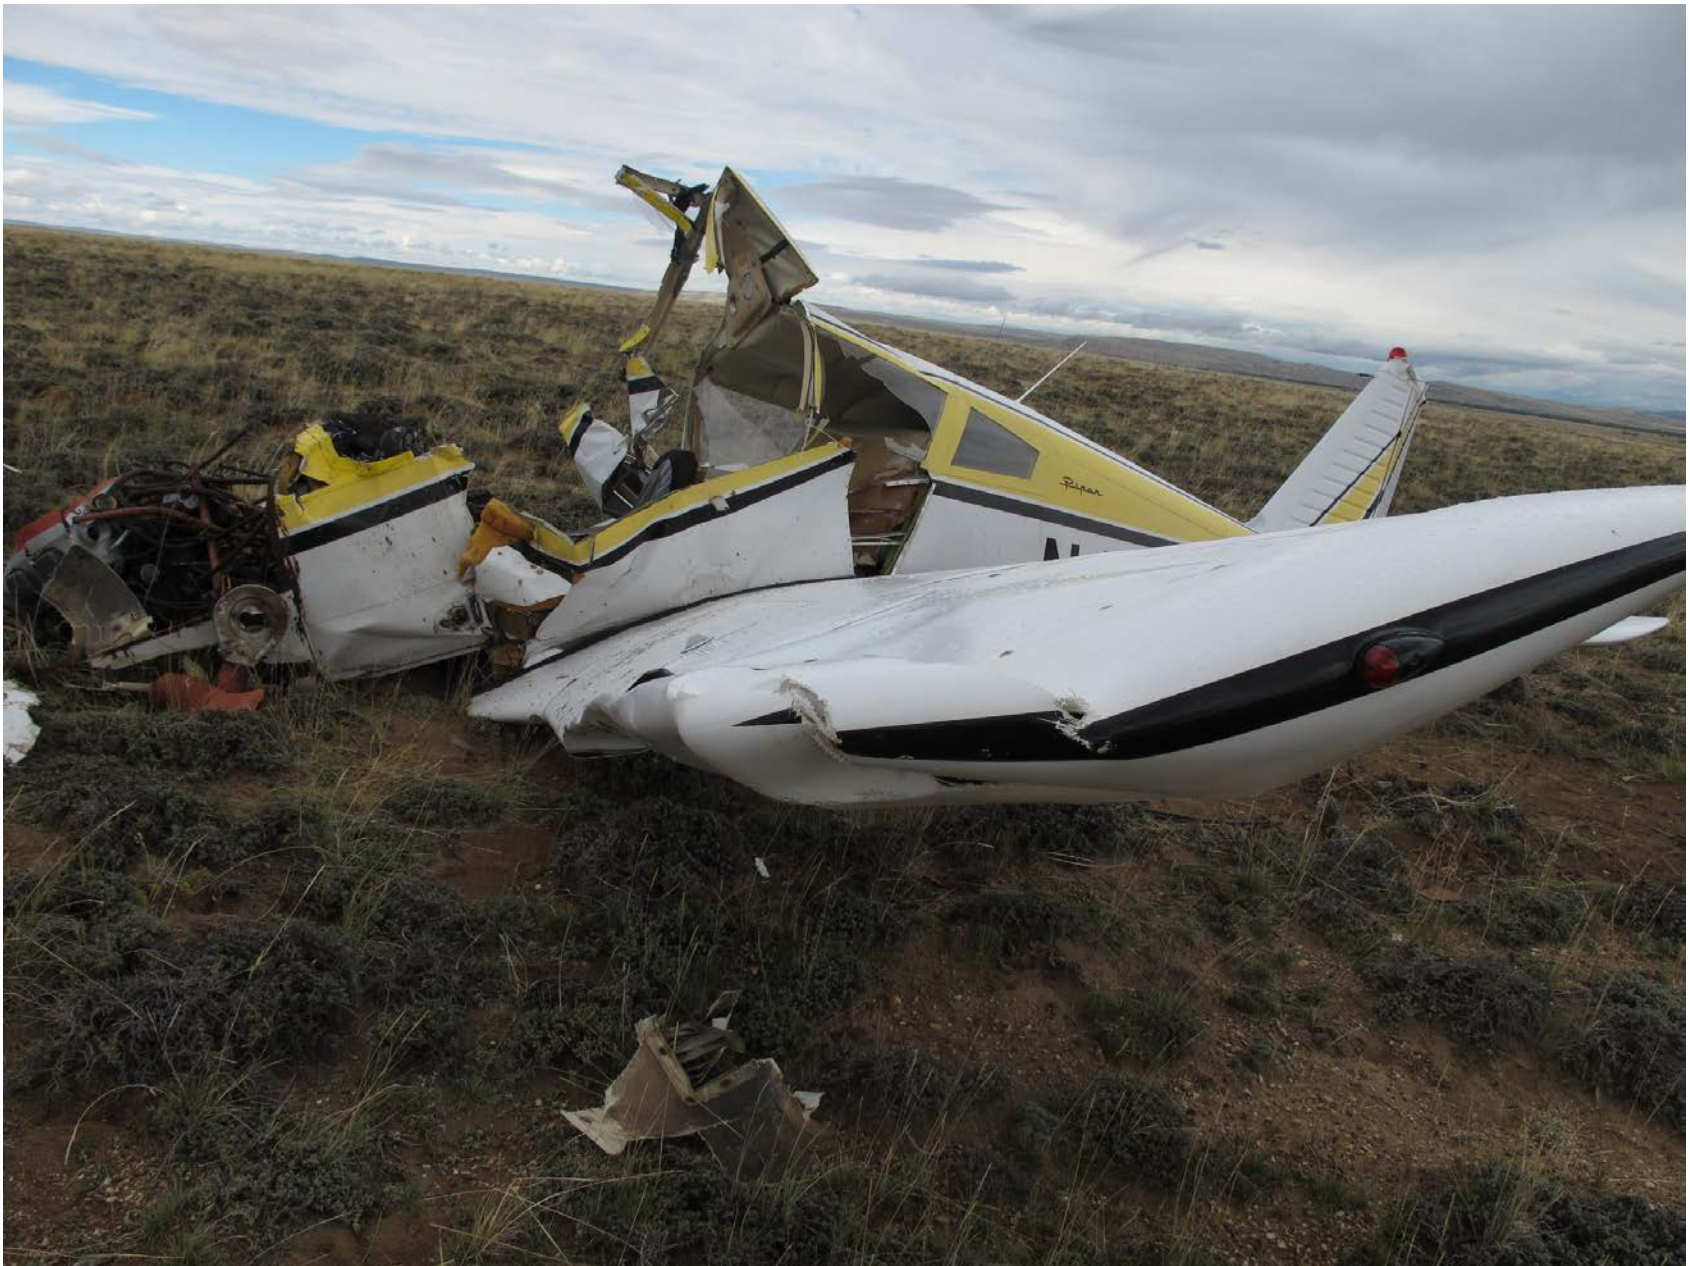
Photo 3 – Main wreckage, left side.

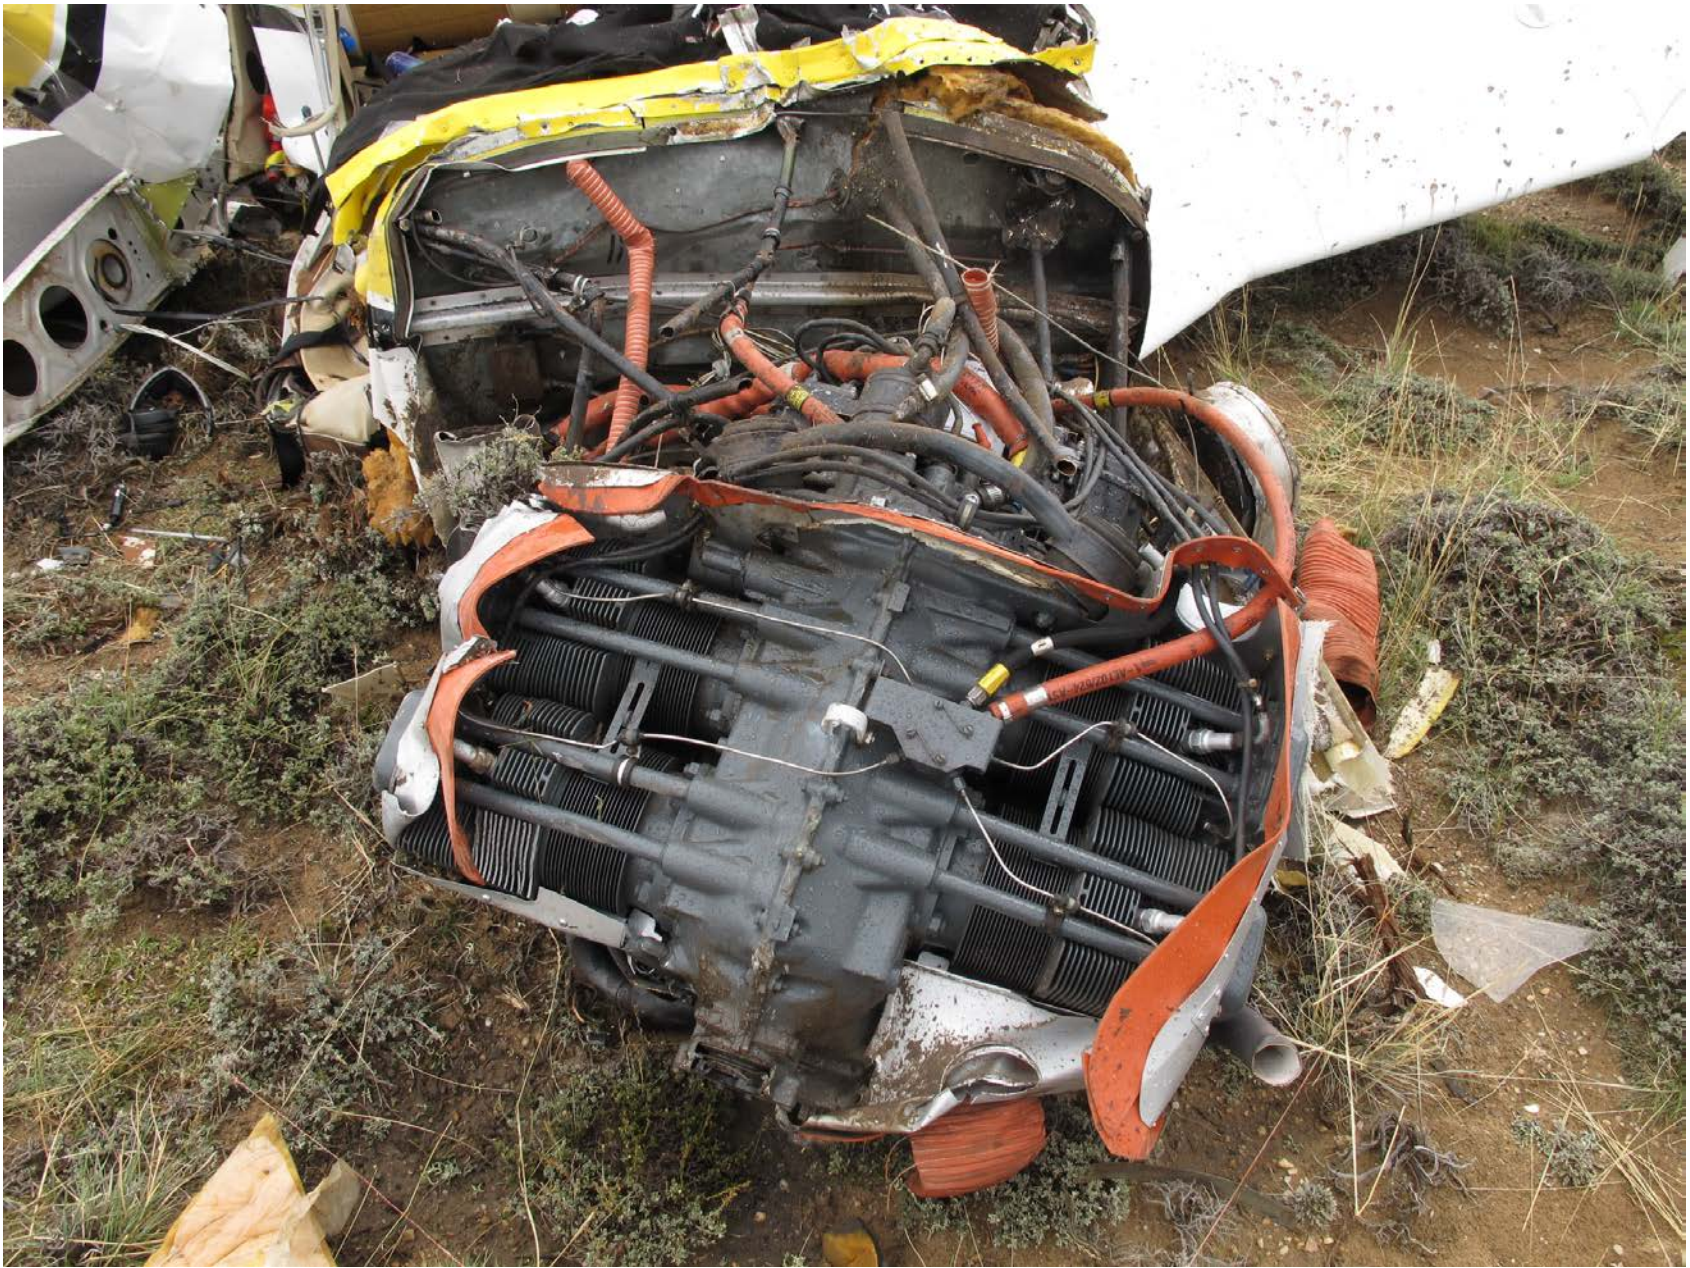
Photo 4 – Top view of the engine.

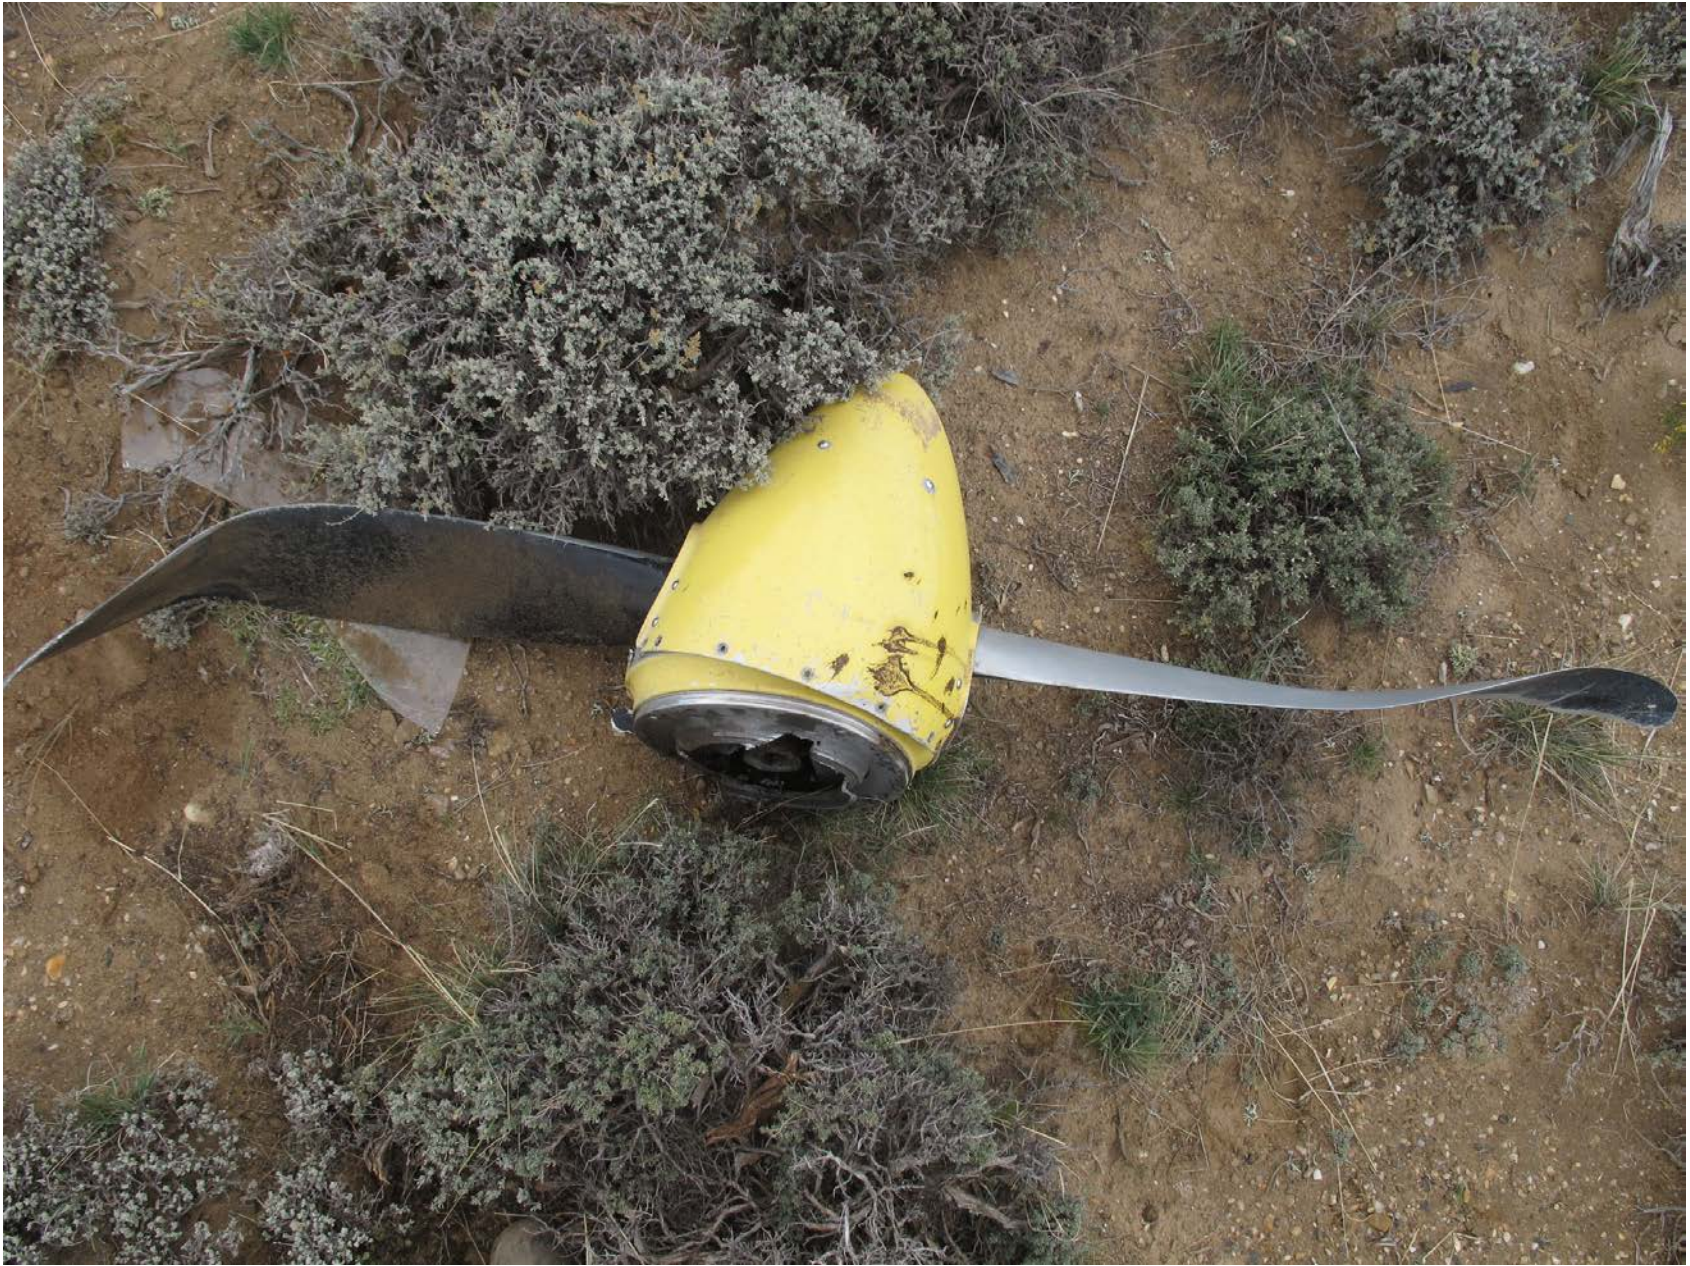
Photo 5 – Propeller exhibiting blade twisting.

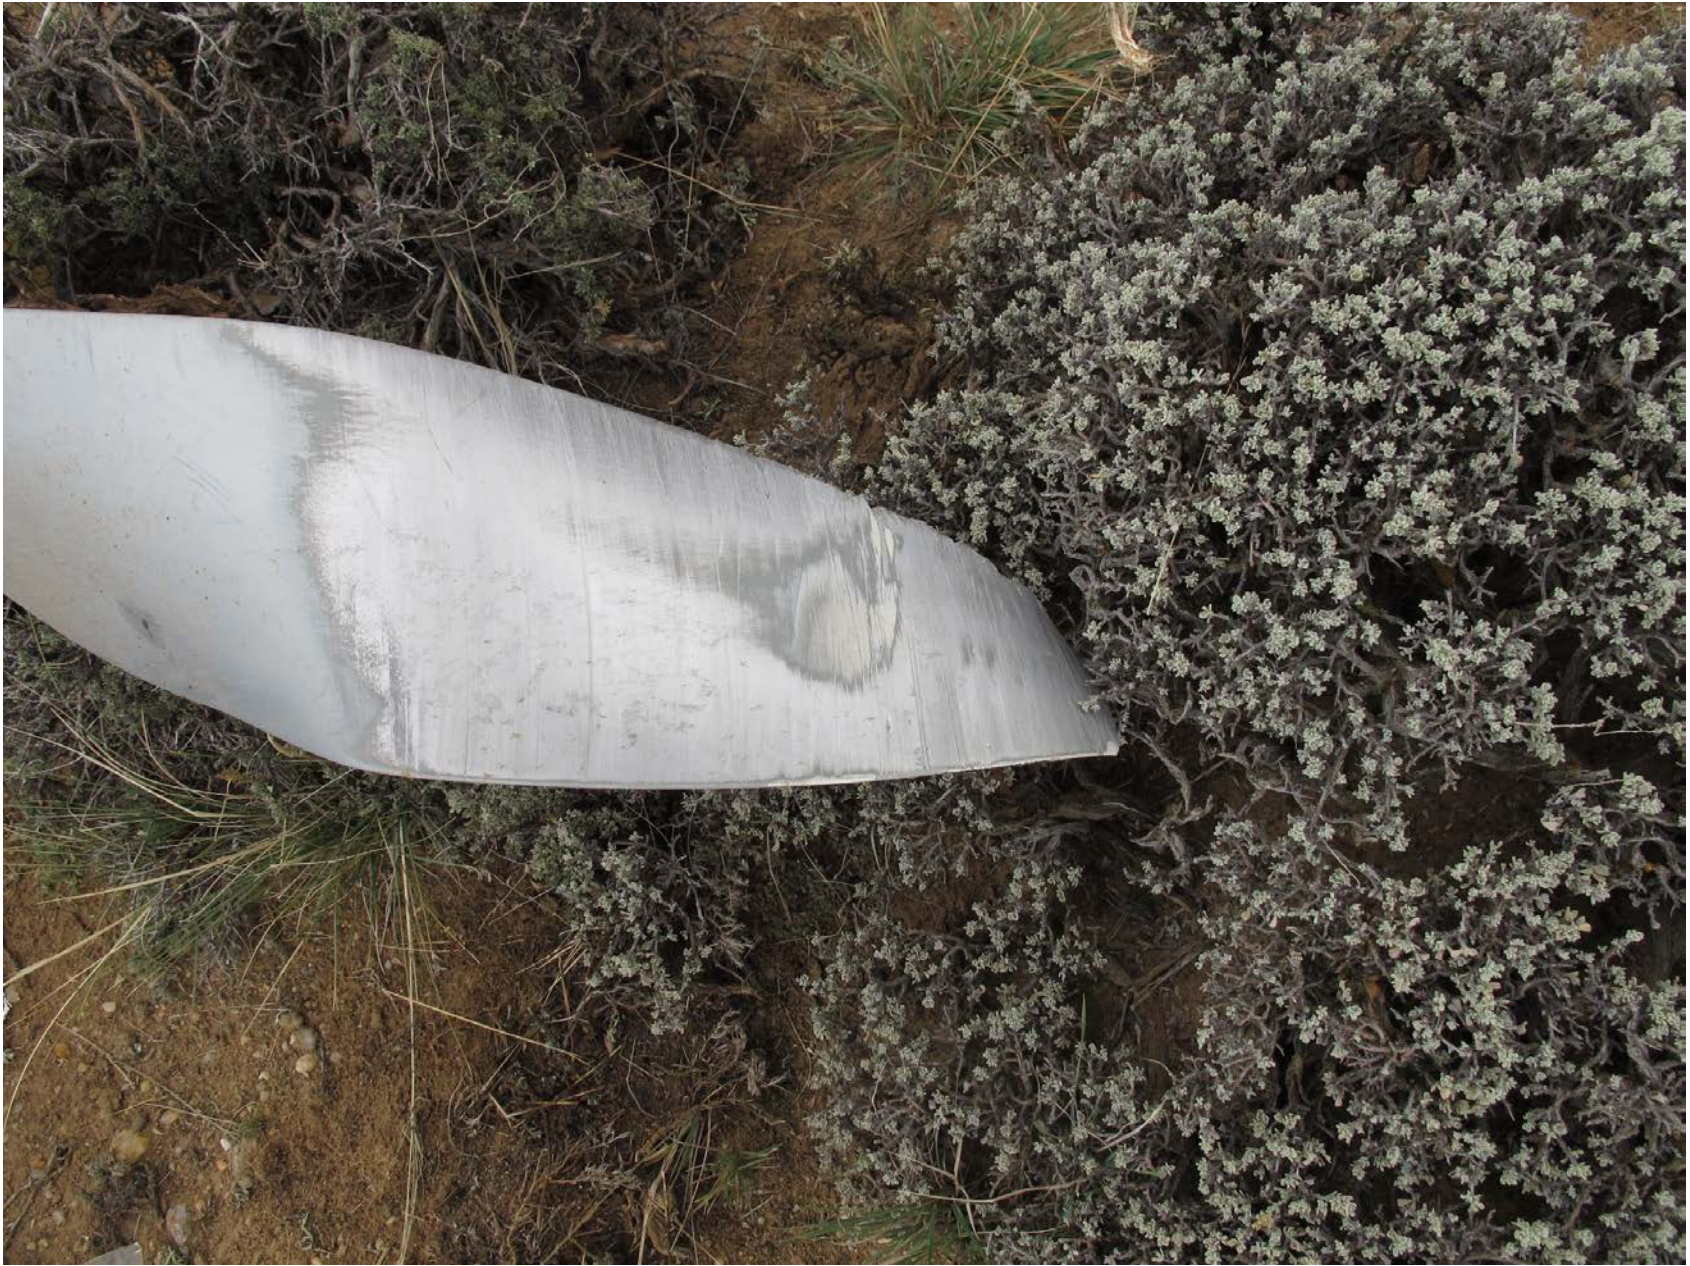
Photo 6 – Propeller blade showing chordwise scratches and polishing.

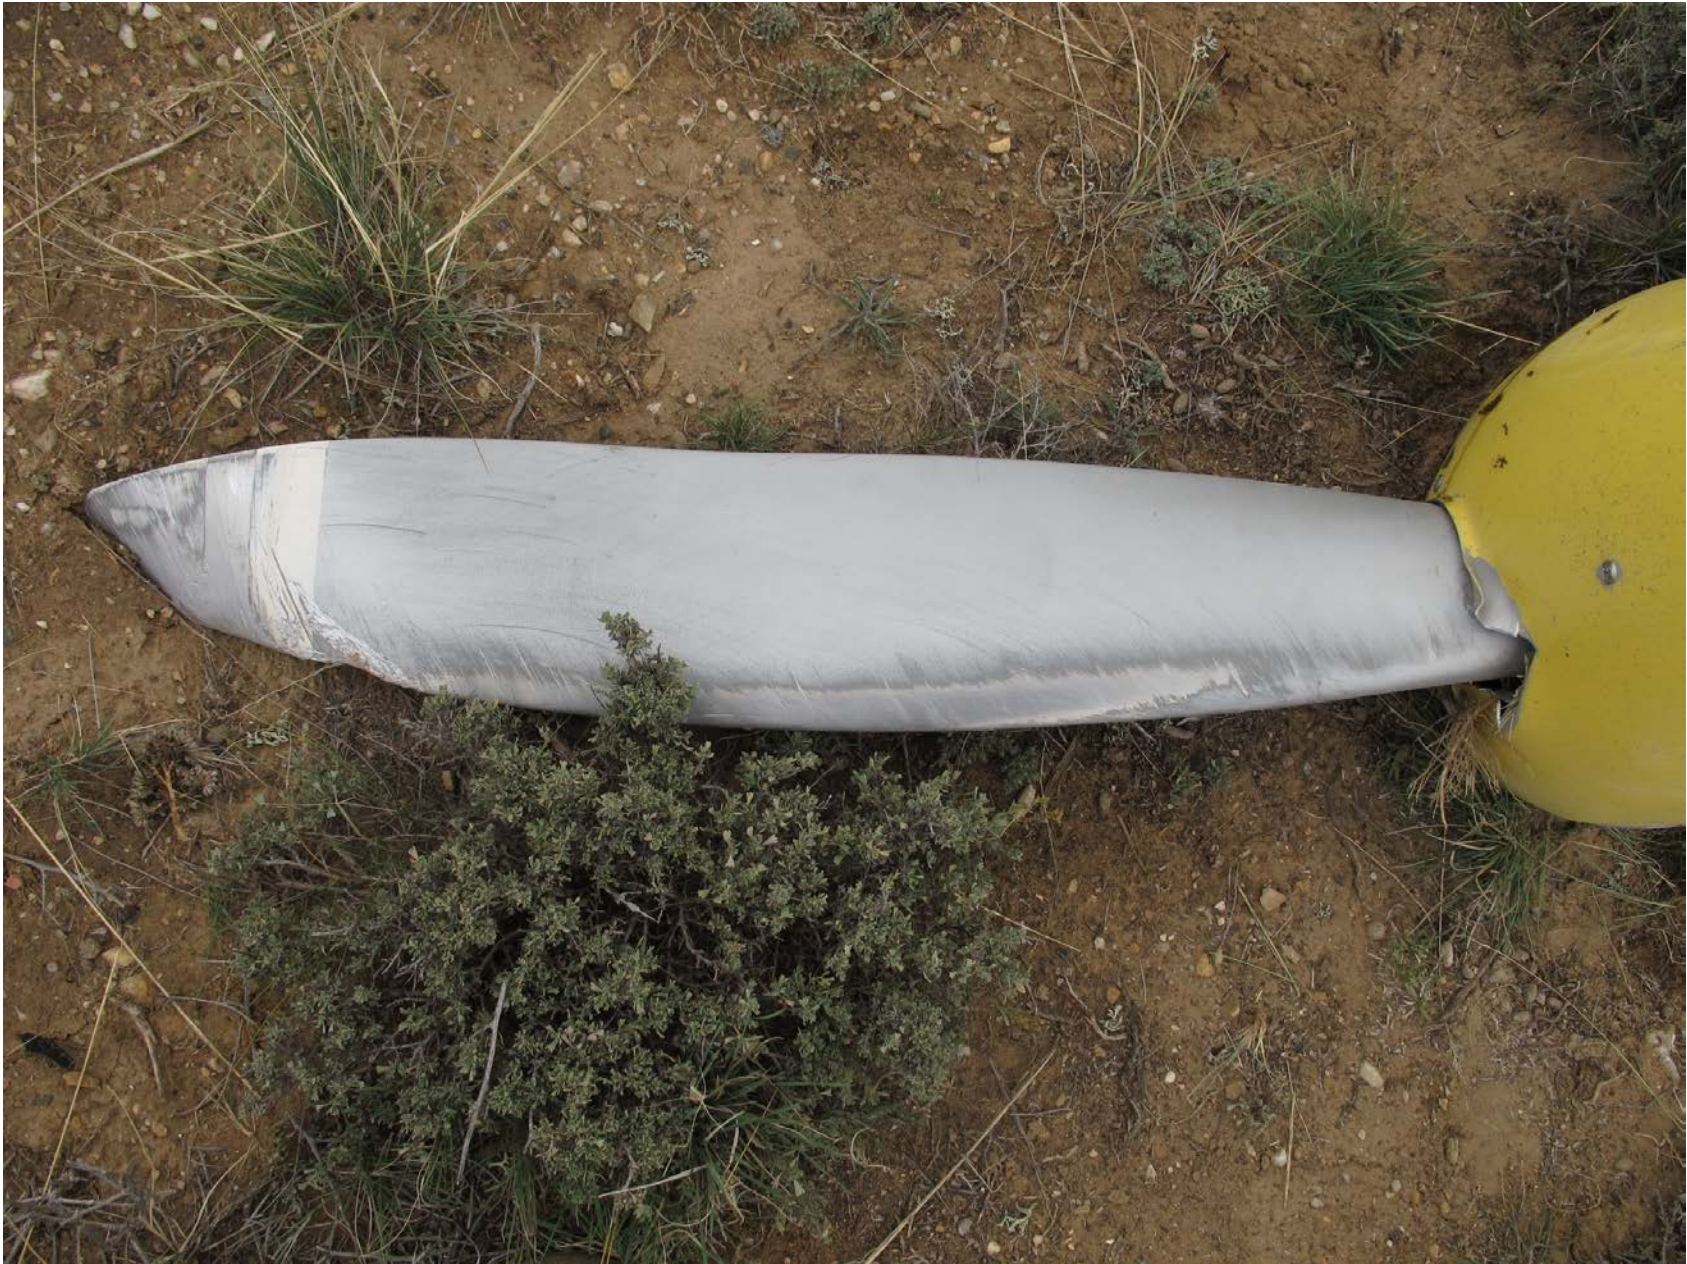
Photo 7 – Propeller blade showing leading edge damage and polishing.
