**NATIONAL TRANSPORTATION SAFETY BOARD
Office of Research and Engineering
Vehicle Recorder Division
Washington, D.C. 20594**

GROUP CHAIRMAN'S FACTUAL REPORT OF INVESTIGATION

ERA18MA099

Group Chairman's Factual Report
By Sean Payne

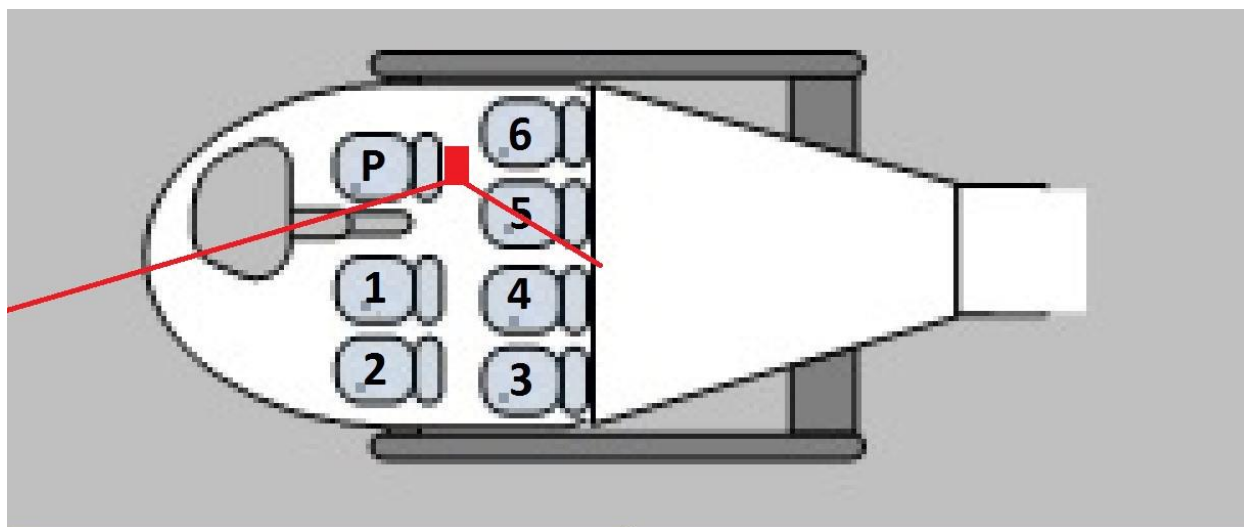
seat 3 in the rear left, outer seat and passenger in seat 4 in the left, inner seat/open door position. The camera's view also included a view out the left front windscreen and a view of out of the removed left front and left rear doors. Figure 1 is a seating chart for the accident flight. Figure 1 denotes the camera's approximate field of view in red.

Figure 1. The seating chart for the accident flight and the camera's approximate field of view shown in red. Seat 1 and Seat 2 were combined as a bench seat. Passengers are referred to as their respective seat number.

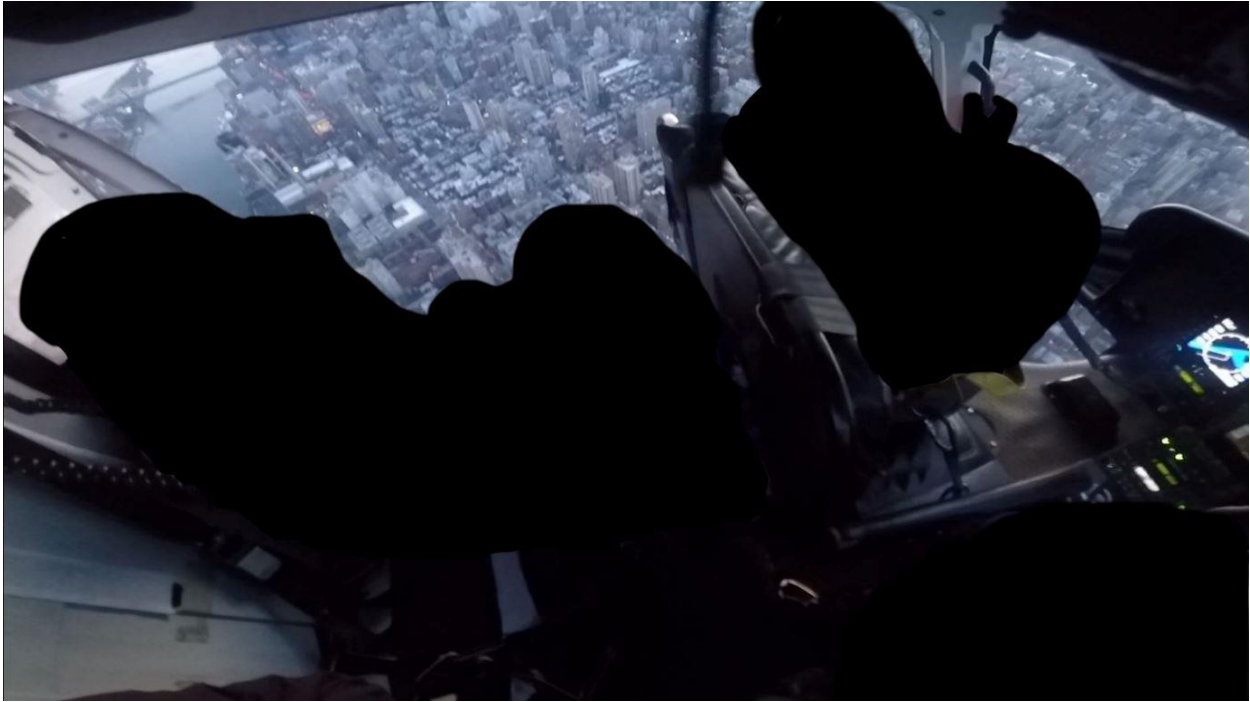
Figure 2. A screenshot captured at 19:06:08.05. The occupants have been redacted.

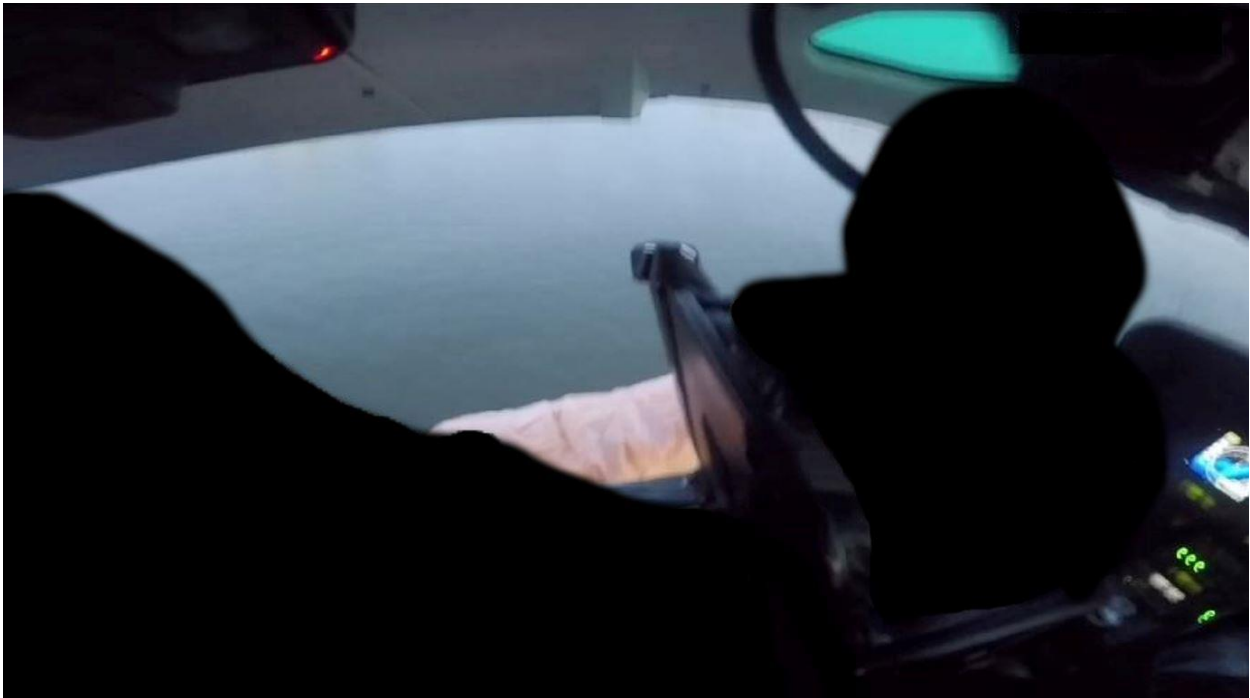
19:07:15.37 During impact, the float was cylindrical in shape and beginning to face forward toward it's inflated position. A number of wrinkles were visible in the float's cylindrical surface. At the same time, the water's surface appeared smooth with some light ripples. **Figure 3 is a redacted screenshot captured at this time. The figure shows the condition of the float.**

Figure 3. A screenshot captured at 19:07:15.37. The figure shows the condition of the float and the surface condition of the water. The occupants have been redacted.

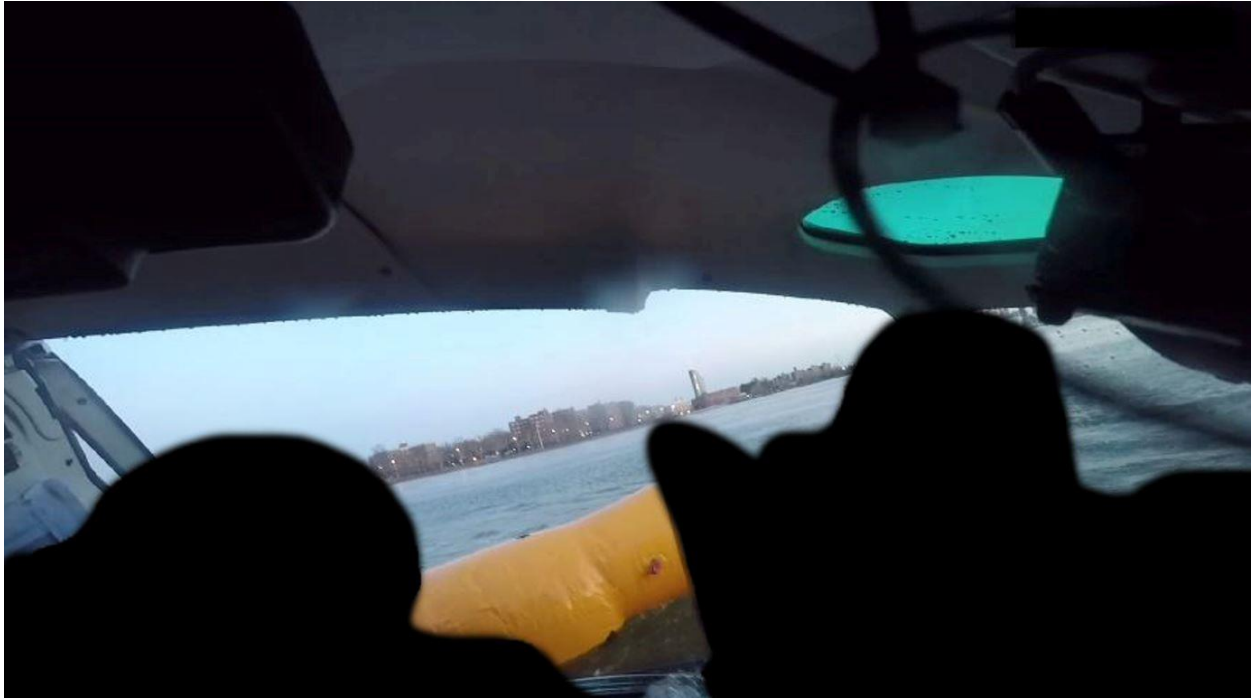
19:07:22.28 The helicopter was not sitting level in the water. The helicopter was pitched forward and rolled slightly right. Water was coming up into the cabin at the floorboard level on the left side of the helicopter. The water surface condition appeared calm with small ripples, in other areas around the helicopter, the water's condition looked slightly wind blown. **Figure 4 is a redacted screenshot at this time. The figure shows the condition of the float and the surface condition of the water.**

Figure 4. A screenshot captured at 19:07:22.8. The figure shows the condition of the float and the surface condition of the water. The occupants have been redacted.

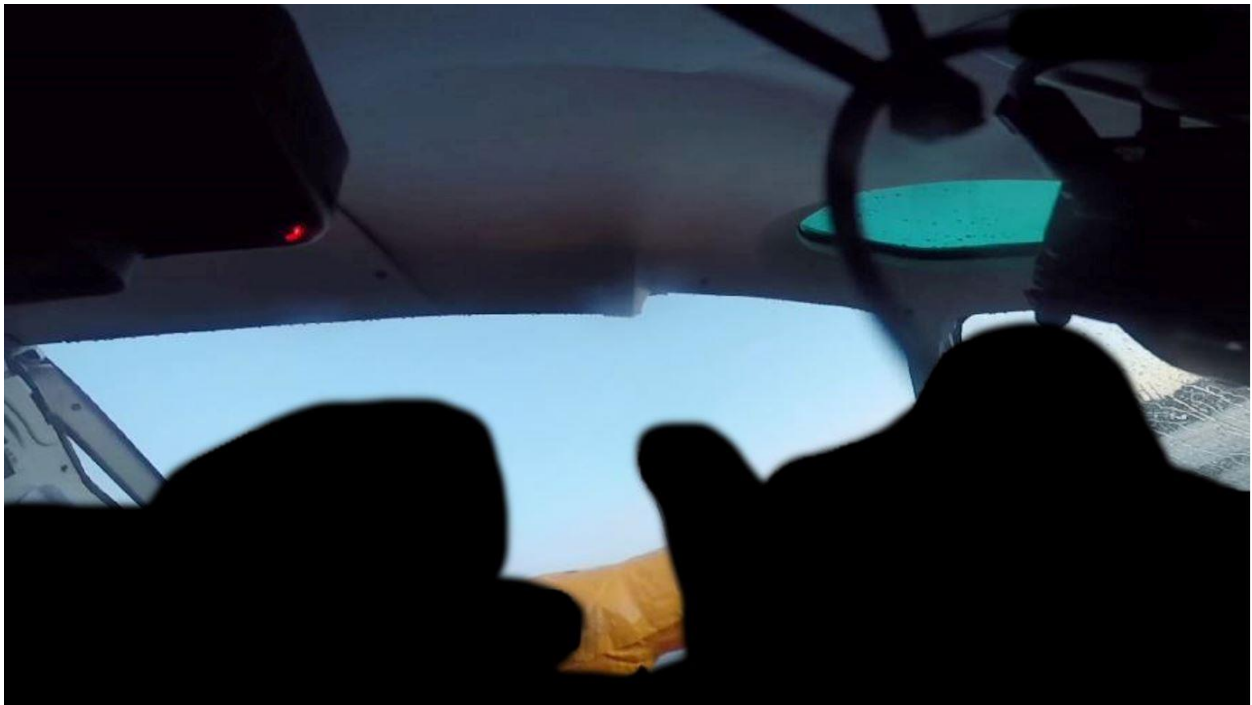
19:07:25.33 **Figure 5 is a redacted screenshot at this time. The figure shows the condition of the float and the surface condition of the water.**

Figure 5. A screenshot captured at 19:07:25.33. The figure shows the condition of the float. The occupants have been redacted.
