NATIONAL TRANSPORTATION SAFETY BOARD
Vehicle Recorder Division
Washington, DC 20594

Onboard Image Recorder

Group Chairman's Factual Report
By Bill Tuccio, Ph.D.

Location: Biloxi, Mississippi
Date: March 7, 2013
Locomotive: CSX230 (Lead)
CSX7870 (2nd Locomotive)
CSX7805 (3rd Locomotive)
Operator: CSX
NTSB Number: HWY17MH010

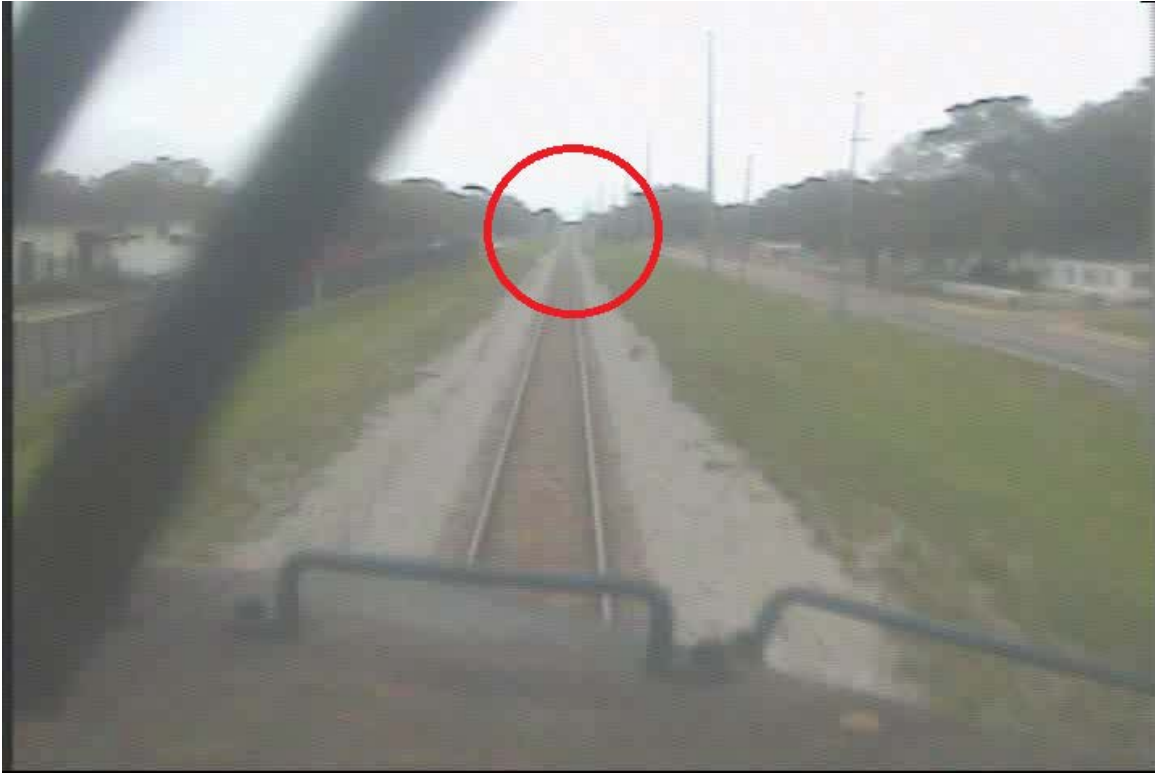
Figure 1. Image at 14:08:33 CST.

At 14:08:33 CST, the I-110 highway overpass was first visible to the Group (at this time, the overpass was about 1 statute mile ahead) (see figure 1); for this particular detail, the purpose is to help inform an objective measure of weather/atmospheric visibility.²

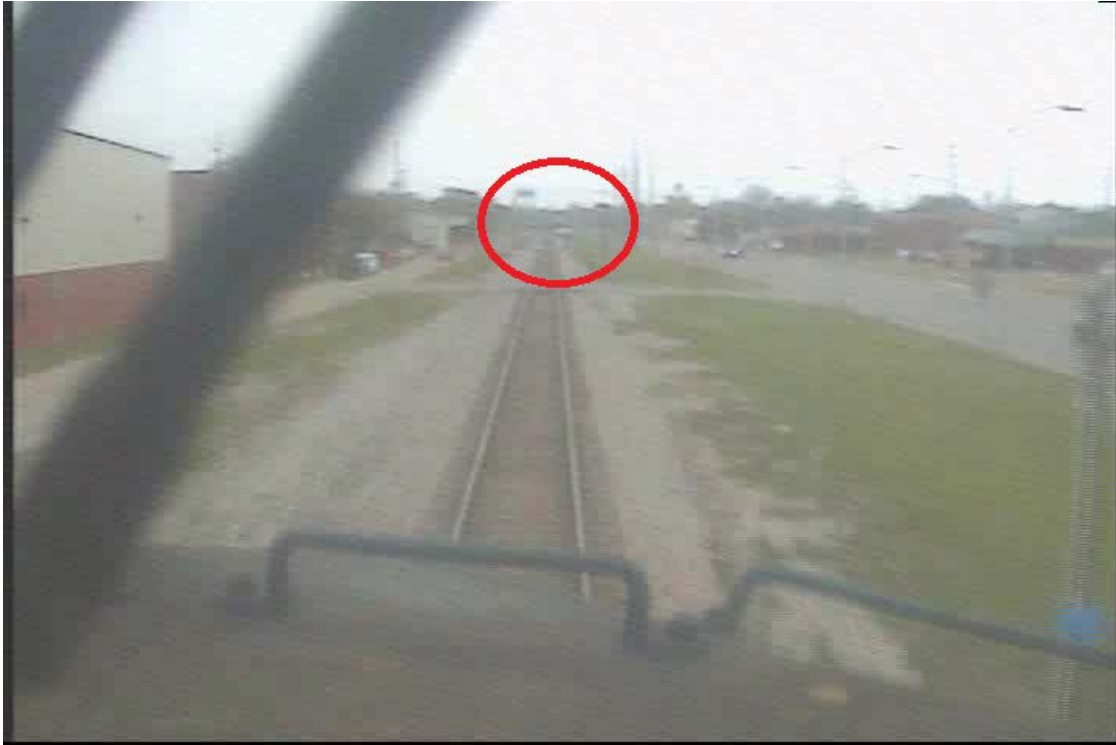
Figure 2. Image at 14:11:15 CST.

At 14:11:15 CST, CSX230 crossed Magnolia Street. At this time, 14:11:15 CST, the motorcoach that was ultimately struck was first visible to the group as an unidentifiable object when viewing CSX230's forward-facing camera (see figure 2); for this particular detail, the purpose is to help inform an objective measure of weather/atmospheric visibility.

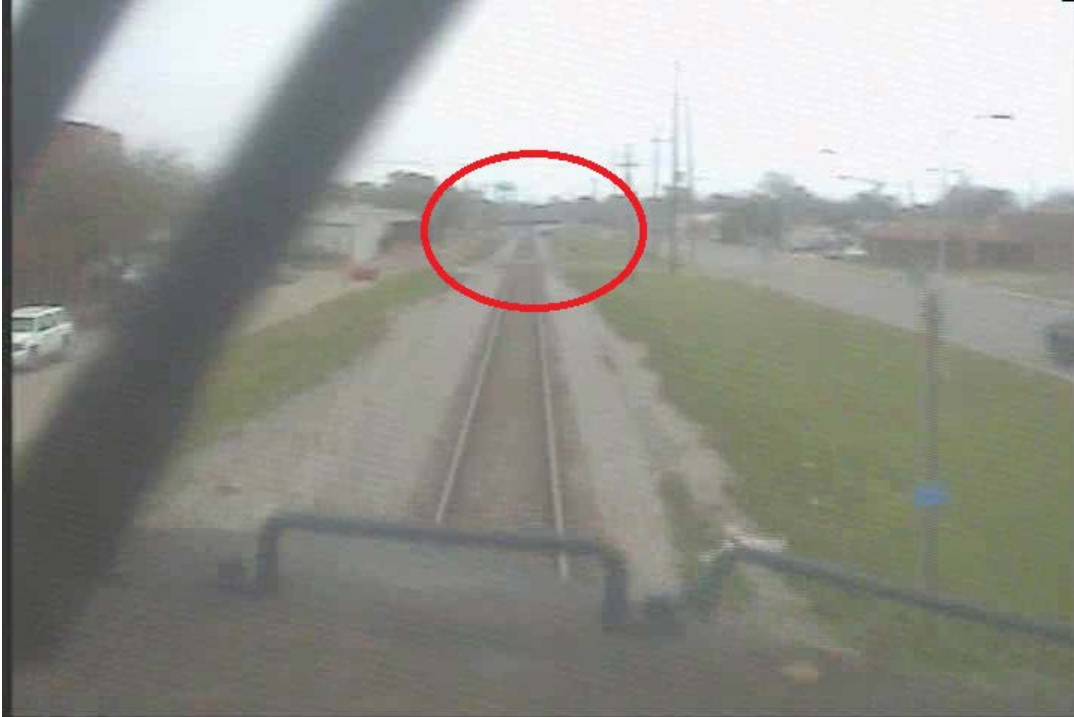
Figure 3. Image at 14:11:21 CST.

At 14:11:21 CST, CSX230 crossed Delauney Street. The forward-facing video image at this time is shown in figure 3; the group identified the object on the tracks as a motorcoach.

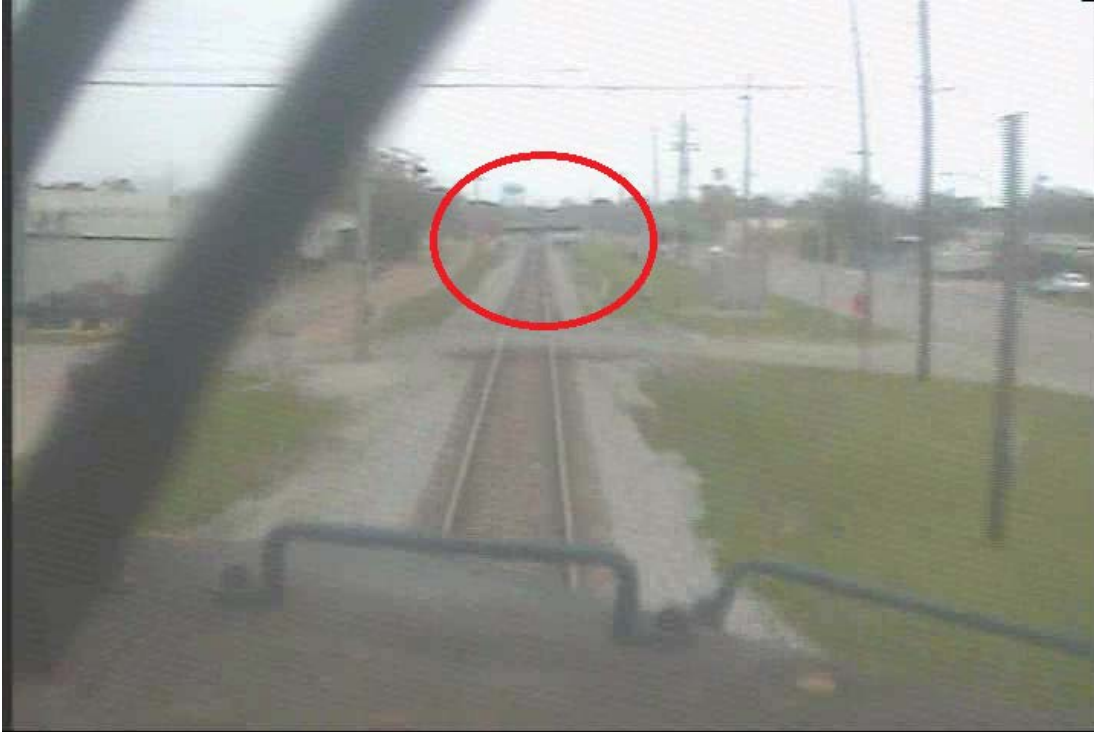
Figure 4. Image at 14:11:26 CST.

At 14:11:26 CST, just before CSX230 crossed Lameuse Street, the sound of high-pressure air, similar to the train initiating emergency airbrakes was recorded; figure 4 shows the forward-facing image at this time.

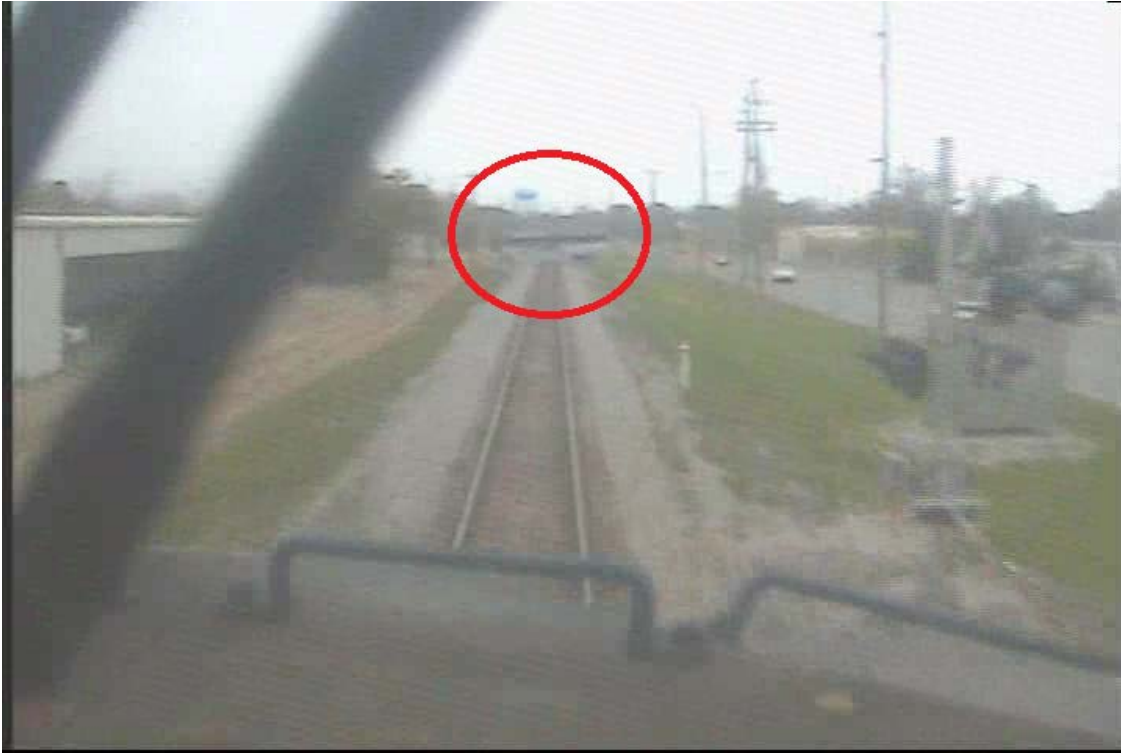
Figure 5. Image at 14:11:28 CST.

At 14:11:28 CST, CSX230 crossed Lameuse Street; the forward-facing video image at this time is shown in figure 5. The motorcoach that was struck was observably stationary although its directional orientation was unclear (that is, whether the front of the motorcoach was to the right or the left). There was vehicular traffic operating on Esters Boulevard to the right of the track.

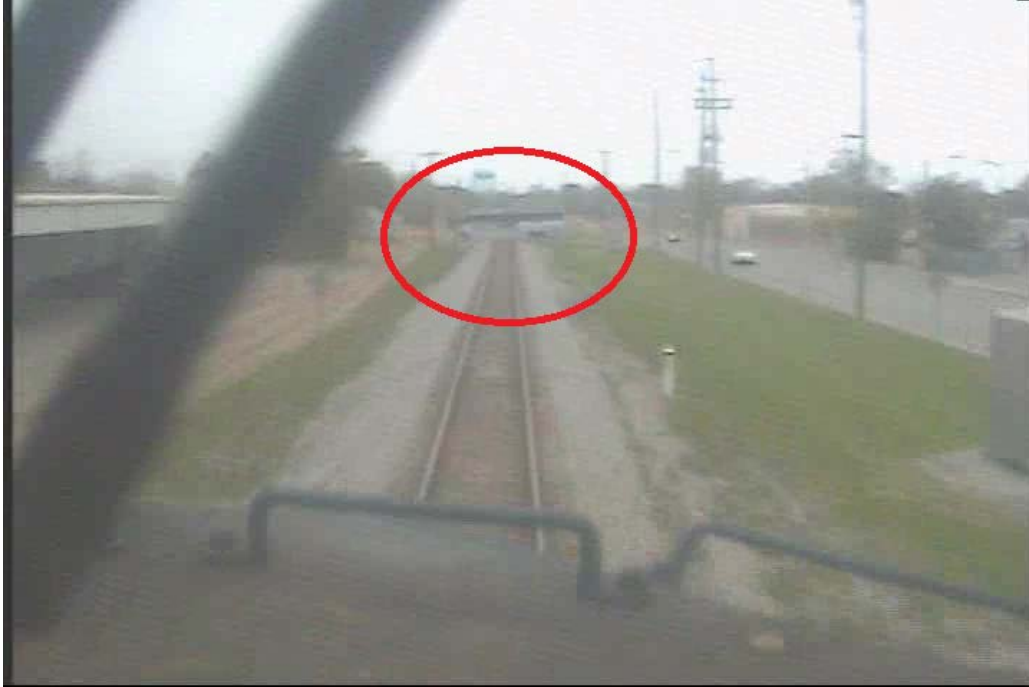
Figure 6. Image at 14:11:29 CST.

At 14:11:29 CST, the CSX230's forward-facing parametric data recorded PCS³ transition from closed to open; figure 6 shows the forward-facing image at this time.

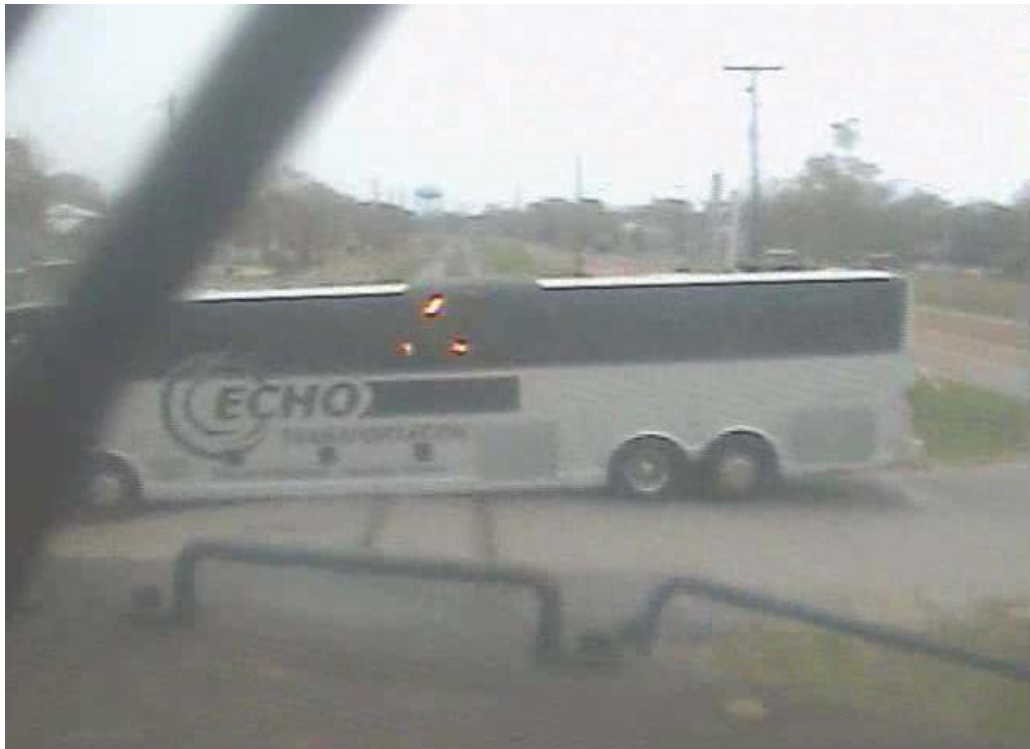
Figure 7. Image at 14:11:41 CST.

At 14:11:41 CST, the reflection of three lights from CSX230 were visible on the bus; these lights were the forward headlight and two auxiliary lights (ditch lights). The auxiliary lights were oscillating. At this time, the right railroad-highway grade crossing gate arm was touching the rear end of the motorcoach. Figure 7 shows the motorcoach at this time, including the center of the motorcoach touching the crossing.
