NATIONAL TRANSPORTATION SAFETY BOARD
Vehicle Recorder Division
Washington, DC 20594

Onboard Image Recorder

Specialist's Factual Report By Sean Payne

Location: Cayce, South Carolina
Date: February 4, 2018
Train/Locomotive: Amtrak PO91, Locomotive AMTK47
Train/Locomotive: CSXT Train F777 03, Locomotive CSXT 130
Train/Locomotive: CSXT Train F777 03, Locomotive CSXT 36
Operator: Amtrak/CSX Transportation
NTSB Number: RRD18MR003
Summary: Refer to the Accident Summary Report, within this docket.

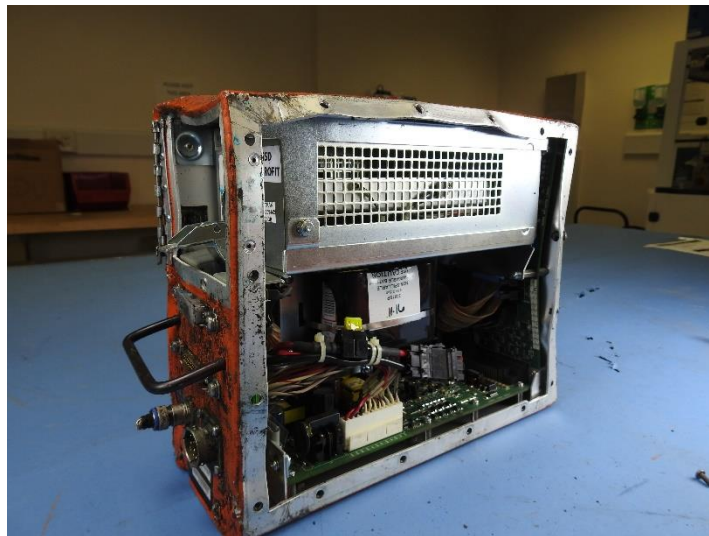
The image recorder from AMTK 47 was ejected from the locomotive. The orange outer chasis was dented and covered in mud. Figure 1 shows the outer casing with the side panel removed. The silver external hard disk enclosure is shown installed inside and undamaged. The external hard disk enclosure was removed and the device was read out normally via a PC using the manufacturer’s software and suggested procedures. The system did not record the impact but recorded many hours leading up to the accident.

Figure 1. The Wabtec VideoTrax recovered from AMTK47.

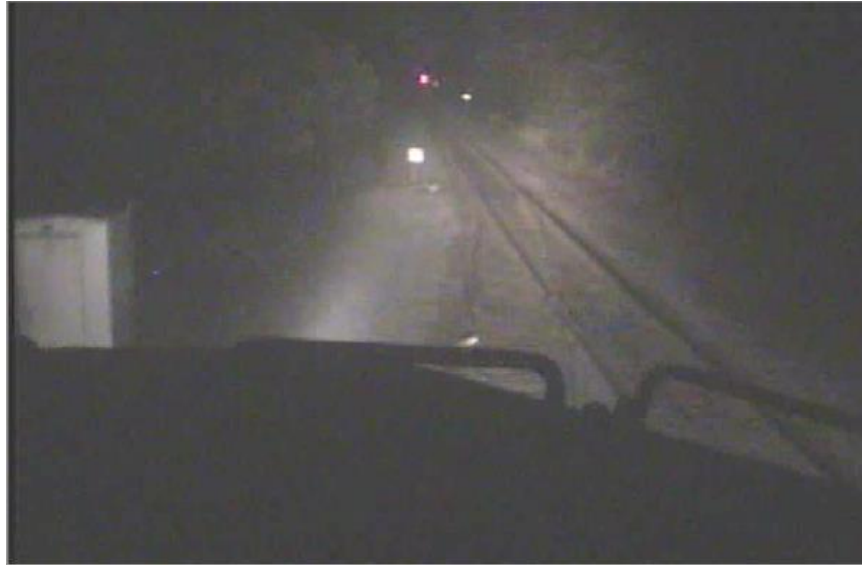
At 01:44:06, the train reversed across the north end of the Silica Storage track switch. The conductor was not seen at the switch after CSX F777 03 passed the switch. CSX F777 03 did not stop as it passed the switch. Figure 4 shows a view of Silica switch at this time.

Figure 4. Silica switch at 06:44:02.

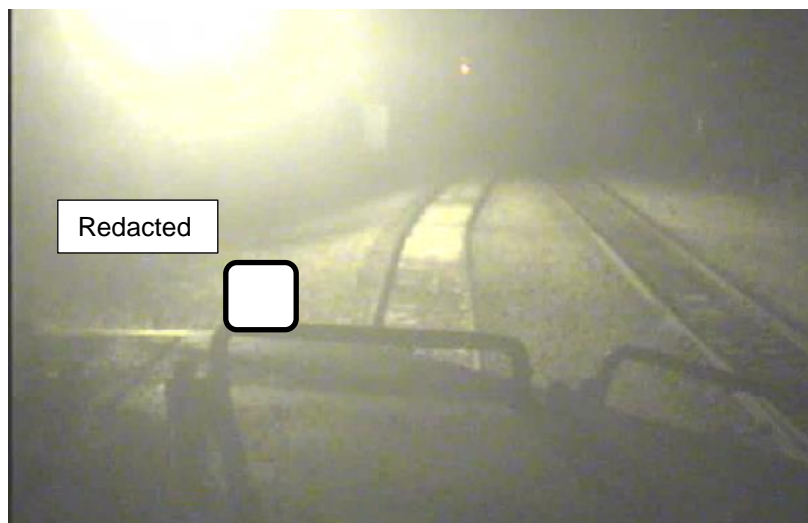
At 01:44:24, the locomotive came to a stop. At almost the same time, the conductor in a safety vest was visible in front of the locomotive. The conductor was bending at the waist, then became upright and walked across the Silica Storage track and the main line (figure 5).

Figure 5. The conductor seen bending at the waist next to the Silica Storage track switch. The conductor's body has been redacted.

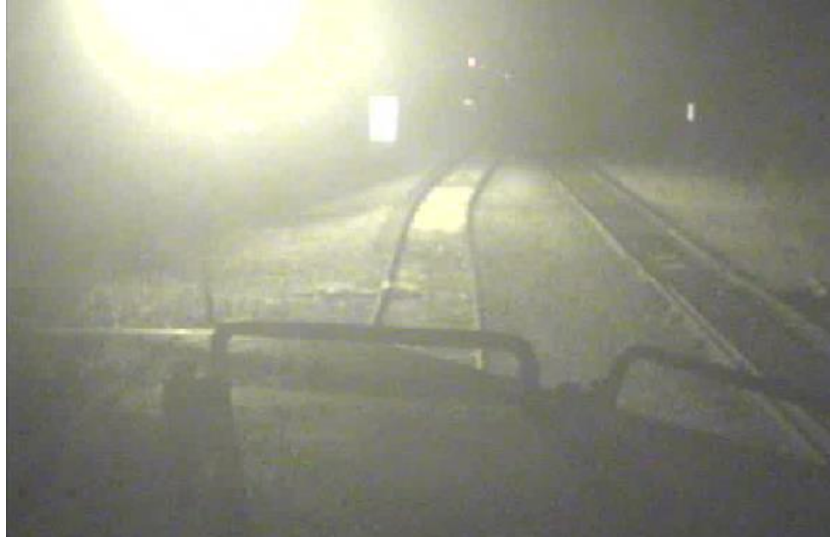
The conductor disappeared from view of the forward facing camera by 01:44:32. The main line switch into the north end of the auto ramp facility can be seen lined for the main line at 01:44:44 (figure 6).

Figure 6. The derail and the position of the track switch.

At 01:45:35, the locomotive began reversing. The derail became visible on the Silica Storage track. The derail was in the derailing position. The locomotive continued reversing until 01:46:31 when it came to a stop.
