**GROUP CHAIRMAN'S FACTUAL REPORT OF  
INVESTIGATION**

**DCA16FR007**

## **Onboard Image Recorder – Outward Facing**

Location:	Chester, Pennsylvania
Date:	April 3, 2016
Locomotive:	ACS-64, 627
Operator:	Amtrak
NTSB Number:	DCA16FR007

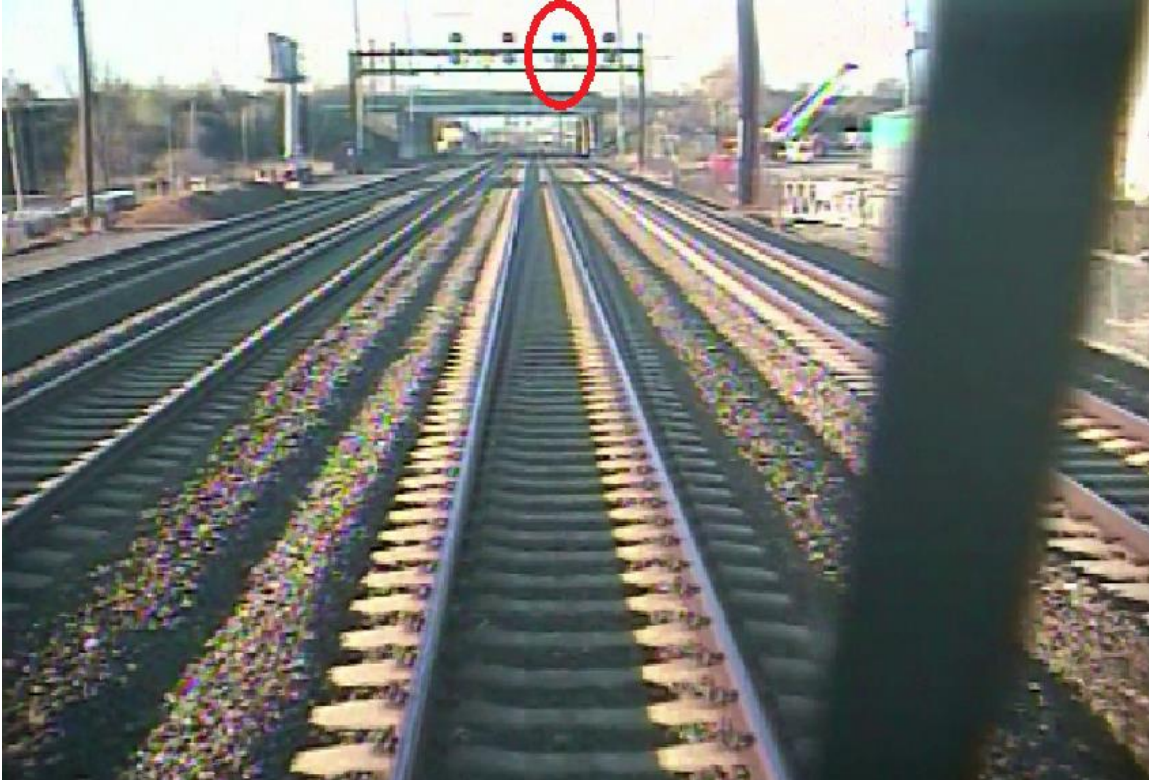
**Figure 1. A still image from the recorder at 07:47:12.9**

**07:47:12.9:** Baldwin southbound home signal bridge in view. The third signal from the left (annotated in figure 1) is displaying green. The train is on main track 3.

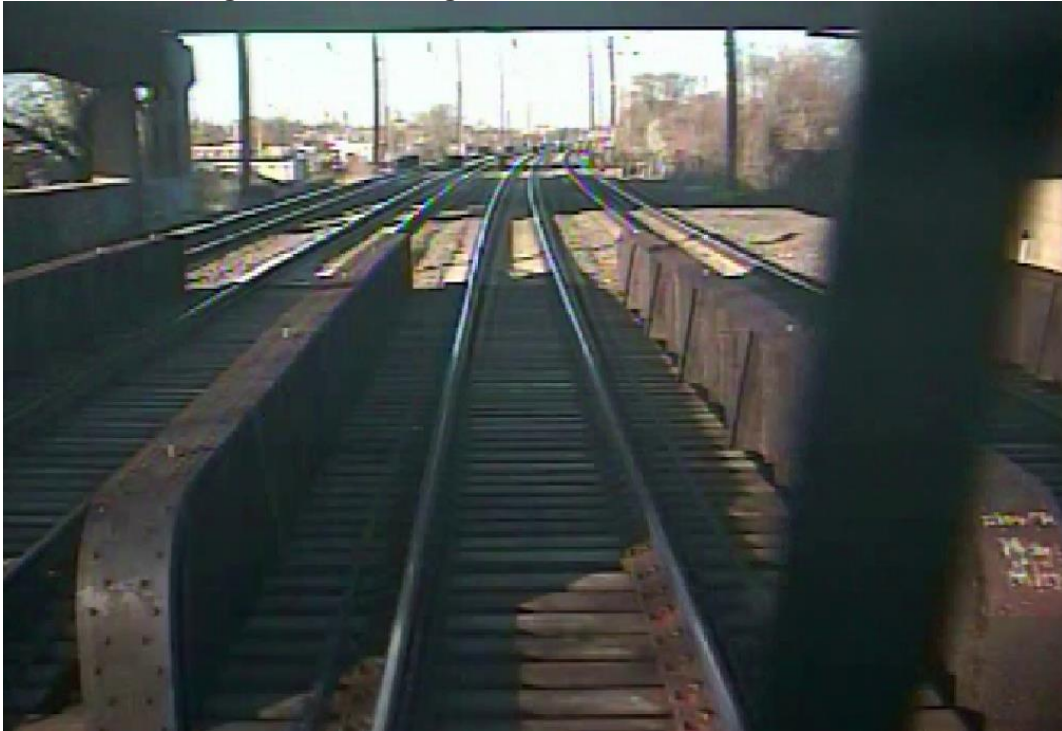
**Figure 2. A still image from the recorder at 07:49:12.2**

**07:49:12.2:** Train entering right-hand curve as it passes Flower Street undergrade, MP 14.8. (see figure 2).

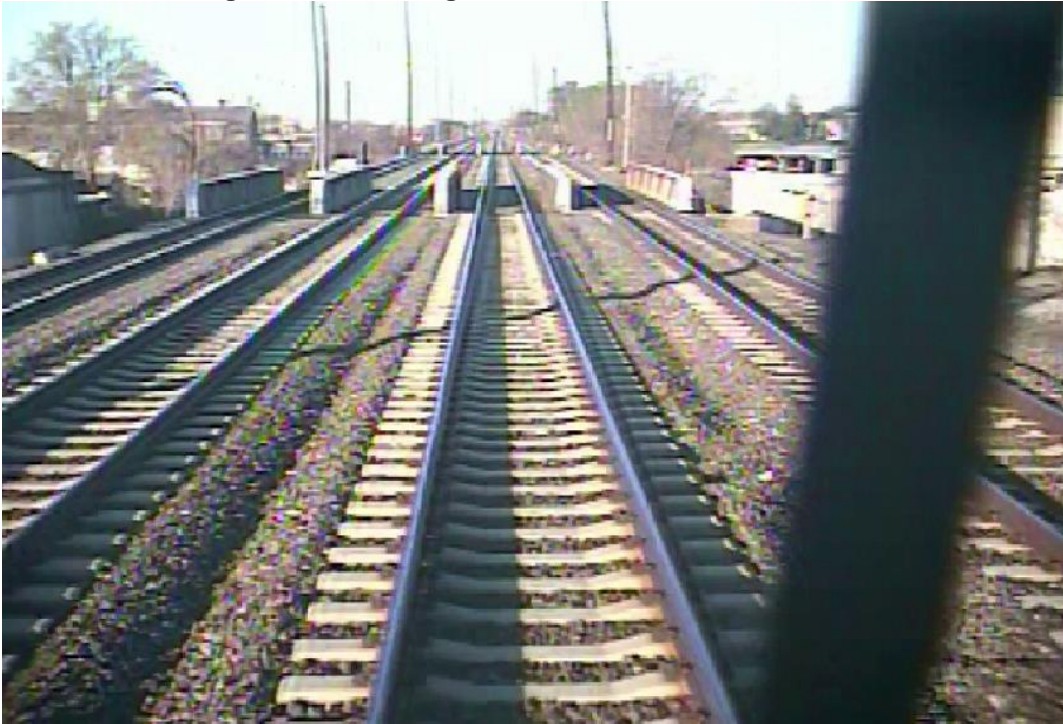
**Figure 3. A still image from the recorder at 07:49:18.4**

**07:49:18.4:** Train is moving forward on straight track. Clear route ahead. (see figure 3).

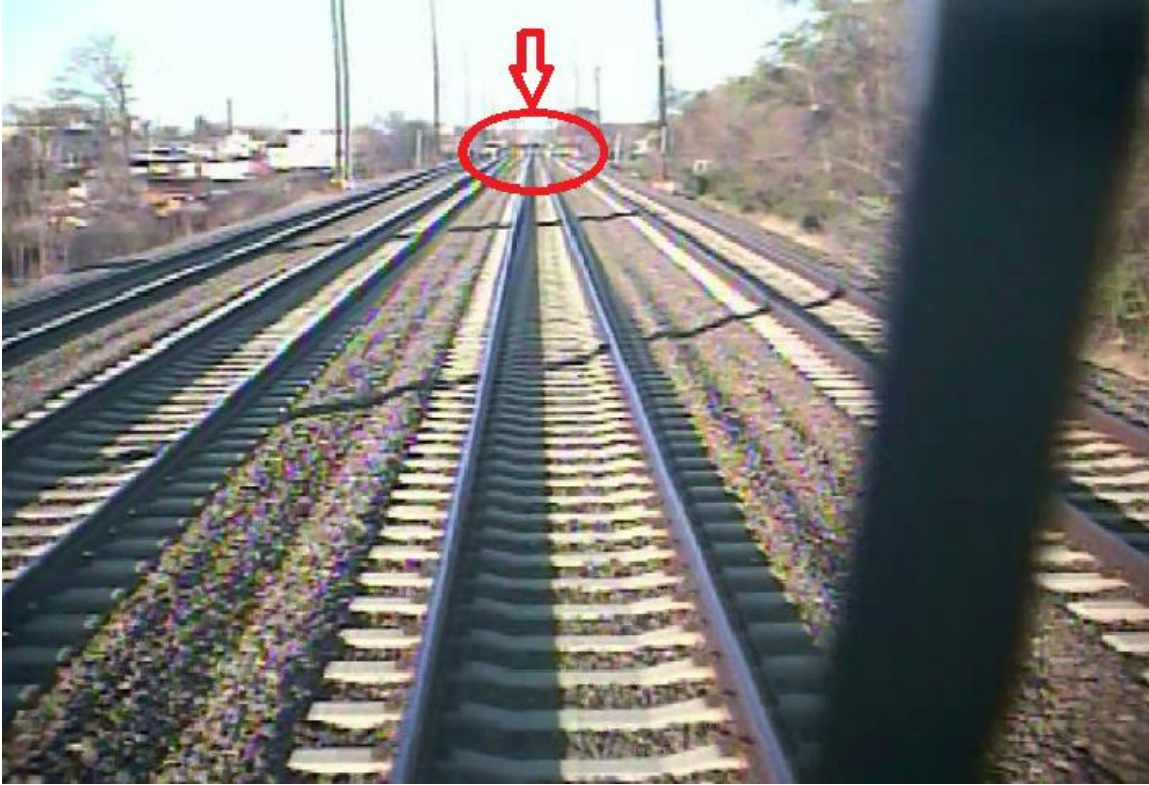
**Figure 4. A still image from the recorder at 07:49:25.9**

**07:49:25.9:** Indiscernible object is first visible ahead. (see figure 4)

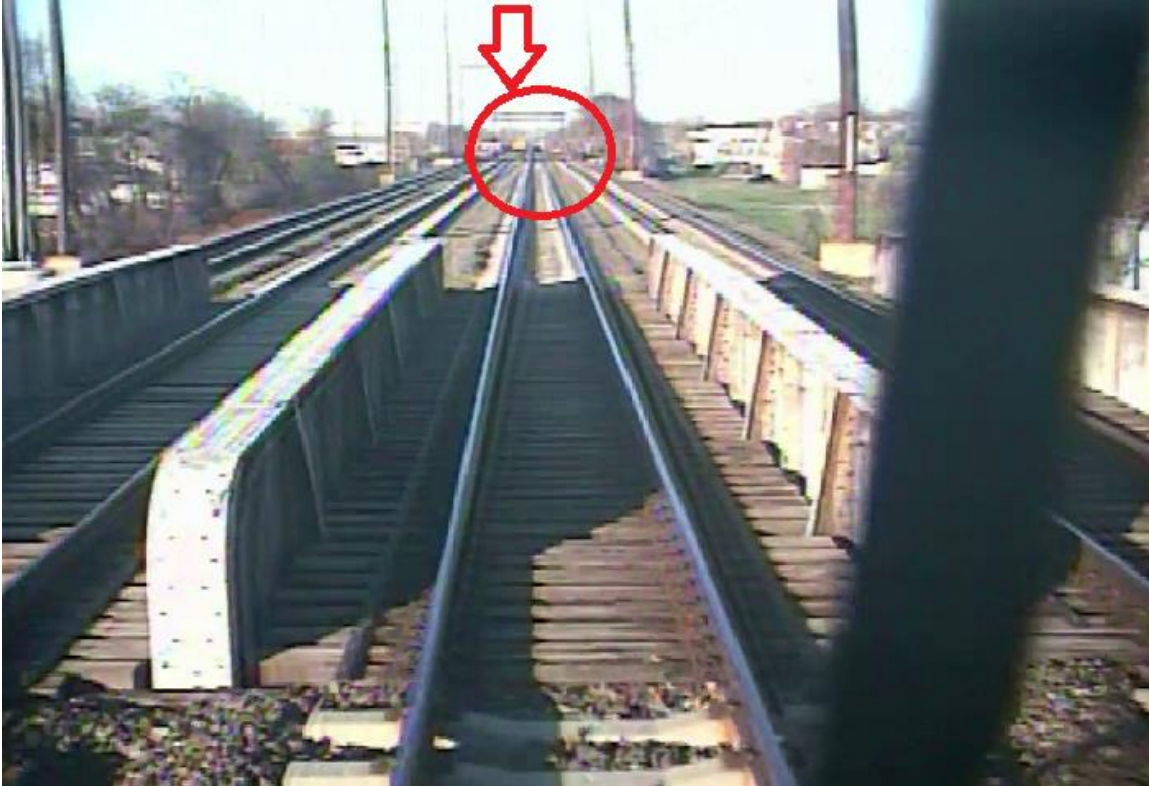
**Figure 5. A still image from the recorder at 07:49:30.8**

**07:49:30.8:** Train is just north of Wilson street undergrade (MP 15.36). Previously indiscernible object now appears yellow and is on a track to the left of main track 3. (see figure 5).

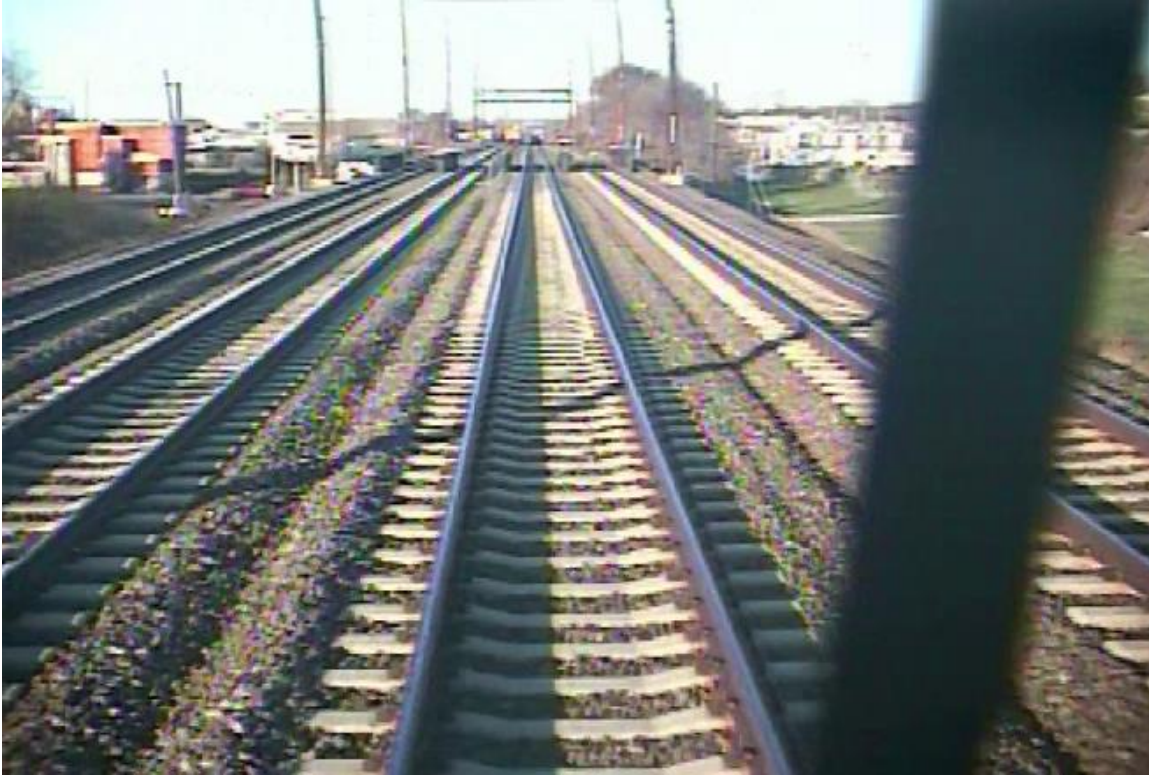
**Figure 6. A still image from the recorder at 07:49:33.4**

**07:49:33.4:** This screen capture was taken at the time the sound of horn was audible on the inward facing recording. Due to microphone placement and other external noises present, the horn was not audible on the outward facing recording, instead, the time the horn became audible was referenced from the inward facing recorder.<sup>1</sup> That moment is captured below in figure 6 at the time listed above. (see figure 6)

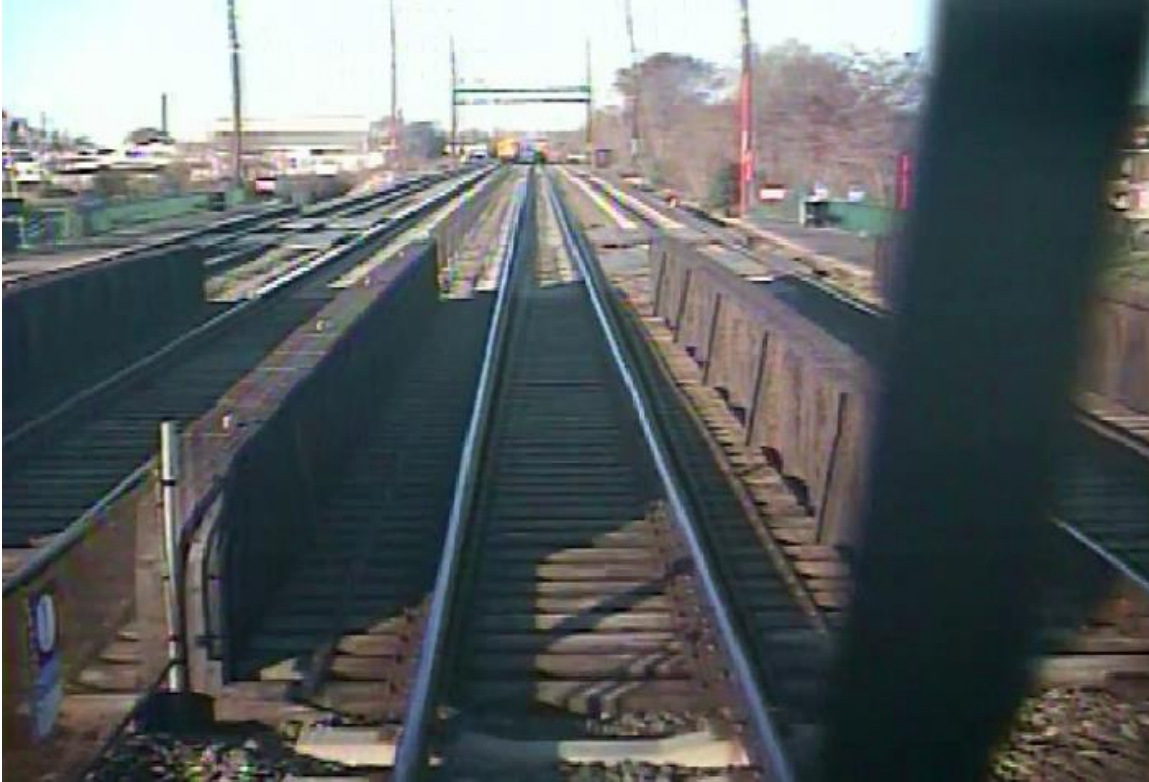
**Figure 7. A still image from the recorder at 07:49:35.4**

**07:49:35.4:** Train is just north of Highland Avenue undergrade (MP 15.5). Details of the previously identified yellow object are more defined. The Highland Avenue through-plate girders are casting shadows to the right of the structure. No watchman lookouts or hand-held whistleboards (also called paddles) are visible. (see figure 7)

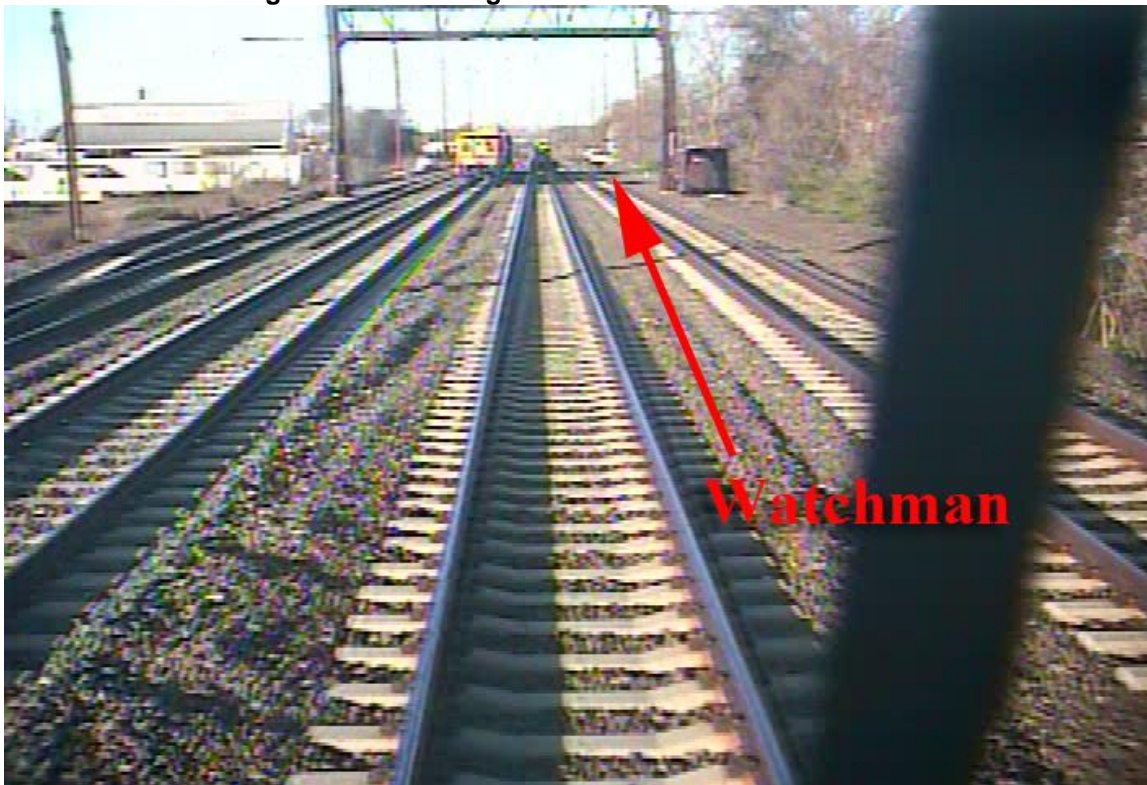
**Figure 8. A still image from the recorder at 07:49:38.7**

**07:49:38.1:** Train is just north of the dragging equipment detector (MP 15.7). Yellow equipment is visible on main track 2 and main track 3. No personnel are discernable on any track or equipment.

**07:49:38.7:** The watchman is first discernable to the right of main track 4. The watchman appears to be in a partial shadow. (see figure 8)

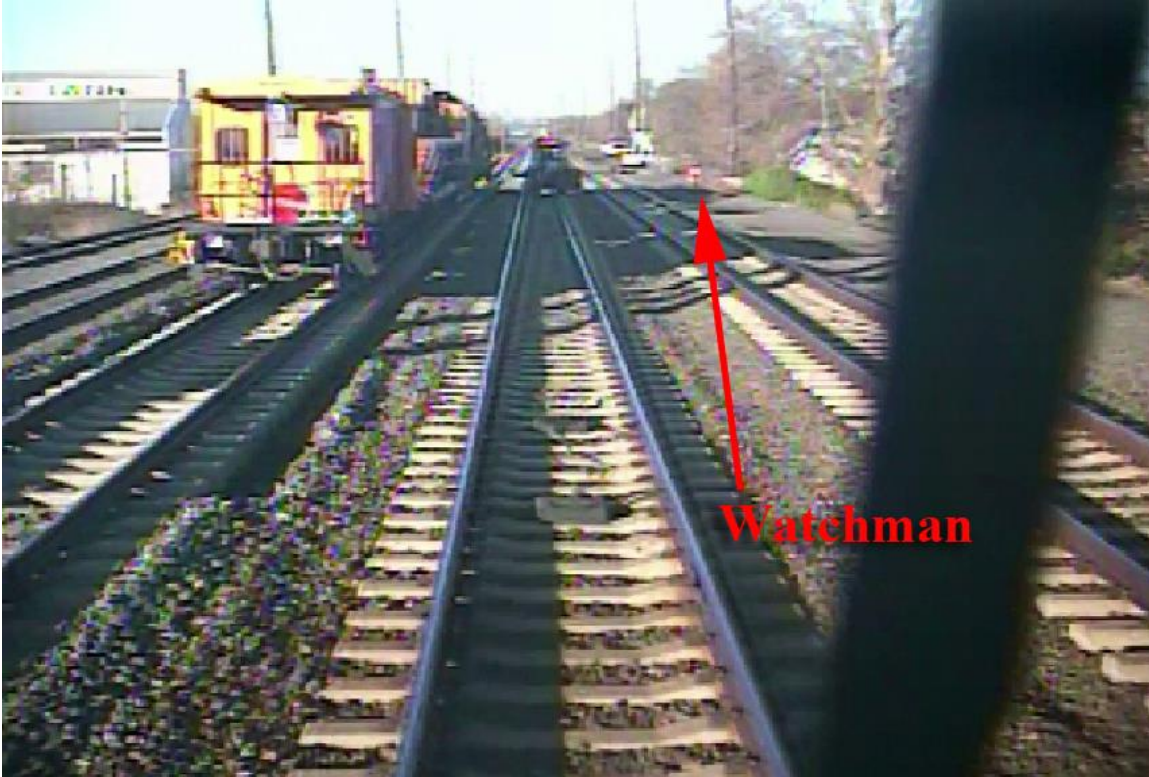
**Figure 9. A still image from the recorder at 07:49:40.1**

**07:49:40.1:** The yellow Loram Vacuum Train is clearly visible on main track 2 with a rear end marker. The Loram is casting a shadow extending over main track 3 and main track 4. Equipment/obstruction is apparent on main track 3 ahead of the train, in the shadow cast by the Loram. An arrow indicates the position of the watchman in red. (see figure 9)

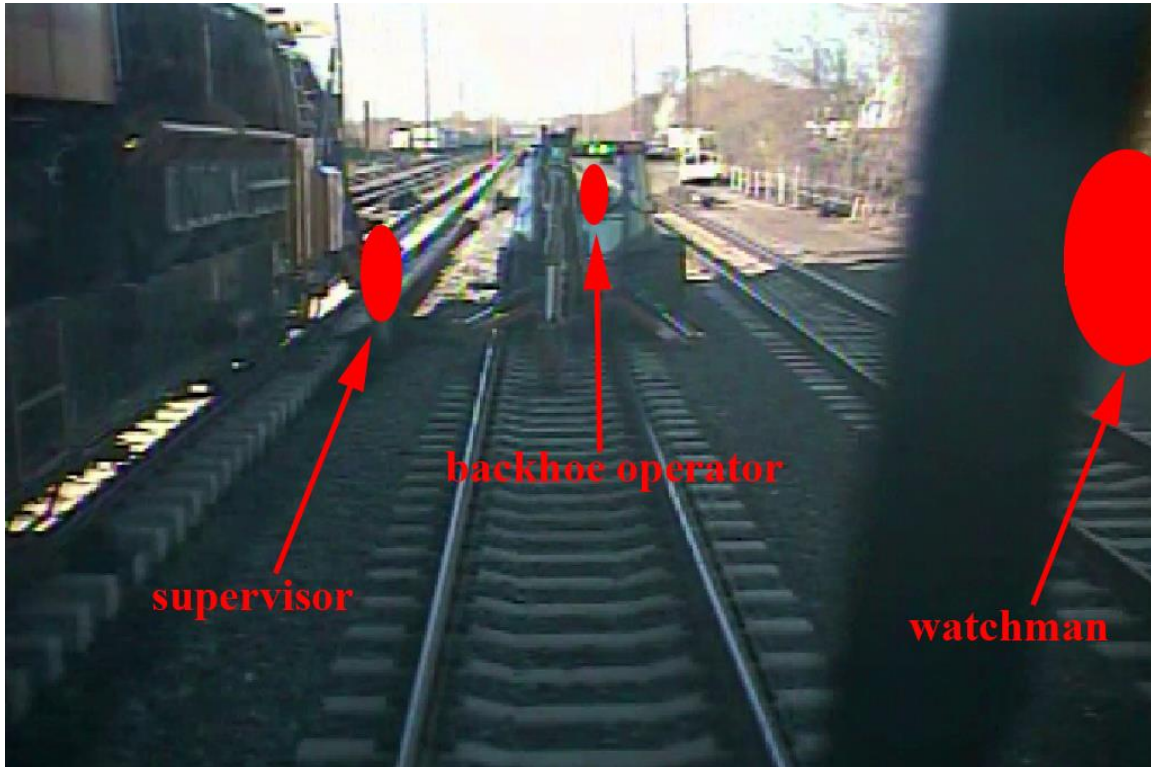
**07:49:41.5:** Watchman visible to the right of main track 4. Watchman is facing north (facing the oncoming train) and his hard hat is discernable. The handheld whistleboard is not raised or discernable (further, whistleboard is not discernable in the half second before the figure included in this report). (see figure 10)

**Figure 10. A still image from the recorder at 07:49:41.5. The image of the individuals has been redacted with red circles**

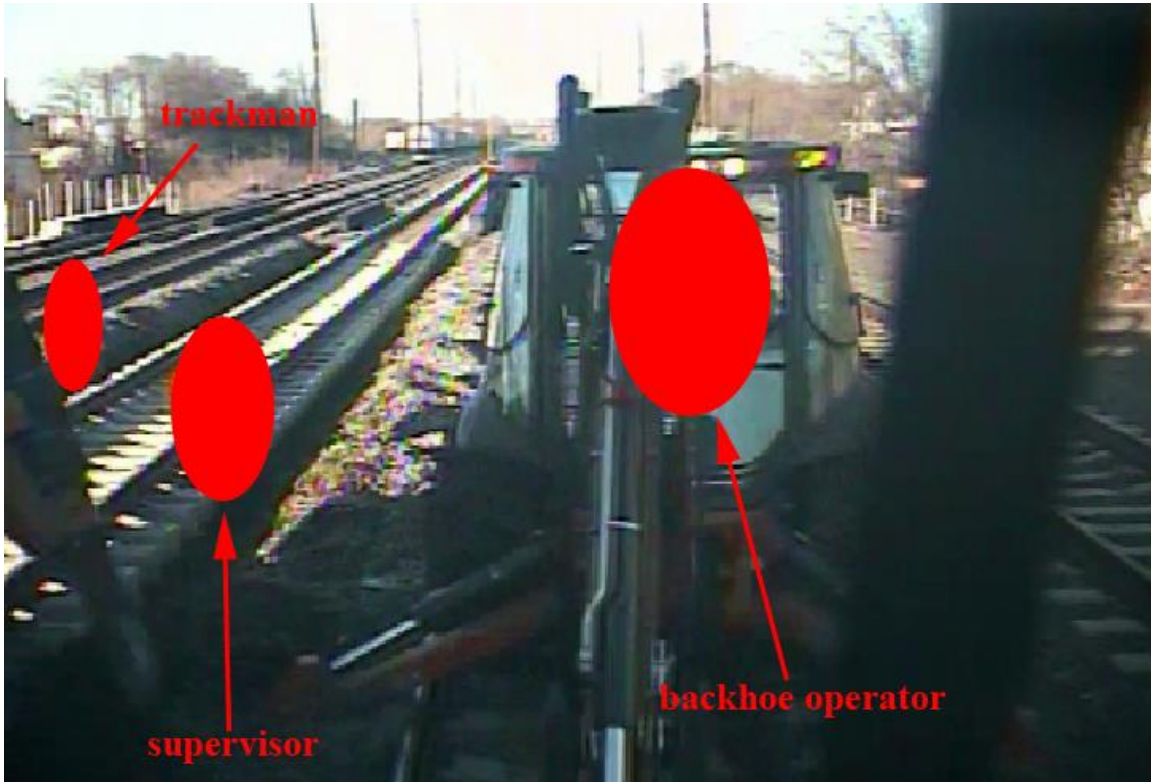
**07:49:41.8:** Supervisor is standing, facing south (away from the train) on the west field side of main track 2. A trackman is standing to the east field side of main track 2. The backhoe operator is sitting in the cab of the backhoe. The worklights on the top of the backhoe are on. The backhoe outriggers are extended and the cribbing bucket is anchored in the ballast between the two concrete ties, touching the track bed. (see figure 11)

**Figure 11. A still image from the recorder at 07:49:41.8. The image of the individuals has been redacted with red circles**

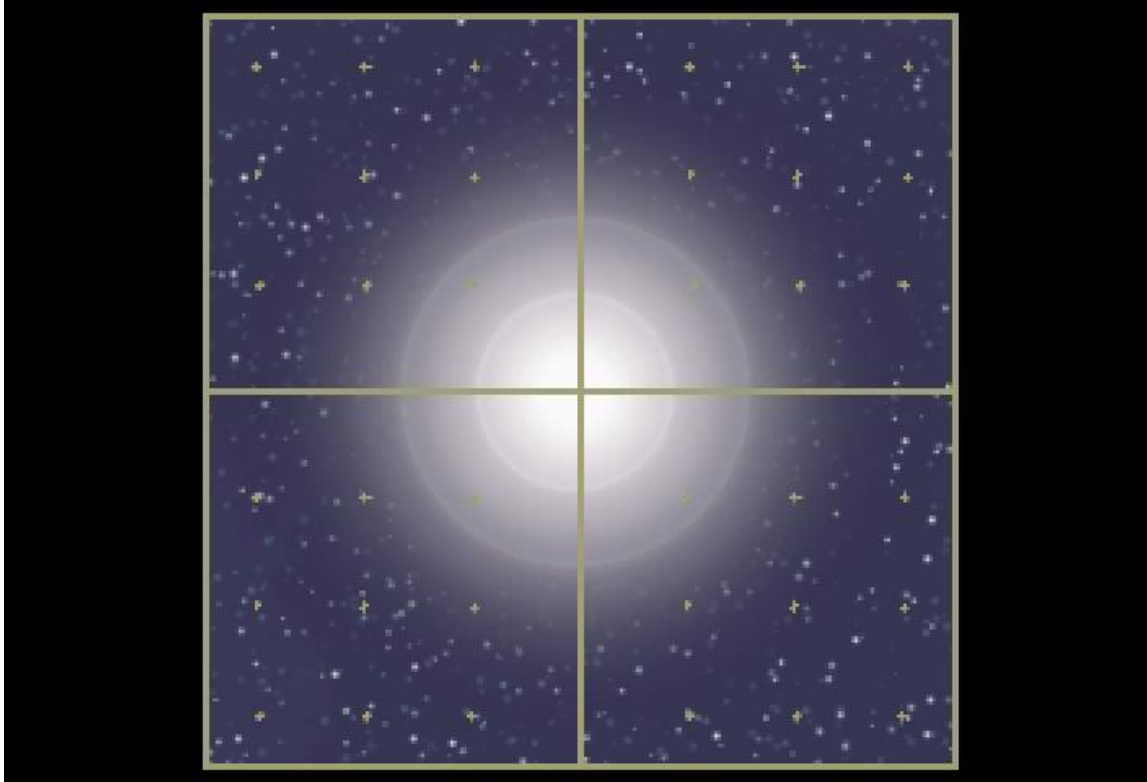
**07:49:41.8:** The video recording fails to produce usable imagery but continues recording sound. The sound of impact is heard as well as the sound of the train's continued motion. (see figure 12)

**Figure 12. The recording showing a loss of imagery data at approximately 07:49:41.9.**
