NATIONAL TRANSPORTATION SAFETY BOARD
Vehicle Recorder Division
Washington, DC 20594

Onboard Image Recorder – Solid State Hard Drive

Specialist's Factual Report
By Sean Payne

Location: Charlottesville, VA
Date: August 12, 2017
Aircraft: Bell 407, N31VA
Operator: Virginia State Police
NTSB Number: ERA17FA274

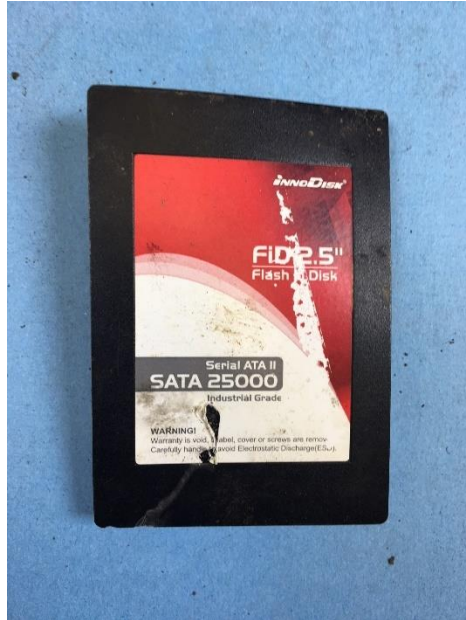
Upon arrival at the NTSB Vehicle Recorder Division, it was evident that the SSD had sustained impact damage. Figure 1 shows the condition of the outer casing.

Figure 1. The condition of the SSD's outer casing.

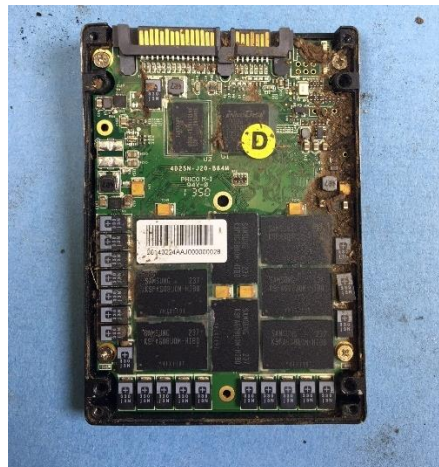
The outer casing cover was removed and the SSD was found to be filled with earthen debris (figure 2). The SSD's board was removed from the outer casing. Figure 3 is an annotated view of the SSD's internal memory board after being removed from the outer casing. Micro-hardware (circled in red) and one non-volatile memory (NVM) chip was found to be displaced from the board.

Figure 2. The SSD with the outer casing removed.

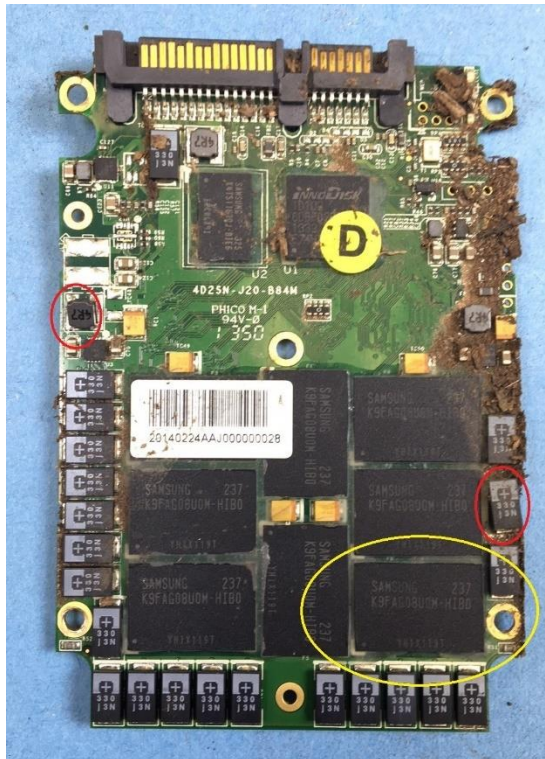
Figure 3. Damage on the SSD's main board, annotated.

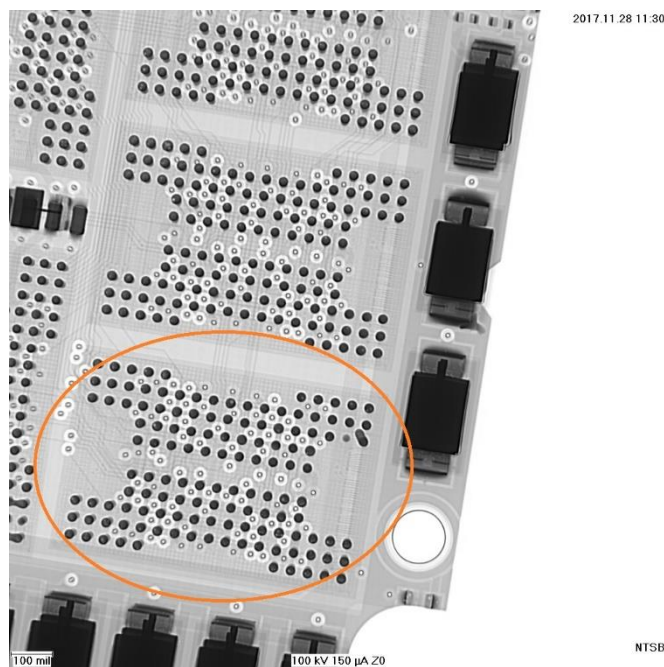
Figure 4 is an x-ray image of the affected area of the displaced memory chip. Ball Grid Array (BGA) style solder connections were found to be displaced between the interface of the memory chip and the board.

Figure 4. An x-ray image of the SSD's board. The affected area is circled in orange. Microsolder connections in the upper right portion of the chip appear to be displaced.

A visual inspection confirmed displacement of the affected memory chip. Additional visual inspection revealed no other anomalies of the main board or its components.

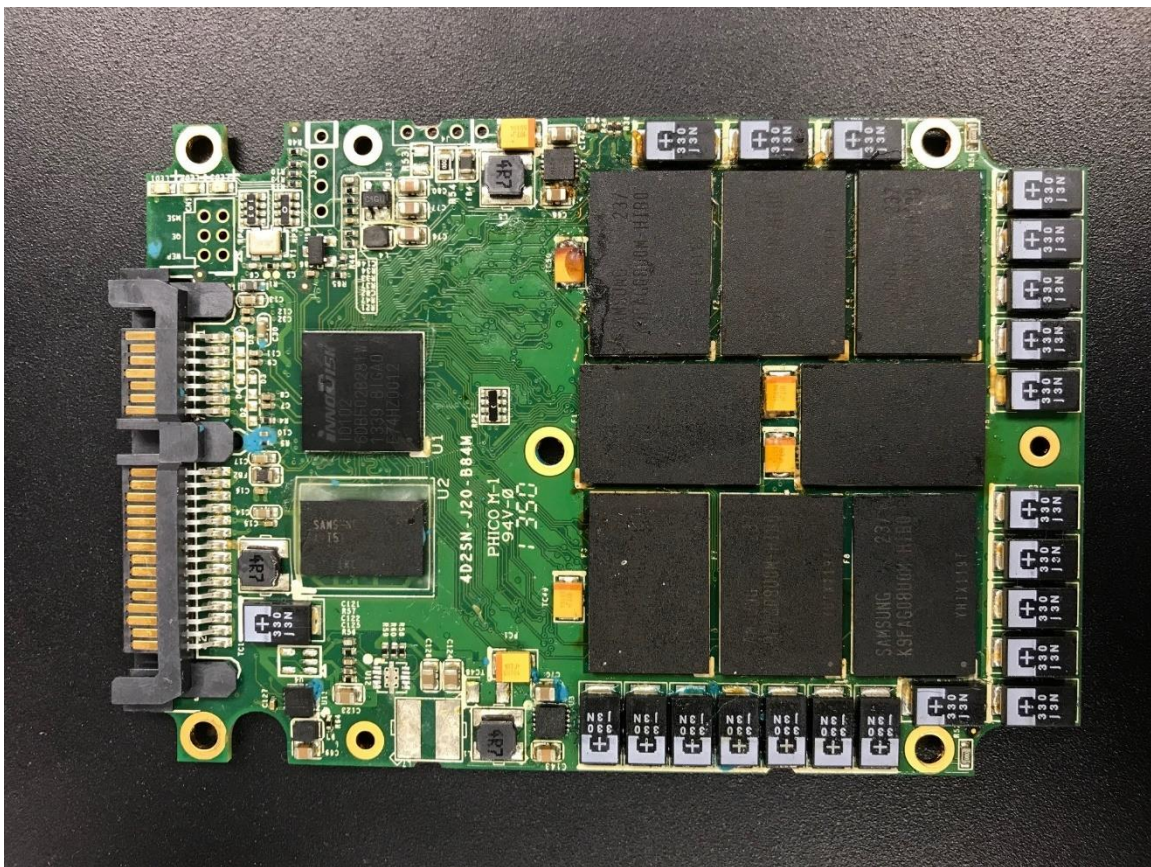
Figure 5. The reworked surrogate SSD with the accident chips and controller placed.

The surrogate drive with the placed accident chips were then attempted to be read using a forensic write blocker on a PC. Using a variety of methods and settings, the PC was unable to detect or access the surrogate hard-drive.

result of comparison between these two chip reads showed that the data differed, and it was likely that the hardware controller had reorganized binary data on the placed memory chips when powered was applied. Ultimately, the data was unable to be recovered.

Upon return of the physical evidence, the NTSB lab then contracted again with the manufacturer of the hot-air re-work station, this time focusing on how to properly place the eight BGA style memory chips. The NTSB procured a surrogate SSD of the same make, model and production lot number from the SSD manufacturer and all eight chips were replaced to the surrogate board. Additionally, the accident board's hardware controller was removed and placed on the procured surrogate. The placed chips on the surrogate drive were then x-rayed for quality control and verified that over 1,000 BGA style solder connections were successfully created and no anomalies were noted. Figure 5 is a photo of the reworked surrogate SSD with the accident chips and controller placed.
