Physical Analysis Report on CEN15FA290

Prepared by Binghamton University
for the National Transportation
Safety Board, September 15, 2015

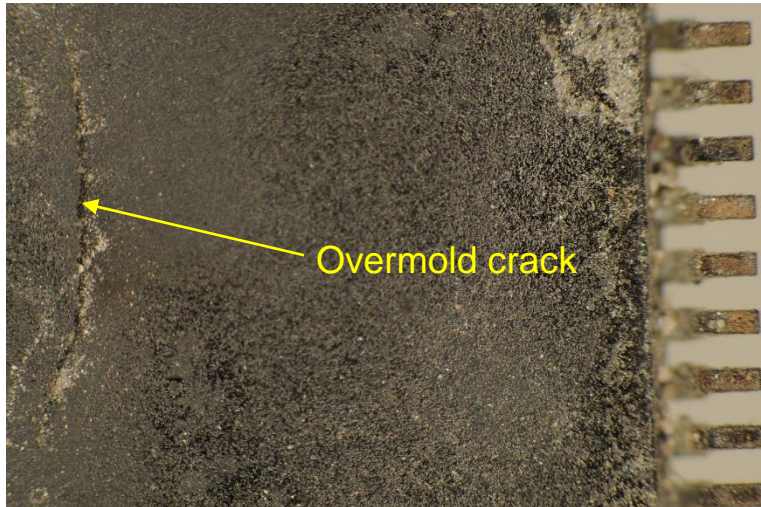
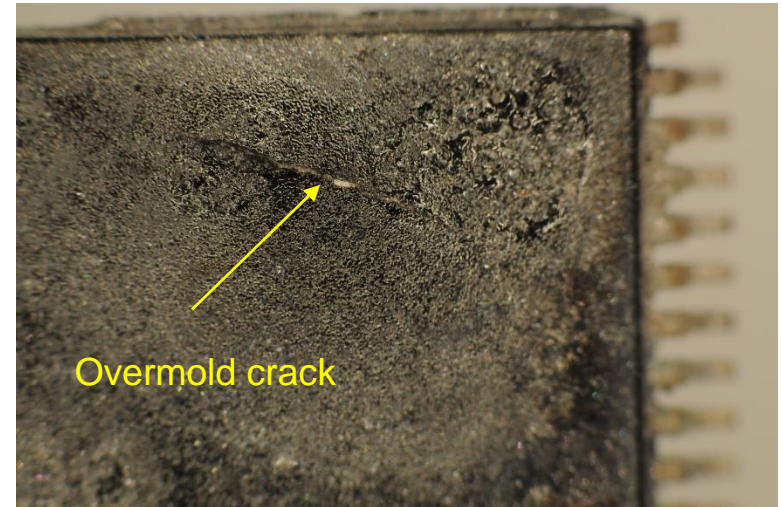
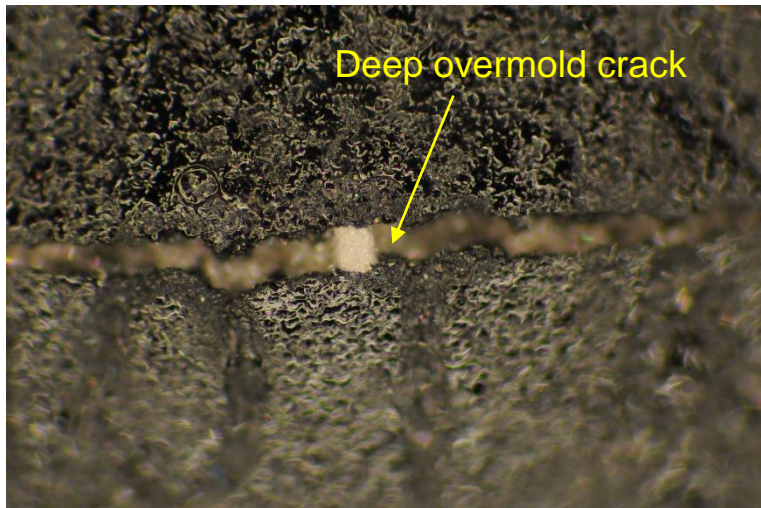
Sample Optical Micrographs of DECU Parts, Box 3

No evidence of bulging from internal expansion

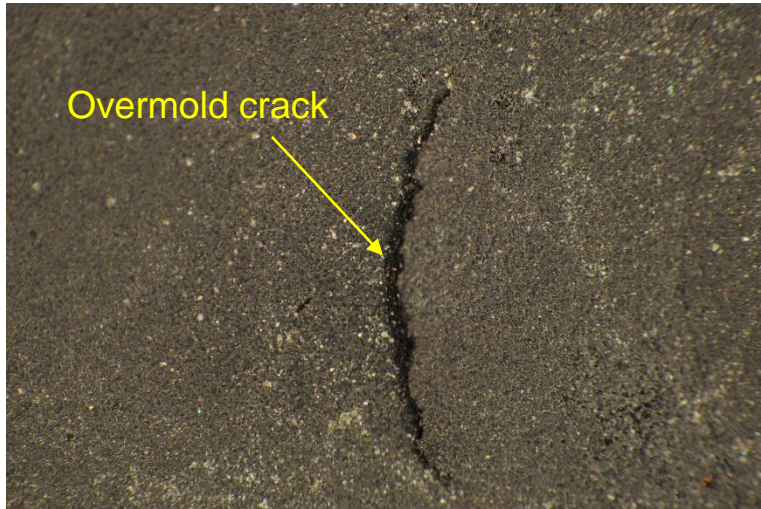
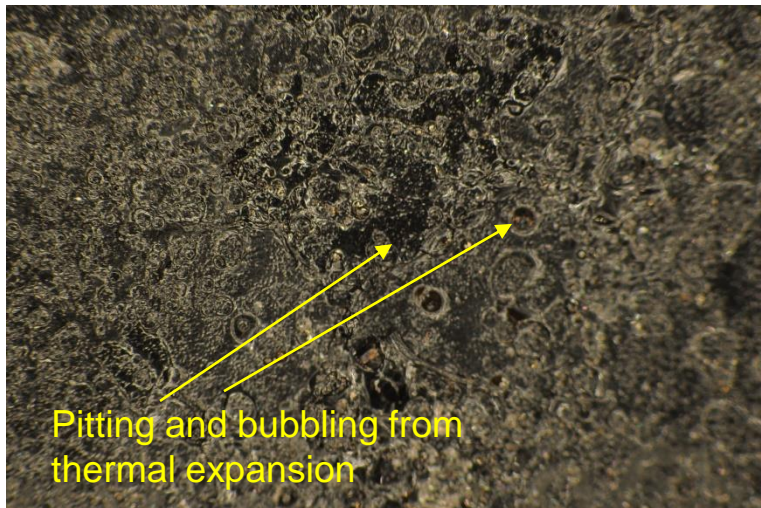
Sample Optical Micrographs of DECU Parts, Box 4

No evidence of bulging from internal expansion

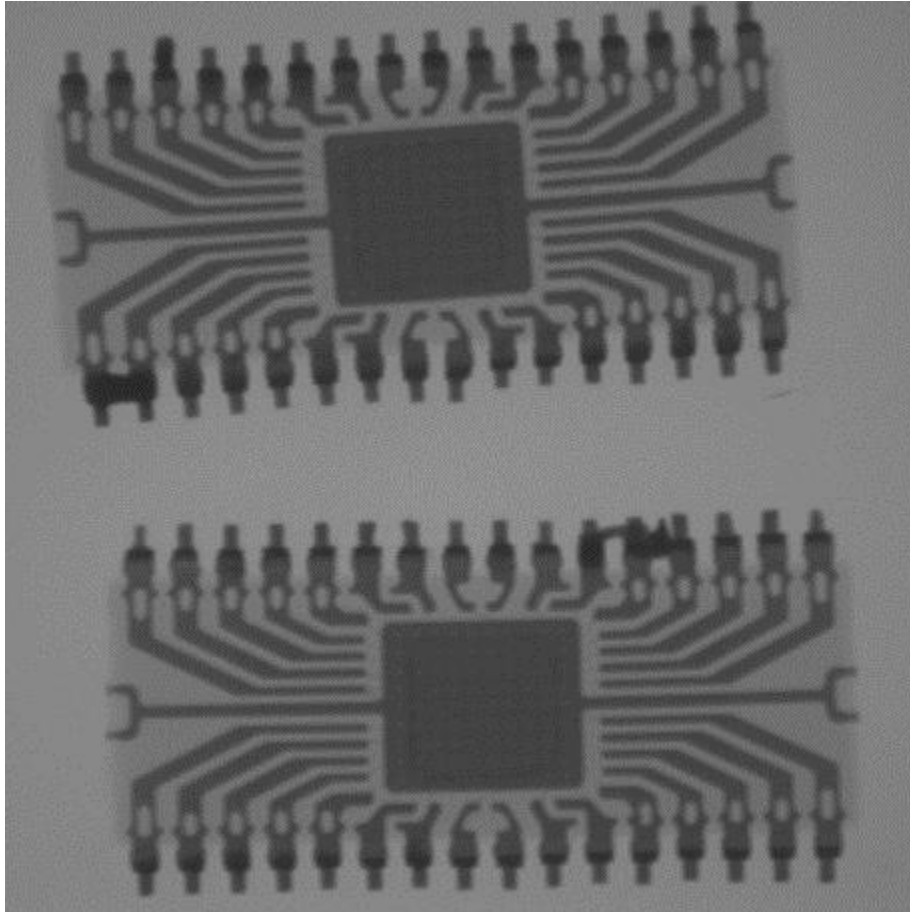
X-rays of DECU Parts, Box 1

Both parts exhibit a simple fan out from the chip to the leads

Fan out circuitry appears to be in tact

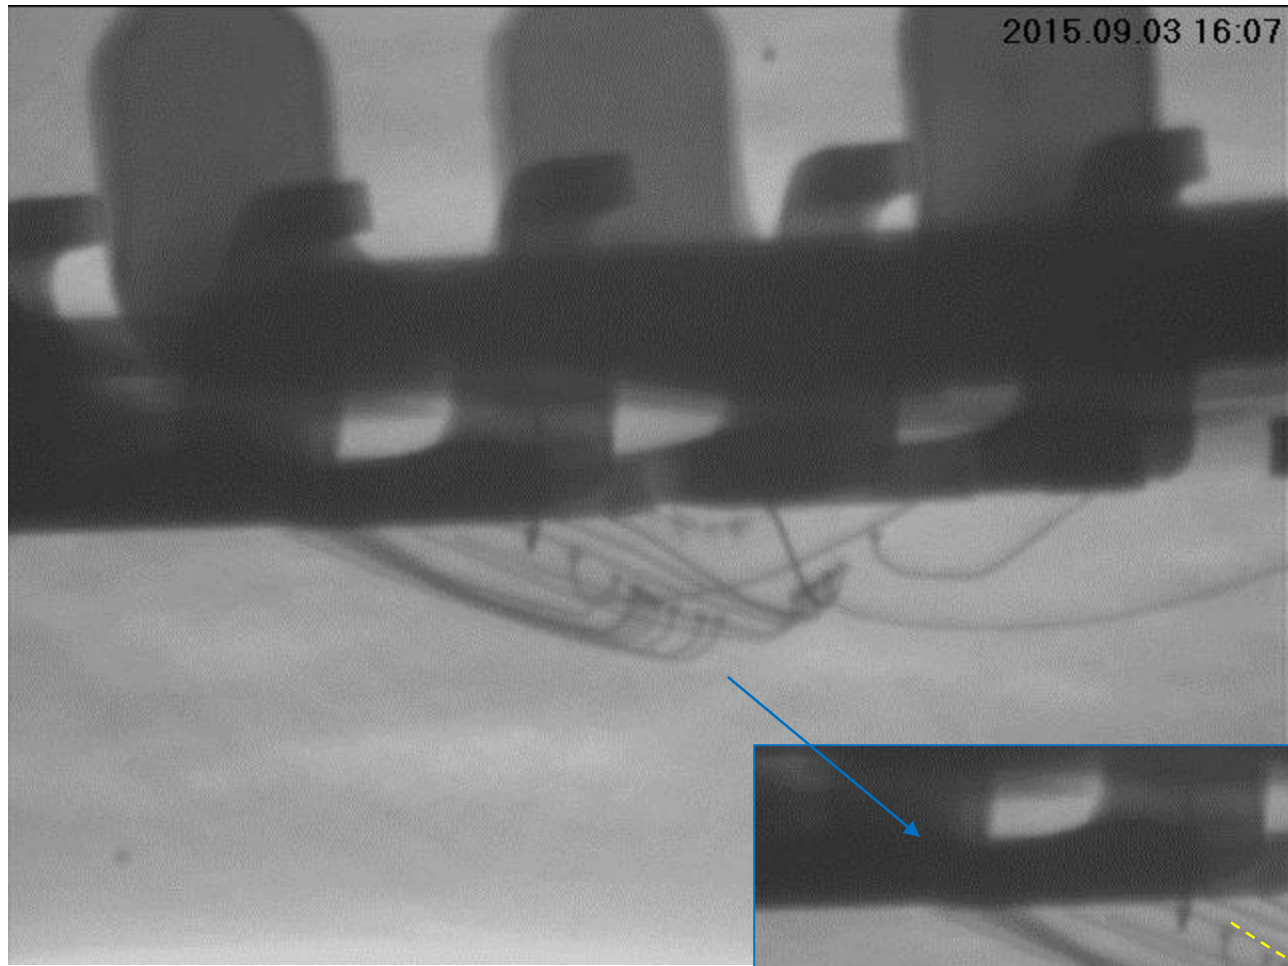
Side X-rays of DECU Parts, Box 1

Z direction bowed pattern of the wire bond balls suggests they were pulled from the chip (presumably by the deformation during the thermal excursion)

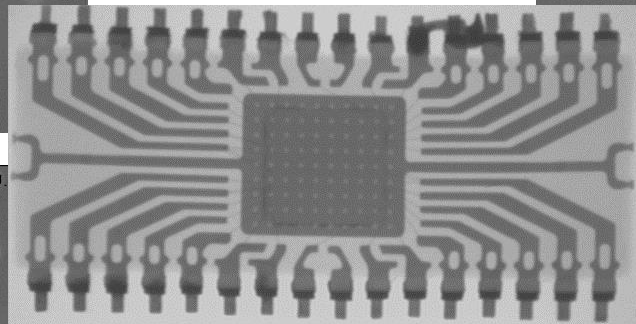
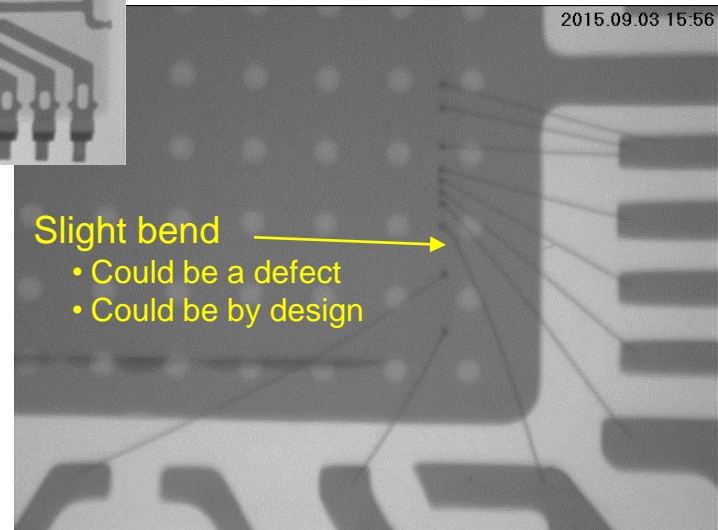
- Slight bend
- Could be a defect
 - Could be by design

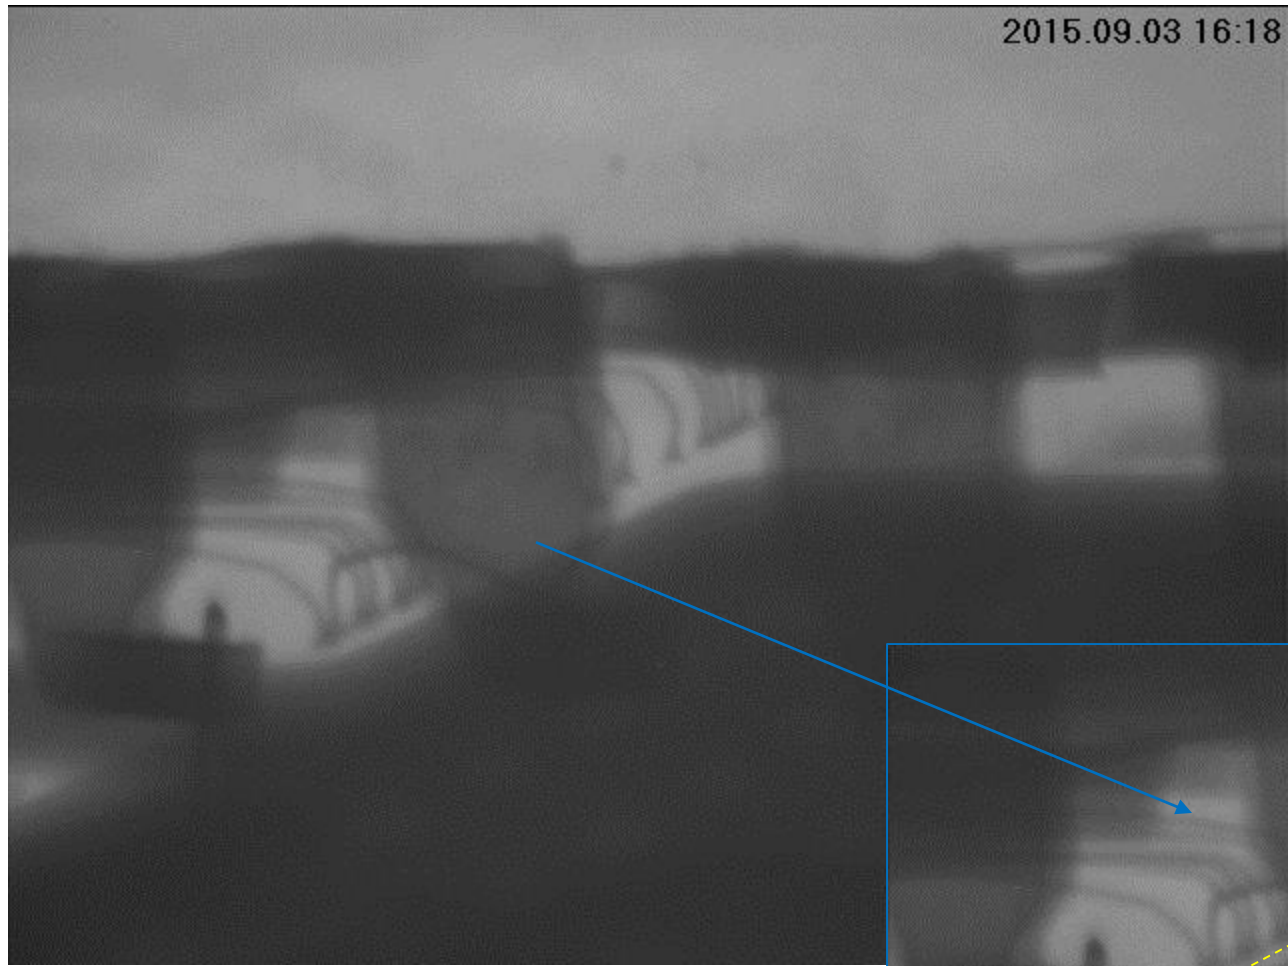
Side X-rays of DECU Parts, Box 1

Wire bond balls appeared to be in a straight line in the Z plane

Interference from the lead frame precluded a similar view of the other wire bond rows

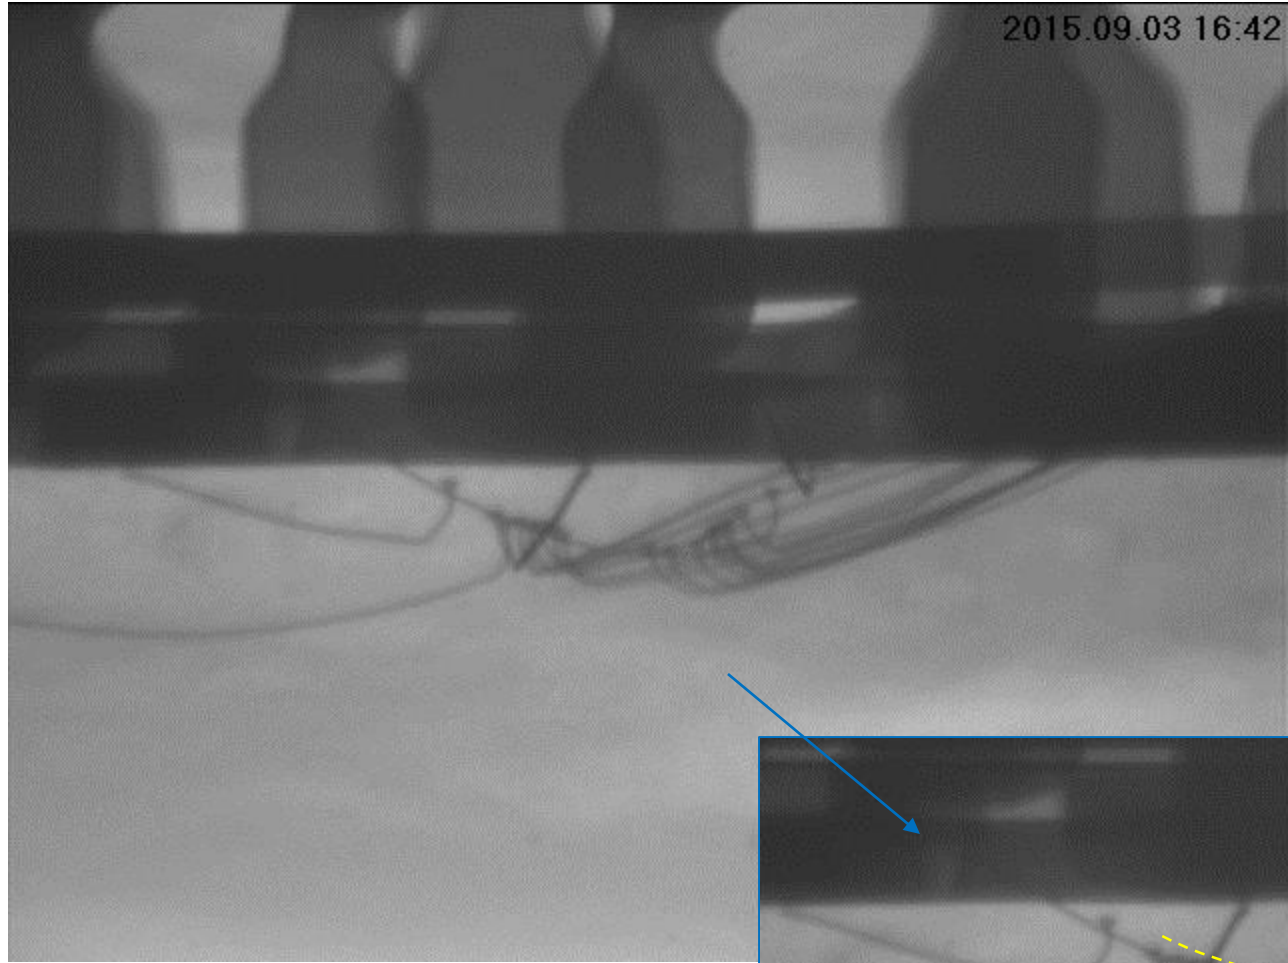
Side X-rays of DECU Parts, Box 2

Z direction bowed pattern of the wire bond balls suggests they were pulled from the chip (presumably by the deformation during the thermal excursion)

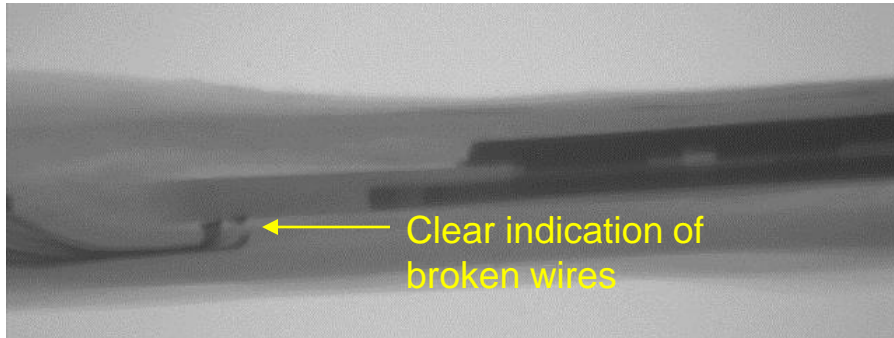
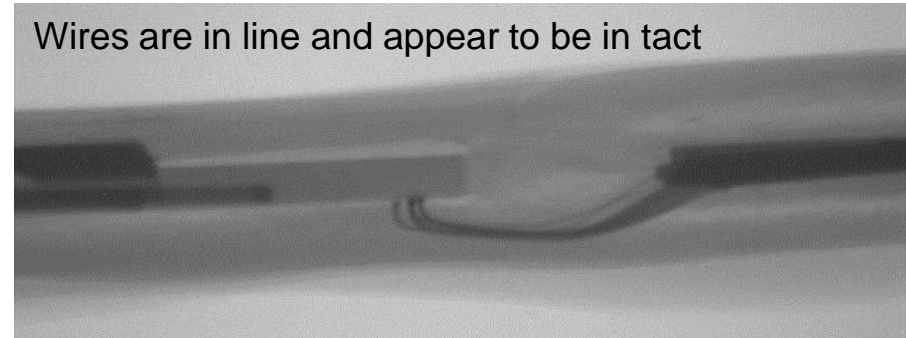
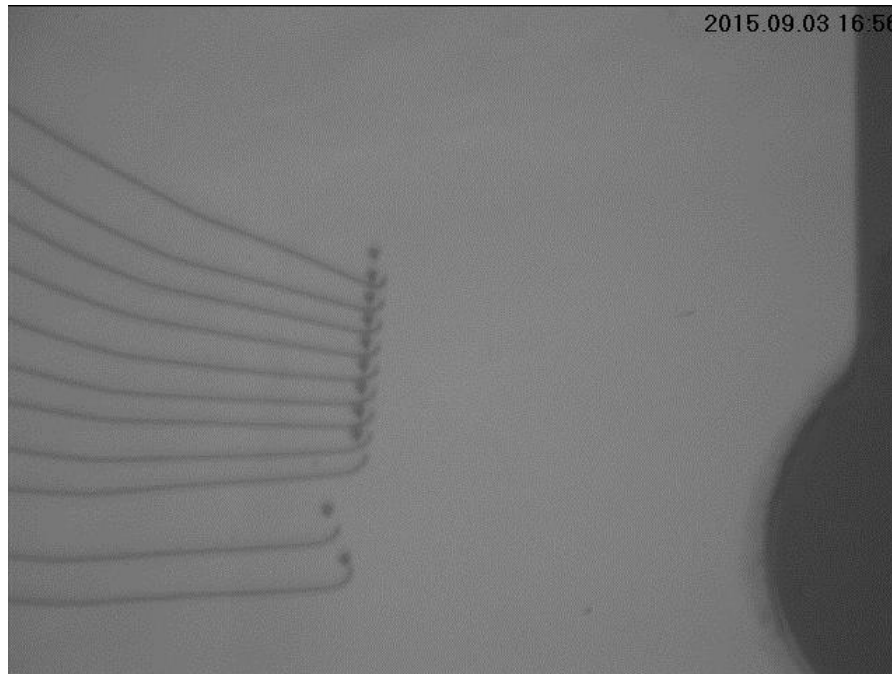
Side and Tipped View X-rays of DECU Parts, Box 3

Tipped view also shows broken wires

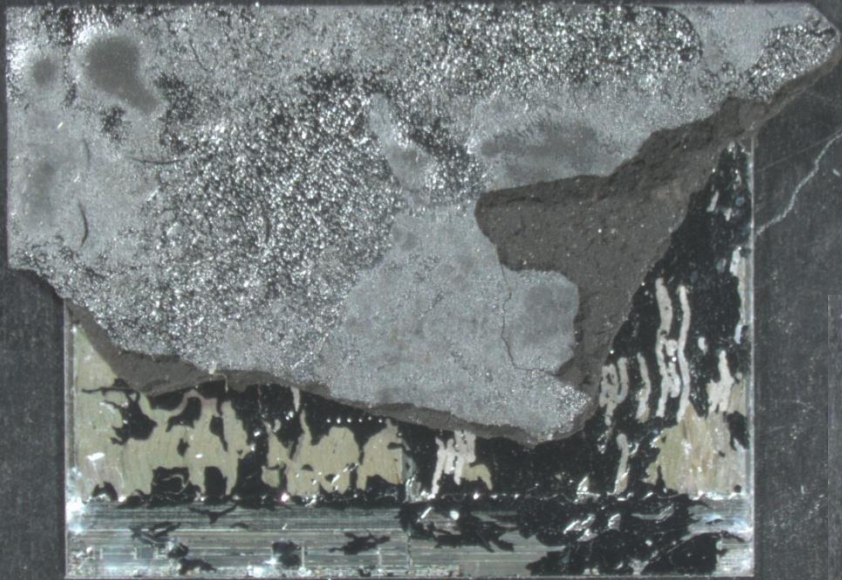
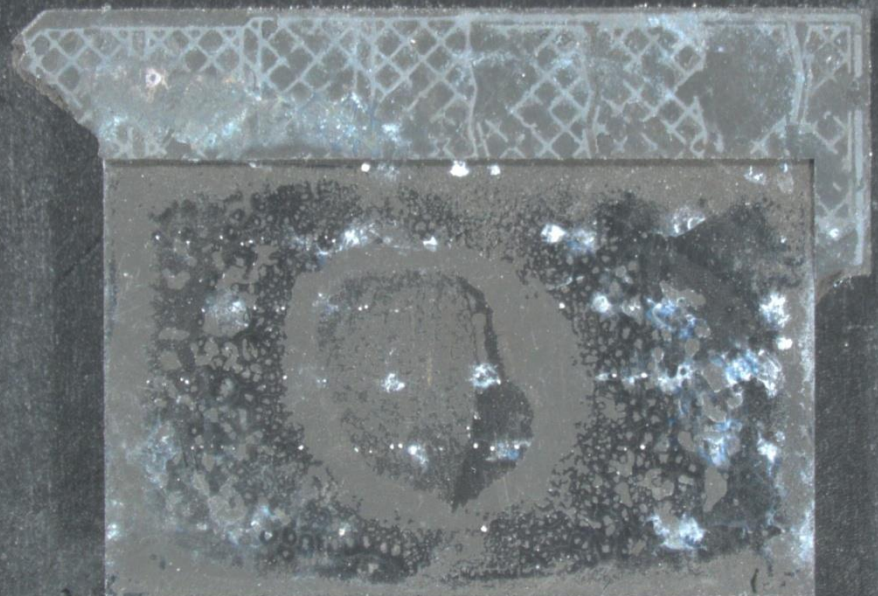
Front and back images of SD-5
package, segment 1 with die

2 mm Appereo-SD-5 segment 1;
broken SD package, front view

2 mm Appereo-SD-5 segment 1;
broken SD package, back view

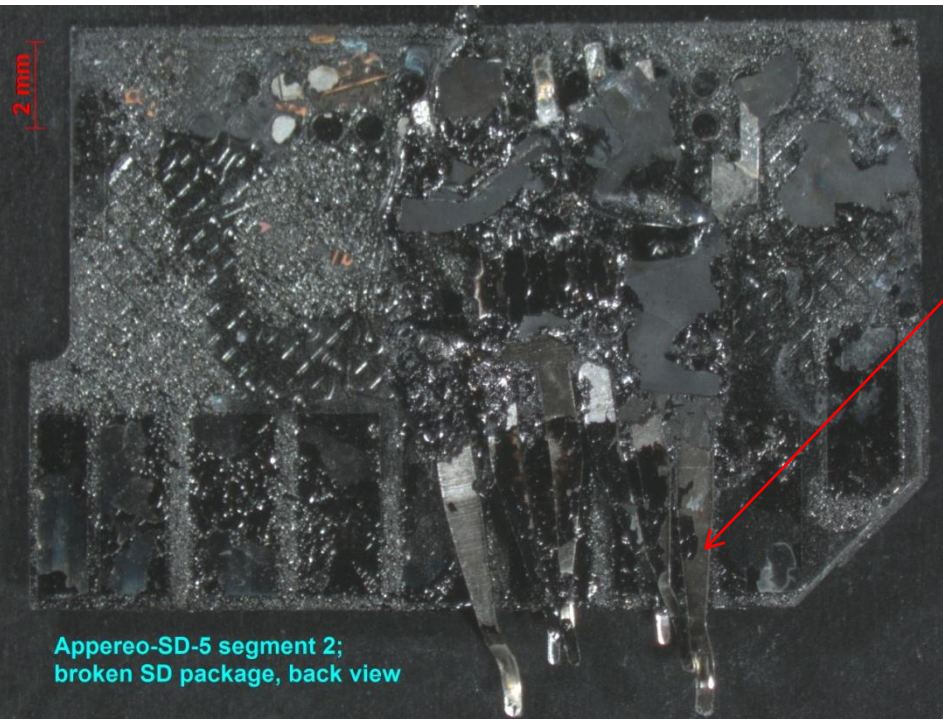
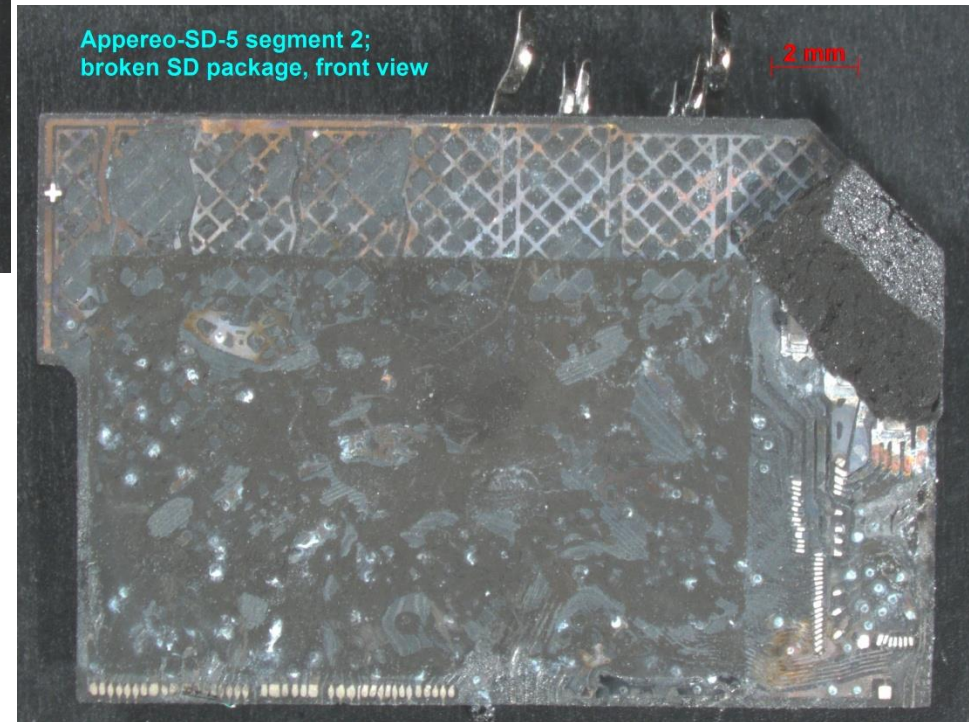
Front and back images of SD-5,
segment 2 with chip carrier

Appereio-SD-5 segment 2;
broken SD package, back view

These pins are external
and do not belong to the
SD card

Appereio-SD-5 segment 2;
broken SD package, front view

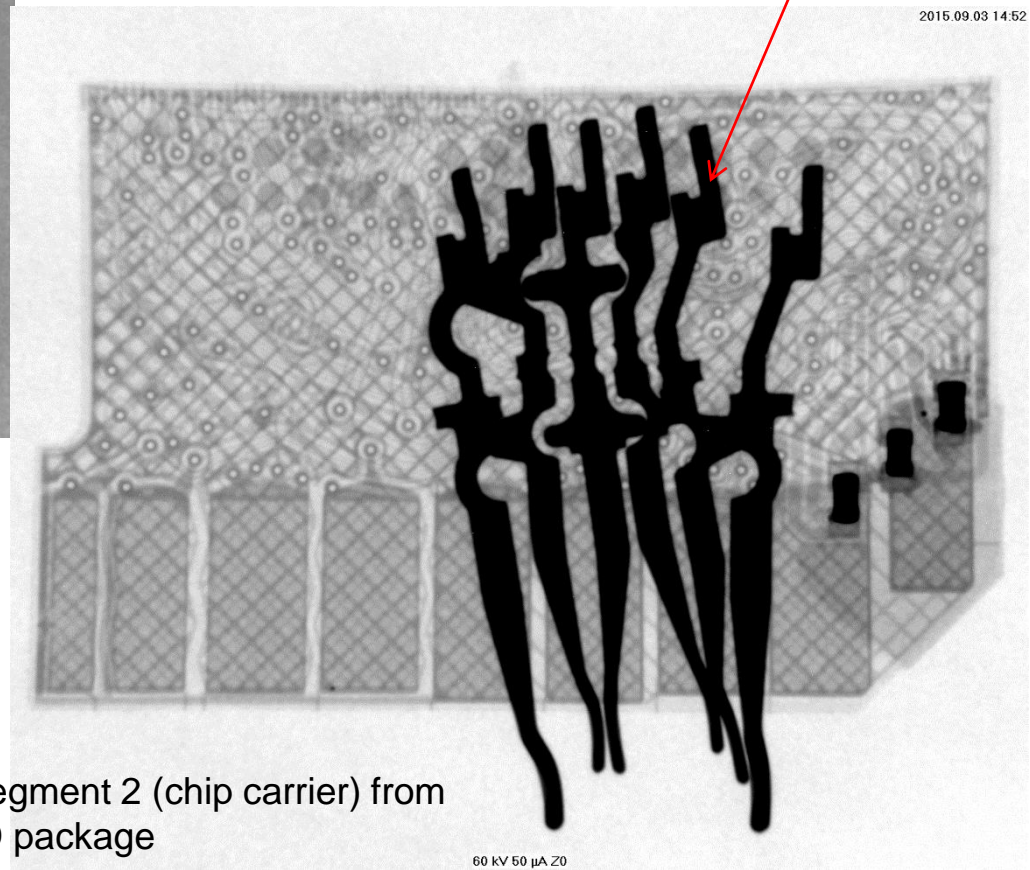
X-ray of segment 2 (chip carrier) from
broken SD package

These pins are external and
do not belong to the SD card

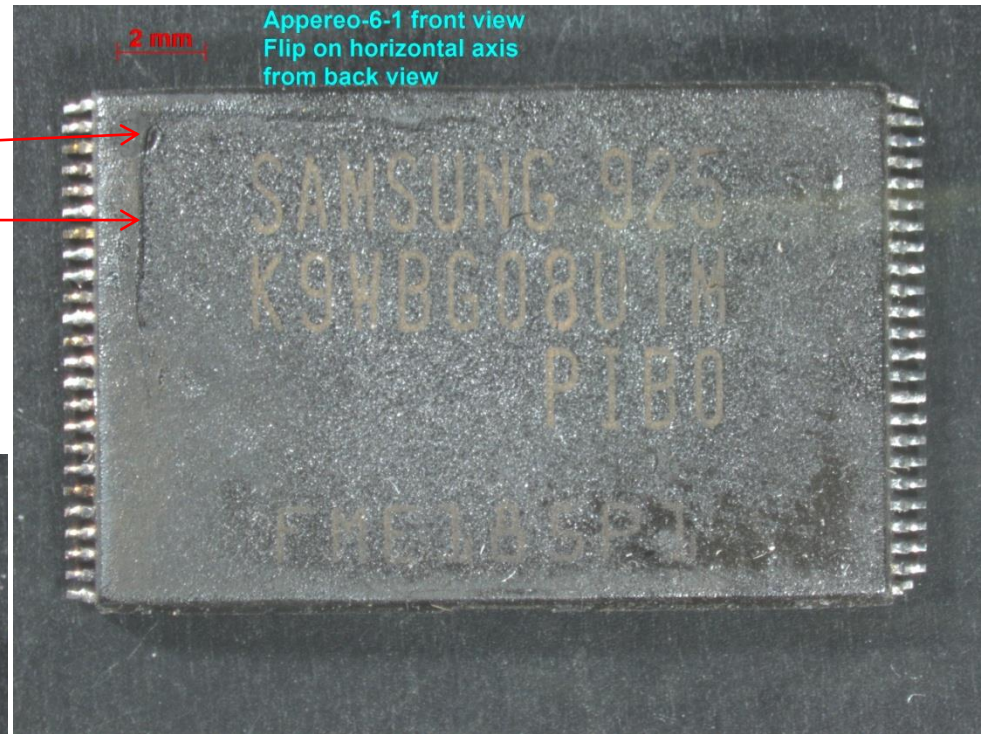
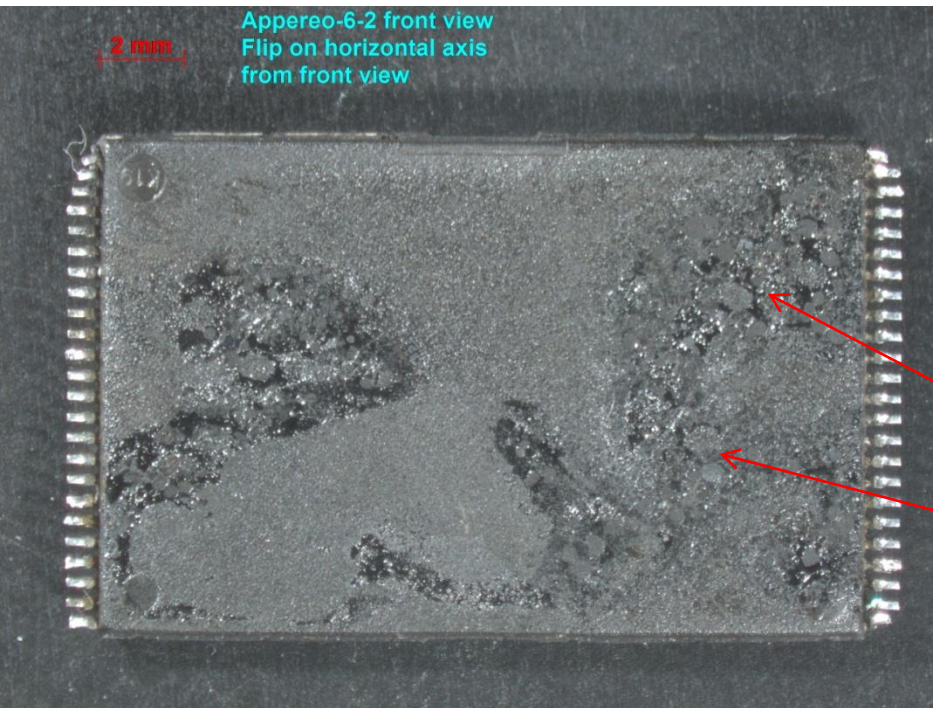
Appereo 6 -1: optical images

This end of the package is damaged:
it is slightly lifted and cracked.

Severe damage to the molding compound

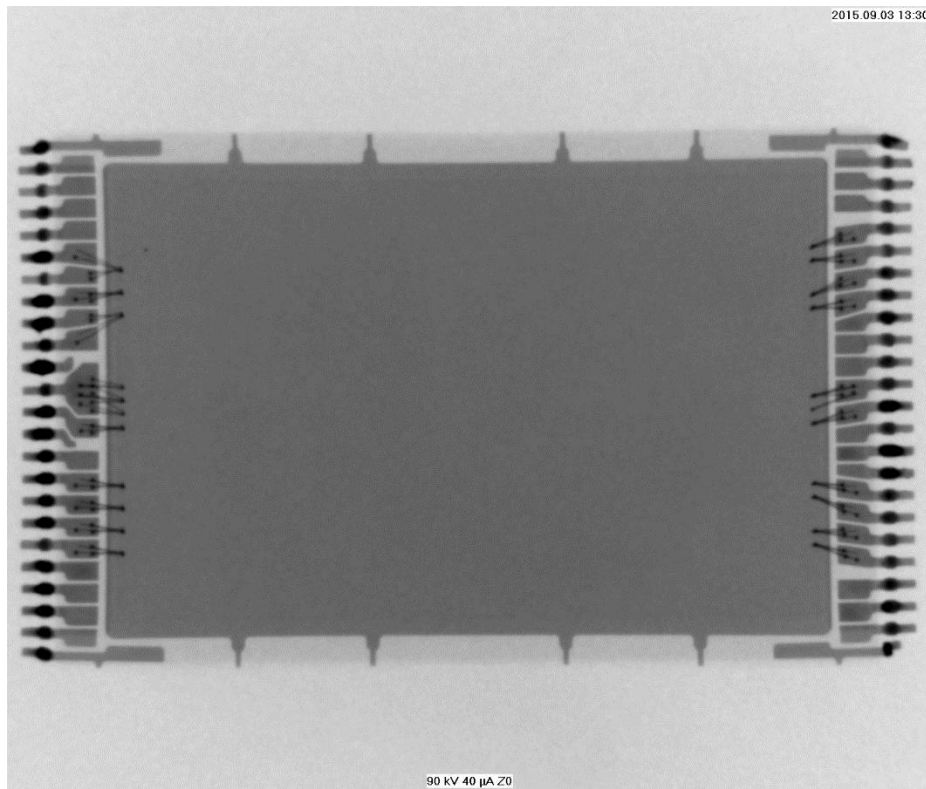
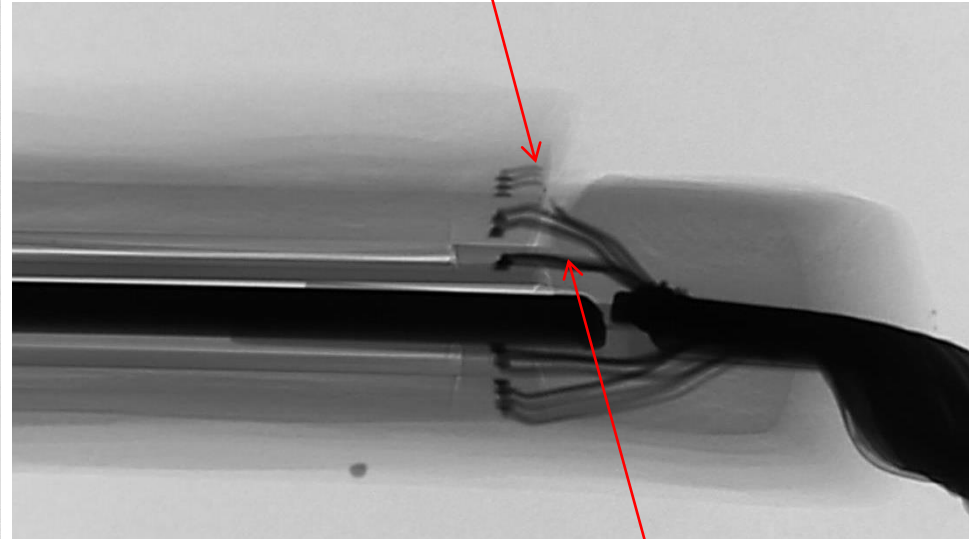
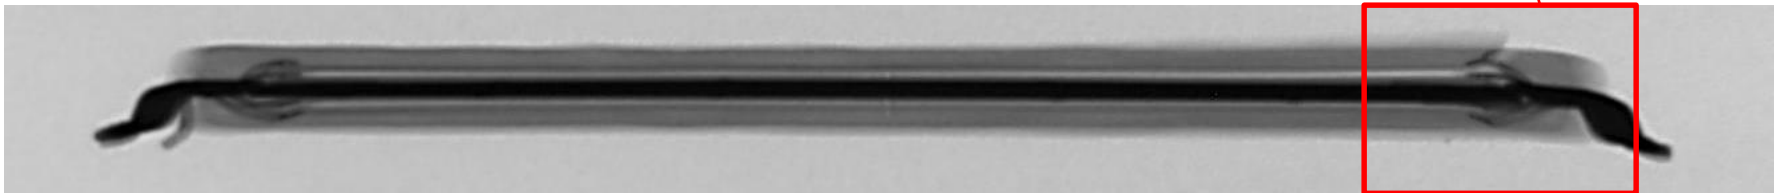
Appareo 6 -1: x-ray images

Damaged corner of the chip with broken wire bonds

X-ray images showing the side view of the package, suggest that there are 4 stacked dies in the package two on each side of the chip carrier.

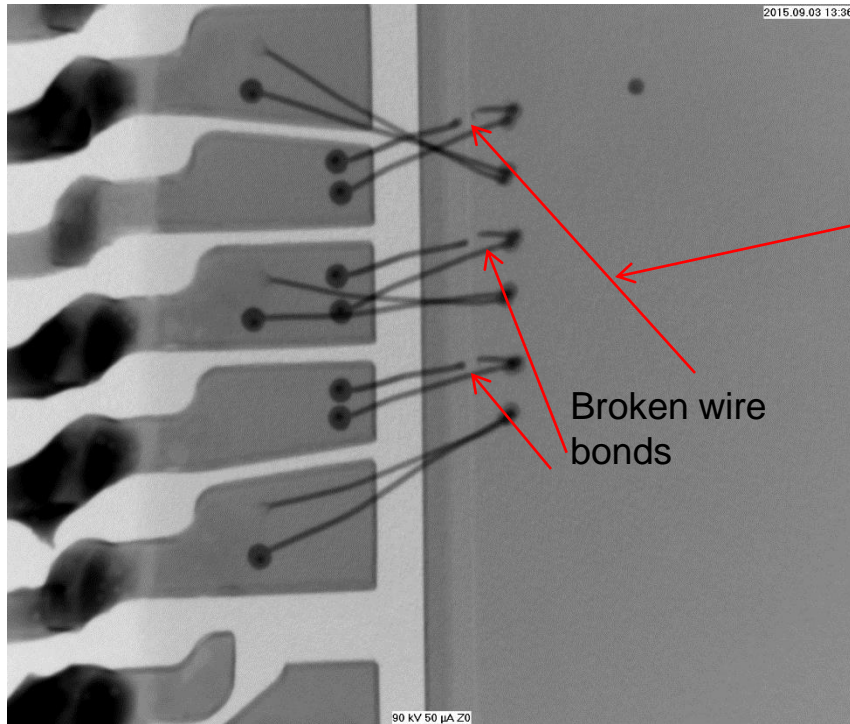
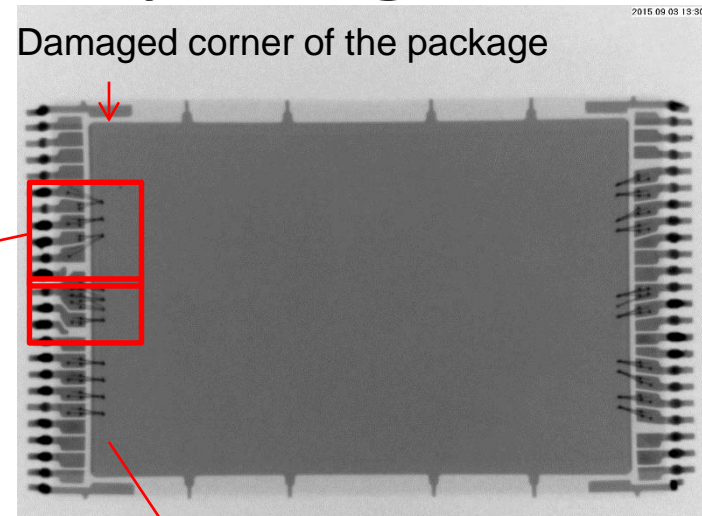
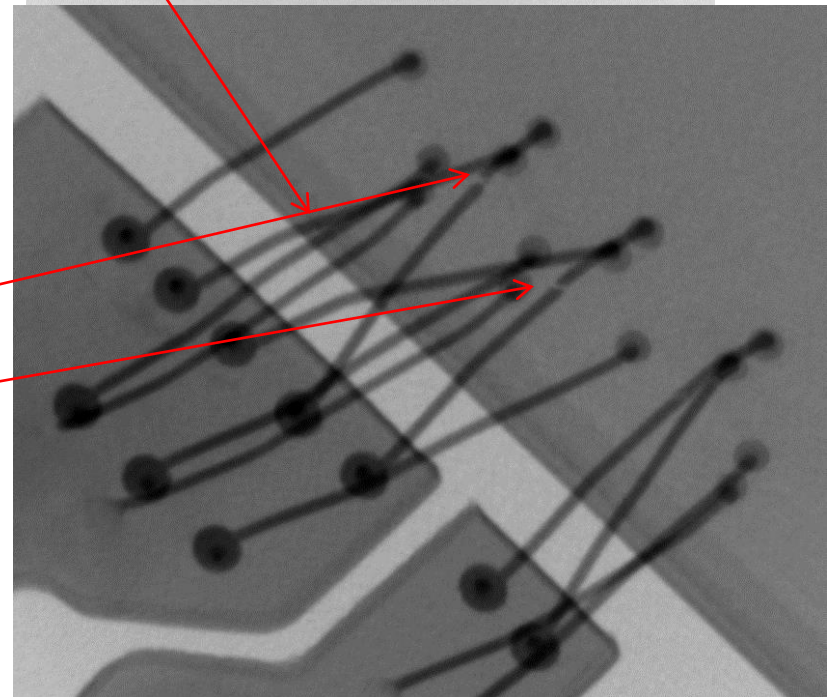
Appareo 6 -1: x-ray images

Broken wire bonds

Broken wire bonds were detected only in the damaged corner of the package.

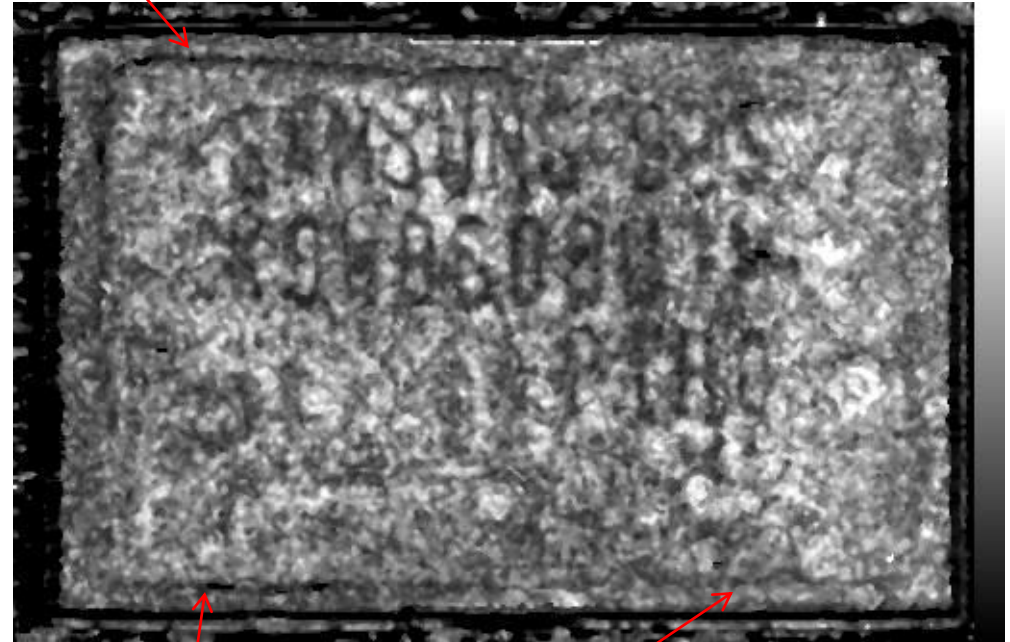
Appareo 6 -1: C-SAM images

Damaged corner of
the package

Both 100 MHz and 50 MHz transducers, were tried to acquire good images of the stacked dies within the package. But features resulting from the severe damage (disintegration) of the molding compound, prevented detection of any details on dies.

Top die outline

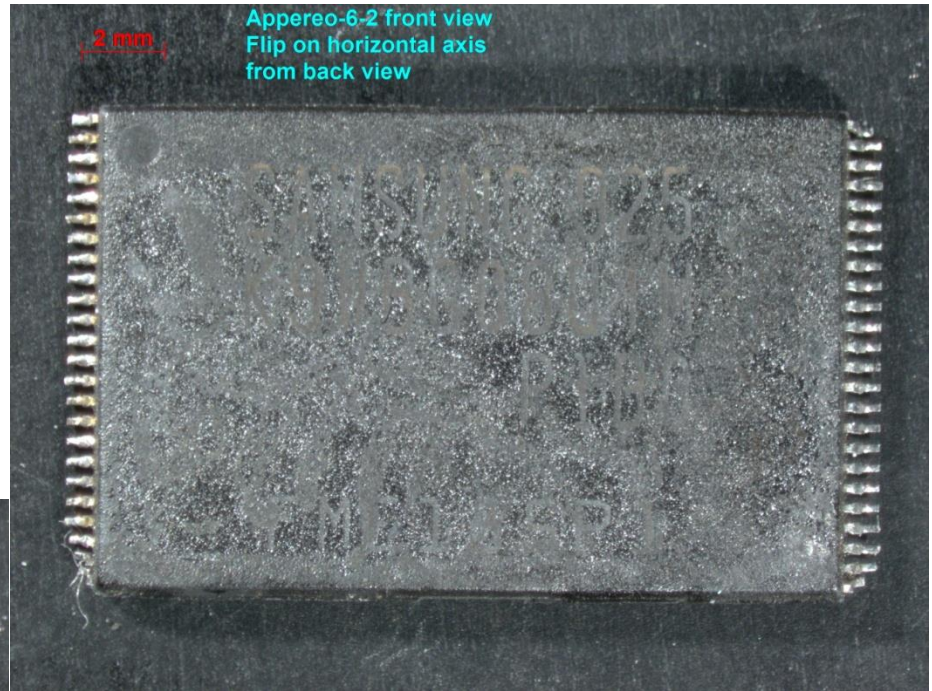
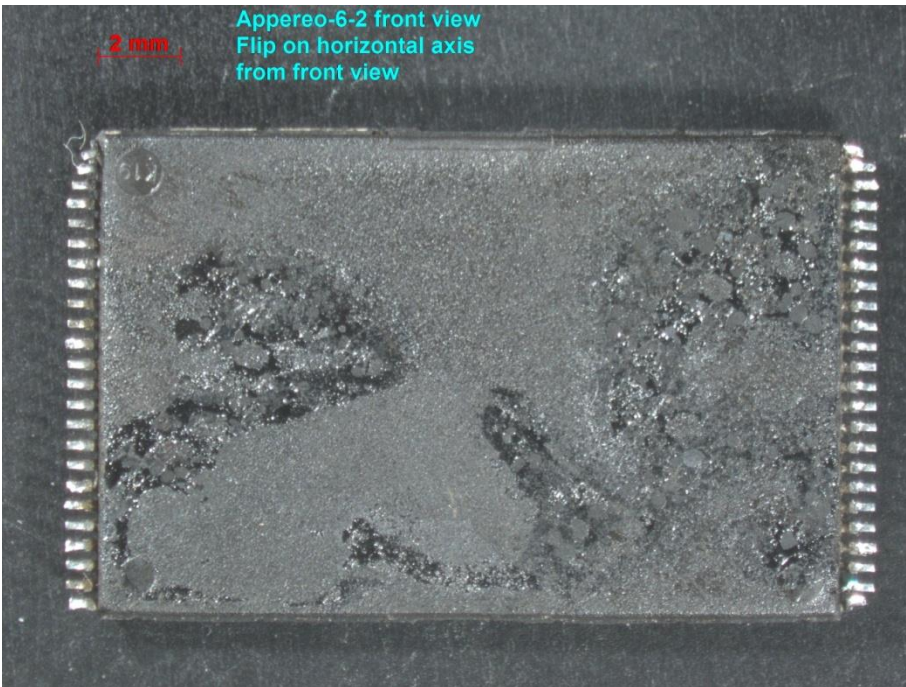
Appareo 6 -2: optical images

Optical images indicate severe damage to the molding compound of the package probably from high temp/fire

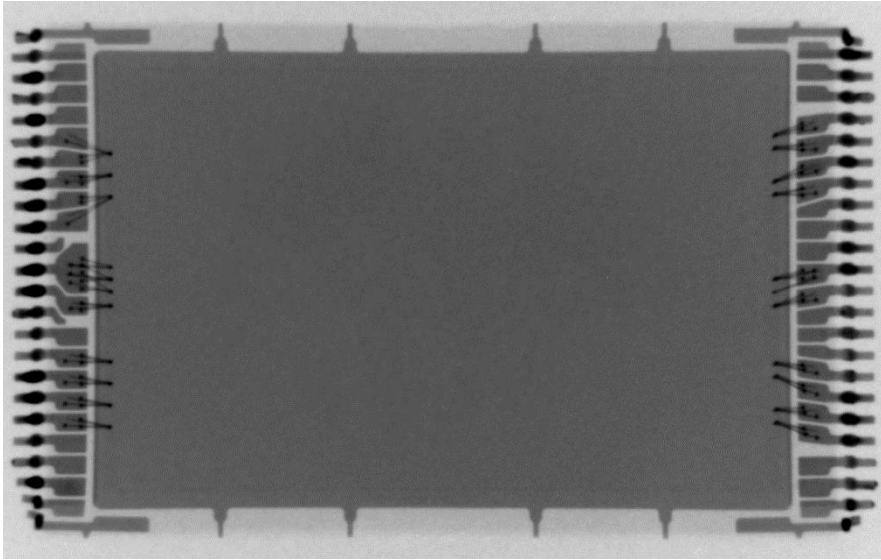
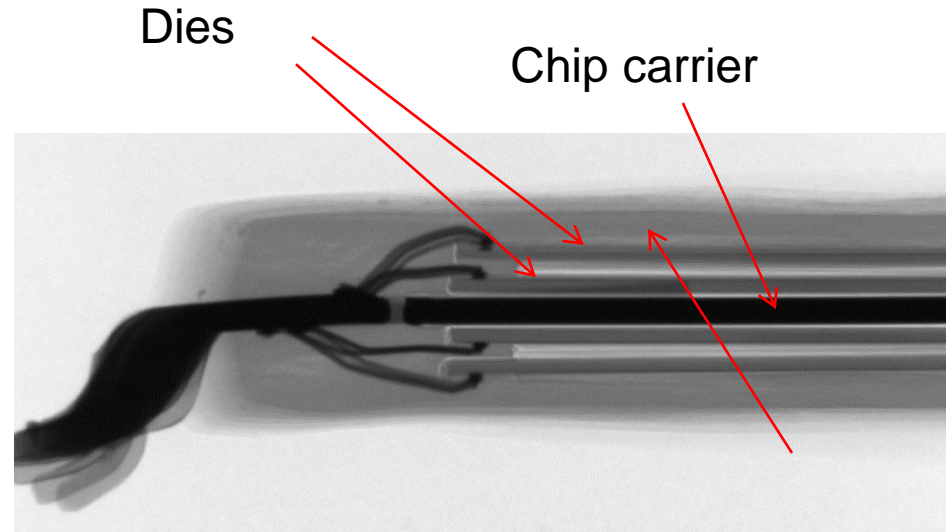
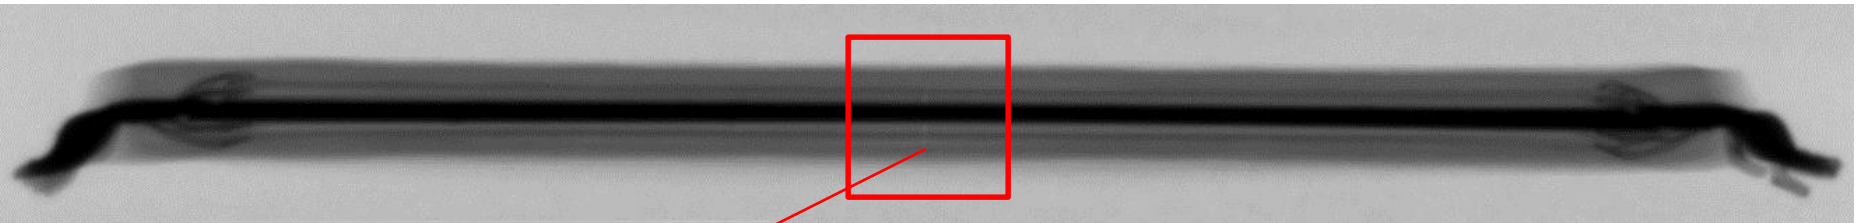
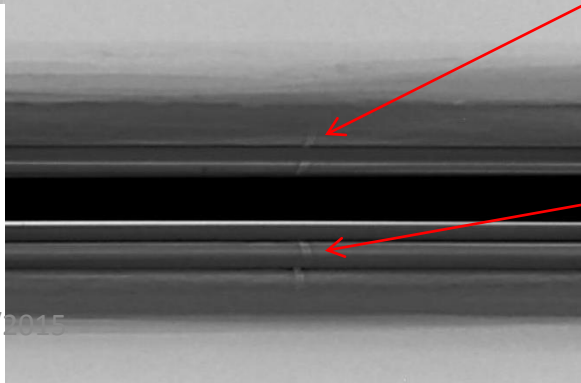
Appareo 6 -2: x-ray images

This feature found in both packages 6-1, 6-2

X-ray images of the side view of the package suggest that there are 4 stacked dies in the package two on each side of the chip carrier

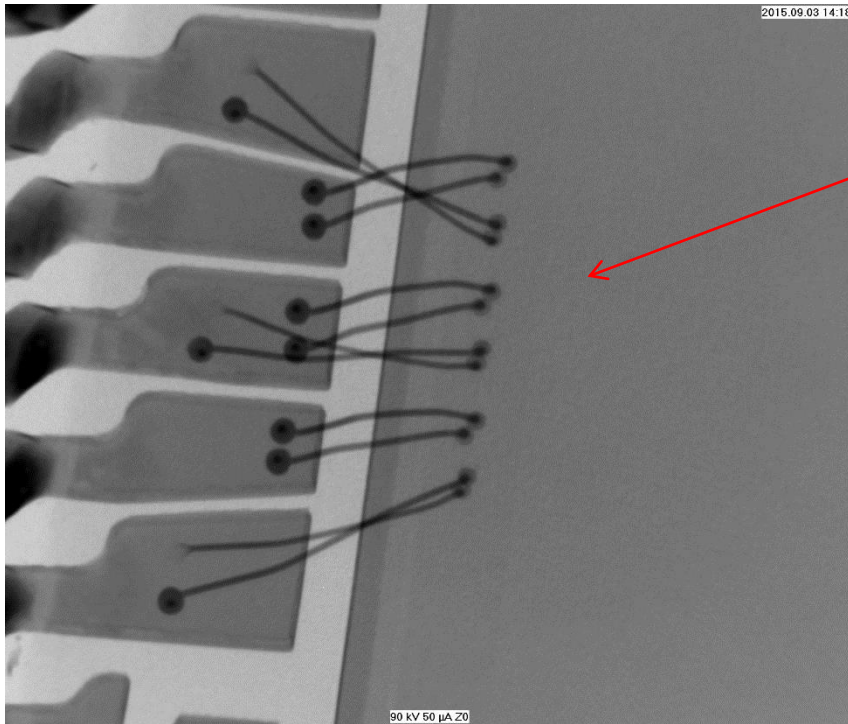
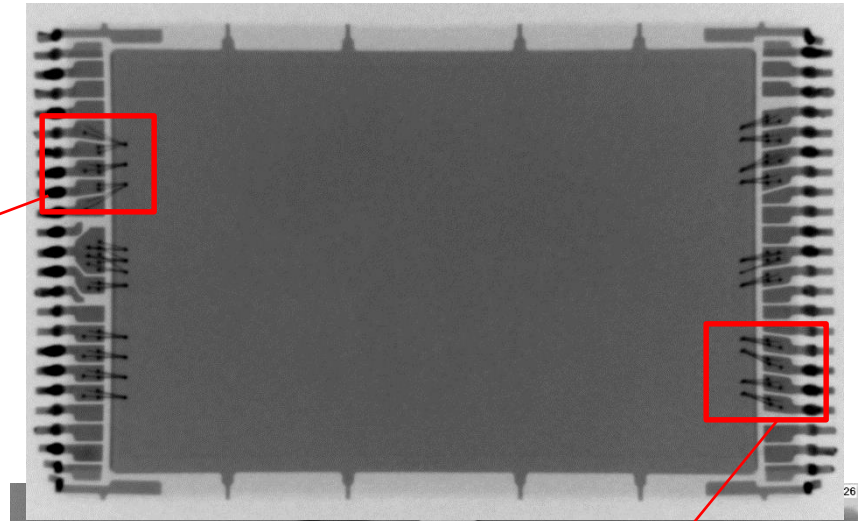
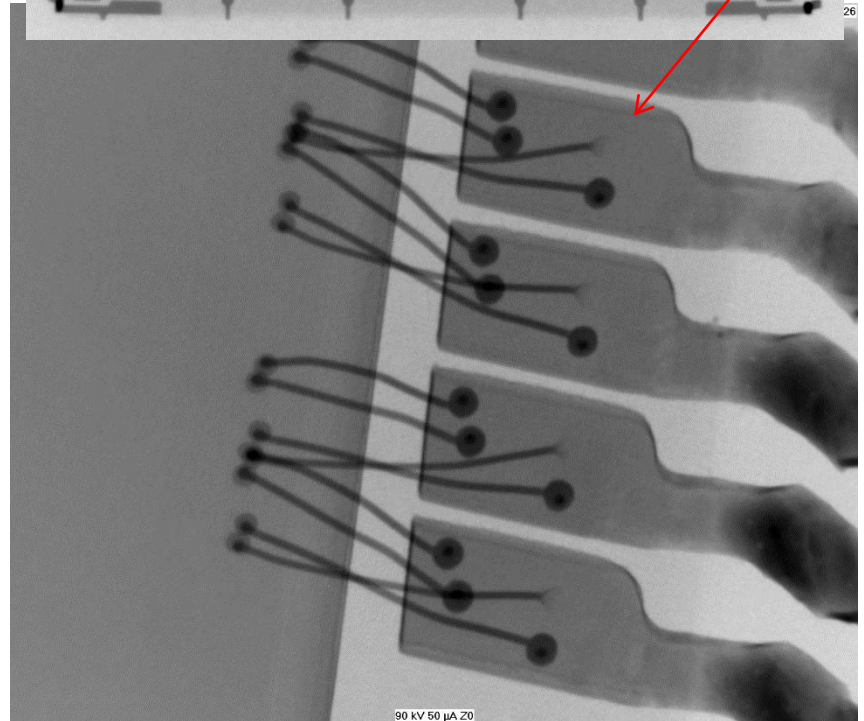
Appareo 6 -2: x-ray images

No anomalies detected in any wire bonds in this package

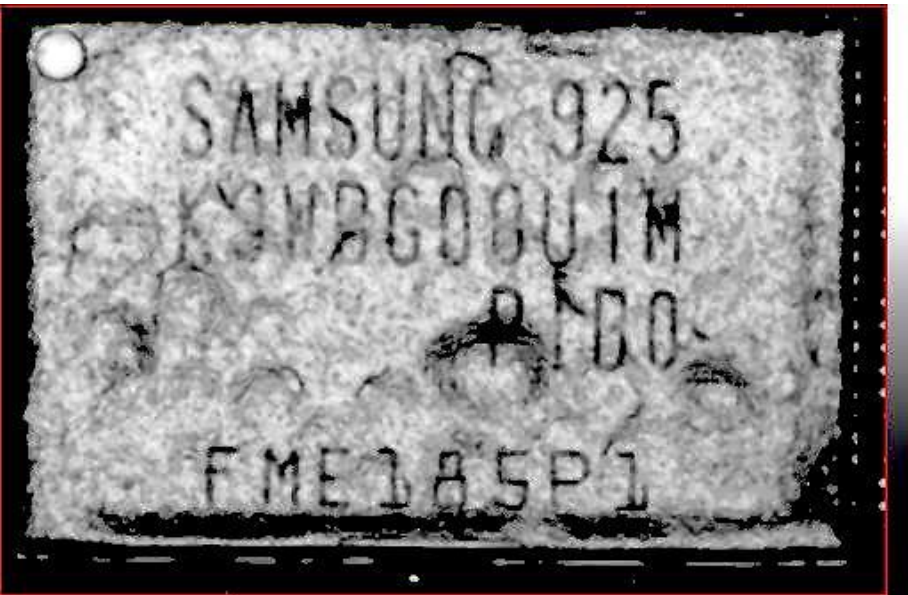
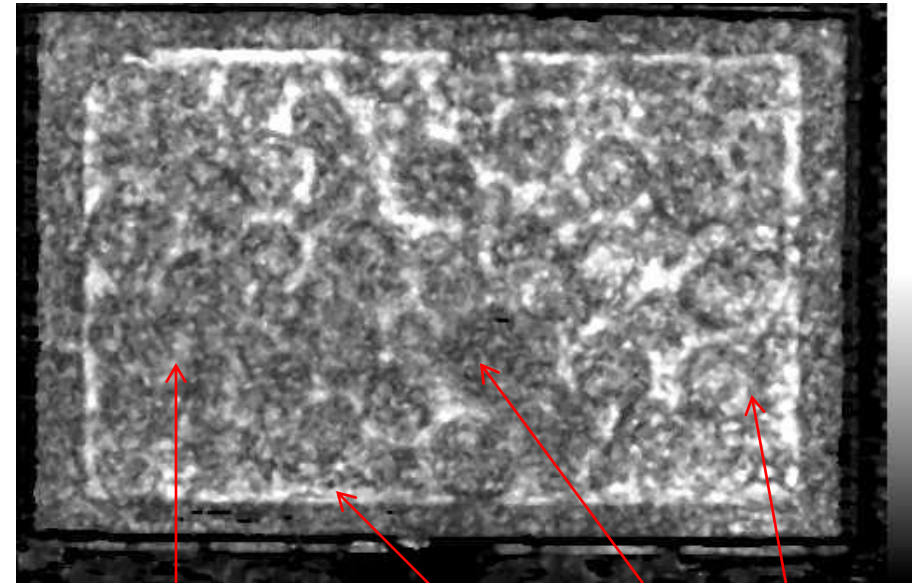
Appareo 6 -2 : C-SAM images

Surface image

Top die image

Shadow of defects within mold compound (preventing detection of details on the dies)

Both 100 Mhz and 50 MHz transducers, were tried to acquire good images of the stacked dies within the package. However, features from the molding compound damage (disintegration) overshadowed any details on dies.
