# CT scan data from Appareo package #2

# Experimental Details

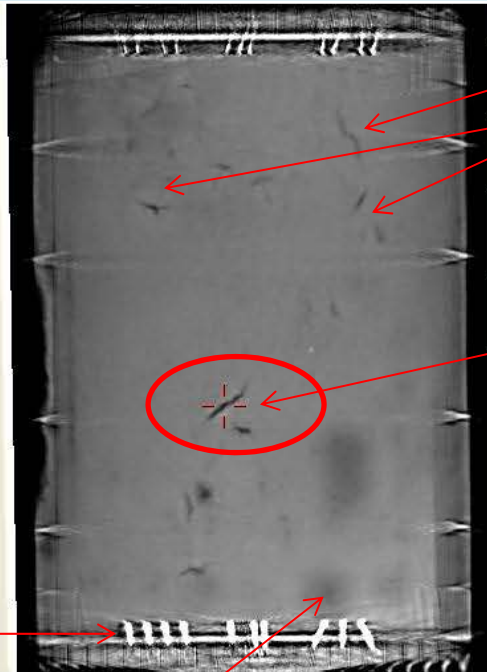
Frontal View

Cracks in the mold

Molding compound crack on surface appears to go down to the die top with circuitry

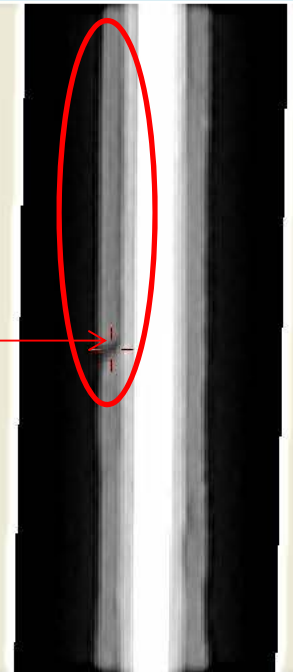
Saggital View

This separation between mold/die top, is close to wire bonds to possibly dislodge/delaminate them.

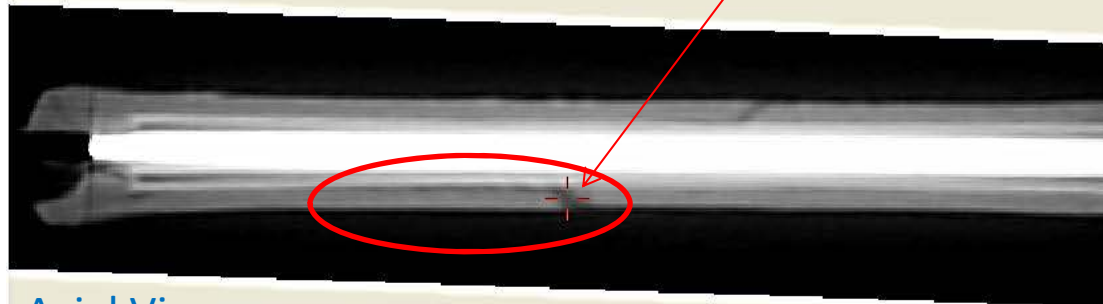
Axial View

Several cracks and separation areas are detected in the molding compound on both sides of the package

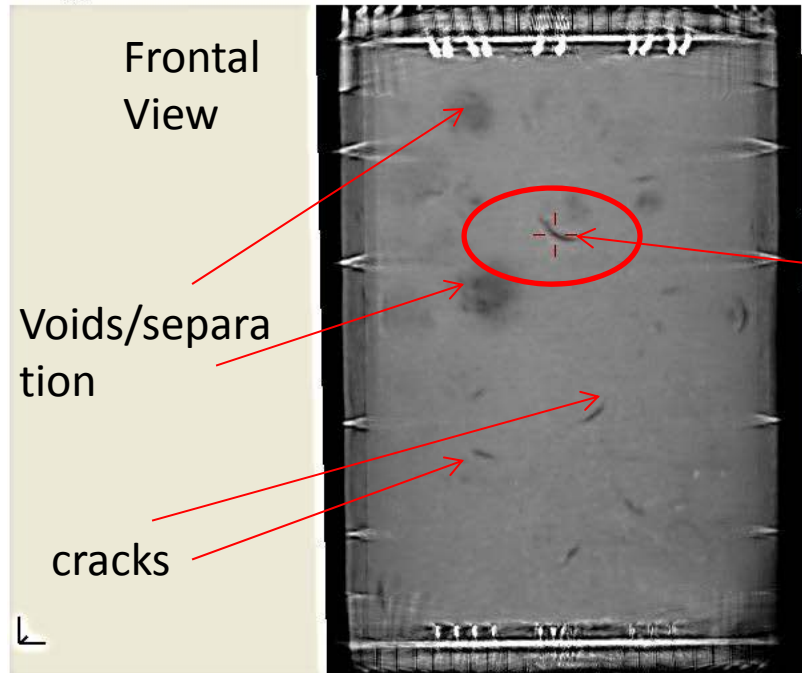
Sagittal (y,z) Slice -0.202

Molding compound crack on surface goes all the way down to the die top with circuitry

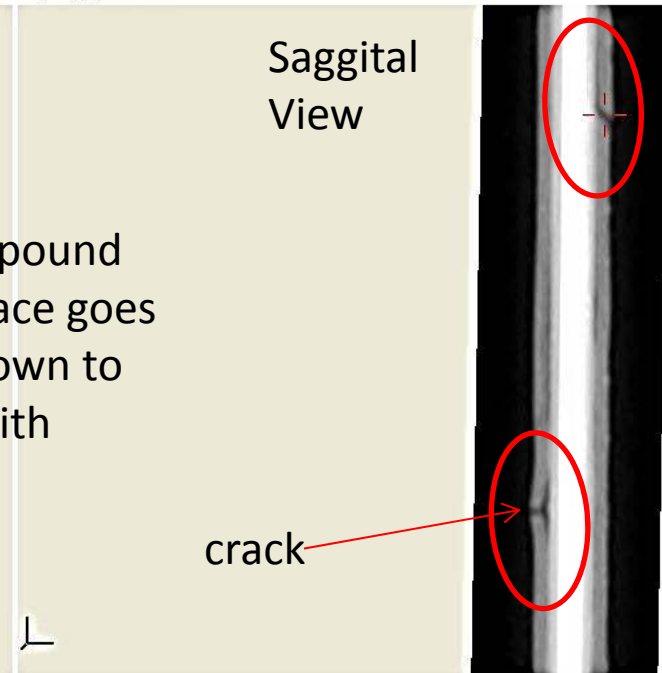
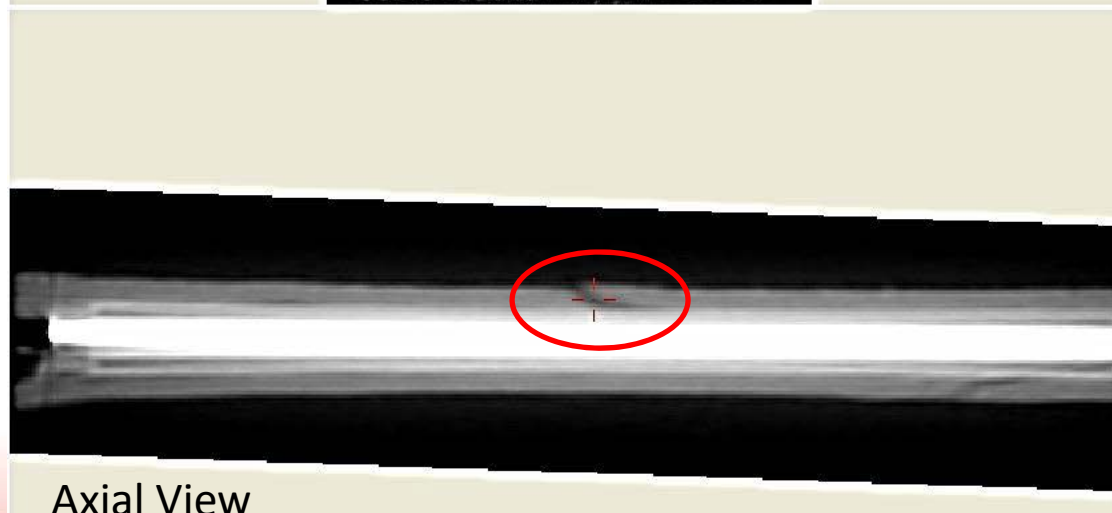
Several cracks, and separation areas are detected in the molding compound on both sides of the package

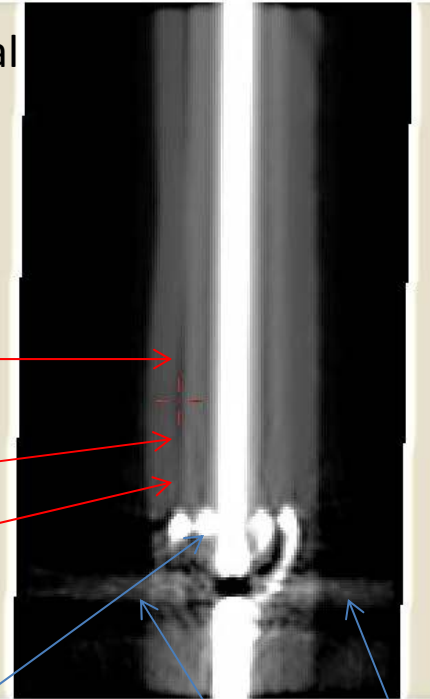
Saggital View

Mold compound separation too close to wire bonds, may dislodge the wire bonds and cause discontinuity

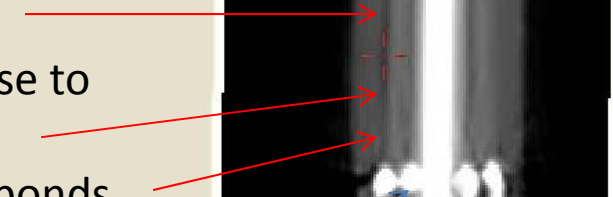
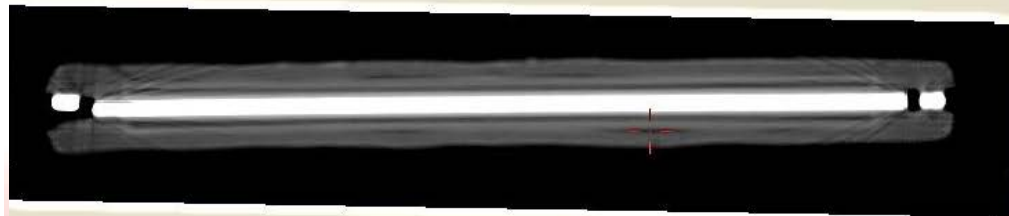
Axial View

Wire bonds

Image artefacts

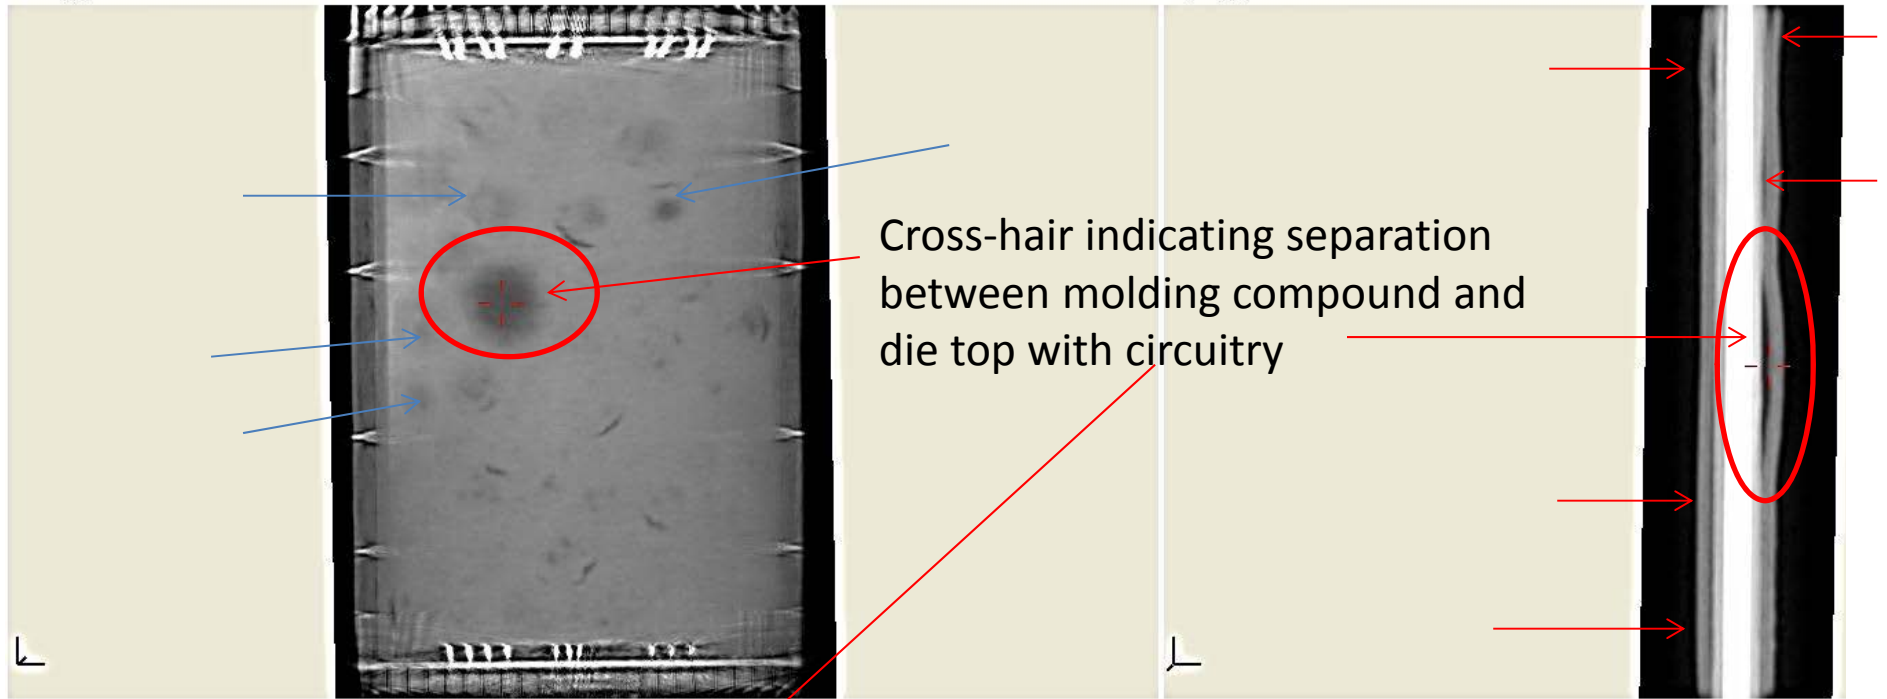
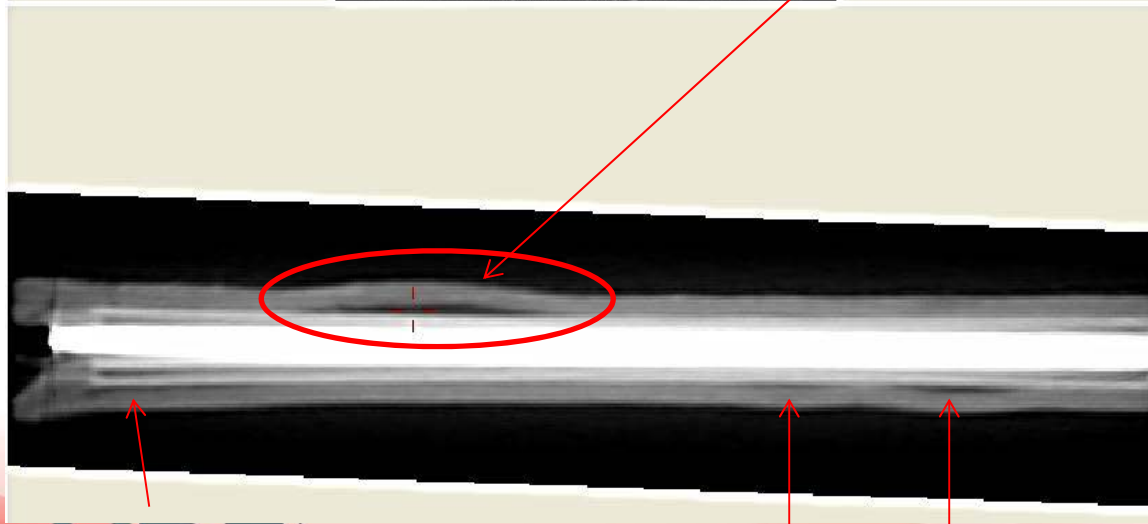
Cross-hair indicating separation between molding compound and die top with circuitry

Other areas of such separation shown by arrows

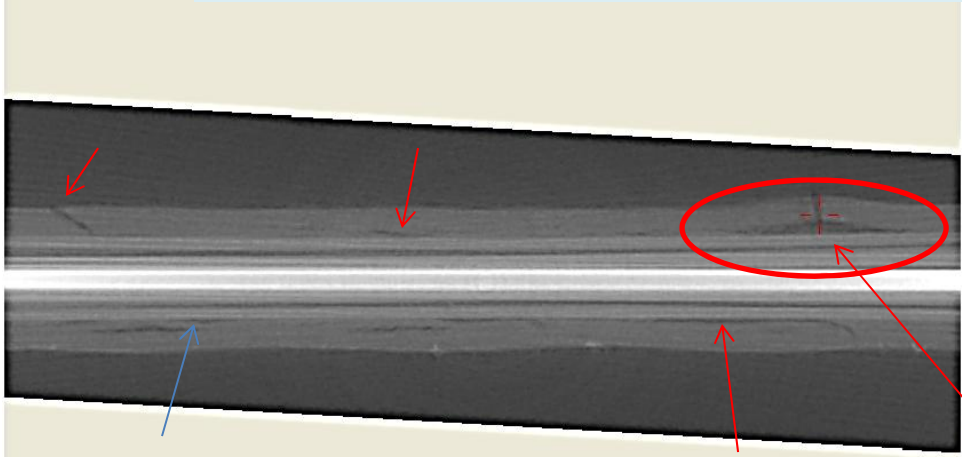
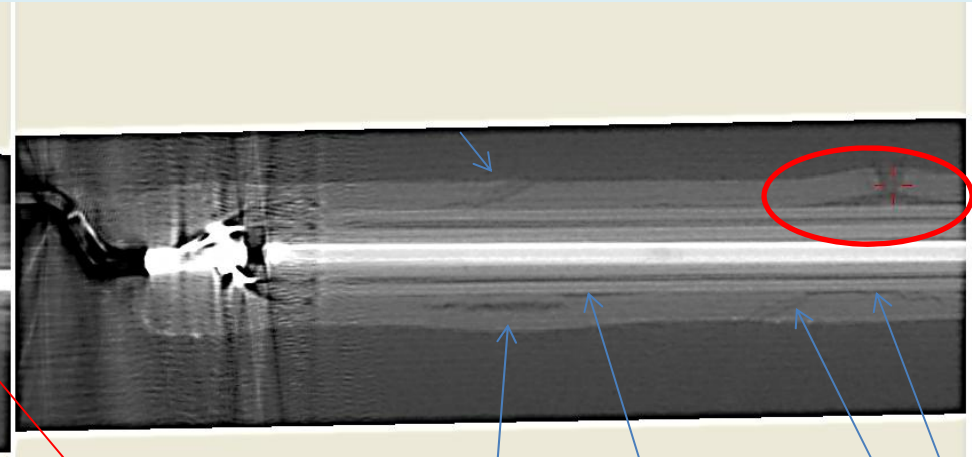
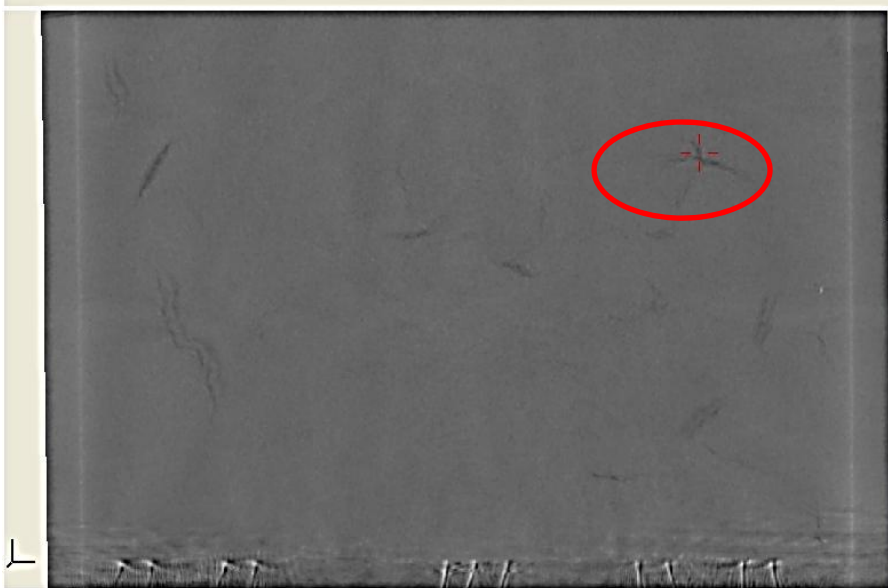
Axial (x,y) Slice 0.506

Cross-hair indicating separation/crack between molding compound and die top

Other areas of such separation/cracks shown by arrows

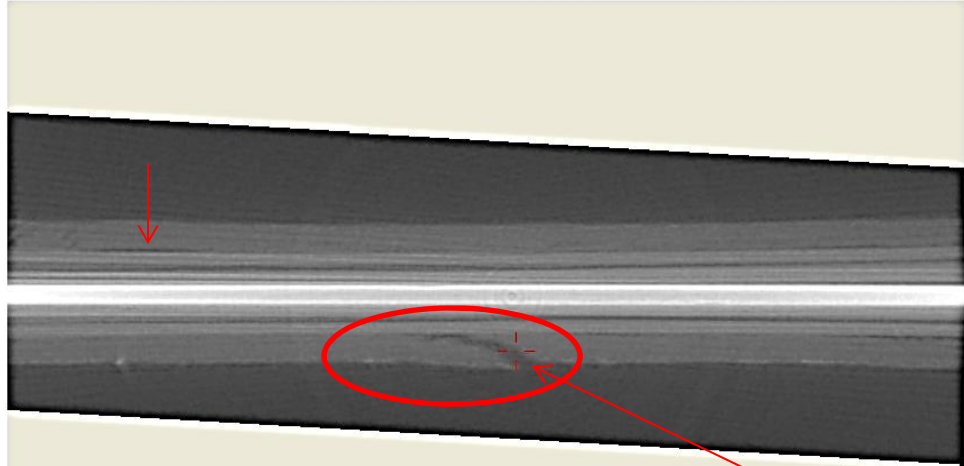
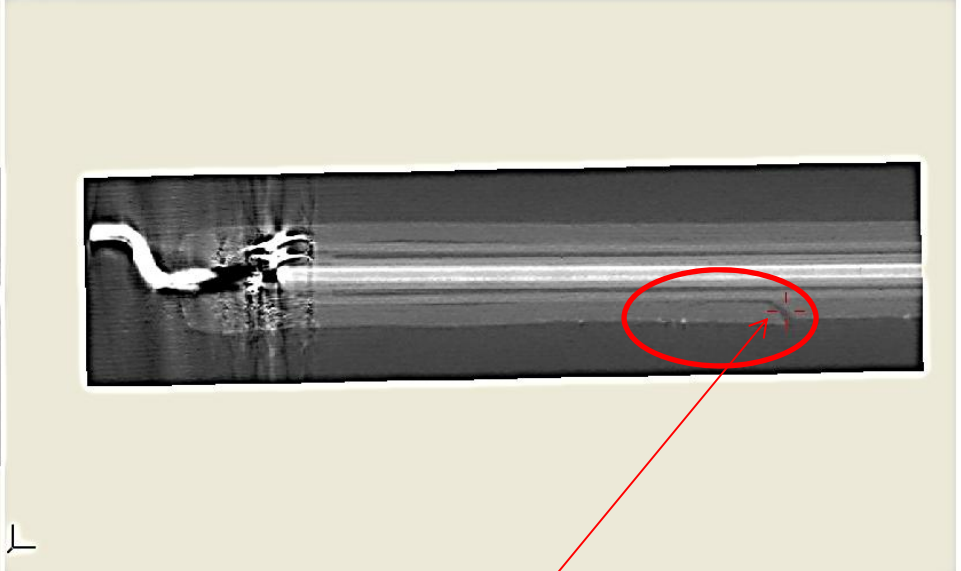
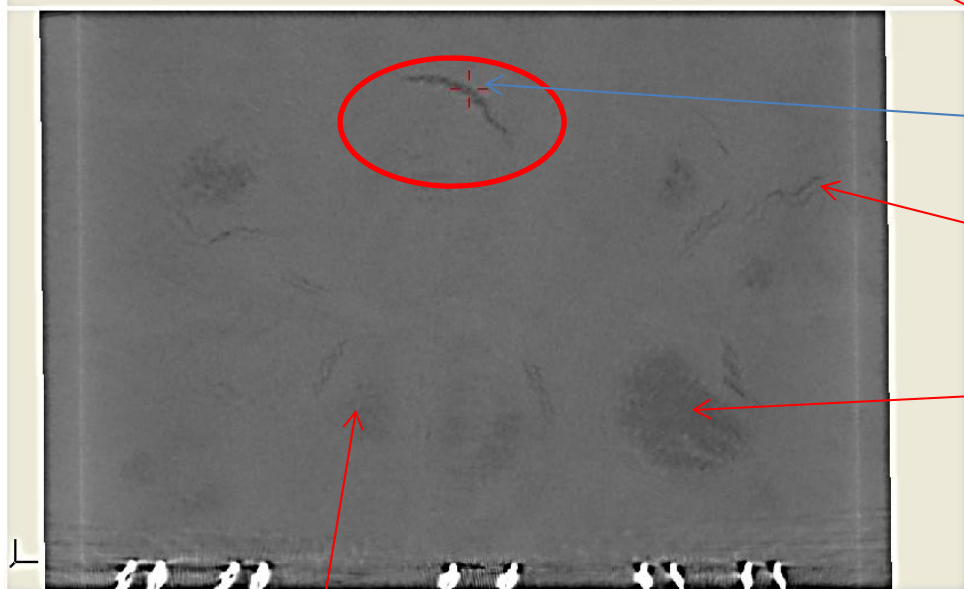
Axial (x,y) Slice -0.381

Cross-hair indicating separation between molding compound and die top

Other areas of such separation/cracks shown by arrows

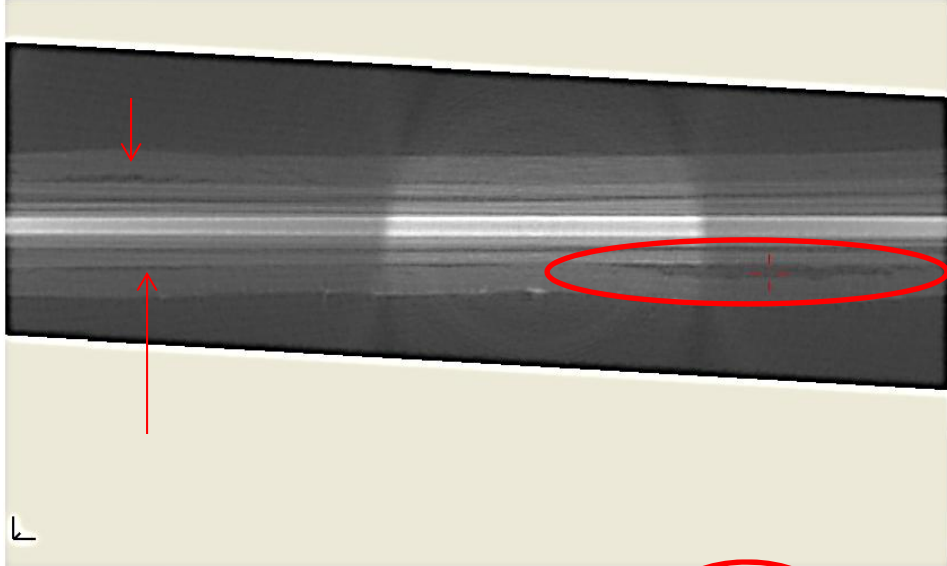
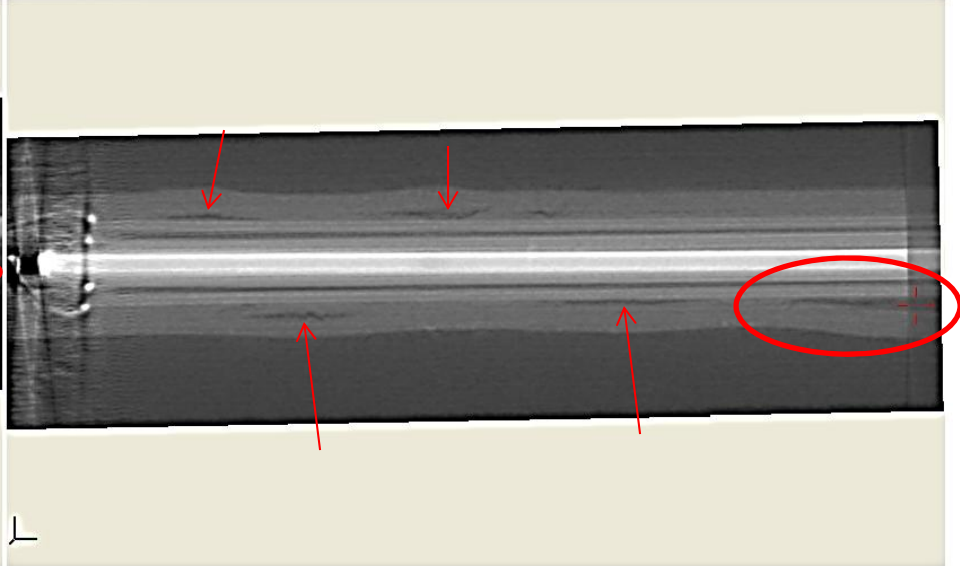
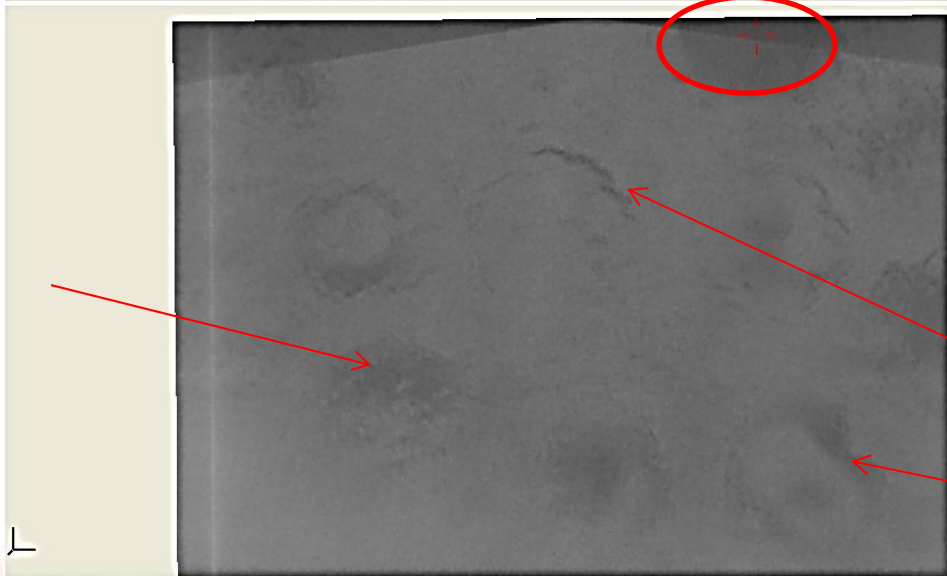
Axial (x,y) Slice -0.307569

Cross-hair indicating separation between molding compound and die top

Other areas of such separation/cracks shown by arrows

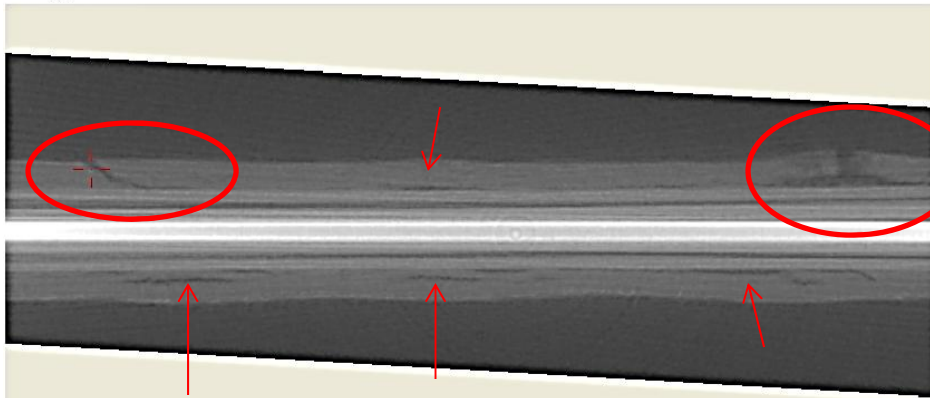
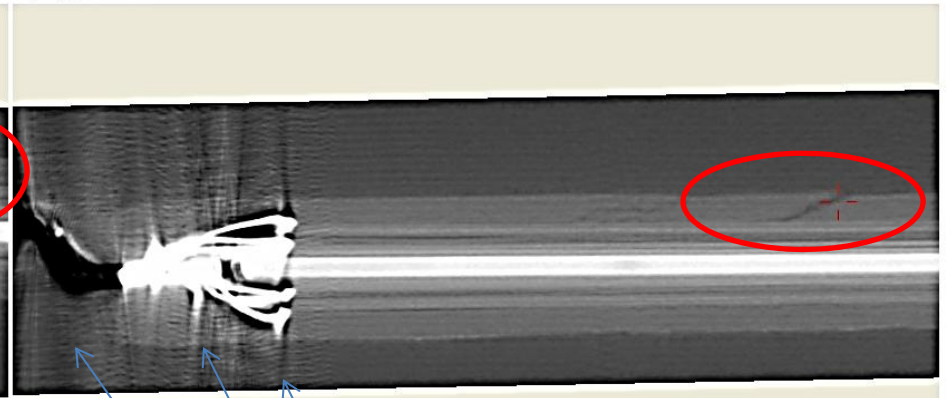
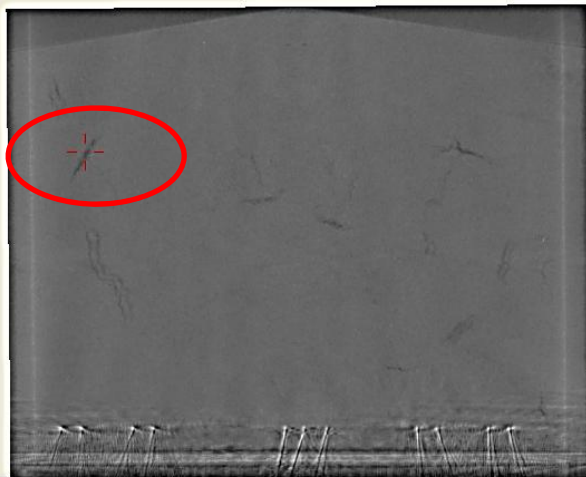
Image artefacts because of high x-ray attenuation gold wires

Red cross-hair indicating separation between molding compound and die top

Other areas of such separation/cracks shown by arrows
