NATIONAL TRANSPORTATION SAFETY BOARD
Vehicle Recorder Division
Washington, DC 20594

Onboard Image Recorder

Specialist's Factual Report
By Sean Payne

Location:	Frisco, Colorado
Date:	July 3, 2015
Aircraft:	Airbus Helicopter AS 350 B3E, N390LG
Operator:	Air Methods Corporation
NTSB Number:	CEN15MA290

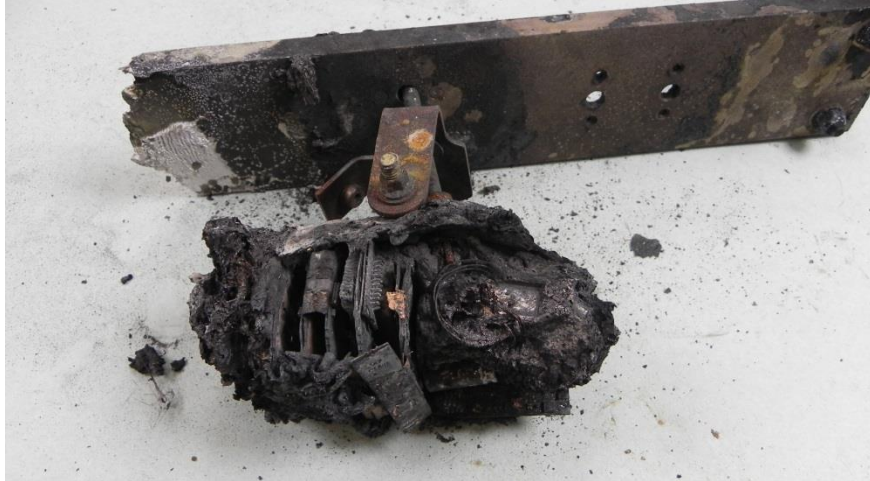
Upon arrival at the NTSB Vehicle Recorder Division, it was evident that the Appareo Vision 1000 had sustained extensive heat damage (figure 1). The device was shipped attached to the installed mounting bracket. The front and rear of the device was identified. The unit's externally removable SD memory card was located and removed from the device (figure 2). The SD card's external packaging was dislocated from the silicon memory device. The silicon memory device was cracked and fractured throughout. Due to the fracture damage of the silicon memory device, data recovery was determined to be impossible.

Figure 1. The arrival condition of the Appareo Vision 1000.

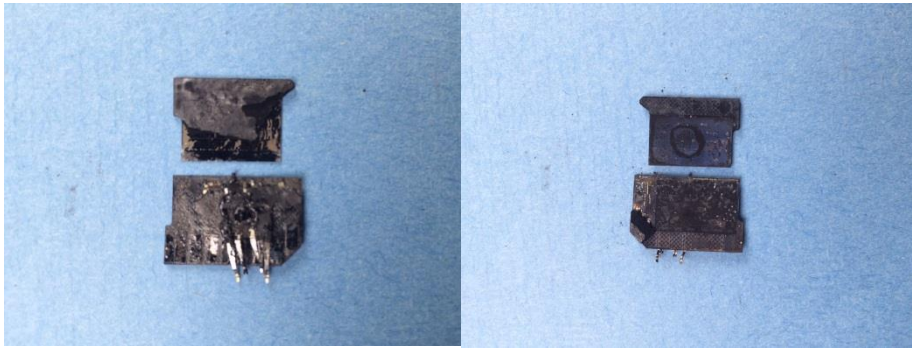
Figure 2. The remains of the SD card packaging and silicon memory device. The front (left) and back (right) of the SD card are pictured.

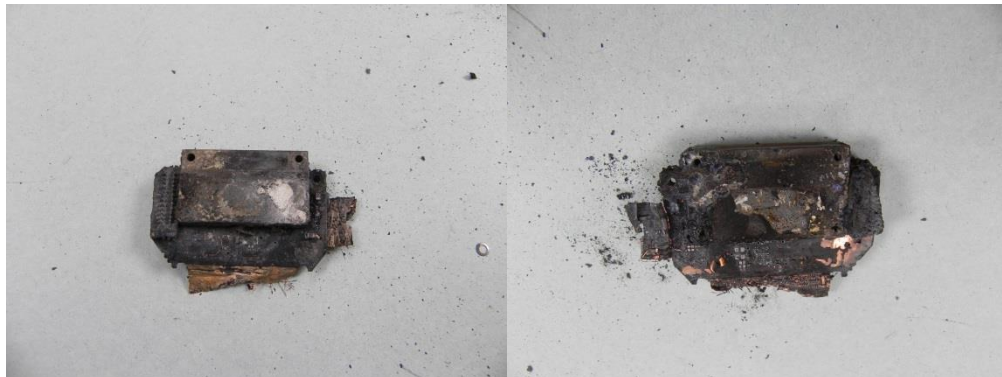
Figure 3. The front (left) and rear (right) of the internally mounted NVM chassis.

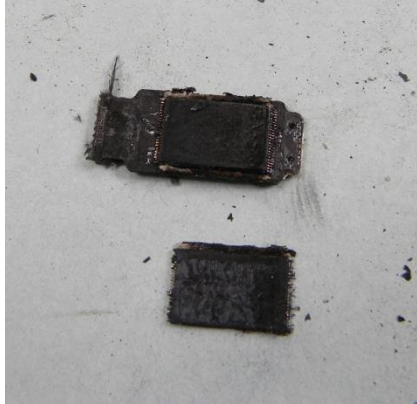
Figure 4. The two individual NVM chips separated from the chassis.

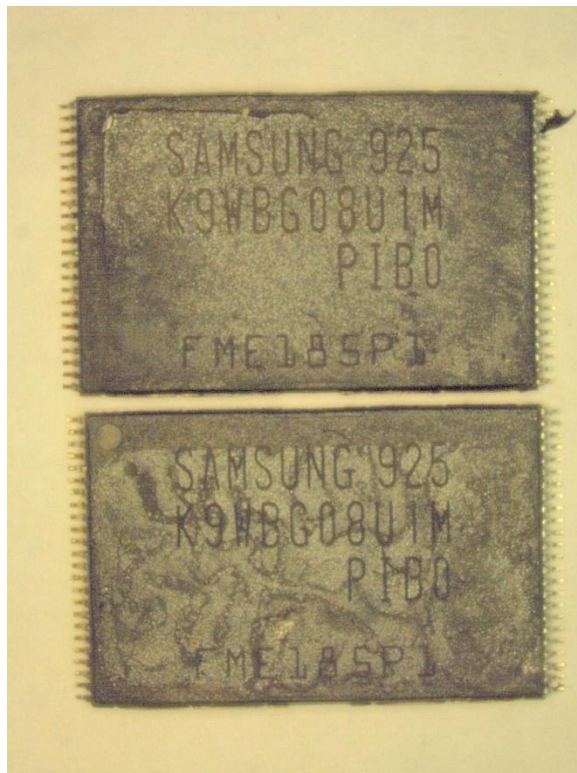
Figure 5. The two individual internal NVM chips after removal and cleaning.

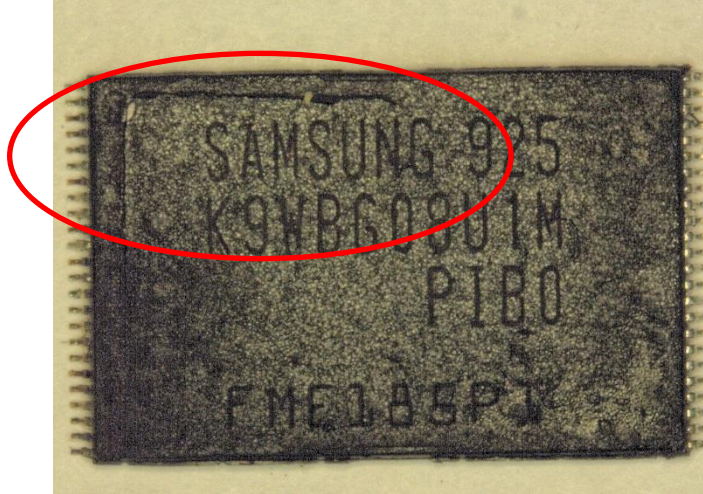
The unit's internally protected non-volatile memory² (NVM) was then located and removed from the device. Figure 3 shows the front and rear of the internally protected NVM memory chip housing. The two NVM chips were then removed from the internal memory device chassis (figure 4). The two NVM chips were then cleaned and photographed under an optical microscope (figure 5). The first NVM chip (NVM chip #1) exhibited bubbling and a crack along the chip's plastic packaging surface (figure 6). The second chip (NVM chip #2) exhibited heavy bubbling in the chip's plastic packaging surface (figure 7).

Figure 6. Bubbling and a crack along NVM chip 1's surface indicative of high temperature heat damage.

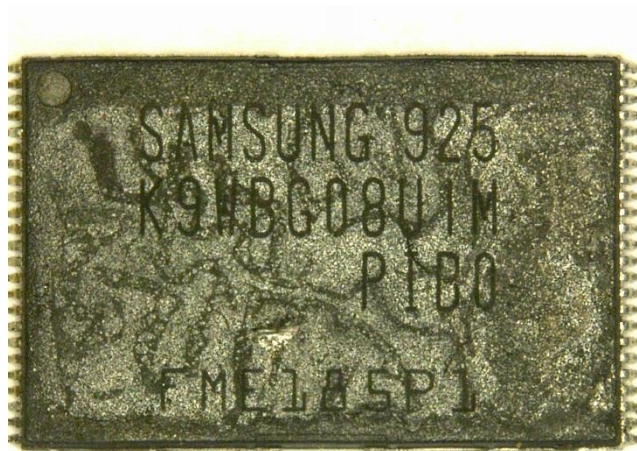
Figure 7. Bubbling along NVM chip 2's surface indicative of high temperature heat damage.

Additionally, NVM chip #2, referred to as “package 2” in the IEEC report, was sent back to The Small Scale Systems Integration and Packaging Center at the IEEC lab at SUNY Binghamton. An additional report, Attachment 2, was prepared that covers the damage to this memory chip in detail. The report characterizes the nature of the damage as extensive, the most severe damage having likely been a result of the chip’s exposure to high temperature fire.

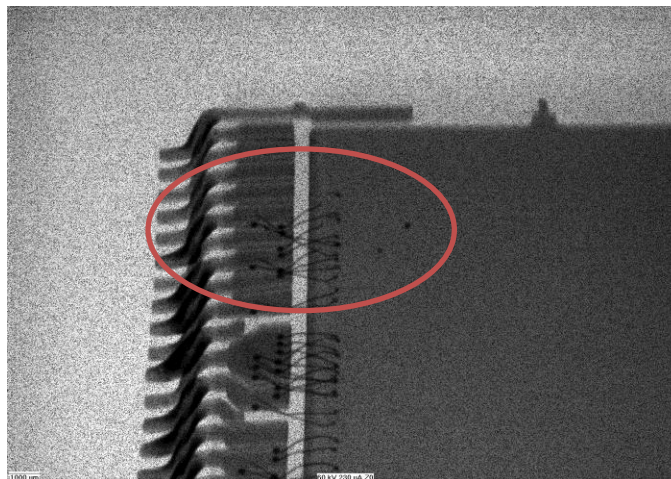
Furthermore, both NVM chips were examined using x-ray microscopy methods. NVM chip #1 x-ray image revealed a region of broken bond wires in the upper left hand portion of the chip (Figure 8). NVM chip #2 was x-rayed and revealed no visible defects (Figure 9).

Figure 8. A top down x-ray of NVM chip 1 showing visible defects in the region of attachment of the chip's bond wires.

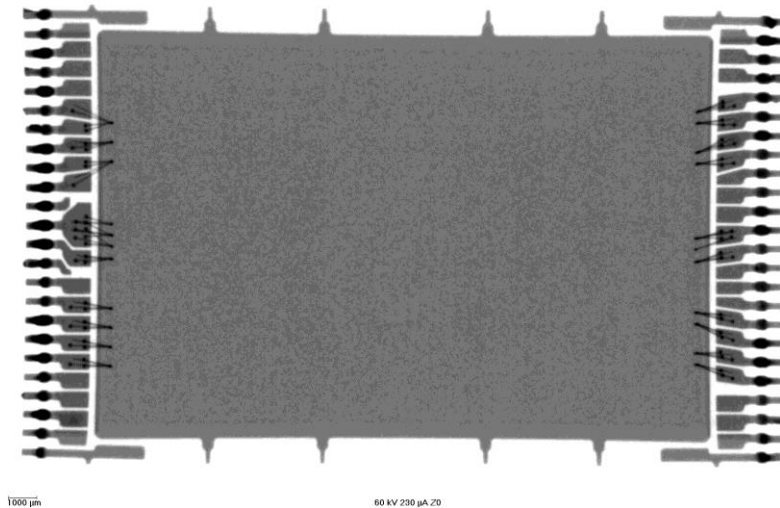
Figure 9. No visible bond wire damage was detected in this x-ray of NVM chip #2.

A binary readout attempt of internal NVM chip #2 from the device was performed in the laboratory using the appropriate type socket for this type of NVM chip. Upon readout, an error message displayed which is typically associated with failures due to unquantified internal damage to the chip. No further attempts were made to read either NVM chip #1 or #2.
