NATIONAL TRANSPORTATION SAFETY BOARD
Vehicle Recorder Division
Washington, DC 20594

Onboard Image Recorder

Specialist's Factual Report
By Sean Payne

Location: New Orleans, Louisiana
Date: February 20, 2016
Locomotive: Norfolk Southern NS8783
Operator: Norfolk Southern
NTSB Number: DCA16FR003

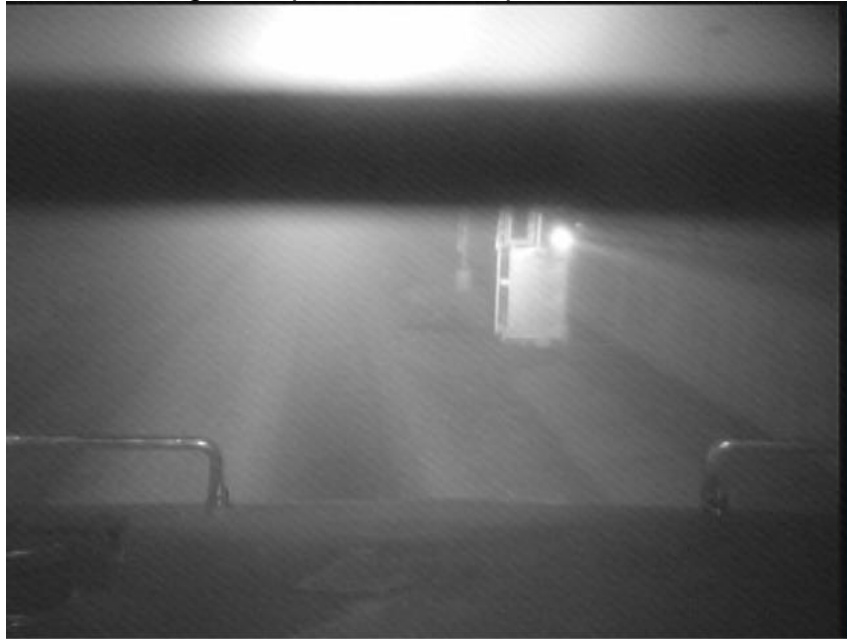
Figure 1 is a screenshot taken at 0605:40.7 (system frame number 74413116). The locomotive was passing a signal. The image was obscured by the locomotive's windshield wiper. The video file's metadata at this time showed the locomotive was traveling at a speed of 46.3 mph.

Figure 1. A exported screenshot at 0605:40.7 at a signal area.

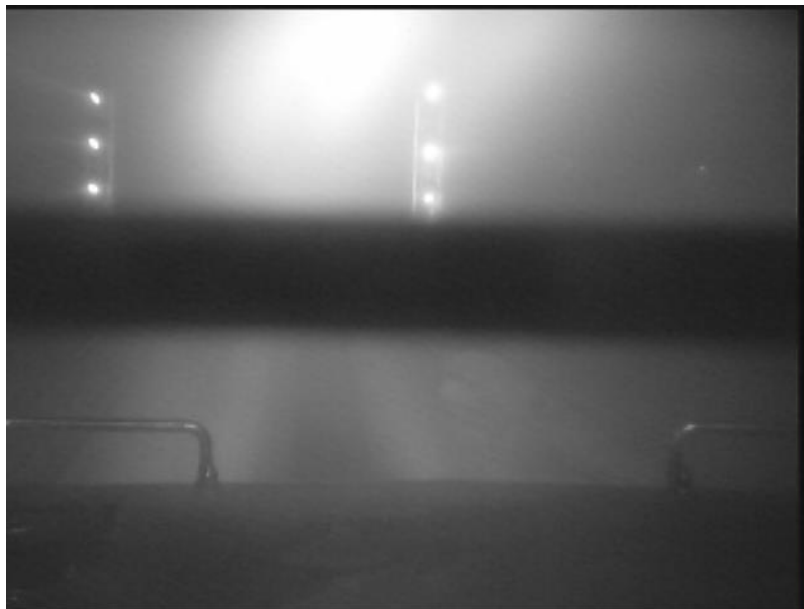
Figure 2 is a screenshot taken at 0607:57.7 (system frame number 74413875). The locomotive was passing a signal. The image was obscured by the locomotive's windshield wiper. The video file's metadata at this time showed the locomotive was traveling at a speed of 57.2mph.

Figure 2. A exported screenshot at 0607:57.7 at a signal area.

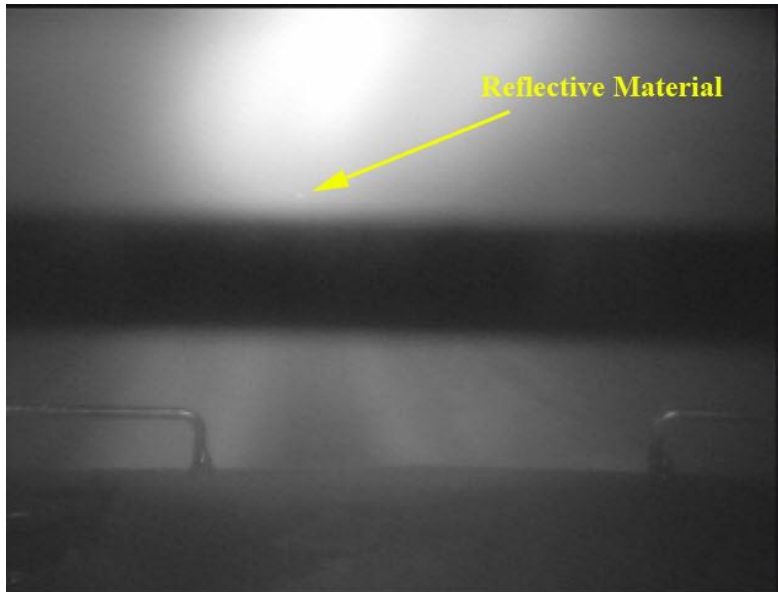
Figure 3 is a screenshot taken at 0608:13.2 (system frame number 74413955). At this time, reflective material was visible for the first time on the camera's recording. The image was partially obscured by the locomotive's windshield wiper. The video file's metadata at this time showed the locomotive was traveling at a speed of 58.0 mph.

Figure 3. A exported screenshot at 0608:13.2 (system frame number 74413955) showing the first image of reflective material.

For the next approximate 16 frames, the reflective material became larger in the camera's frame. During this time interval, the reflective material began to become defined as multiple individual pieces of reflective striping.

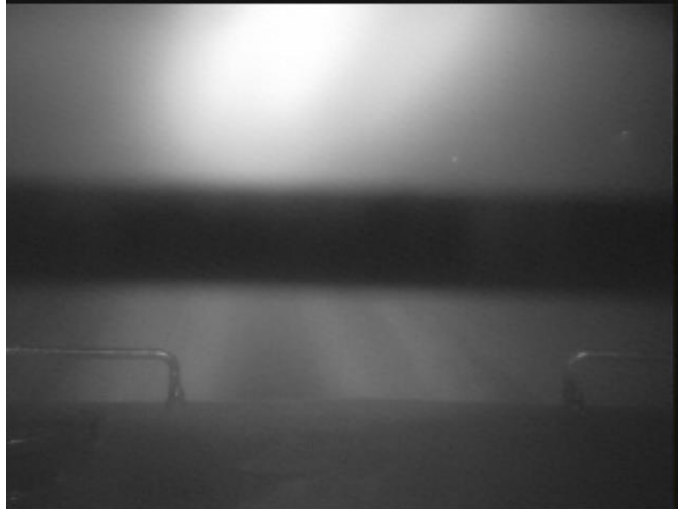
In system frame number 74413972 (0608:16.3), the reflective material disappeared behind the obscuration made by the locomotive's windshield wiper. Figure 4 is a screen capture from the system's software at this time.

Figure 4. A exported screenshot of system frame number 74413972 at 0608:16.3. The reflective material disappeared behind the locomotive's wiper.
