NATIONAL TRANSPORTATION SAFETY BOARD
Vehicle Recorder Division
Washington, DC 20594

Onboard Image Recorder

Specialist's Factual Report
By Bill Tuccio, Ph.D.

Location:	Front Royal, Virginia
Date:	October 7, 2017
Aircraft:	Piper PA-25-235, N90866
Operator:	Skyline Soaring Club
NTSB Number:	ERA18FA006

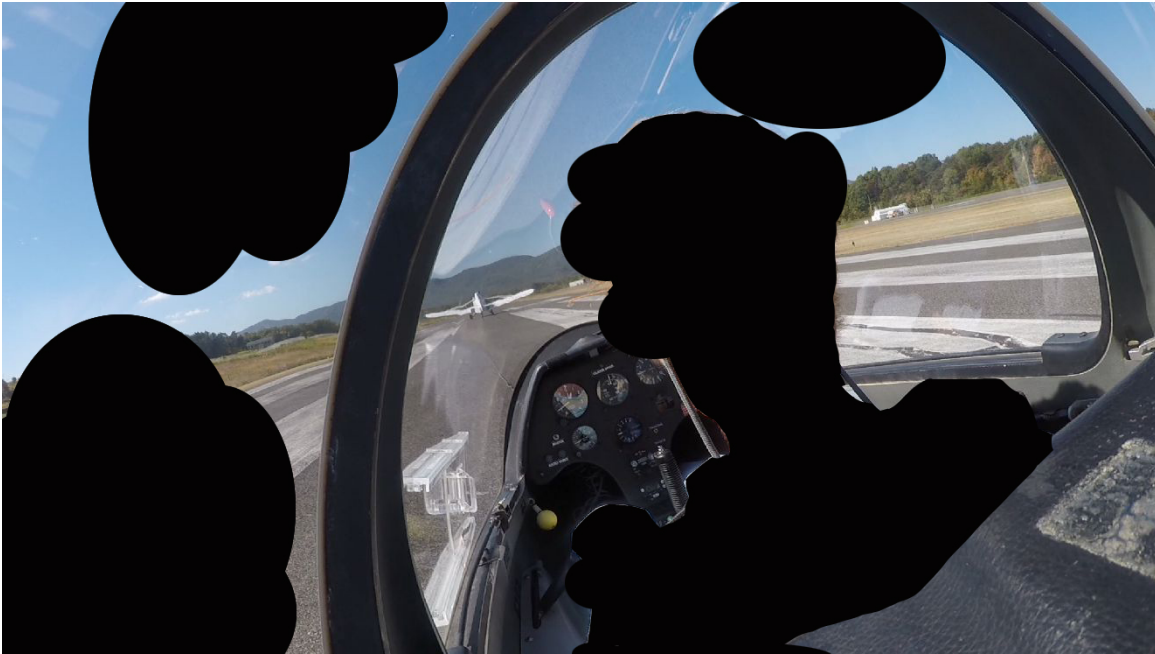
Figure 1. GOPR0172.mp4 at 00:00:00.00.

[00:00:00.00] The glider was stationary on the ground, connected to the towplane via a slack towrope. The camera vantage point was behind and to the left of the front seat passenger, as shown in figure 1. The airspeed indicator read 0, the altimeter read 700 feet, and the g-meter read about 0. The control stick position remained in the neutral position until just before the takeoff roll began (about 30 seconds hence, as reported herein). The blue spoilers/brake handle was full aft. The sky had few high clouds, visibility greater than 20 miles. The towplane's propeller was turning. The glider pilot was seated in the back of the towplane and the passenger in the front. The glider pilot and passenger were talking, with the glider pilot explaining how the tow would proceed. Throughout the video, unless otherwise noted, the passenger did not touch the control stick.

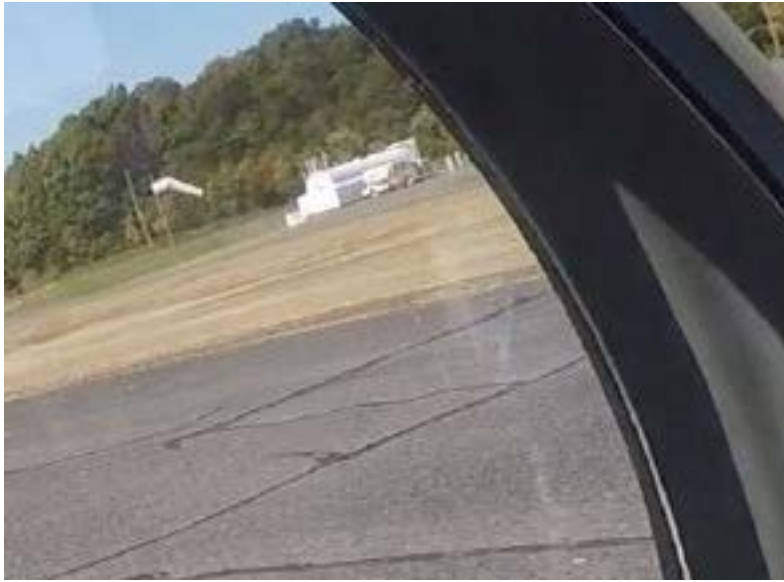
Figure 2. GOPR0172.mp4 at 00:00:31.15.

[00:00:31.15] At this time, a windsock was visible to the right of the runway. There was a left quartering headwind, as shown in figure 2. The glider's yawstring was about 45 degrees to the right.

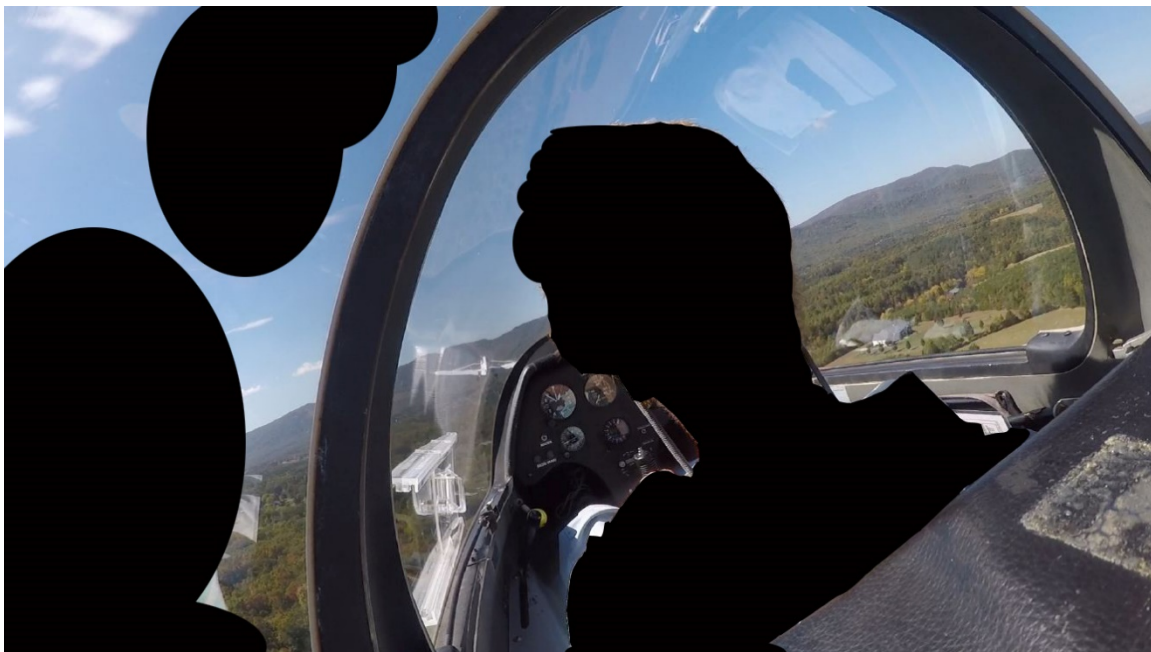
Figure 3. GOPR0172.mp4 at 00:01:03.21.

[00:01:03.21] The video ended, as shown in figure 3. The glider altimeter indicated about 900 feet, and the airspeed indicated about 60 knots. There was a white house visible at about the 2 o'clock position of the glider. The position of the glider relative to the towplane was consistent with a high tow position.³

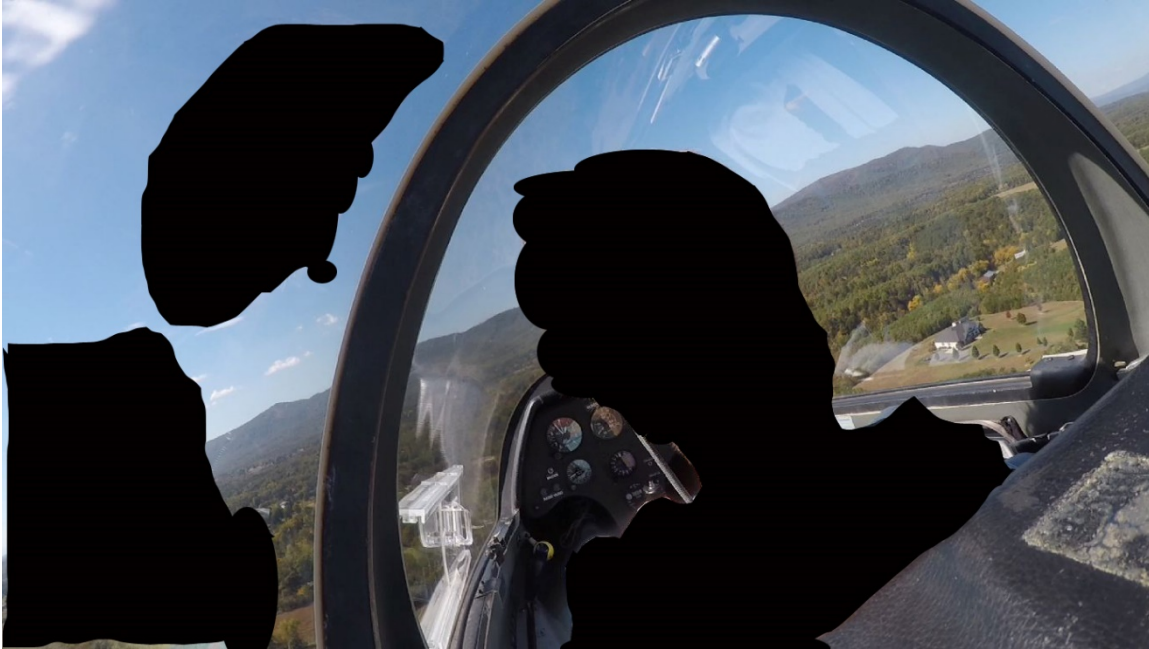
Figure 4. GOPR0173.mp4 at 00:00:00.00.

[00:00:00.00] The video resumed, the first frame shown in figure 4. The white house had moved to about the 2:30 position of the glider. The altimeter indicated

about 950 feet and the airspeed indicated about 70 knots. The towplane was not visible to the camera's vantage point/field of view.

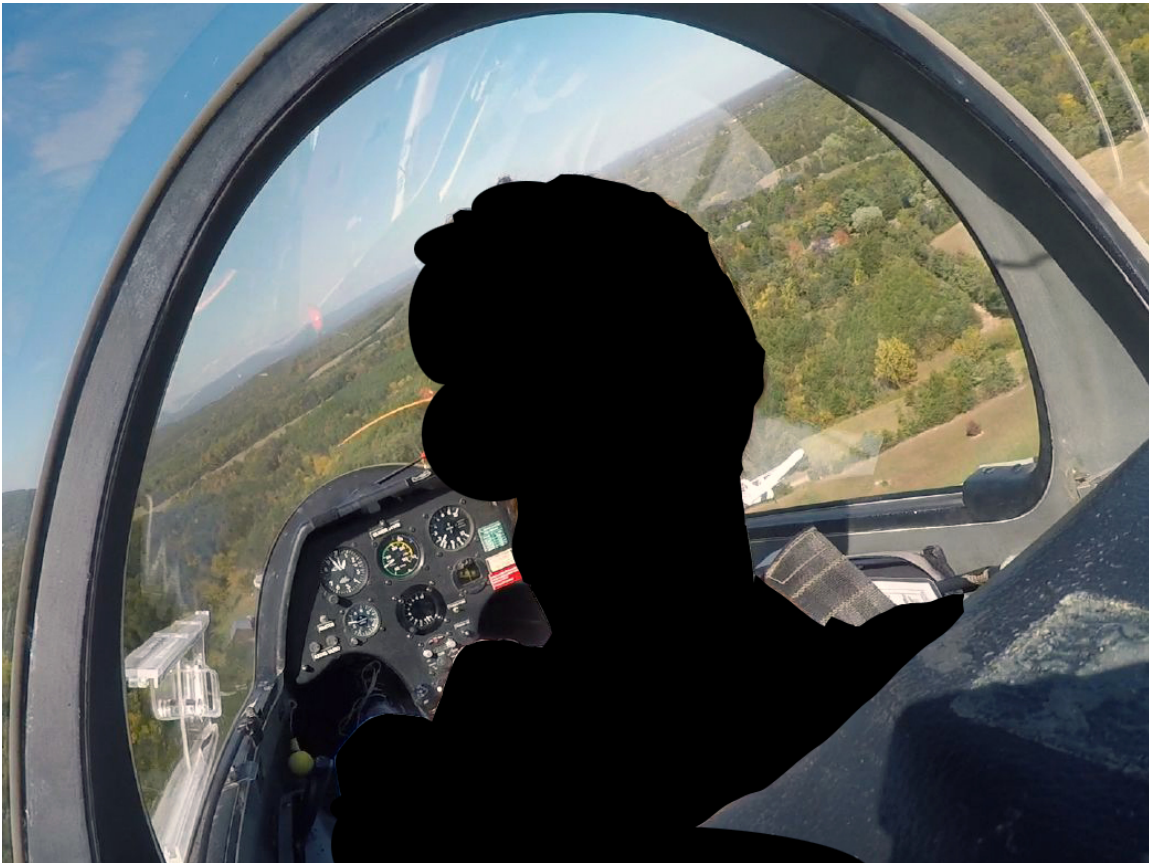
Figure 5. GOPR0173.mp4 at 00:00:08.23.

[00:00:08.23] The towplane's position at this moment is shown in figure 5. The tow plane was to the right of the glider and below the glider.

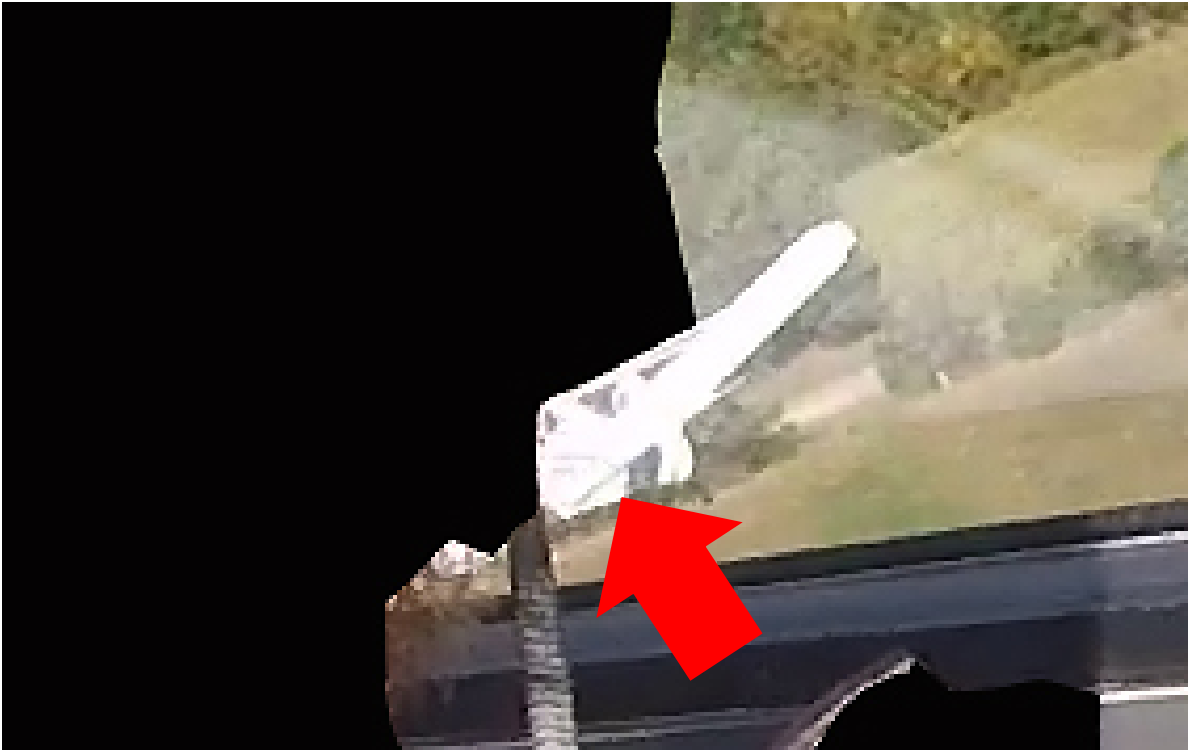
Figure 6. Elevator emphasis, image cropped and sharpened.

Figures 6 and 7 show enhancements of figure 5, with an emphasis on the towplane's elevator. Image resolution was not sufficient to discern/identify the towrope.
