NATIONAL TRANSPORTATION SAFETY BOARD

Onboard Video Sound Spectrum

Specialist's Study Report by Bill Tuccio, Ph.D.

Location:	San Juan, Puerto Rico	
Date:	July 4, 2017	
Aircraft:	Piper PA-28-180	
Registration:	N9427J	
Operator:	Horizon Aviation	
NTSB Number:	ERA17LA227

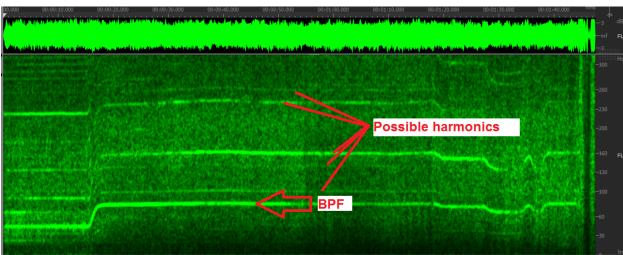
Figure 1 shows the sound spectrum during the recording. The assumed BPF is annotated, as are possible harmonics.

Figure 1. Sound spectrum during recording.

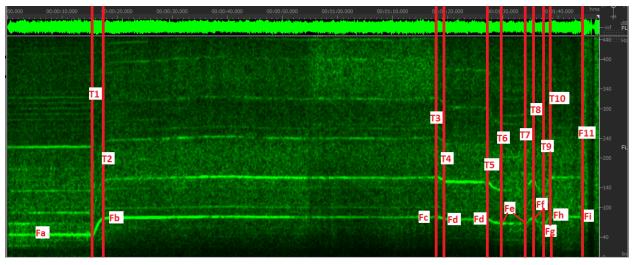
Figure 2 shows the same sound spectrum image, annotated with measurement points. Values for the measurement points are detailed in table 1. All times are in onboard video elapsed time. Trial conversions of the "BPF" annotated frequency trace (figure 1) created expected RPM values; accordingly, this trace was used as the BPF to convert to RPM.

Figure 2. Sound spectrum, annotated with measurements.

Prior to 15.2 seconds (T1), the engine was operating at 1,344 RPM, as the airplane was entering the runway but had not yet started its takeoff.

At 18.9 seconds (T2), the engine was operating at 2,385 RPM, and the airplane had commenced its takeoff roll.

At 77.5 seconds (T3), the engine RPM had increased slightly to 2,451 RPM, as the airplane had climbed above the departure end of the runway.

At 79.8 seconds (T4), the engine RPM decreased to 2,265 RPM; this occurred about as the airplane had banked slightly right.

Between 79.8 seconds (T4) and 87.1 seconds (T5), the engine RPM remained steady at 2,265 RPM.

By 90.1 seconds (T6), the engine RPM decreased to 1,980 RPM; shortly after this reduction the airplane began to bank left.

Between 90.1 seconds (T6) and 93.9 seconds (T7), the engine RPM remained steady at 1,980 RPM; by this point the airplane had started to descend and was still banking left.

At 95.5 seconds (T8), the RPM momentarily increased to 2,292 RPM.

At 98.4 seconds (T9), the RPM momentarily decreased to 1,950 RPM.

From 98.4 seconds (T10) until just before impact at 104.5 (T11), the RPM was stable between 2,373 to 3,451 RPM.

After takeoff, there was a reduction in RPM, and then an increase in RPM towards the end of the recording. The reasons for the RPM changes could not be determined from this study.
