NATIONAL TRANSPORTATION SAFETY BOARD

Onsite Examination

WPR18FA139

Aircraft: Beech BE76, Registration Number: N803FC, Serial #: ME-150

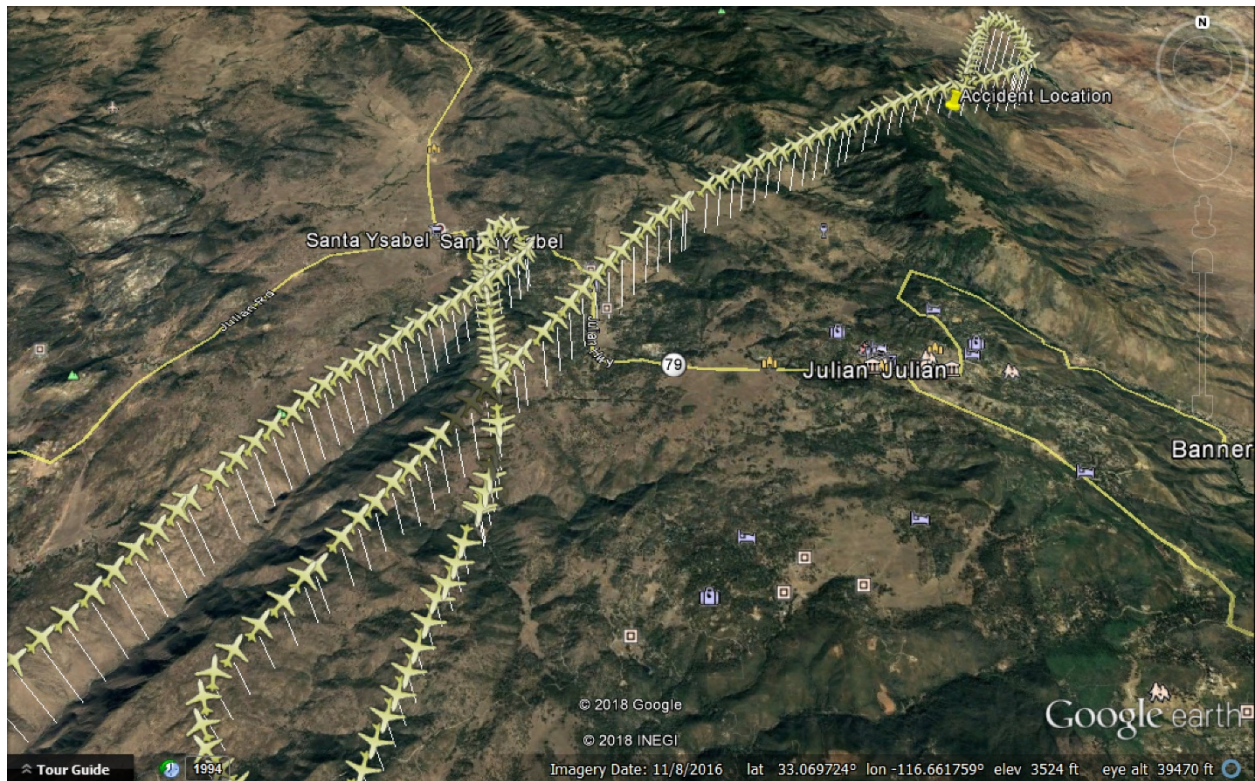
Figure 2: View of radar picked up from primary returns.

Review of preliminary radar data provided by the Federal Aviation Administration (FAA) identified the airplane near the Ramona Airport (RMN) about 2003. Radar tracking showed that the airplane traveled east from RMN, climbed to about 5,600 ft mean sea level (msl), with the groundspeed varying from 116 knots to 133 knots for about 14 miles. The airplane then began to slow and it made a left turn from about a 48° course heading to about a 176° course heading. Throughout the turn, the altitude remained about 5,600 ft msl, and the groundspeed decreased to 55 knots. At the completion of the turn, the groundspeed increased to about 67 knots, and a climb

was initiated to 6,600 ft msl while continuing on a southwestern course of about 195°. The airplane then made a right turn to an easterly heading for about 10 miles.

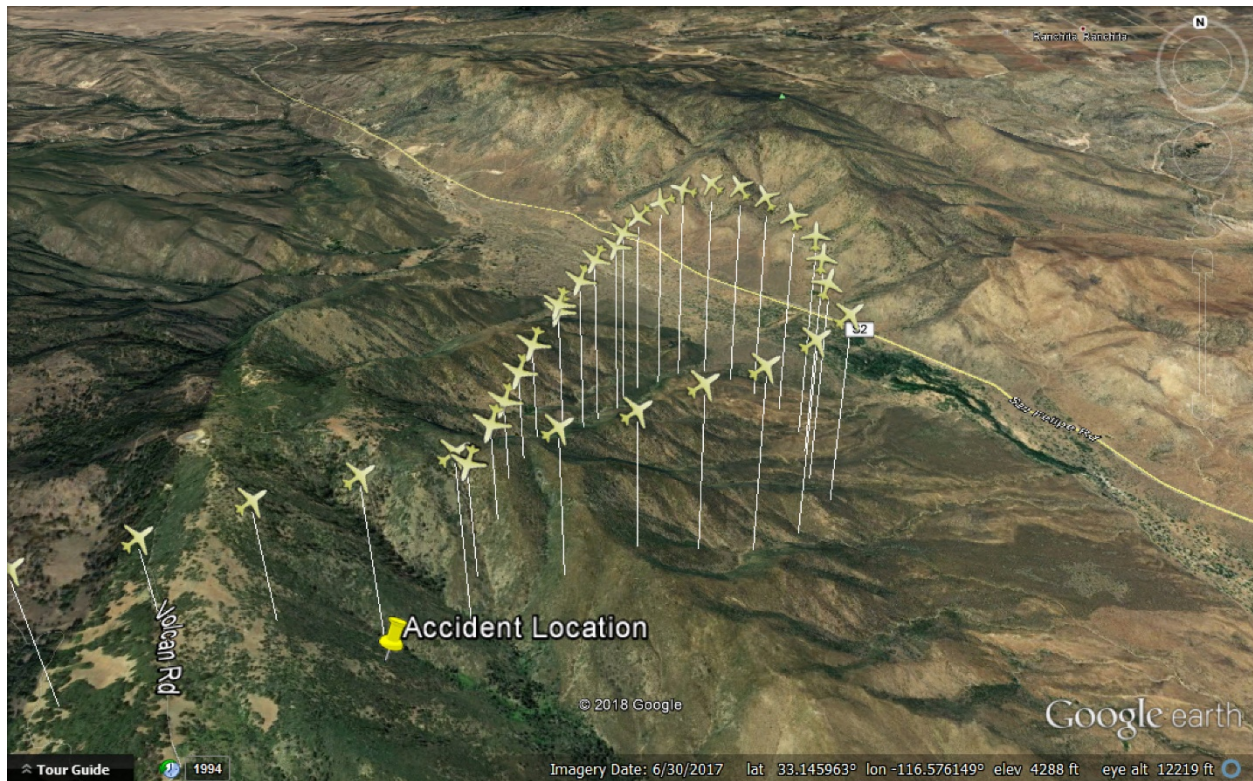
Figure 3: View of accident maneuver.

The radar data further depicted a left 180° turn was initiated at an altitude of 6,200 ft msl and a groundspeed of about 121 knots. At what appears to be the apex of the turn, the airplane was at 6,100 ft msl and a groundspeed of 50 knots. The airplane then began to descend, and groundspeed increased to 74 knots, then decreased to 50 knots. The last radar return was

recorded at 2031, with the airplane at an altitude of 5,700 ft msl and a groundspeed of 67 knots in the vicinity of the accident site.

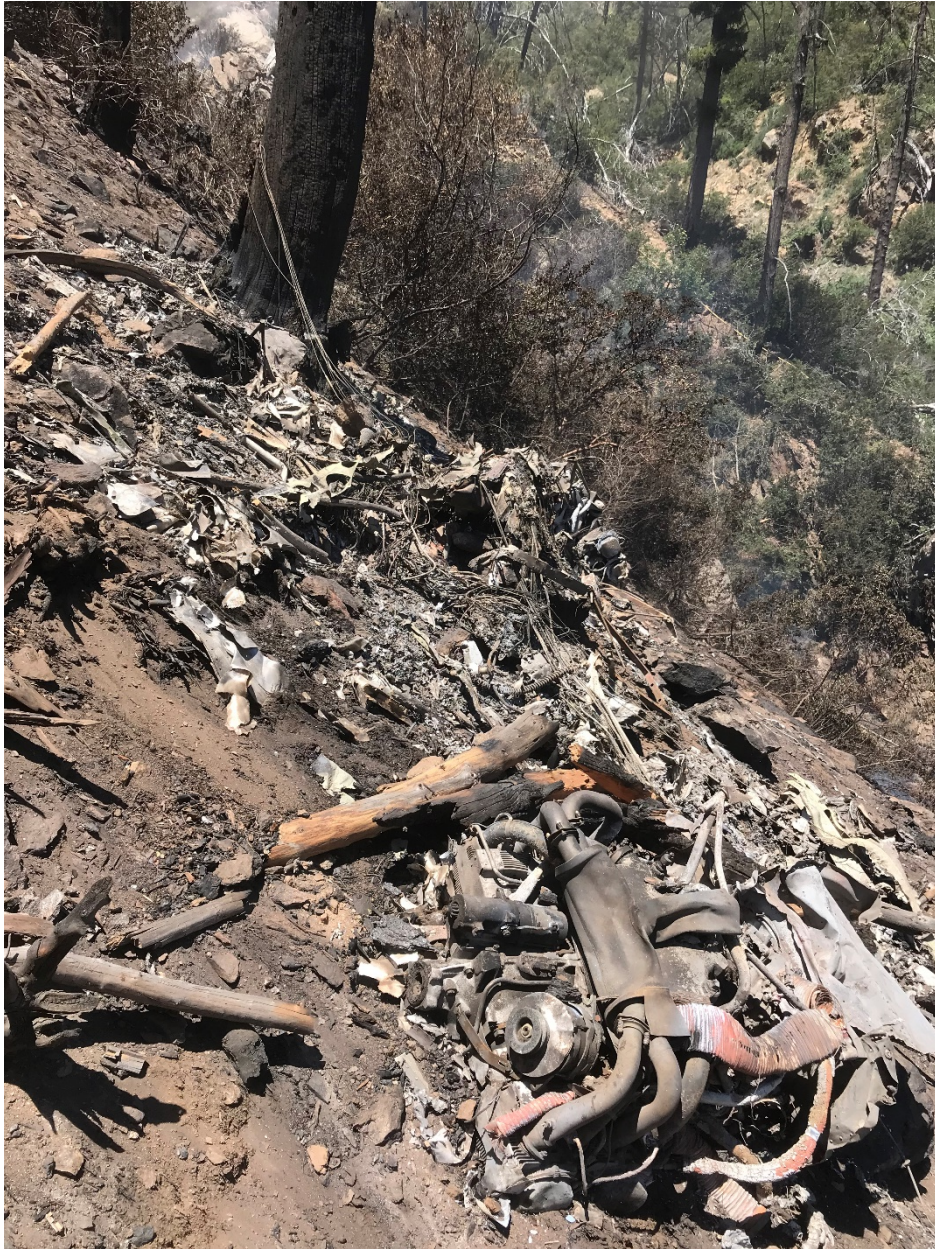
Figure 7: View of Main Wreckage

The main wreckage consisted of the fuselage, both wings, and both engines. The overall diameter of the main wreckage was about 20 ft. All structural components of the airplane were consumed by post impact fire, with the exception of a small part of the left aileron and some of the left wing.

All flight control cable pullies, with the exception of the two aileron pullies in the center cabin area, were destroyed by the post impact fire. The flight control cables were observed in photographs taken at the site wrapped around a tree. The cockpit control handles for ailerons and elevator were observed with the aluminum tubing between the handles and the control “T” burned away during the fire.
