NATIONAL TRANSPORTATION SAFETY BOARD

Operations Group Chairman's Factual Report

DCA17IA020

Operator: Eastern Air Lines
Location: New York, New York
Date: October 27, 2016
Time: 1942 EDT¹
Airplane: Boeing 737-7L9, N278EA

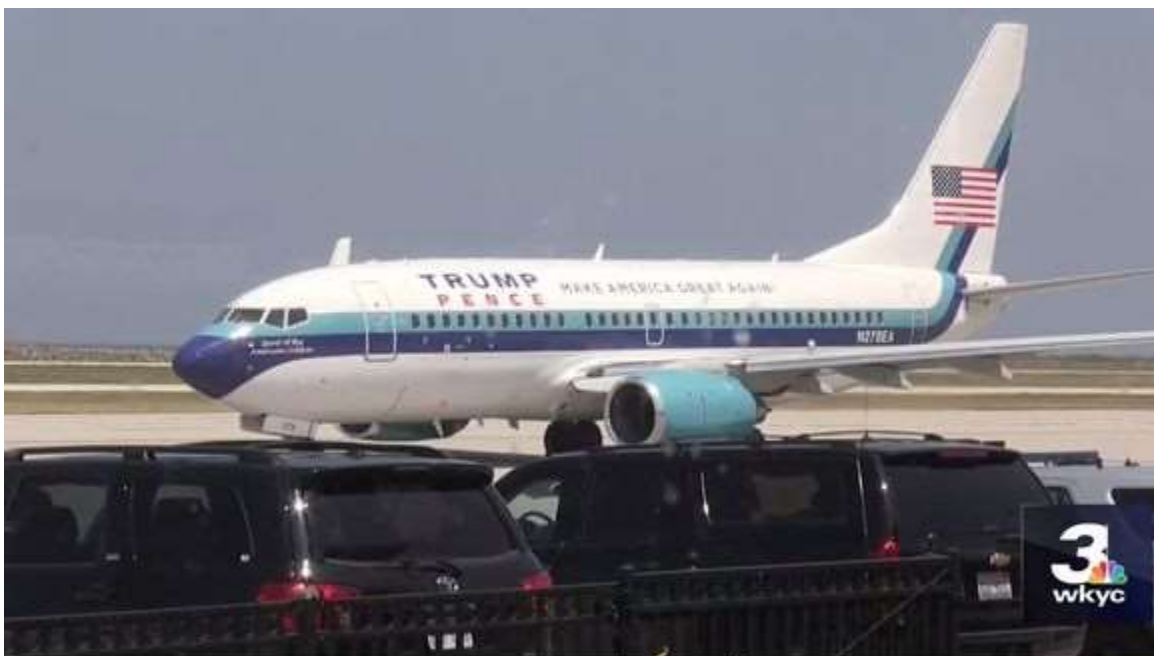
Photo 1: Incident Airplane (Registration N278EA)

The incident airplane was a Boeing 737-7L9, FAA registration N278EA, Serial No. 28006, and was manufactured in 1998. The registered owner was Wells Fargo Bank Northwest NA Trustee, and it held a transport category airworthiness certificate. The airplane had a maximum taxi weight of 69,626 kilograms (kg)⁴⁸, had a total passenger seating capacity of 64⁴⁹, and contained 2 flight crew seats and 7 cabin crew seats. A review of NTSB and FAA records found that the incident airplane had not been involved in any previous incidents that merited a formal investigation or accidents⁵⁰ as prescribed in 49 *CFR* Part 830.2, “Definitions.” However, according to interview summaries of Eastern Air Lines personnel, the incident airplane was involved in an event in which the left wingtip made contact with a light pole during parking in March of 2016.
