## **NATIONAL TRANSPORTATION SAFETY BOARD**

### **Group Chairman's Factual Report**

# **OPERATIONAL FACTORS**

CEN17FA168

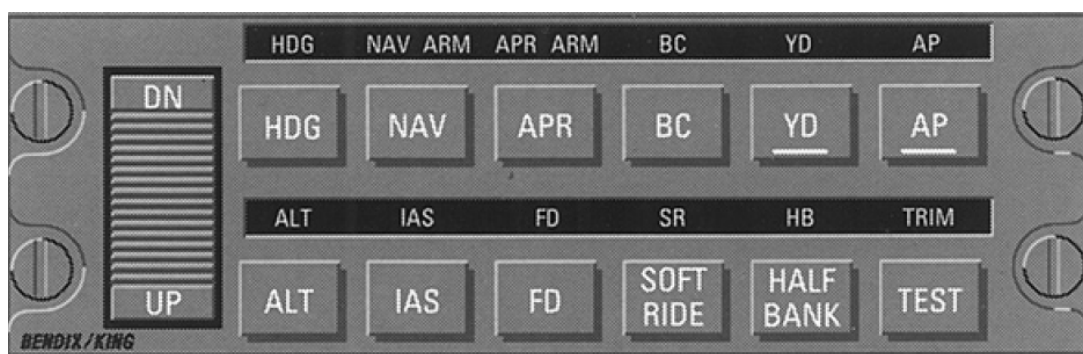
Figure 2: Honeywell KFC 325 Autopilot Control Mode Panel (source: Bendix King)

According to interviews, the recurring malfunction was typically annunciated to the pilot with an airplane master warning light, an autopilot-trim warning tone (continuous beeping), red *TRIM* light on the autopilot mode control panel, (figure 2), and a red *A/P TRIM* light on the Crew Alerting and Warning System (CAWS) panel (figures 3). The autopilot would automatically disengage.
