FedEx Flight 1478 Operational Factors

Captain David J. Ivey Group Chairman

Operational Factors

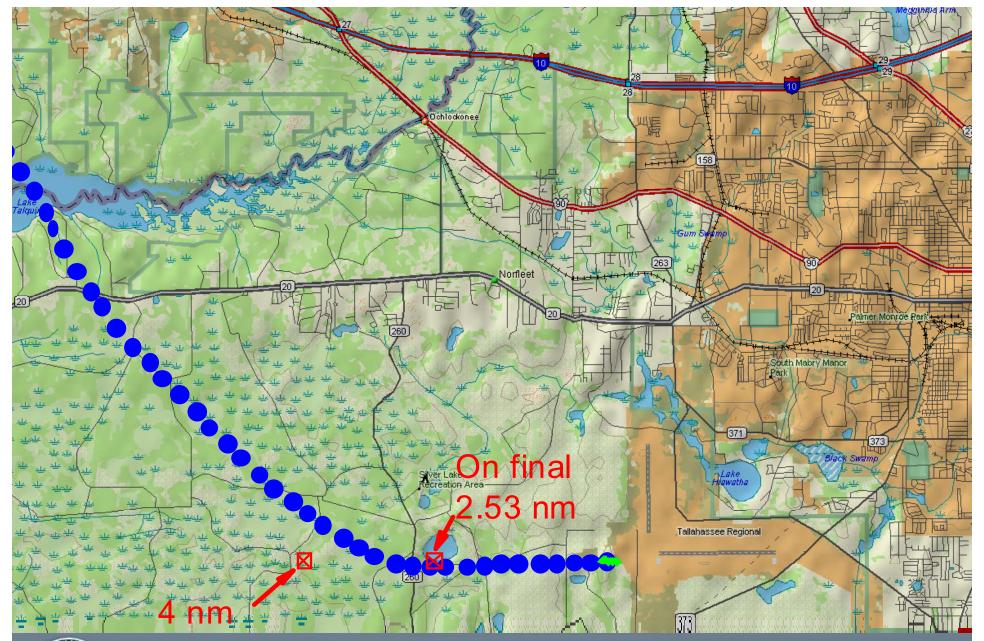
- Plan to be established on runway centerline NO LATER than 4nm from the runway threshold
- Turn to final at an altitude that will allow sufficient time to stabilize at 500 feet
- Rate of descent <1,000 FPM on final
 - Advisory Callouts such as visual cues (PAPI), "sink rate"

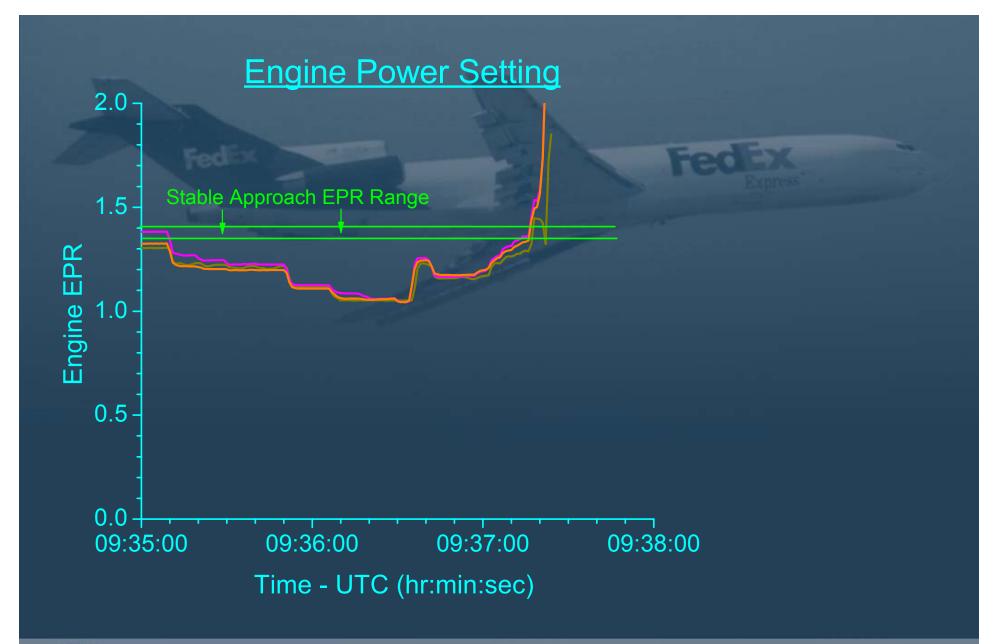
Stabilized Approach Corridor 500 Feet AGL

- Landing gear/flaps/slats in final landing configuration
- Stable Airspeed (± 5 knots of target)
- Engines spooled up and steady at proper approach setting
- Proper descent angle/rate of descent

MANDATORY CONDITIONS/LIMITS
