NATIONAL TRANSPORTATION SAFETY BOARD
Office of Aviation Safety
Washington, D.C. 20594
March 25, 1997

Group Chairman's Addendum and Errata

OPERATIONS/HUMAN PERFORMANCE

DCA97MA059

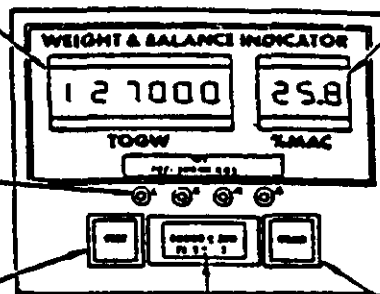
Weight and Balance STAN System

Failure or malfunction of the system is indicated by failure of the test switch to call up the correct placard response. The system is primarily used to verify that calculated weight and balance are within limits.

Actual gross weight and CG displayed in respective digital indicators.
