Head-end Collision of Two BNSF Freight Trains

Panhandle, Texas

NTSB Accident Number: DCA16FR008

Operations and Human Performance Factual Report

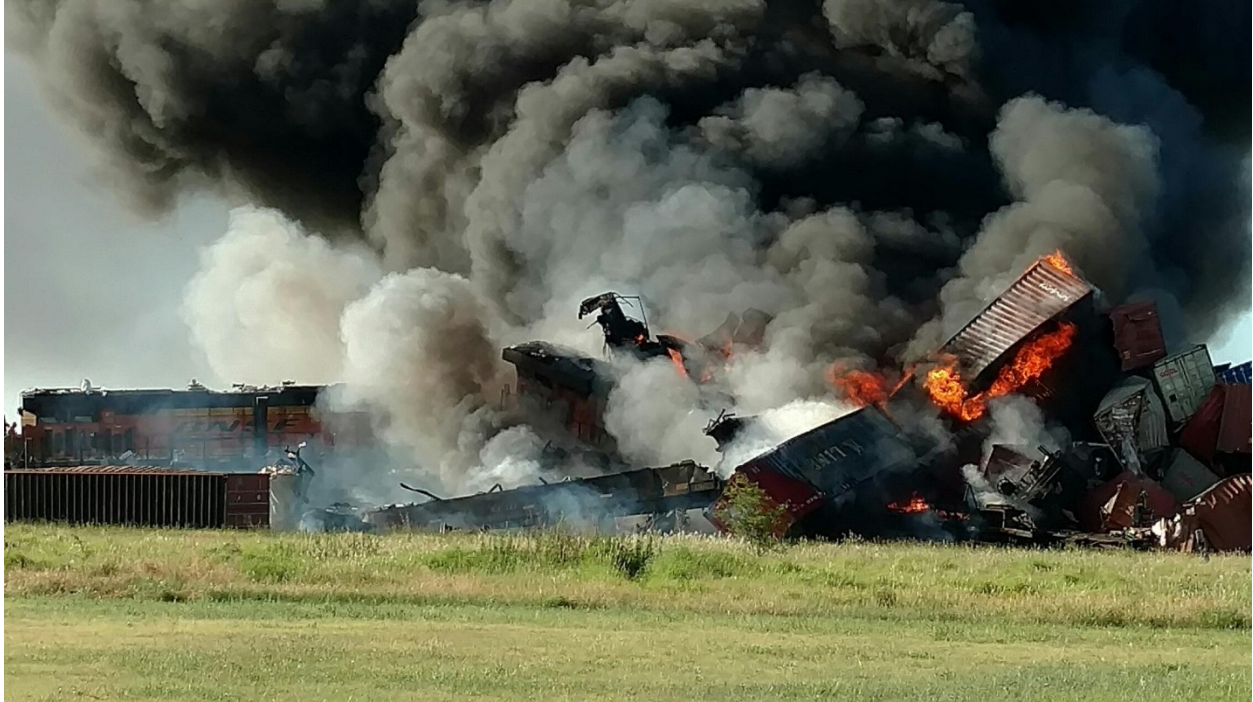
Figure 1: Burning wreckage of collision. (Photo courtesy of BNSF.)
