NATIONAL TRANSPORTATION SAFETY BOARD  
OFFICE OF AVIATION SAFETY  
Anchorage, Alaska, 99513

Operations / Witness Group Chairman's Factual Report

Operator: Helicopter Consultants of Maui, Inc.  
Dbas: Blue Hawaiian Helicopters  
Location: Pukoo, Hawaii (Island of Molokai)  
Date: November 10, 2011  
Time: 1214 Hawaiian standard time<sup>1</sup>  
Helicopter: Eurocopter EC130 B4, Registration Number: N11QV, MSN: 4909

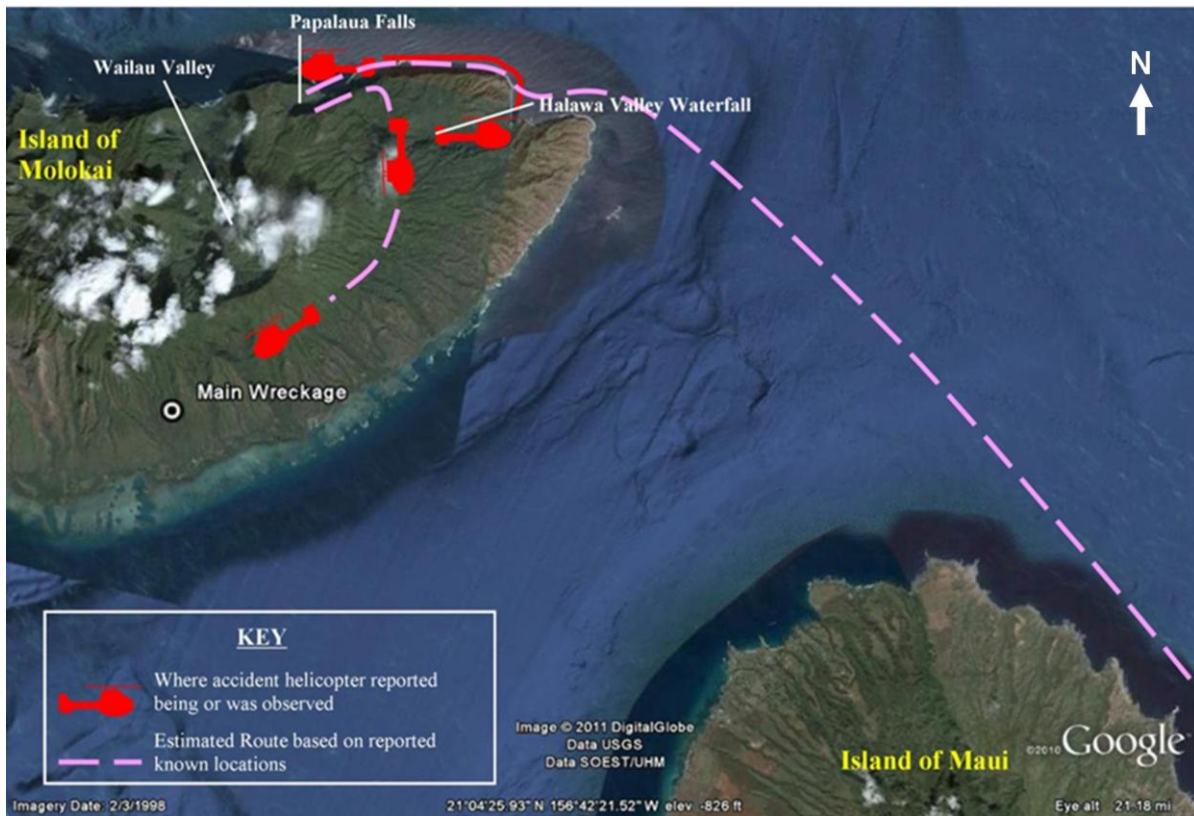
**Figure 2: Presumed Flight Track of Accident Helicopter**

Pilots from other air tour operators that were flying around the Island of Molokai about the same time as the accident pilot reported that overall weather conditions would not have allowed the accident pilot to fly through Wailau Valley. Additionally, they reported seeing and/or talking with the accident pilot at various times and locations throughout the flight. These locations were near the Papalaua Waterfalls, the Halawa Valley Waterfall, and along the southern side of the Island of Molokai. The map below shows the accident helicopter's approximate route of flight given the prearranged flight route and statements from the other pilots.

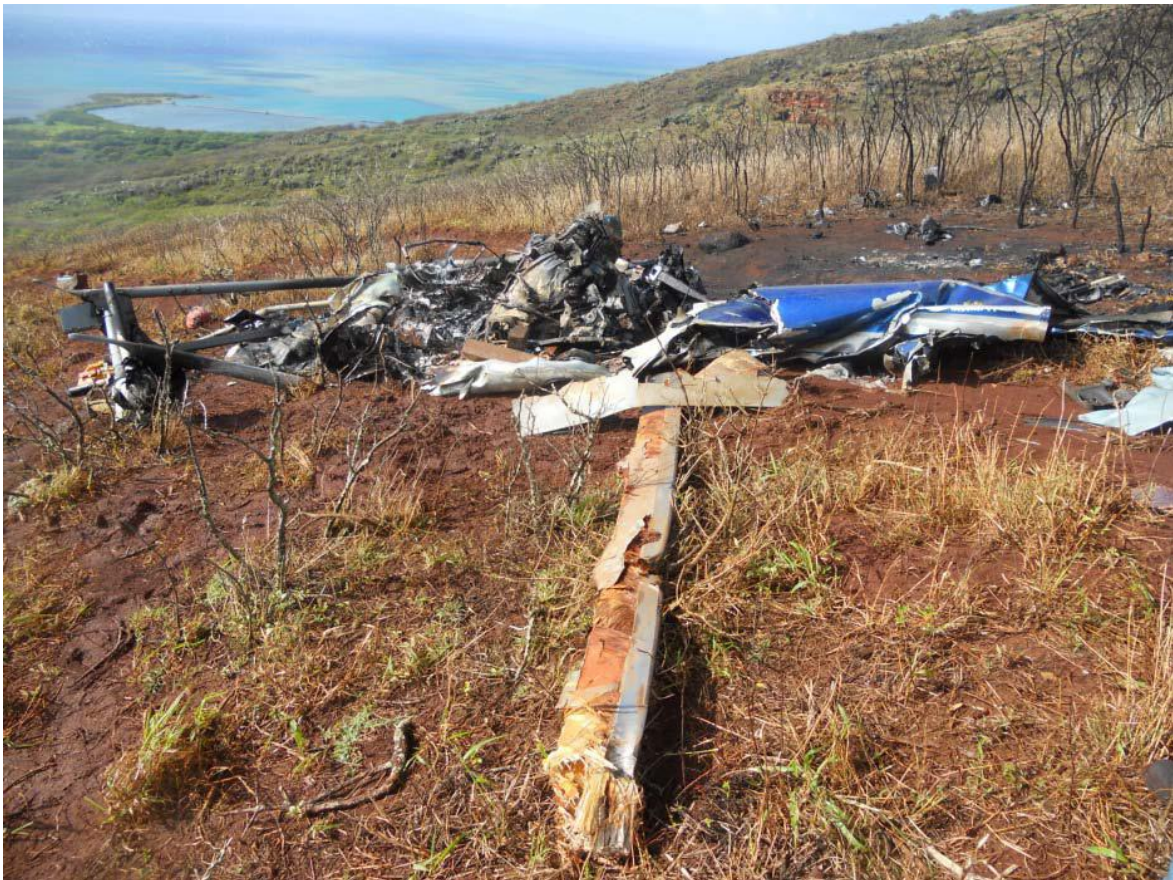
**Figure 3: Main Wreckage Site**

The below image is of the main wreckage. The wreckage debris path was approximately 1,330 feet long extending west northwest from the main wreckage.

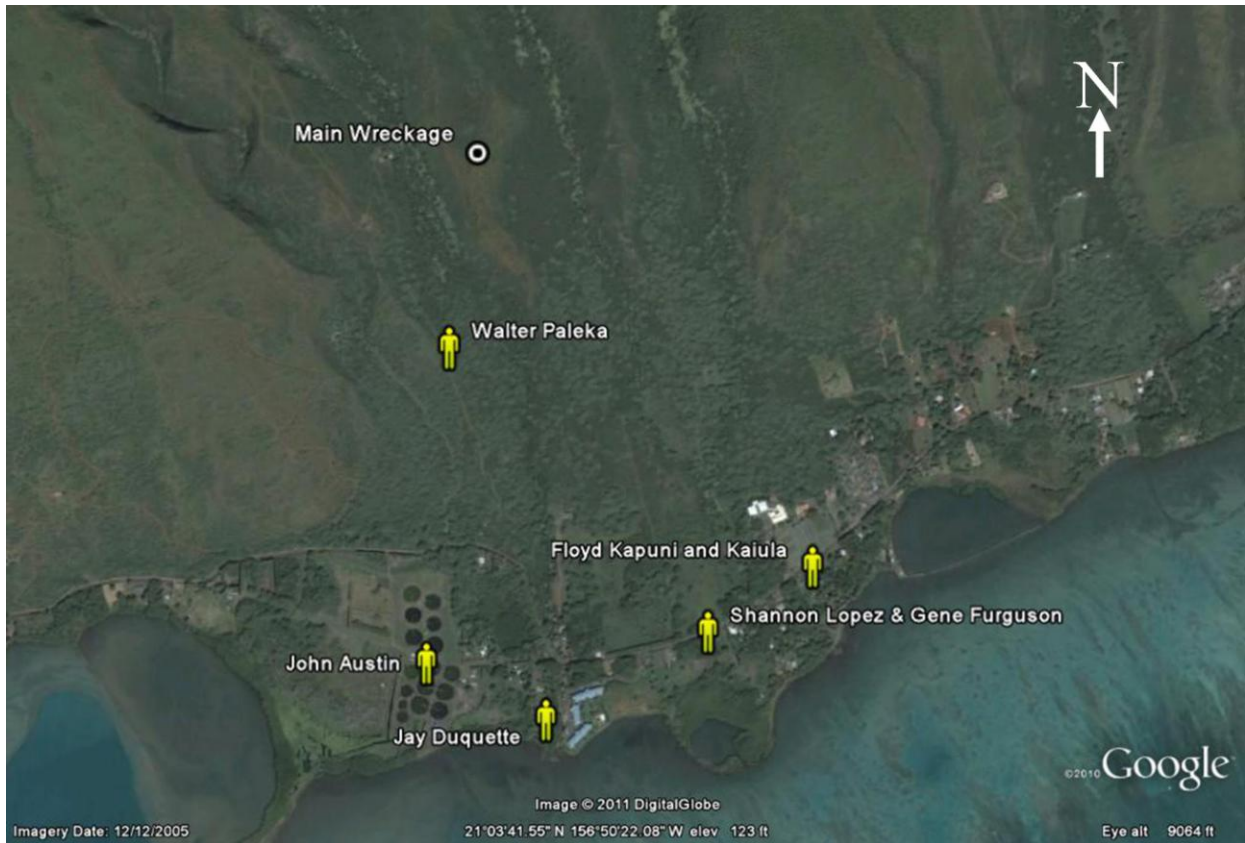
**Figure 5: Witness Locations in Relation to Main Wreckage**

The operations/witness group interviewed each person at the same location from which they had observed the accident. A photograph was taken from each perspective. A red circle on the image indicates the approximate location of the accident site (not visible to the witness); a solid red dot indicates where the witness observed the accident.

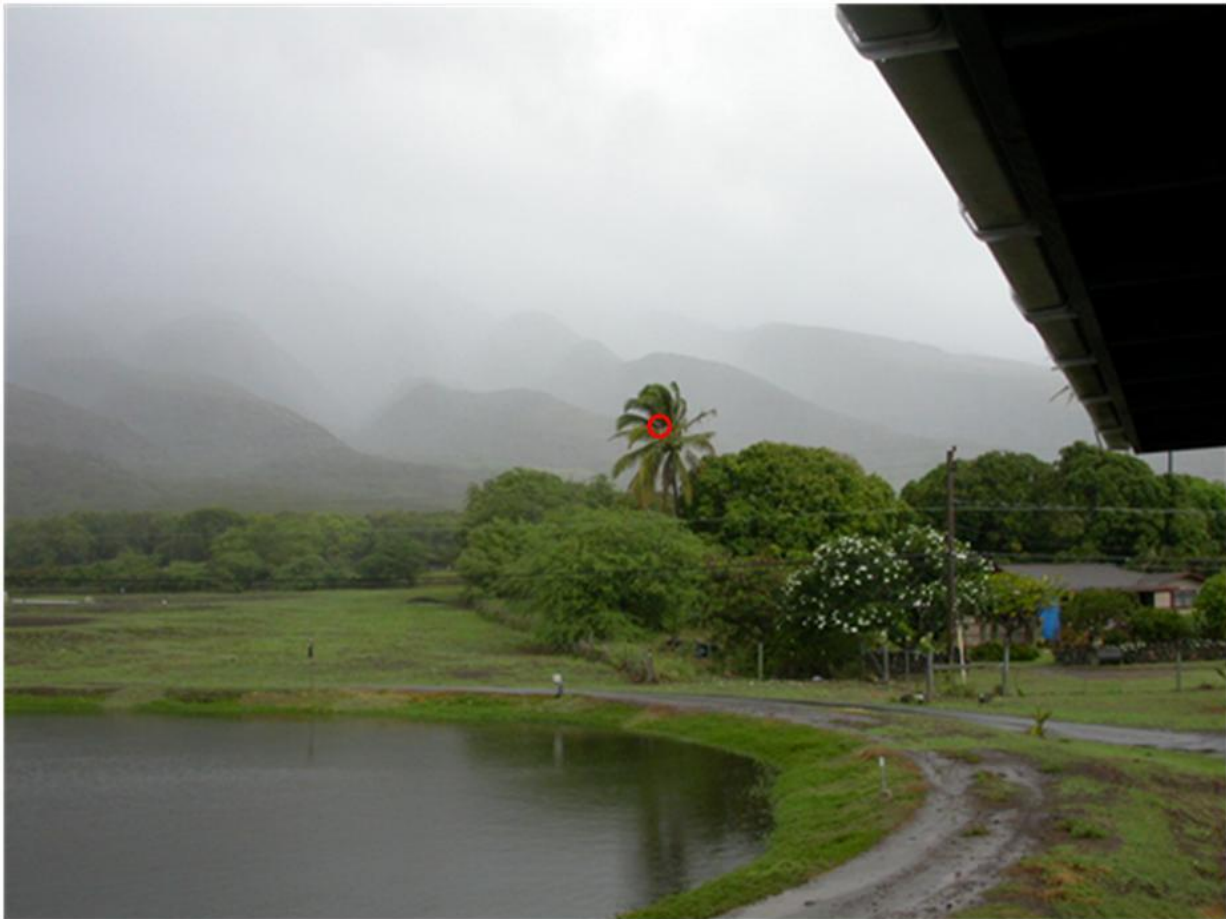
**Figure 6: Mr. Austin's View at the Time of the Accident.**

Mr. Austin, who is a private single-engine land airplane pilot, stated that he was outside his home under a covered patio when a squall of heavy rain, which consisted of large raindrops and heavy wind entered the area. Mr. Austin stated that the wind was stronger than normal because it shook his house, which doesn't normally happen; he estimated the wind to be about 45 knots out of the northeast. He stated that his attention was first drawn to the helicopter when he heard a "wooshing" sound that turned into vibrations. These sounds lasted for about 10-15 seconds. Mr. Austin reported hearing the impact, although he could not see it because of a coconut tree blocking his view. Mr. Austin contacted 911 at 1215.

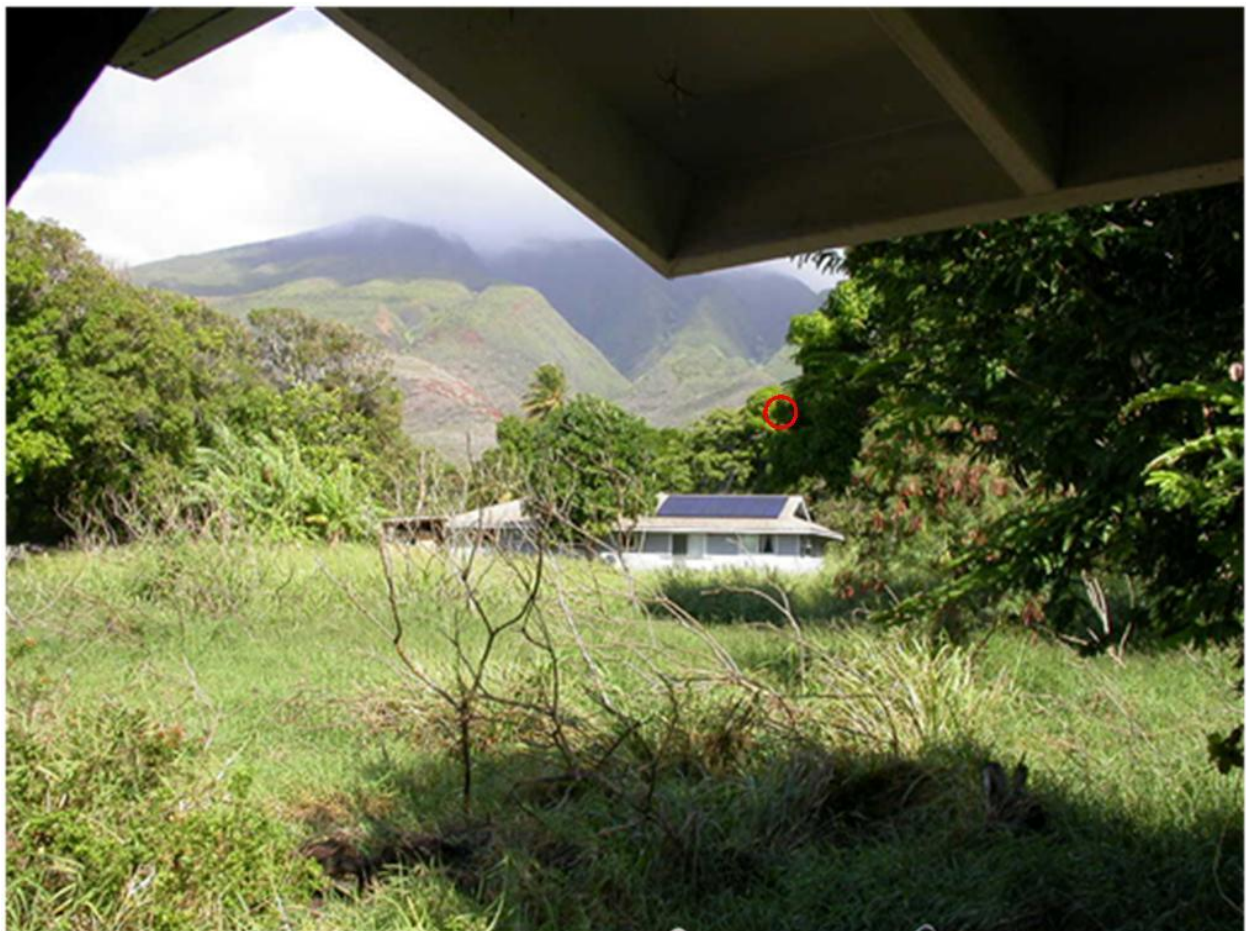
**Figure 7: Mr. Duquette’s View at the Time of the Accident**

Mr. Duquette reported that he was working outside of his home when it started to rain abnormally hard for the area. After a squall had passed, his attention was drawn toward the helicopter when he heard a very loud hissing sound followed by a “woop, woop, woop” sound, which lasted about 10-20 seconds. During the accident sequence, he reported that he possibly saw a wispy trail of smoke behind the helicopter before he heard an explosion and saw a fireball. He was unable to see the impact because his view was obstructed by trees. Mr. Duquette reported that it was not raining at his home at the time of the accident, although, in the mountains, it was very dark and rainy with limited visibility. Mr. Duquette contacted 911 and proceeded up the mountain to assist any survivors.

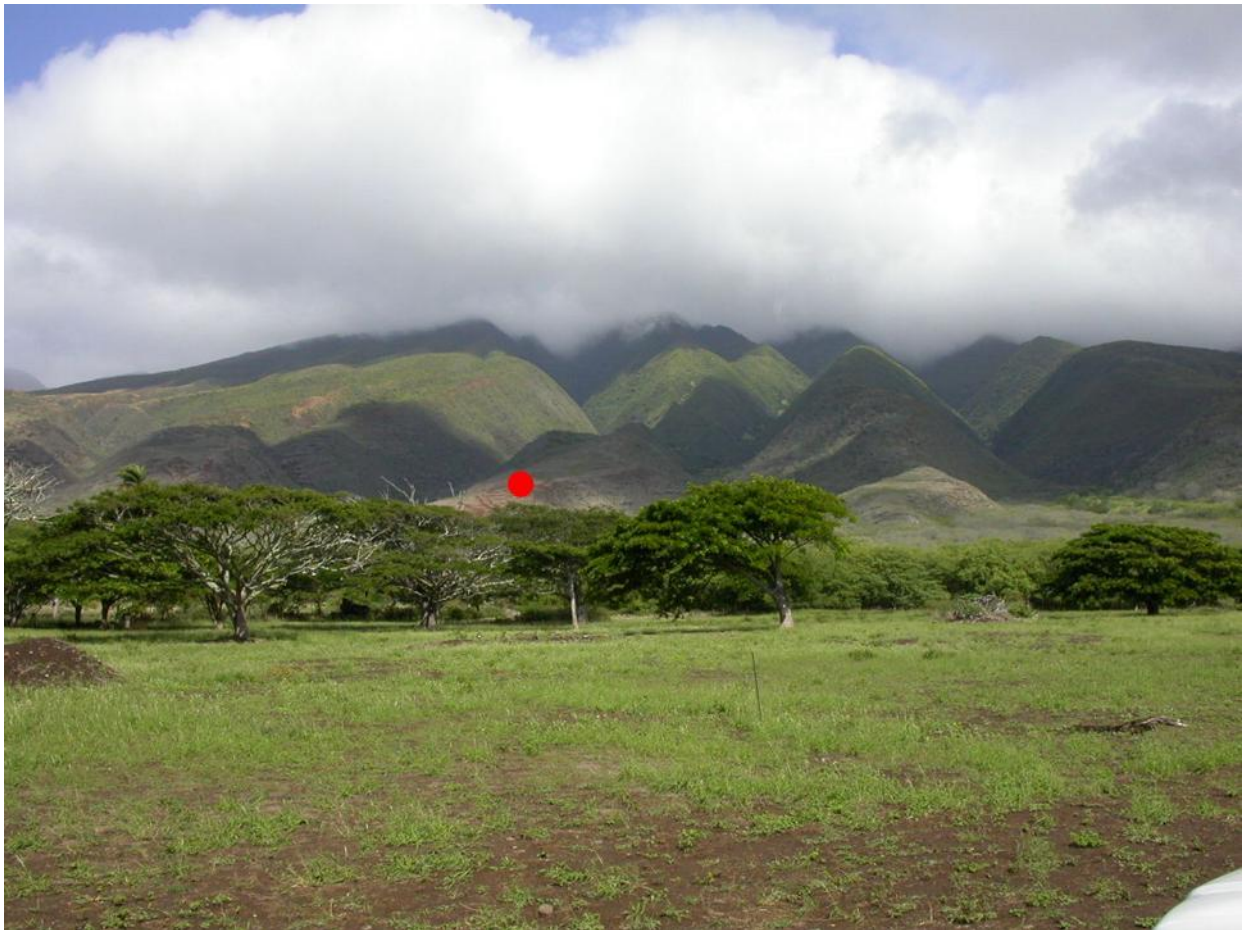
**Figure 8: Mr. Lopez’ View at the Time of the Accident**

Mr. Lopez reported that he was driving on the road when he heard a “woop, woop” sound. He stopped his vehicle, looked towards the helicopter, and caught a glimpse of something falling straight down. He mentioned that he was unsure if the object was falling from the helicopter or not because the area was obscured by fog, heavy rain, and weather. Mr. Lopez then heard a loud explosion followed by an orange fireball. Mr. Lopez proceeded towards a friend’s home to contact 911 before proceeding up the mountain side to assist any survivors. After arriving on-scene, he noted that it started to rain heavily.

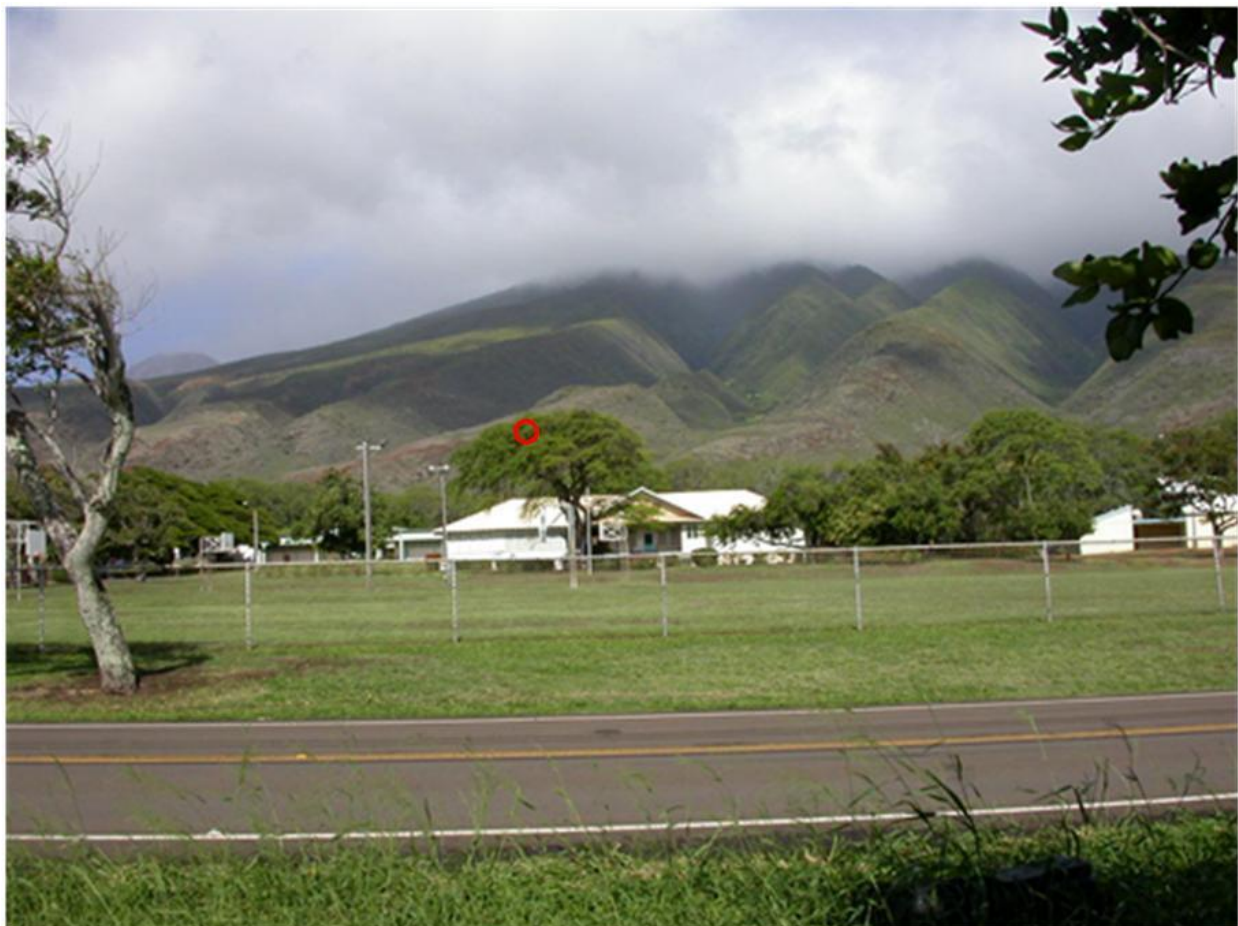
**Figure 9: Mr. Kapuni’s View at the Time of the Accident**

Mr. Kapuni reported that the weather in the area was raining hard with “big rain;” the squall was all dark and the rain was dark; he couldn’t see the mountains. His attention was drawn to the helicopter when he heard a “weird tat, tat, tat noise.” He stated that he saw that the back of the helicopter’s engine was cherry red and looked like the back of a missile. He saw the “red flash” descend straight down fast followed by an explosion. When asked, Mr. Kapuni stated that the helicopter was red for about 2-3 seconds prior to the explosion. Mr. Kapuni further stated that it appeared as if the pilot lost control in the squall.

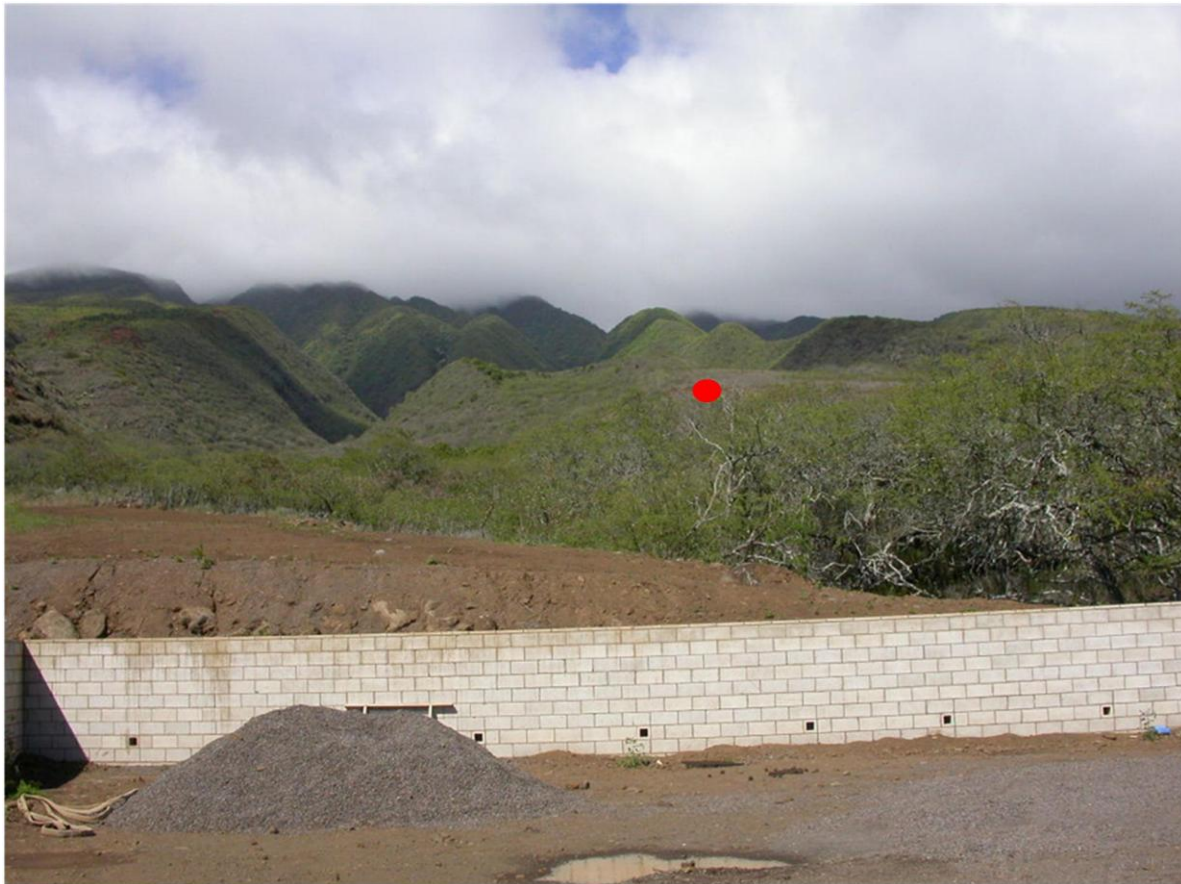
**Figure 10: Mr. Paleka’s View at the Time of the Accident**

Mr. Paleka reported that, at the time of the accident, he was working at a site, which was later measured to be about 1/3<sup>rd</sup> of a mile south of the accident site. He first noticed the helicopter when he heard a “woop, woop” noise, as if the propeller was slowing down. (Note: It was later verified with Mr. Paleka that when he says propeller he was referring to the main rotor blades.) The helicopter was descending down the mountain side and to the right (the pilot’s left) from in between a saddle of a lower ridge. During this time, Mr. Paleka stated that he had observed parts and pieces falling off of the helicopter. He then heard a pop when the main rotor blades “stopped and popped” off of the helicopter. At this time, Mr. Paleka observed that the cabin area was “on fire, no explosion, just fire.” About 10 feet above the ground, the helicopter rolled away from Mr. Paleka showing him its “belly,” descending sideways before striking the ground. When asked, Mr. Paleka stated that the helicopter “went straight down,” it was not spinning. Mr. Paleka further reported that at the time of the accident, the weather was ok and not raining, although it was cloudy back in the valley. He further stated that right after the accident; it started to rain with winds a little stronger than normal.
