**NATIONAL TRANSPORTATION SAFETY BOARD**

**OPERATIONS  
FACTUAL REPORT**

**DCA11MA075**

**Operator:** Omega Aerial Refueling Services, Inc.  
**Location:** Point Mugu Naval Air Station, California  
**Date:** May 18, 2011  
**Airplane:** Boeing 707-321B, Registration Number: N707AR

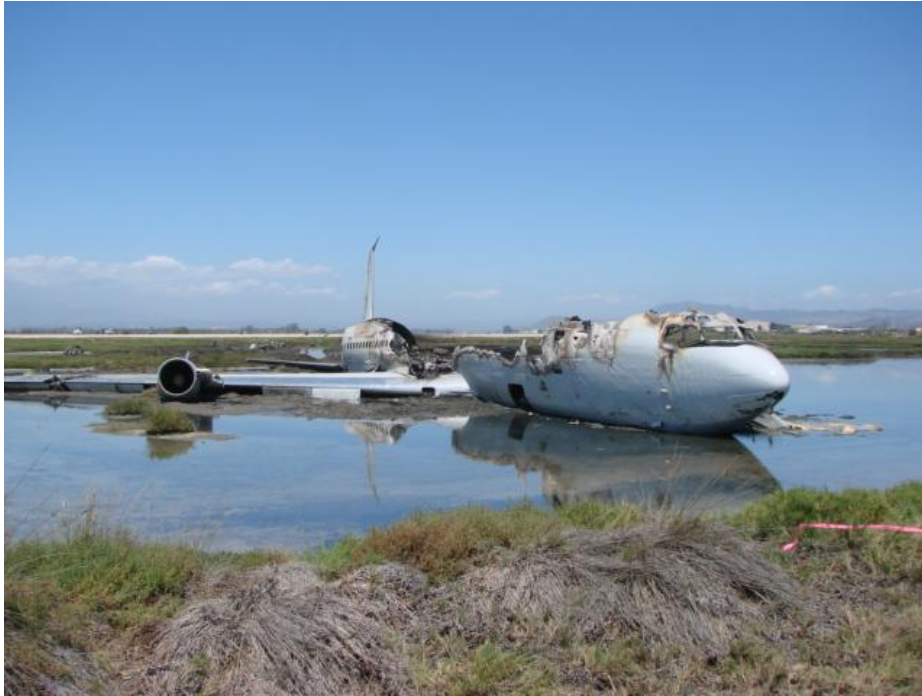
**Photo 1: Accident Aircraft N707AR<sup>3</sup>**

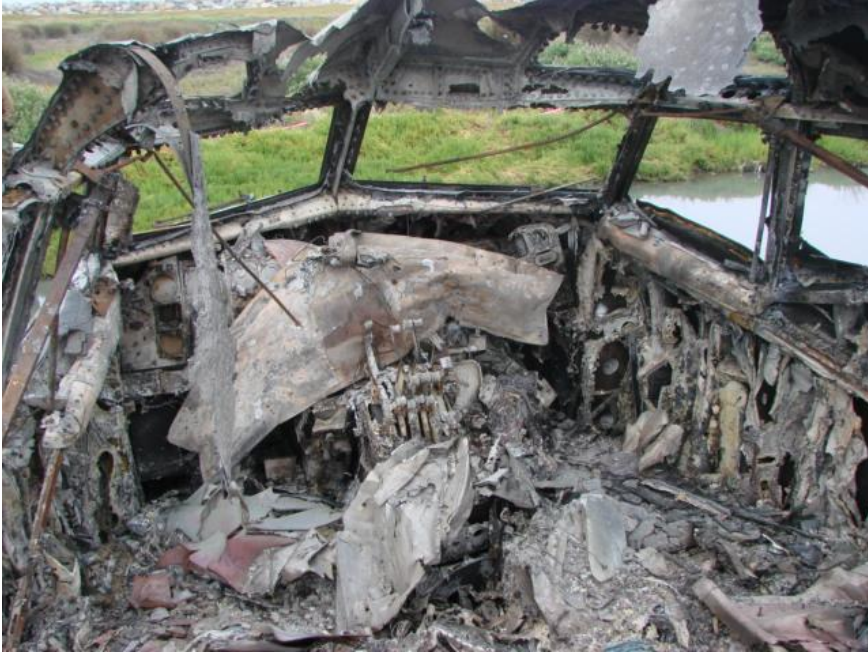
**Photo 2: Cockpit Photo of N707AR.**

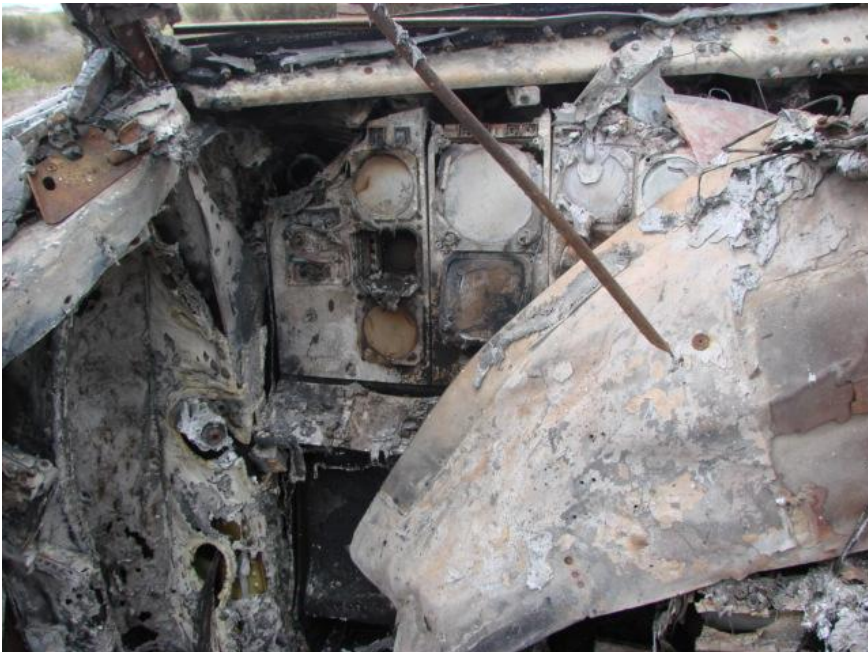
**Photo 3: Captain Instrument Panel of N707AR.**

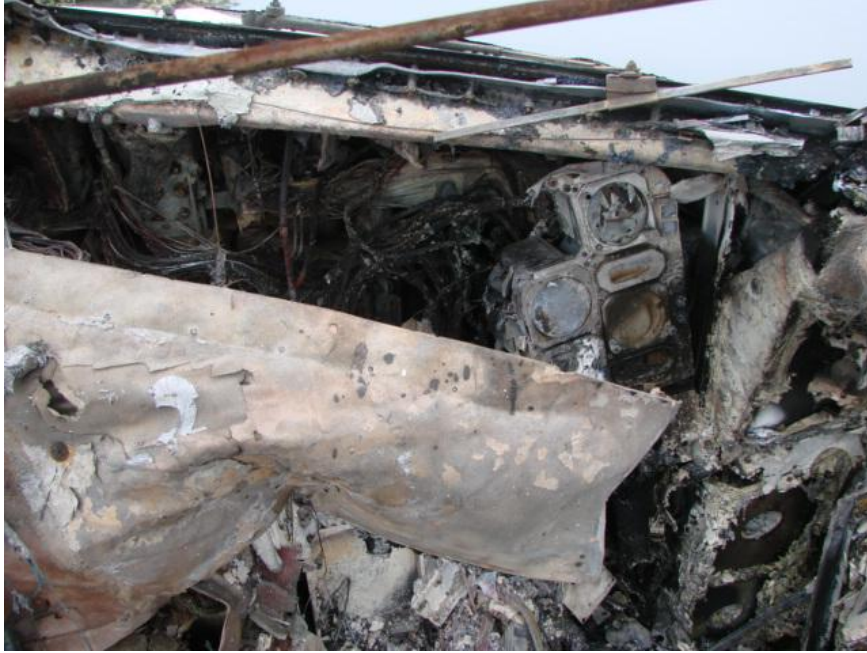
**Photo 4: F/O instrument panel of N707AR.**

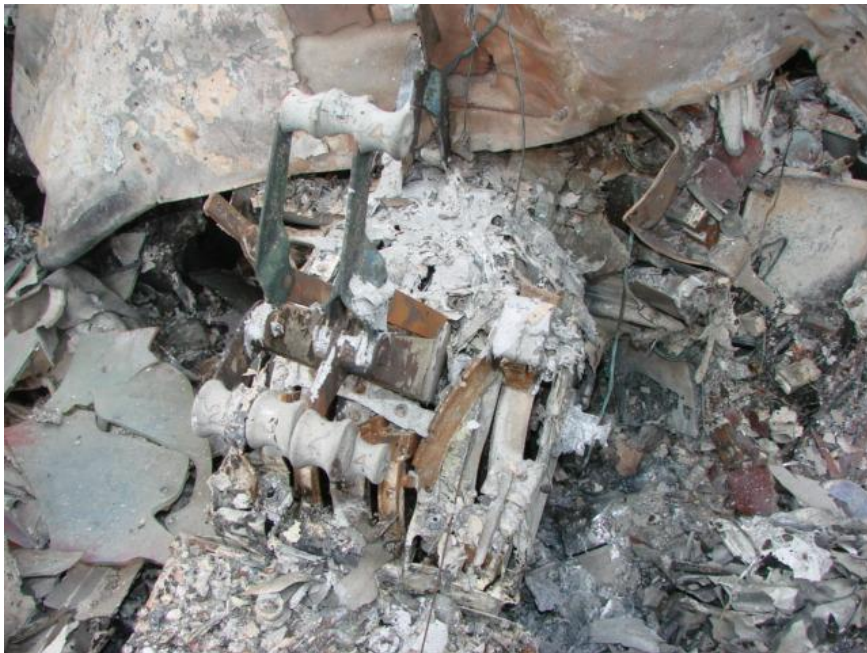
**Photo 5: Throttle Quadrant of N707AR (right side view).**

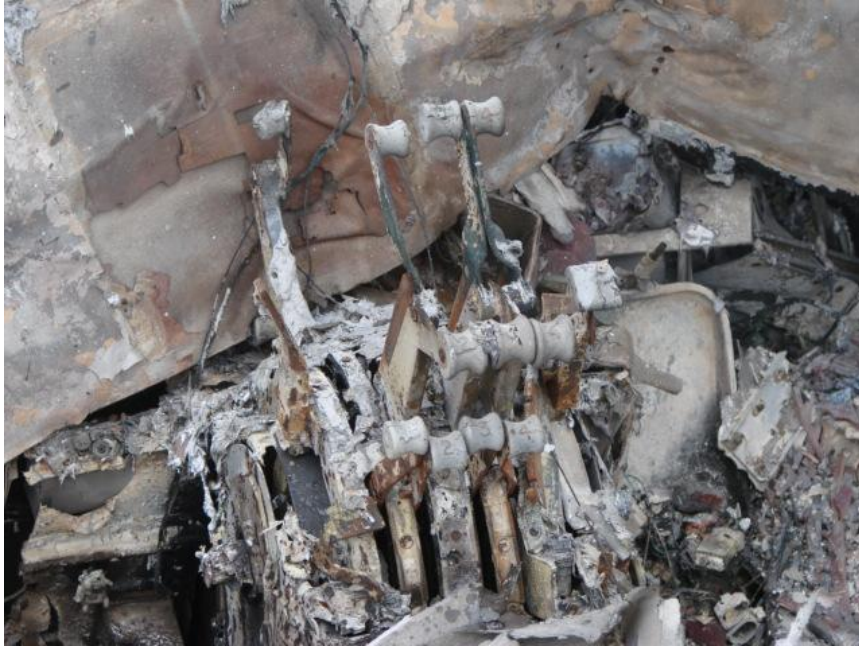
**Photo 6: Throttle Quadrant of N707AR (left side view).**

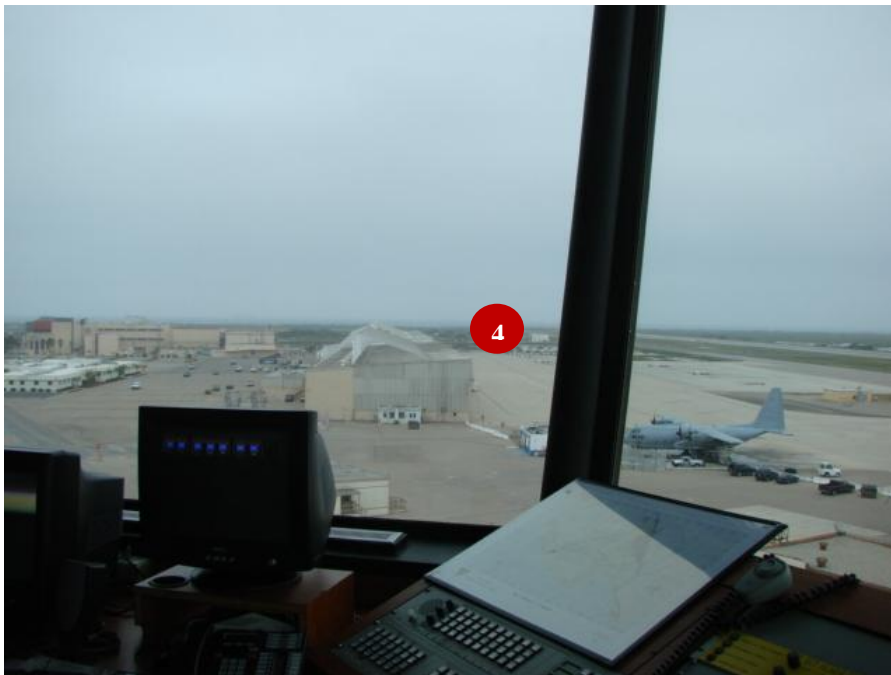
Photo 13: Photo from ATC tower looking toward accident site (4)
