# National Transportation Safety Board

## Railroad Operations – Factual Report of Investigation

DCA13FR008  
Union Pacific Railroad  
Collision  
Hays, Kansas  
July 16, 2013

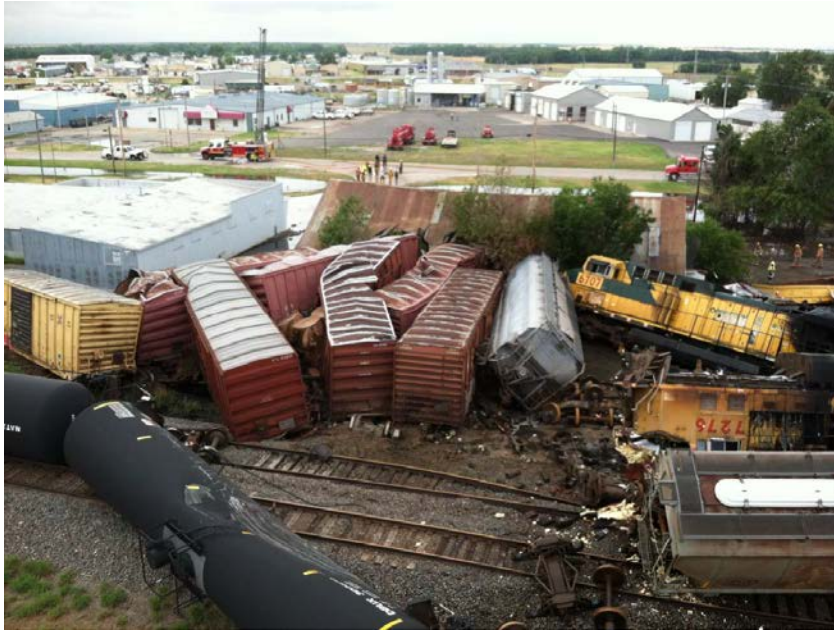
When they struck the standing cars on track 740, their train derailed and in turn the train derailed the standing cars of the LDG89 15 on the adjacent track 141.

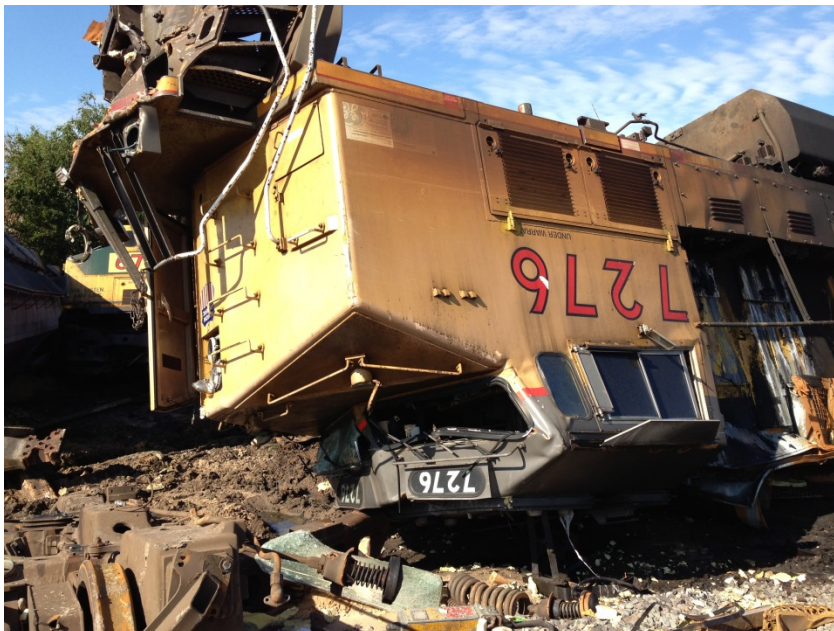
The lead locomotive (UP 7276 West) of the MSIDV 15 turned 180 degrees and ended up pointing east. It also rolled over coming to rest upside down.

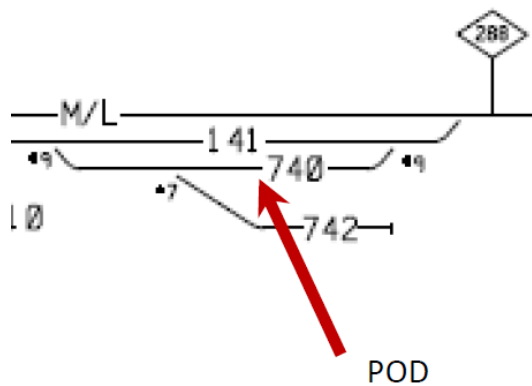
Figure 1 Diagram of Switches

When the brakeman lined the main track switch for Train LDG89 15, he was changing the route from the main track into the passing track 141. He then walked past the switch for the storage track 740 to reach the derail on track 141.

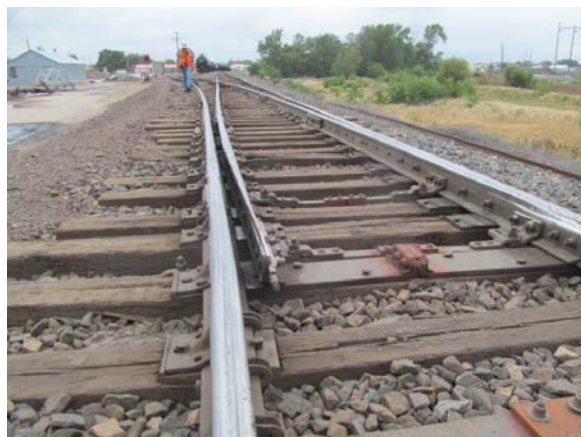
Figure 2 Switch points for track 141.

The main track switch numbered 141, was found lined for the passing track from the main track. In this photograph, the switch is lined for the passing track and trains will diverge to the left.

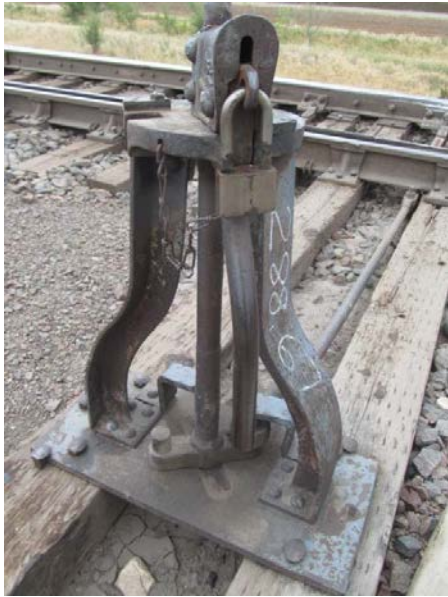
Figure 3 Switch stand and lock for track 141.

The lock was found hooked in the switch for track 141 but the lock was unlocked. When this type of lock is new the key cannot be removed unless the lock is locked. However, this lock was tested and the key could be removed without the lock being locked.<sup>2</sup>

<sup>2</sup> With repeated use, the mechanism that prevents the keys from being removed will wear out.

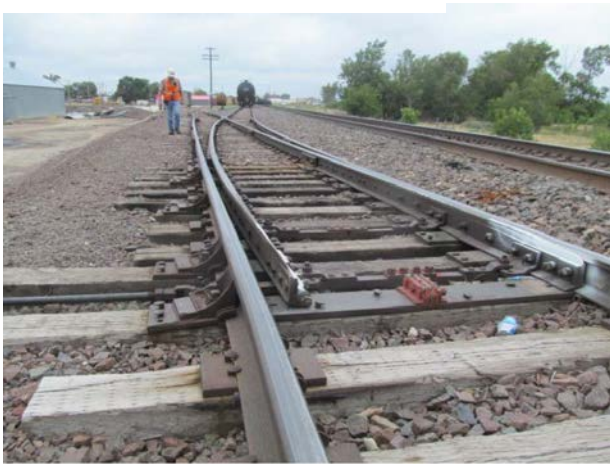
Figure 4 Switch points for track 740.

The switch for track 740 was found lined for track 740 and not for the passing track that train LDG89-15 had entered. This is the track train MSIDV 15 entered and struck the stored steel cars.

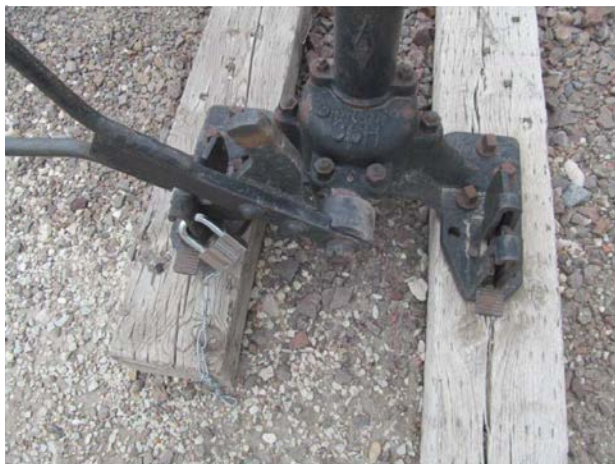
Figure 5 Switch stand and lock for track 740.

The switch for track 740 was found lined and locked for trains to enter track 740.
